ARBORICULTURAL REPORT & Impact Assessment to BS 5837:2012 at:

***5 Willow Bank,
Barnsley,
S75 1BN***

Prepared for:
NYPAS Ltd

Reference: *AWA6389*

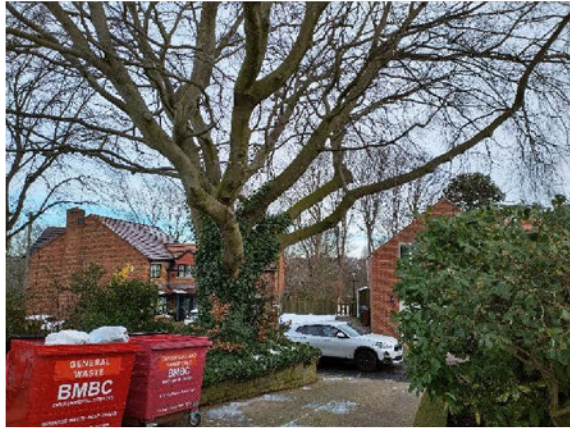
- 3.2.7 Most of the trees are semi-mature with occasional early mature to mature trees.
- 3.2.8 The sites most significant tree is T1, a mature Beech. Situated in the northeastern corner of the site, within a raised planting area, this tree is prominent throughout the site and surrounding area, with a moderate level of amenity value. Beech T1 has previously been crown lifted above the

road and away from the telephone wires running through the eastern crown but is generally in good condition with good long-term prospects. T1 is covered by a Tree Preservation Order (Ref: 6/G1) and is a retention category 'A' tree.

Photo 1: T1 from southwest.

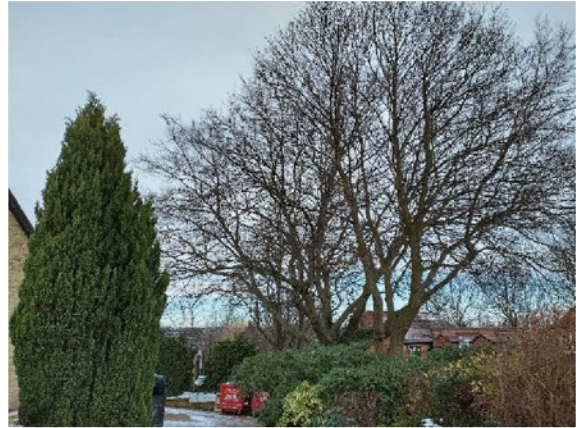
- 3.2.9 Other notable trees on site are the retention category 'B' trees: Sycamores T2, T4 and Beech T9. T2 and T4 are early mature Sycamore trees on the eastern front of the site within raised garden planting areas. Both are located within planted shrubbery groups and have old pruning wounds and minor dead wood within the crown. Both T2 and T4 are in overall good condition, with good long-term prospects and provide a moderate level of amenity. T2 and T4 are also both under a Tree Protection Order (Ref: 6/T2 and 6/G2 respectively). T9 is an adjacent early-mature Beech tree situated within the adjacent garden to the rear of 5 Willow Bank. T9 is twin stemmed and has old pruning wounds and stubs but appeared to be in good condition, with moderate amenity value.

Photo 2: T1 and T2 from southwest.

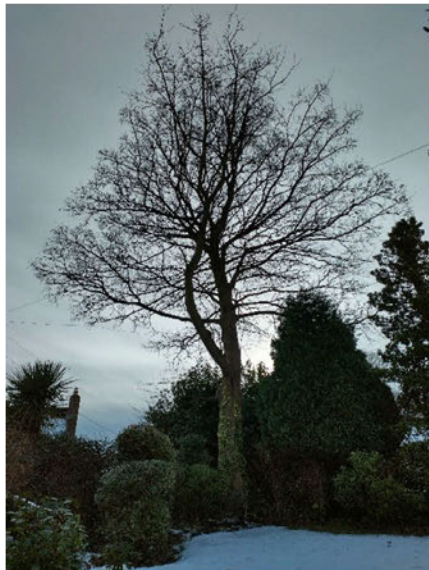
Photo 3: T4 from northwest.

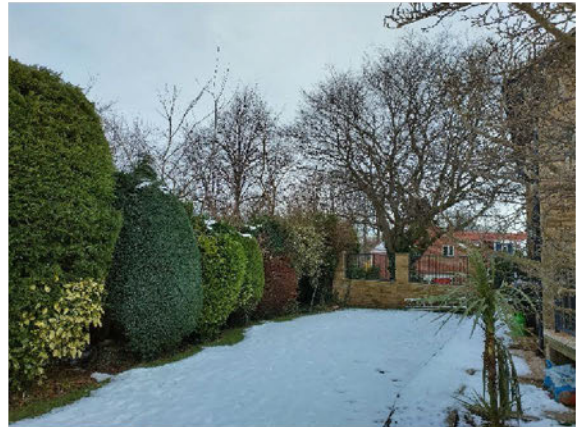
Photo 4: T1 and G7 from southwest.

- 4.2.1 From assessing the new development proposals, no trees or tree groups will require removal to facilitate the development.
- 4.2.2 1 tree group requires minor pruning to facilitate the development – G7.
- 4.2.3 G7 requires minor pruning back from the south to facilitate the proposed games room. Reduce the southern crown by 1m to provide adequate clearance for the proposed development. Do not prune beyond the boundary.
- 4.2.4 G7 is a retention category 'C' group and the required pruning works are very minor. The pruning works will have no long-term negative impacts on the trees within G7.

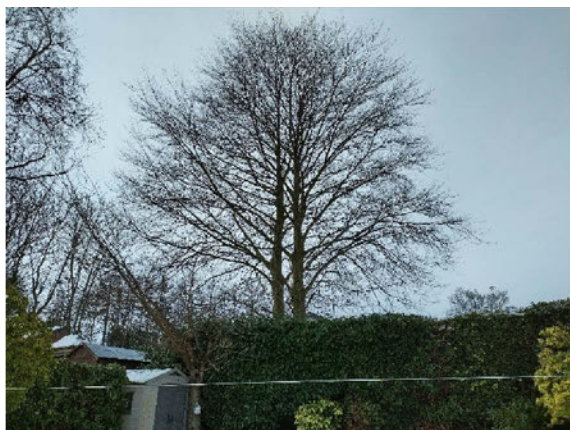
Photo 5: T9 and T10 from east.

T9	Beech	<i>Fagus sylvatica</i>	Early-mature	17	2	300, 300	Yes	5	6	7	6	5	Limited access around base	Twin stemmed at 1m. Vertical. Epicormic growths. Old pruning wounds. Stubs	Old pruning wounds. Minor dieback. Minor deadwood	Within adjacent property with limited access at base. Measurements estimated.	Good	Good	>40 yrs	Moderate	B	No works required to facilitate the development.
T10	Cherry	<i>Prunus sp.</i>	Semi-mature	7	1	380	No	2	3	5	7	1	No visual defects	Single stemmed. Vertical. Epicormic growths. Old pruning wounds. Stubs	Old pruning wounds. Minor dieback. Minor deadwood	Has been previously topped at 2m. Has been harshly pruned back in the past with some epicormics growths. Bird box attached to stem. Some cavities with decay on the branches in the crown. Situated unsuitably close to shed.	Fair	Good	10 to 20 yrs	Low	C	No works required to facilitate the development.

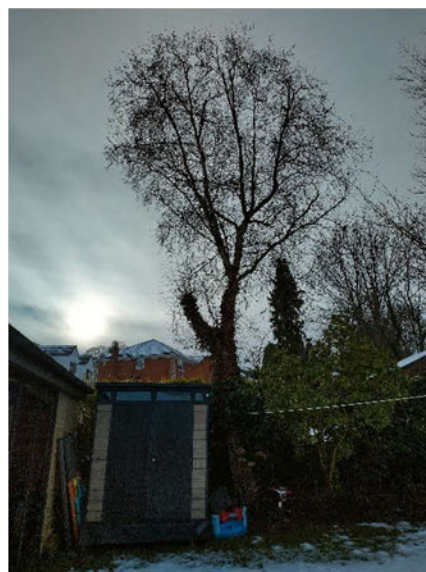
Photo 6: T11 from north.

Tree Species		Measurements					Crown (m)				Tree Condition				Value		Management					
Tree ID	Common Name	Latin Name	Maturity	Height (m)	Stems	Stem Diameter (mm)	Estimated	Crown height	N	E	S	W	Roots	Stem	Crown	Comments	Physiological	Structural	Life Expectancy	Amenity	Category	Works
	T11	Birch	<i>Betula pendula</i>	Early-mature	12	1	380	No	3	3	3	4	3.5	No visual defects	Single stemmed. Slight lean. Epicormic growths. Old pruning wounds. Stubs	Old pruning wounds. Minor dieback. Minor deadwood	Limb above garage has been previously removed. Slightly leaning eastwards but corrects itself at 4m. Dead ivy covered on stem.	Fair	Fair	20 to 40 yrs	Low	C

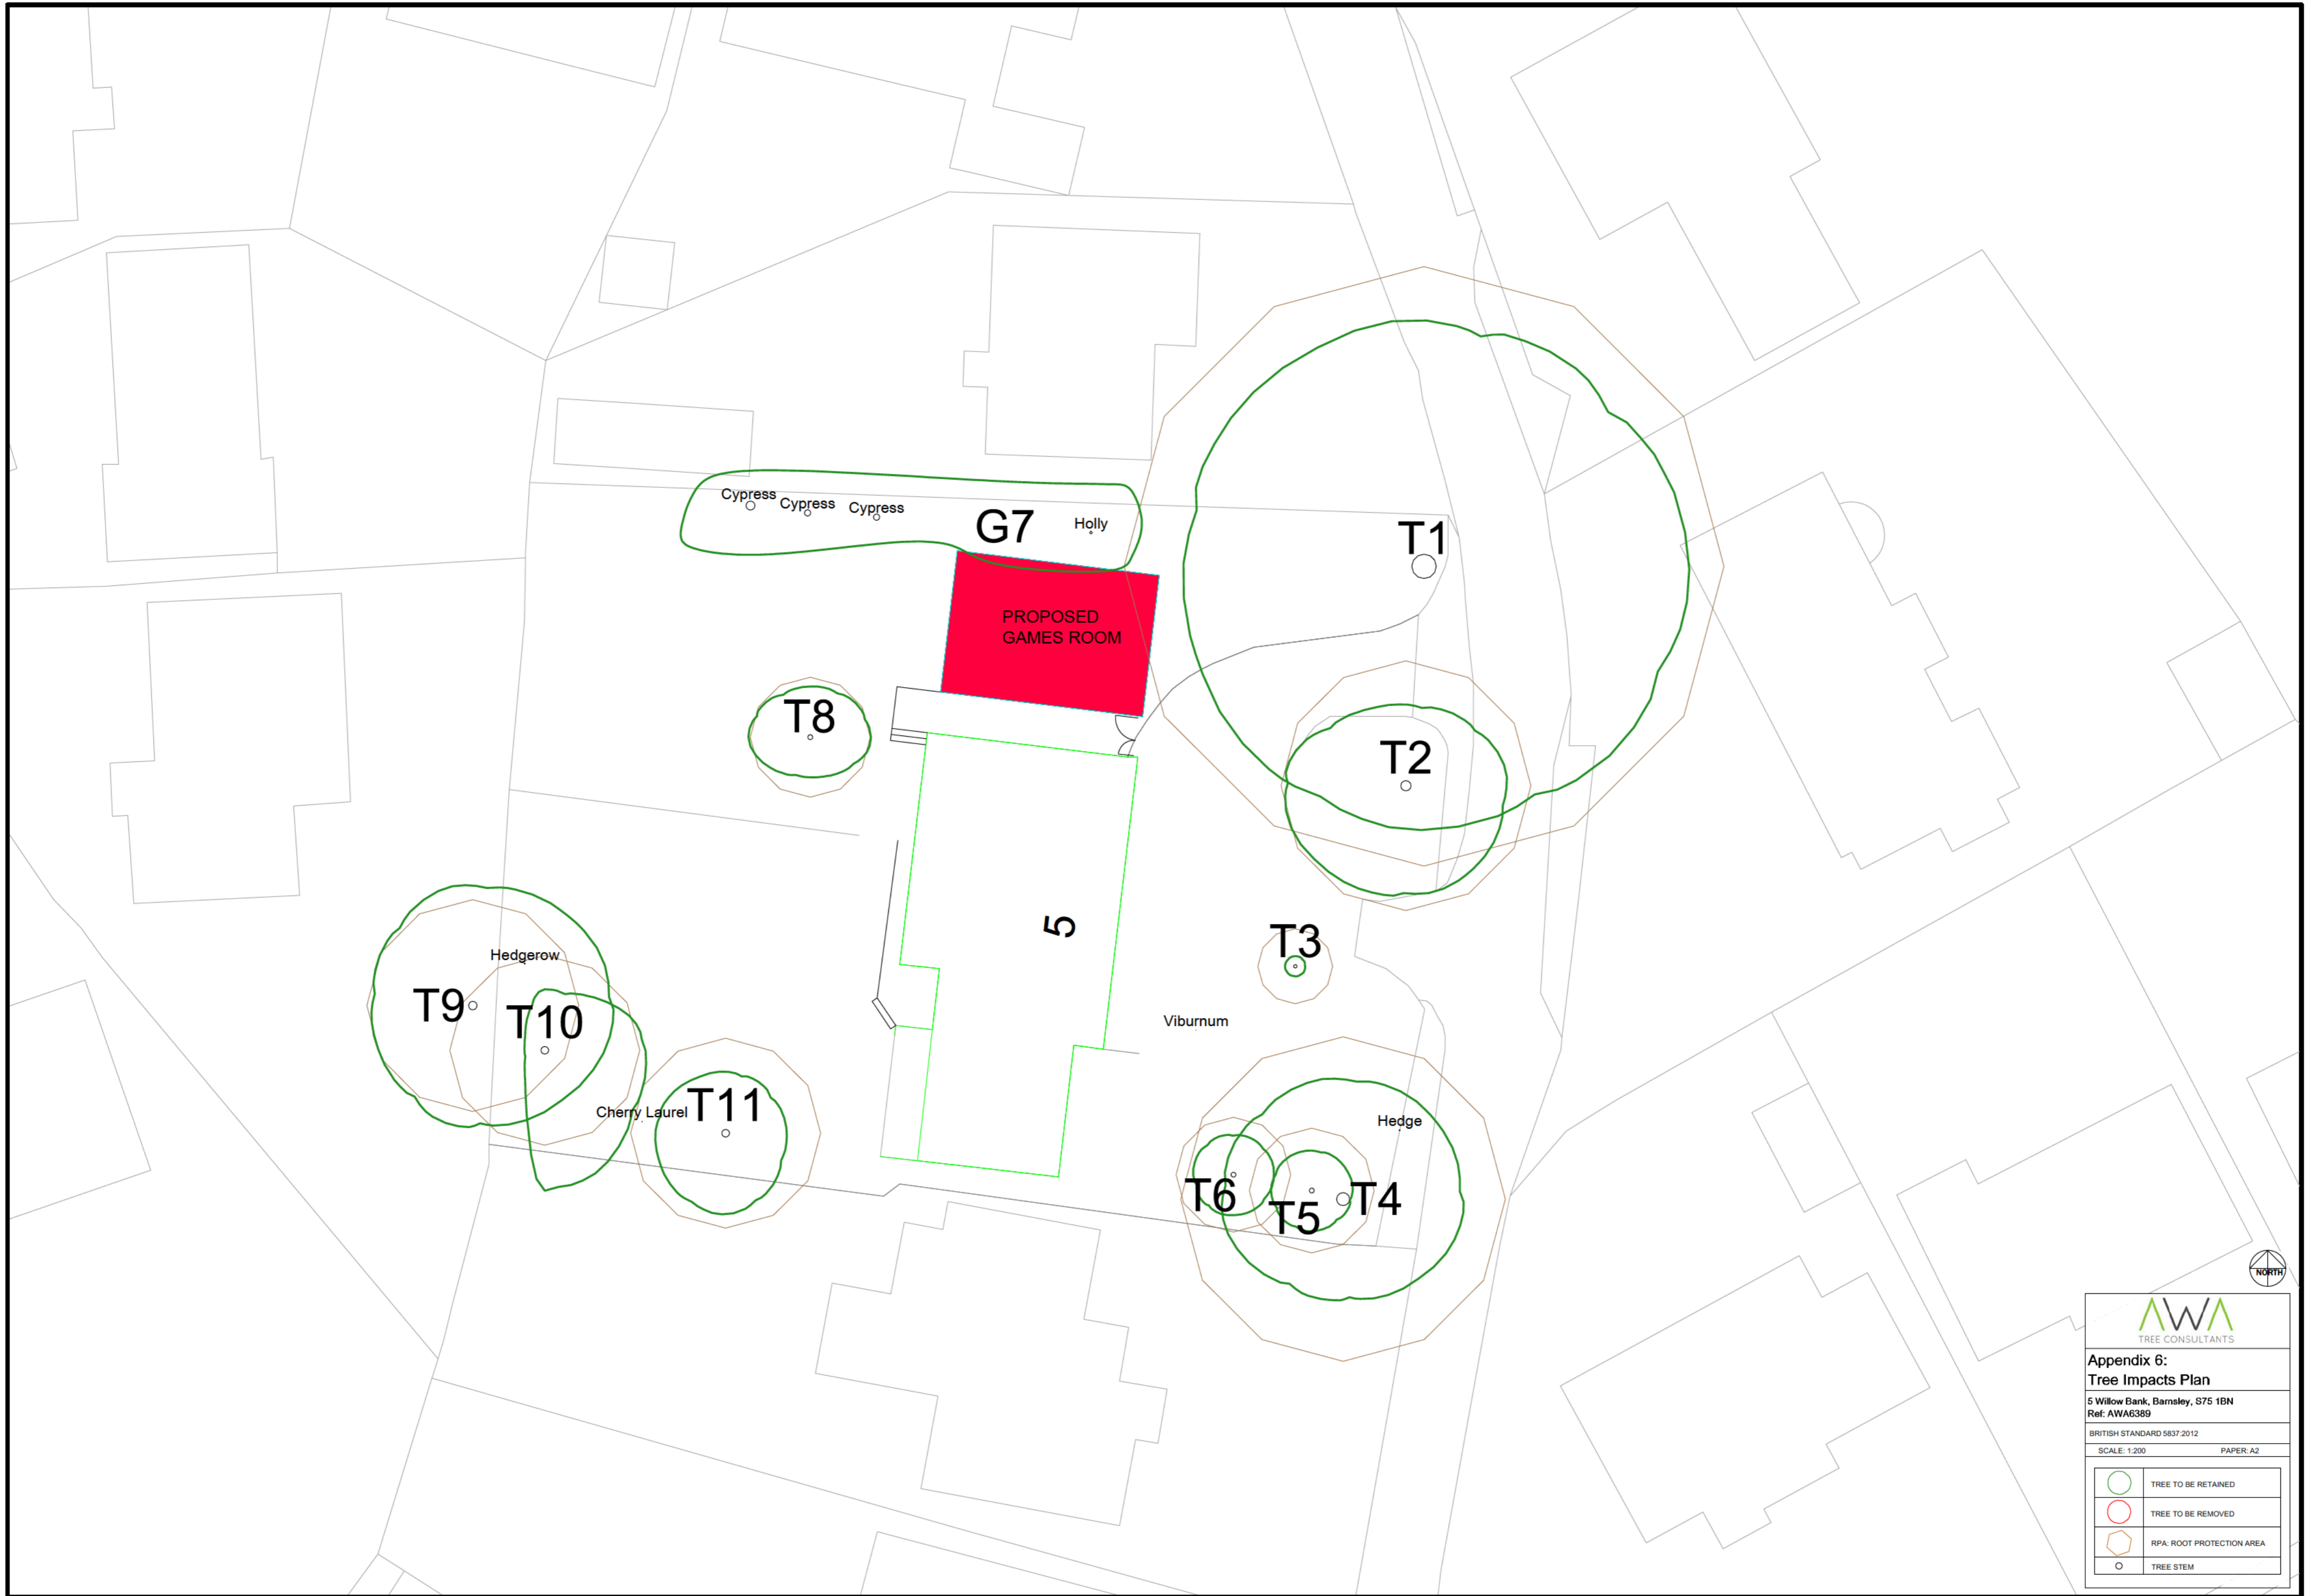
**Appendix 6:
Tree Impacts Plan**

- 4.3.2 Potentially damaging activities are proposed in the vicinity of retained trees. The new development encroaches close to and into the edge of the RPA of T1. Construction within the RPA, can have negative impacts on tree roots. However, the encroachment is very minor, and there is existing hard standing for the driveway and road surrounding the stem of T1 which has likely limited the extent of the roots within the area of the proposed games room. As such, it is unlikely that significant roots will be within these areas and the retained tree will remain largely unaffected by the works, provided care is taken during construction.

4.4.1 The retained trees will require protection by fencing in accordance with BS 5837: 2012, during the development phase.
