Ref: AWA5872

# **Arboricultural Risk Report**

## **THE LAITHE, 38 HAIGH LANE, HOYLANDSWAINE, SHEFFIELD, S36 7JJ**

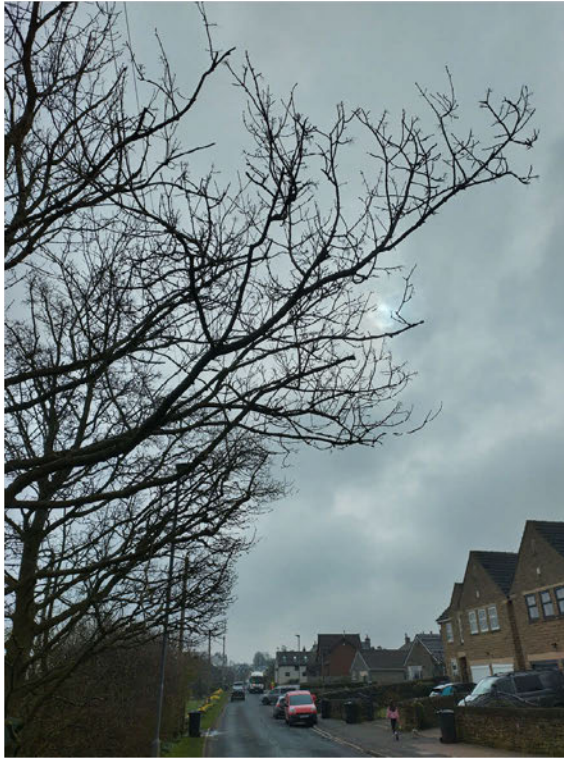
**T1 Crown overhanging looking south east**

- Frequent stubs and minor deadwood in crown with the occasional sections of moderate deadwood, particularly in the upper central crown and over the adjacent road.

- Occasional lesions at 3<sup>rd</sup> order branch junctions with frequent dead epicormic growths.
- Crown is sparser than usual, showing moderate deadwood and dieback within the central crown. Moderate symptoms of Ash Dieback Disease in upper crown - Class 2 level – 75% - 51% of crown remains.

- The tree currently has a Tolerable / Low level of risk; however, the tree has limited long-term prospects, and the level of risk is likely to increase in the next few years as the Ash Dieback Disease progresses.
- Remove tree and replant with suitable replacement species.

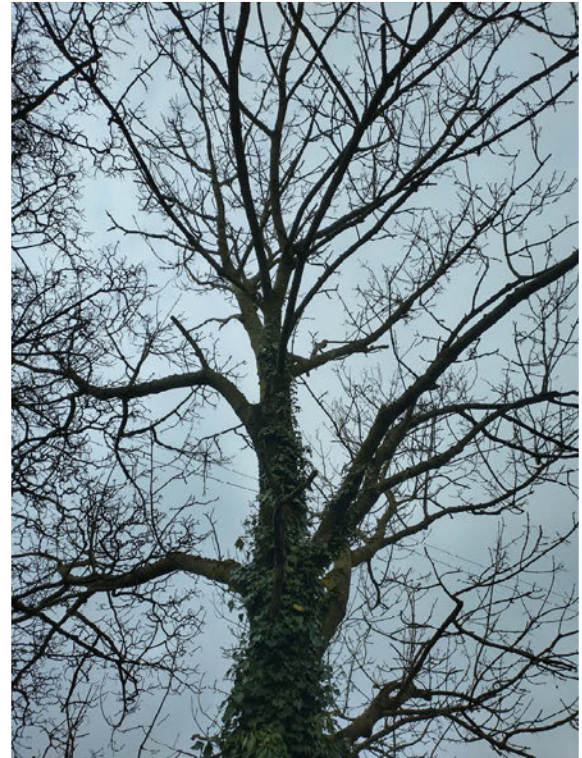
**Lower crown of T1**

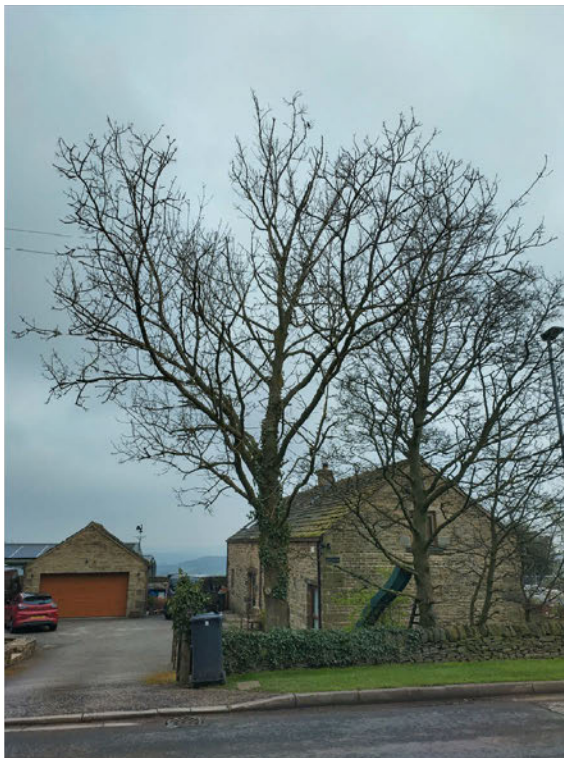
**T1 looking north east**

- The tree is situated at the site's southern boundary overhanging Haigh Lane to the south. A driveway is situated to the west of the tree and garden areas to the north and east.

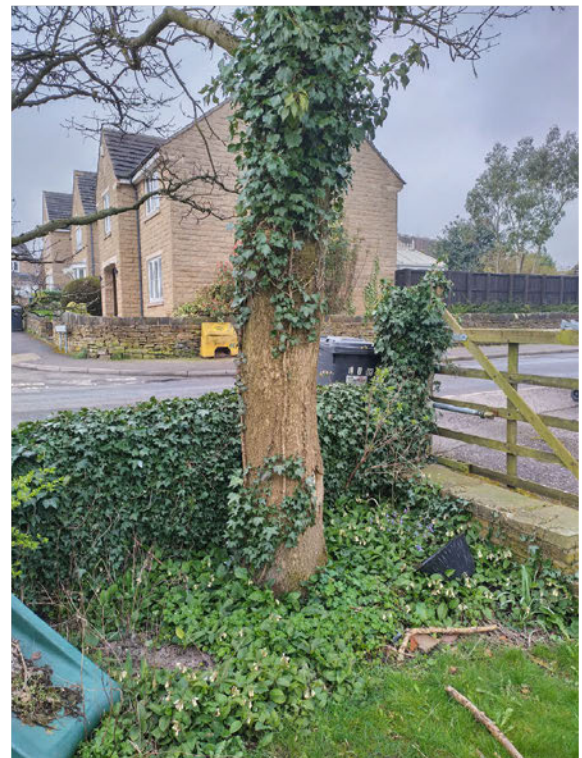
**Stem of T1 looking south west**

- There were no visible defects to the roots or surrounding ground at the time of the survey.
- The stem features a 20cm long bark wound at 0.5m above ground level on the north west side but there were no signs of decay with good occlusion. There are some small old pruning wounds to the stem at 2m and 3m above ground level to the south west. The stem has some ivy coverage from the base up to 6m.
