Our Ref: TCH/JM/311

28 March 2012

Structural Inspection - 27/29 George Street & 1 Kings Croft, Worsbrough Dale, Barnsley

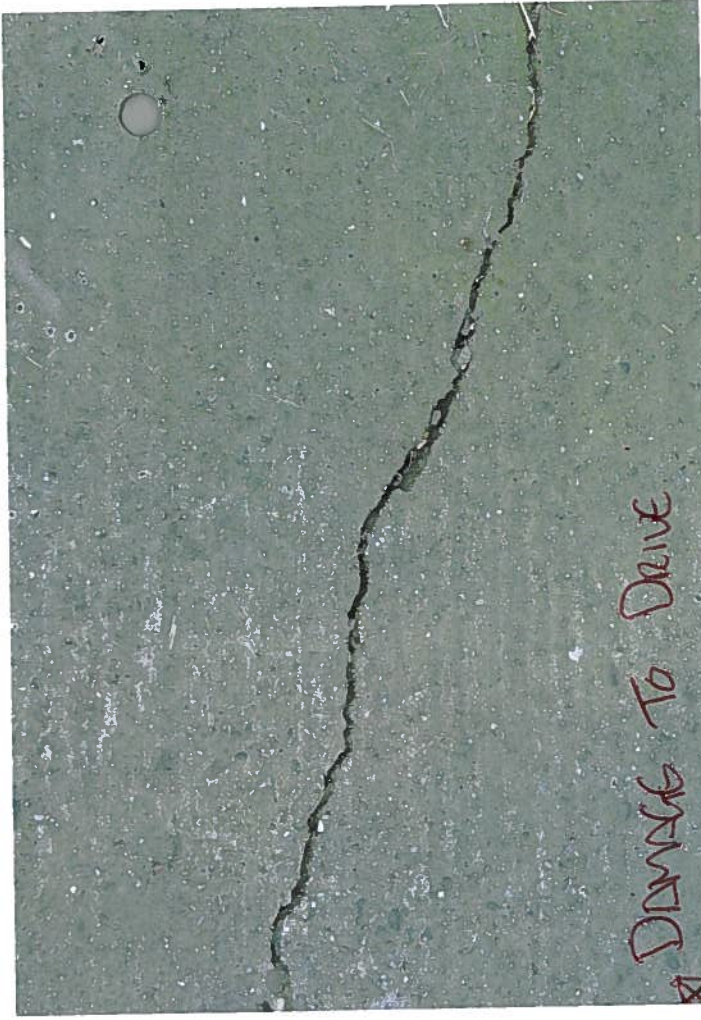
Damage To Drive

The ground immediately alongside the rear of No. 27 was in situ concrete paved and this displayed relatively noticeable fracturing particularly in the vicinity of the drainage inspection chamber cover and with the cracking to the concrete again possibly caused by the vegetation.

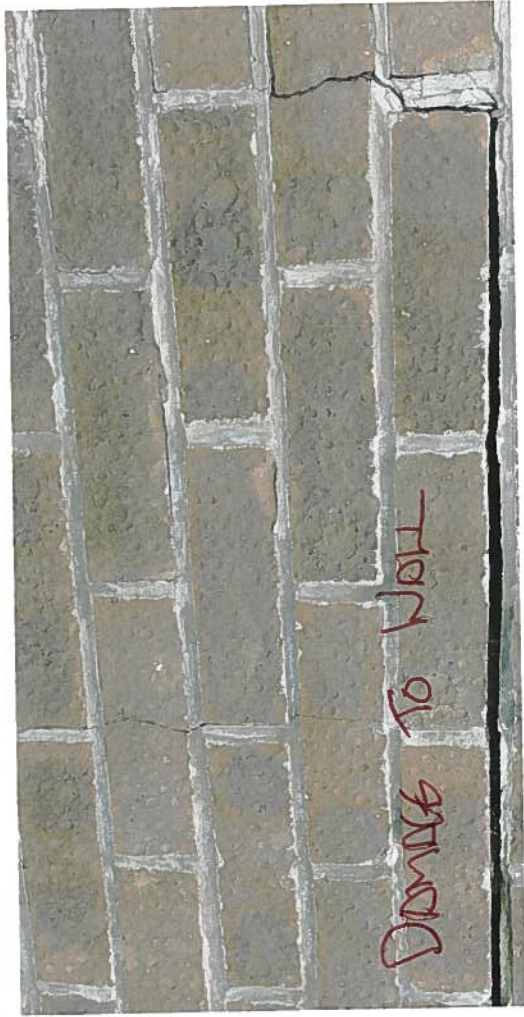
Damage To Wall

This wall displayed relatively pronounced stepped and bed joint fracturing consistent with a differential foundation movement of the wall.

In addition to the cracking along the brick jointing, individual bricks were sheared at a number of positions. The cracking was considered to be recently active and in view of the proximity of the two trees must be assumed to be associated with seasonal ground moisture changes due to the vegetation possibly compounded by the physical presence of roots immediately beneath the apparently relatively shallow foundations of the wall.

The damage to the boundary wall between 27 and 29 George Street is considered to be associated with the root moisture demands of the trees causing seasonal differential movement of the foundations to the wall, and with this possibly combined with the effect of physical root presence from the substantial trees.

It is, therefore, felt that significant reduction in this tree presence should be considered in order to ensure the long term stability of the boundaries and especially the retaining wall between Nos 27 & 29 .

It is considered unrealistic for this wall to be made stable unless by means of piled underpinning. The cost of such would be high.

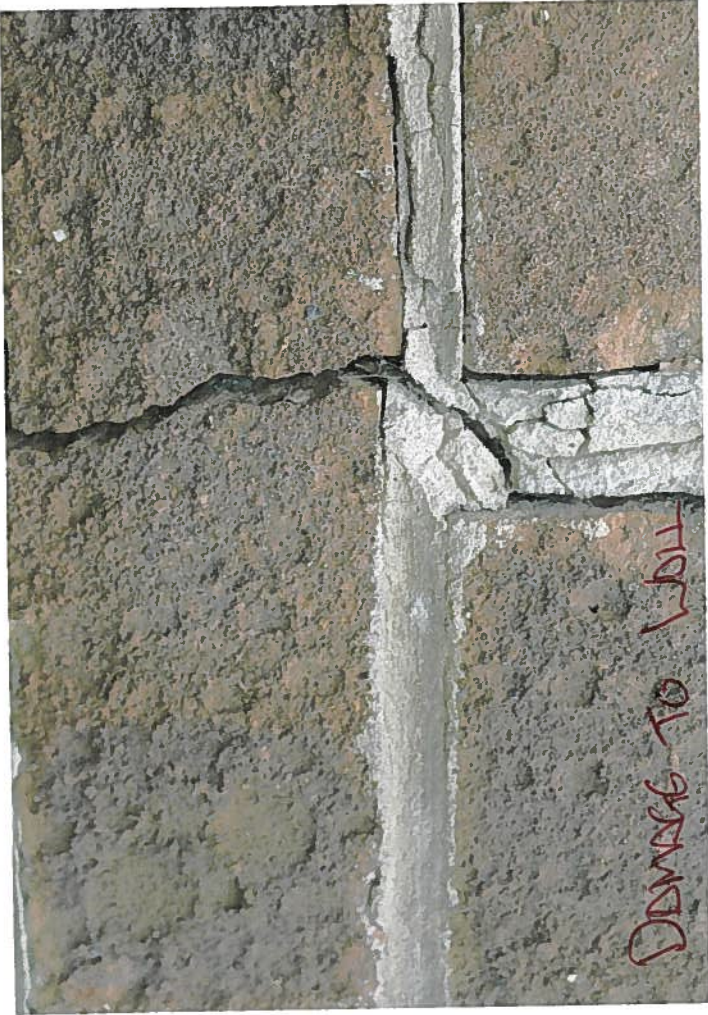
Damage To Wall

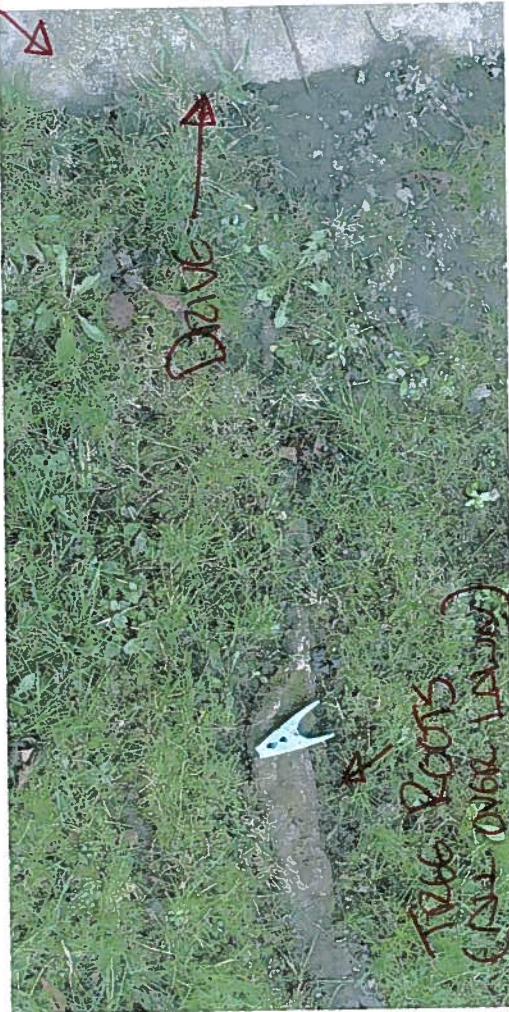
DRIVE

TREE ROOTS
(SEE OVER LEAF)

In addition to the cracking of the wall the physical presence of the substantial roots to the trees was noted within the lawn area with this again demonstrating the potential for structural damage to occur to the boundary wall due to the presence of the vegetation.
