# **Structural Conditional Report for Existing Boundary Retaining Wall to Plot 2 Delf Garth, Dodworth**

Prepared for:  
Mr & Mrs D Whitaker

**Design - it**  
**Structural Solutions Ltd**

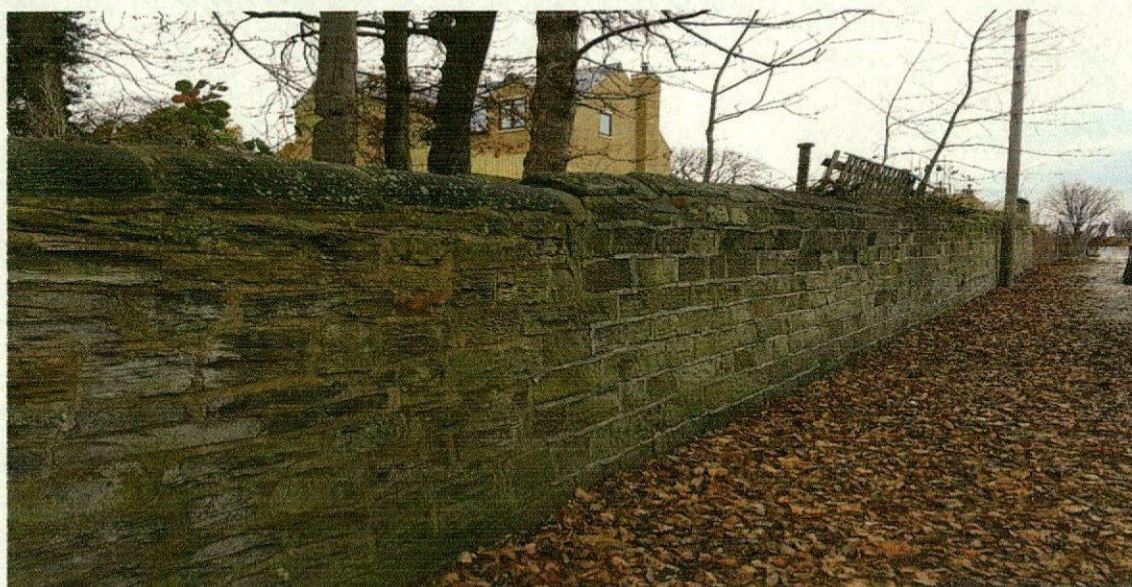
**Photo 1**

From our observations, the boundary retaining wall is of solid coursed stone construction, approx. 450 thk, which extends 30m from the bottom corner boundary back up the hill before the construction changes to a 9" solid brick built wall. The existing stone wall is approx. 1.8m in height, of 8 courses and a coping / header stone. Refer to Photo 1.

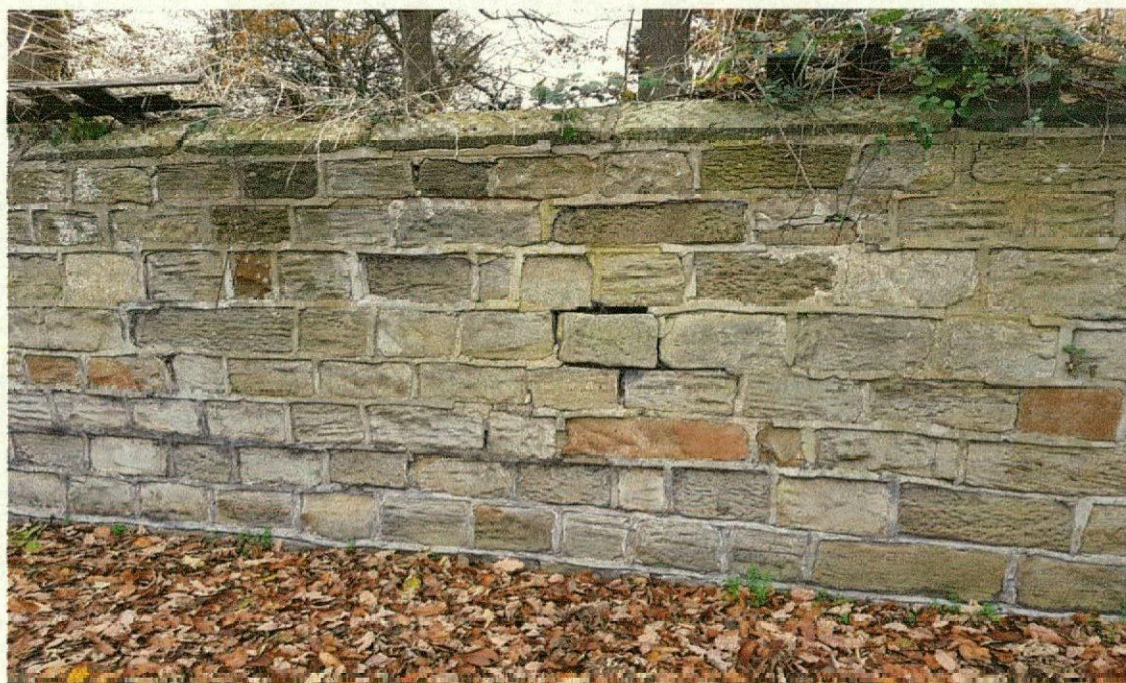
**Photo 2**

It is our opinion that it will be necessary to undertake rebuilding works to the existing stone boundary wall. The lower section of the boundary wall, from the existing telegraph pole to the corner of the site, approx. 20m in length, has suffered distortion. The stone construction appears to be bulging, and sections of the coursed stone are cracked on the bed joints. Refer to Photo 2. We suggest that the structural issues viewed are a direct result of the influence of existing trees, which are in very close proximity to the boundary wall, refer to Photo 3.

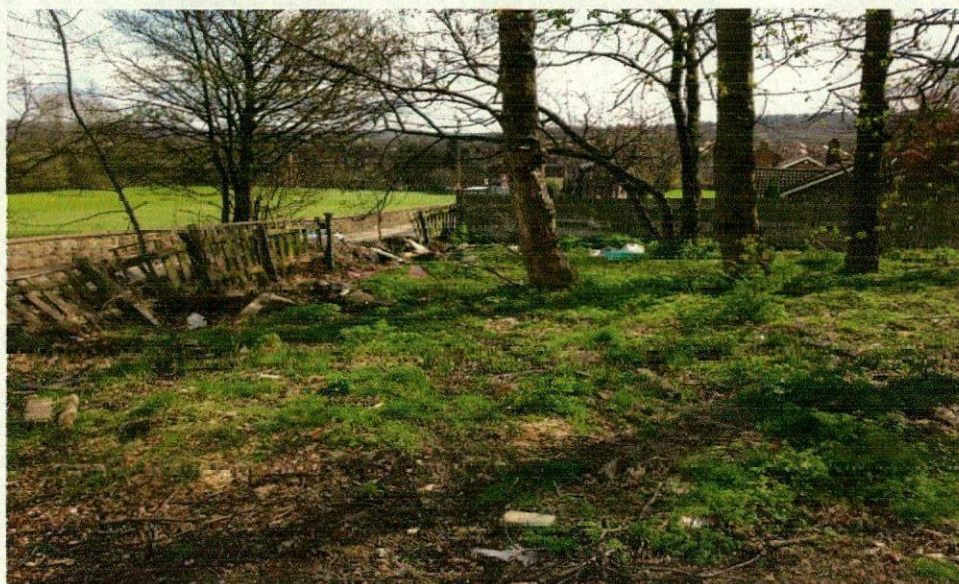
**Photo 3**

We would suggest that although the wall has been damaged, due to pressures from tree root growth, it does appear that the wall is rotating about the foundation. From our inspection of the wall, the 2 courses of stone above pavement level appear to be structurally sound with no distortion. This would suggest that tree roots have pushed the upper section of the stonework outwards.

We would suggest that if the trees are removed this will remove surcharge pressure off the back of the upper section of the wall. In this regard, appropriate remedial works would be to take down rebuild and realign the upper section of the wall. To be able to undertake rebuilding remedial works to the wall, and to maintain the structural integrity following repairs it will be necessary to remove trees T1 – T5, as noted in AWA's report.

4. Removal of the top 7 courses of the wall, including the header stones, can be undertaken. This could be carried out in sections or in its entirety.
5. Re build the wall, using existing stonework if possible, allowing for movement joints in the coursed stone at 10m max intervals and/or at steps in the wall line depending on the wall span between previous joints.
