# **91a High Street, Dodworth, Barnsley, S75 3RQ**

## **Preliminary Roost Appraisal**

Final Report

30 November 2024

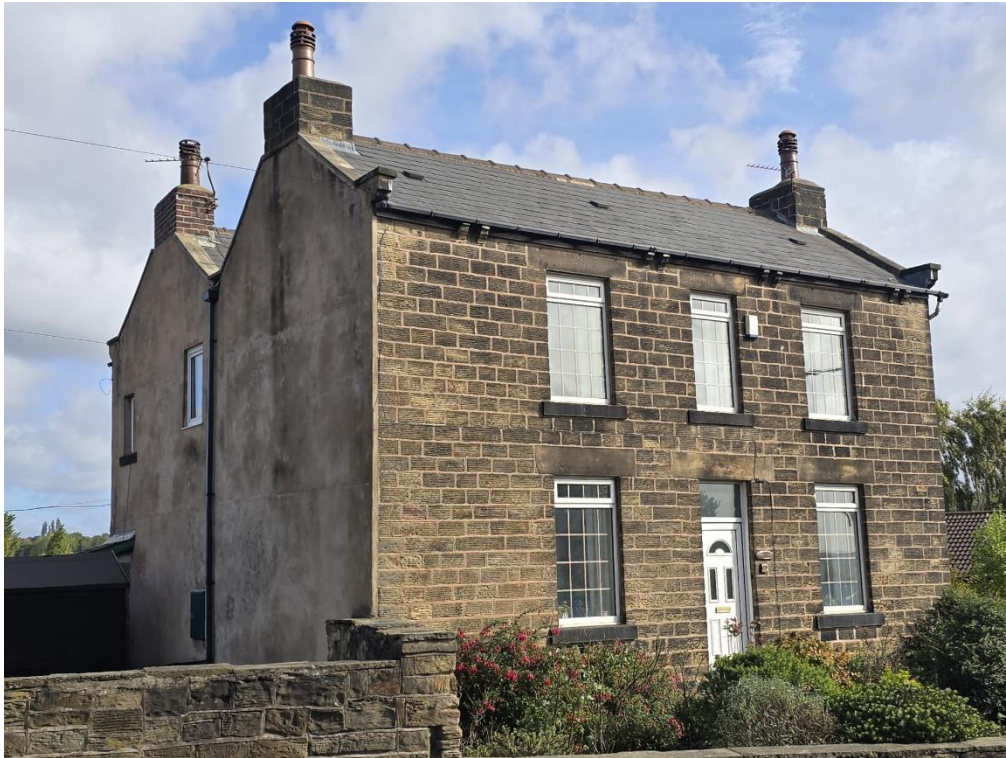
Photograph 1: Front of main house

- 3.6 The following was noted:
- The building is two storey, double pitch house. The walls are constructed from brick, with rendered gable ends.
  - The roofs are pitches, with slate tiles and clay ridge in good condition. The roofs look tight with no visible gaps. Through use of close focussing binoculars it was possible to examine the tiles on both of the middle pitches of the building.
  - The window and door frames are constructed from uPVC.
  - There are four chimneys present. All flashing looks tight with no visible gaps.
  - No signs of nesting birds were recorded.

3.8 The house is considered to hold negligible potential to support roosting bats due to a lack of suitable access points, or roosting opportunities.

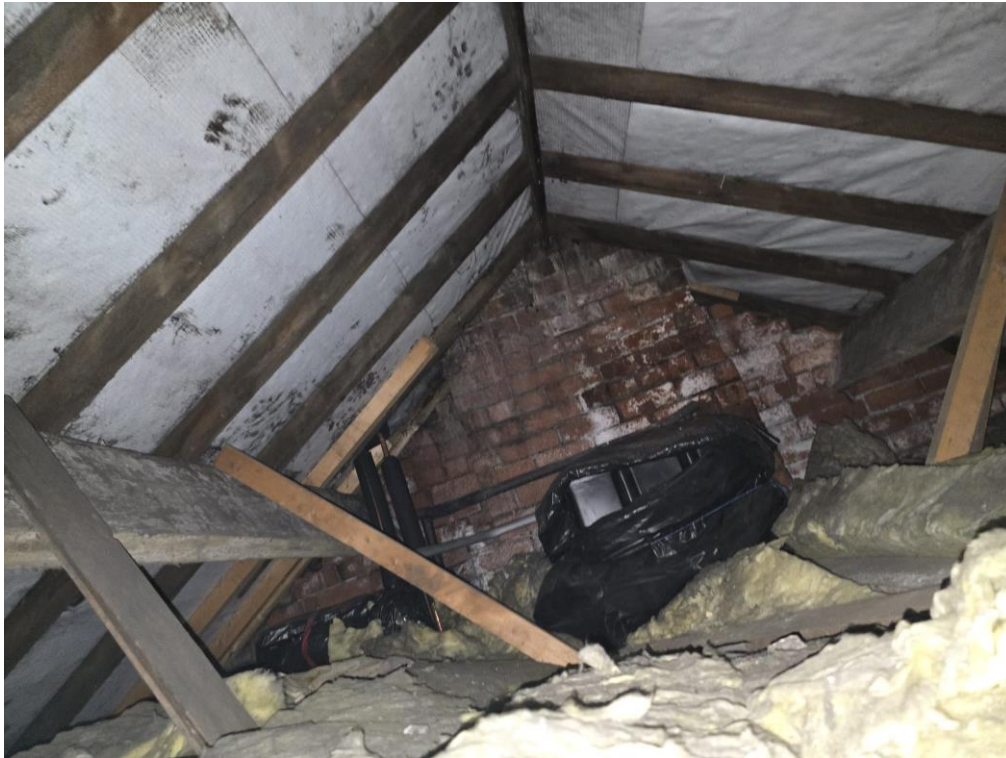
Photograph 3: In roof void of main house

- The beams, struts and purlins are constructed from wood.
- There is a breathable membrane liner in the void.
- Fibreglass insulation is present, covering a lot of the rafters. This is in reasonable condition.
- There is a disused water tank present which is fully covered.
- No signs of bats or bat droppings were recorded in the void.

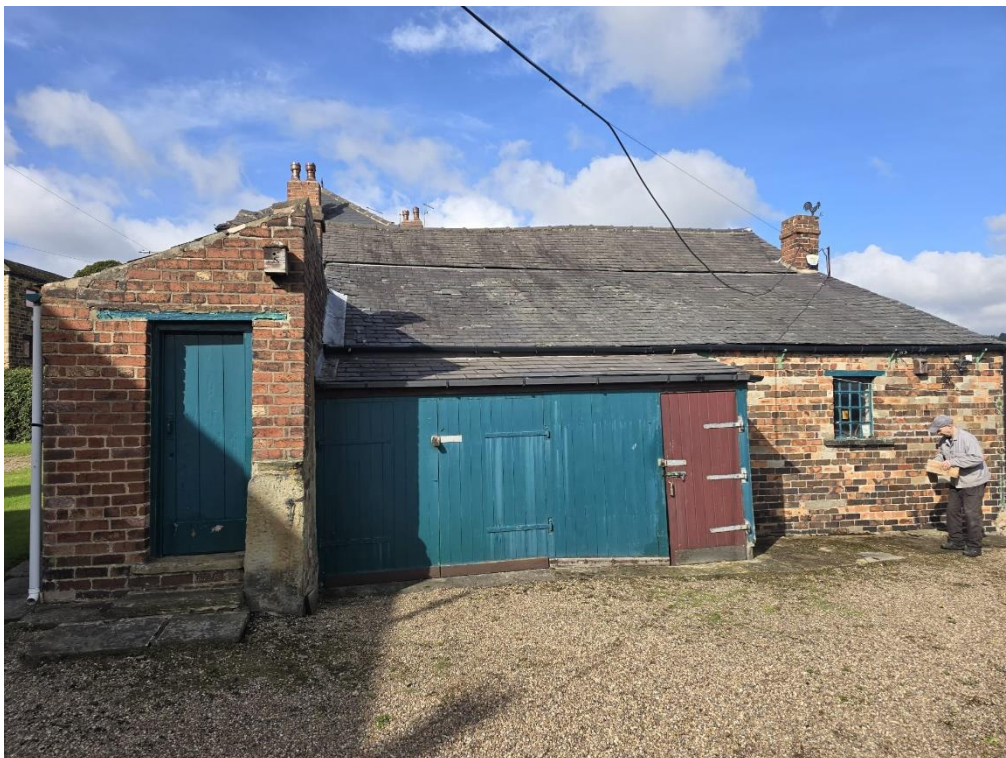
Photograph 4: Outbuilding 1

3.9 There is a large outbuilding to the north west of the house which comprises a variety of segmented buildings. The building is a two storey brick building, with a single storey extension on the eastern elevation. The window and door frames are constructed from wood and are in reasonable condition. The majority of the doors and windows are well sealed with no gaps. There is a chimney present on the toilet block in the east of the building. The roof on the main building is pitched and constructed from slate tiles with some gaps. The roof of the toilet block and other areas are also pitched/mono-pitched and constructed from slate roof tiles.

- 3.11 There were a small number of crevice features which could not be assessed due to their location. As such outbuilding 1 is considered to hold low potential to support roosting bats.

- 3.12 The building is considered to hold low potential due to a very small number of crevice opportunities, which would, at best offer potential to support individual crevice dwelling species. This is considered unlikely due to the locations of the closest records of bats, which are 1.4km east of the site with the M1 as a barrier to flight, and the others 1.6km south of the site, with minimal connectivity between the site and the location of the records. The connectivity for the bats for the records 1.6km south is far stronger to the south and to the west of the record.

- 4.4 A precautionary working method statement will be produced prior to works commencing, which will document the thought process behind the decision to not apply for the licence, and demonstrate the risks were minimised and detail how. This will include the following measures:

- A toolbox talk will be given to all contractors who will be working on the removal of the wooden cladding by the licensed bat worker. The pre-works endoscope inspection of the wooden cladding will be undertaken by a licensed bat worker to check for presence of bats.

- Given the low potential for bats and use of a non-licence method statement, timing constraints are required. Works should be undertaken between 1st October and 30th April to avoid the main breeding season for bats. However, should the works be undertaken in December, January and February, this will only commence when nighttime lows are consecutively above 8°C for four nights prior to the cladding removal.

- Temporary roosting provision will be provided in the form of a woodstone bat box so that in the unlikely event a bat is found during the works it can be moved by a licenced bat worker to the bat box.

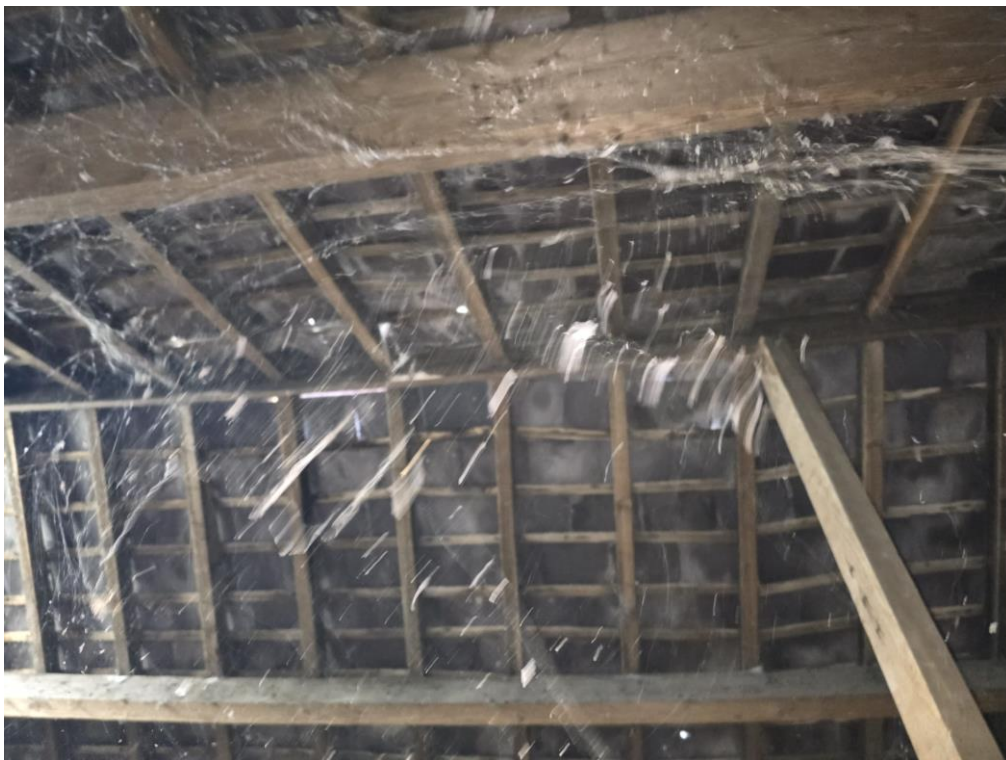
Photograph 6: Inside outbuilding 1

3.10 Internally the building is open to the rafters in the majority of places, with dense cobwebbing along the beams showing multiple years of dust accumulation on the cobwebs. The interior of the tiles was viewed in large portions of the building and no evidence of bats or physical bats were present. The areas where tiles could be checked internally are shown on the aerial image below. There are some areas of the building which are used for storage, but the majority of the building is currently not in use. It was possible to check the majority of the features present in the building for presence of roosting bats and no bats or signs of bats were recorded.

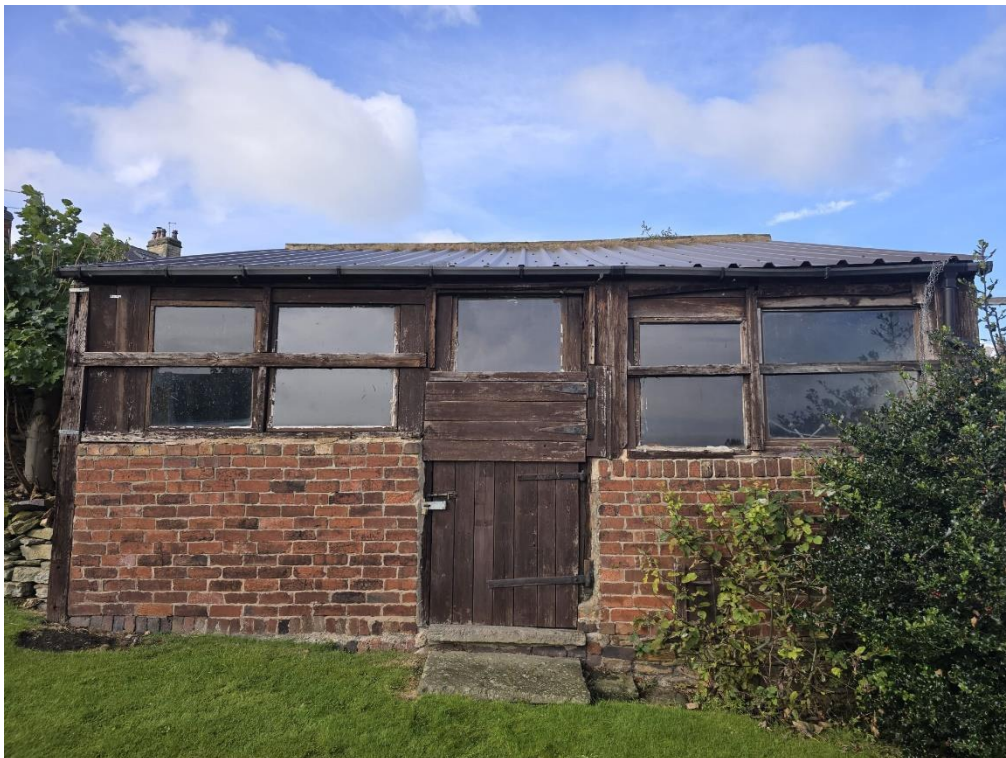
Photograph 8: Outbuilding 2

- 3.14 There is a small outbuilding in the north-west corner of the site. The outbuilding is a single storey brick building with a mono-pitched roof constructed from corrugated sheet material. There are wooden window and door frames, with no visible gaps present.
- 3.15 Internally the beams are constructed from wood, and repairs to the beams are visible from the newer wood which is reinforcing the older structure. The outbuilding is used for storage. No bats or evidence of bats was recorded in the outbuilding. There are no access opportunities into the building.
- 3.16 Outbuilding 2 was considered to have negligible potential to support roosting bats.
