# Arboricultural Hazard Assessment

Site Address: Tolson Court  
Penistone  
Barnsley  
S36 7BU

Report Ref: TCPB02-26

Report Date: 19th May 2026

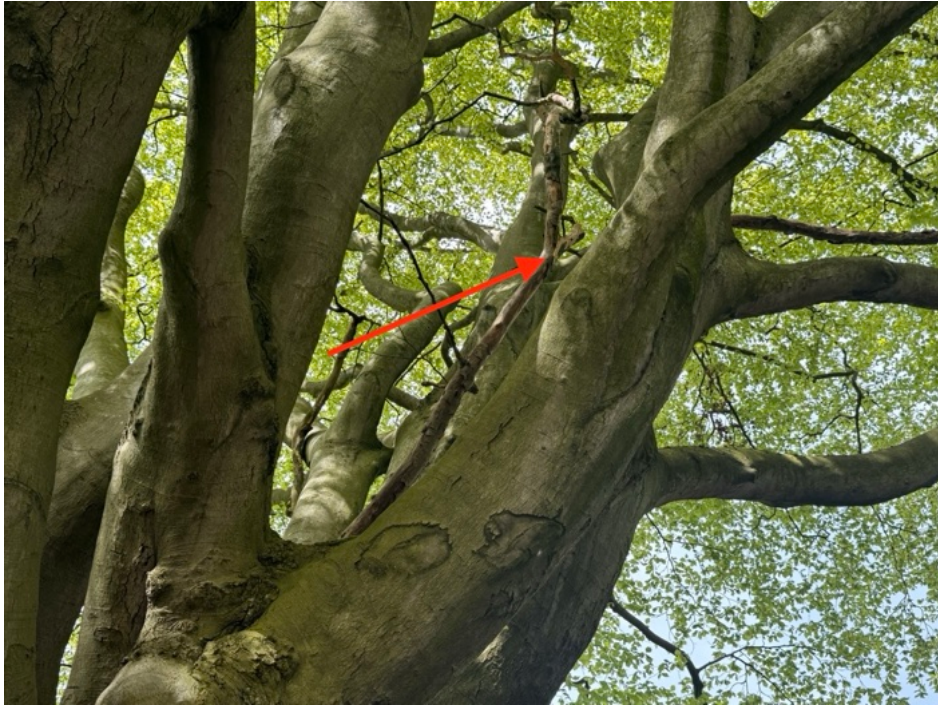
Tree T1, a large mature Beech overhanging both the highway and site entrance, remains in particularly good condition for a specimen of its scale and age. While minor deadwood is now developing within the upper canopy, no evidence of significant structural dysfunction, basal decay, or progressive instability was identified. Routine crown cleaning is considered sufficient to maintain the tree within a broadly acceptable level of risk.

| ID | Age Class | Species | Height (m) | Crown Spread (m) | Diameter (mm) | Vitality | General Observations | Assessed Part | Target | Size of Part | PoF | Reduce Mass | Risk of Harm | Management Recommendations | Image Ref. |
|---|---|---|---|---|---|---|---|---|---|---|---|---|---|---|---|
| T1 | Mature | Beech ( <i>Fagus sylvatica</i> ) | 22 | 11, 13, 14.5, 12 | 1500 | Normal | <p>A significant mature Beech displaying extensive heavy scaffold branching with well-developed branch architecture throughout the crown. The primary unions appear structurally adequate, with multiple instances of natural bracing present between limbs, suggesting adaptive loading responses typical of mature Beech specimens of this scale. The canopy extends over the driveway and partially over the adjacent highway.</p> <p>The canopy displays strong physiological vigour with only very minor deadwood present during the original inspection. No visible fungal fruiting bodies or significant basal defects were observed, and buttress development appears good, indicating satisfactory adaptive growth around the root plate.</p> <p><b>2026:</b> No visible fungal fruiting bodies, staining, or symptoms associated with basal dysfunction were identified during the reinspection. No evidence of branch failure, tear-out wounds, or progressive structural instability was observed. The canopy remains in good physiological condition, although several small instances of deadwood are now present throughout the upper canopy, typical of a mature Beech of this age and scale.</p> <p>The current Risk of Harm remains within a broadly acceptable threshold.</p> | Falling deadwood | 2 | 4 | 2 | 50% | 1/100K | Undertake a crown clean to remove deadwood throughout the canopy to aid ongoing assessment. | Fig 1. |

**Figure 1.** Deadwood within the crown of T1.

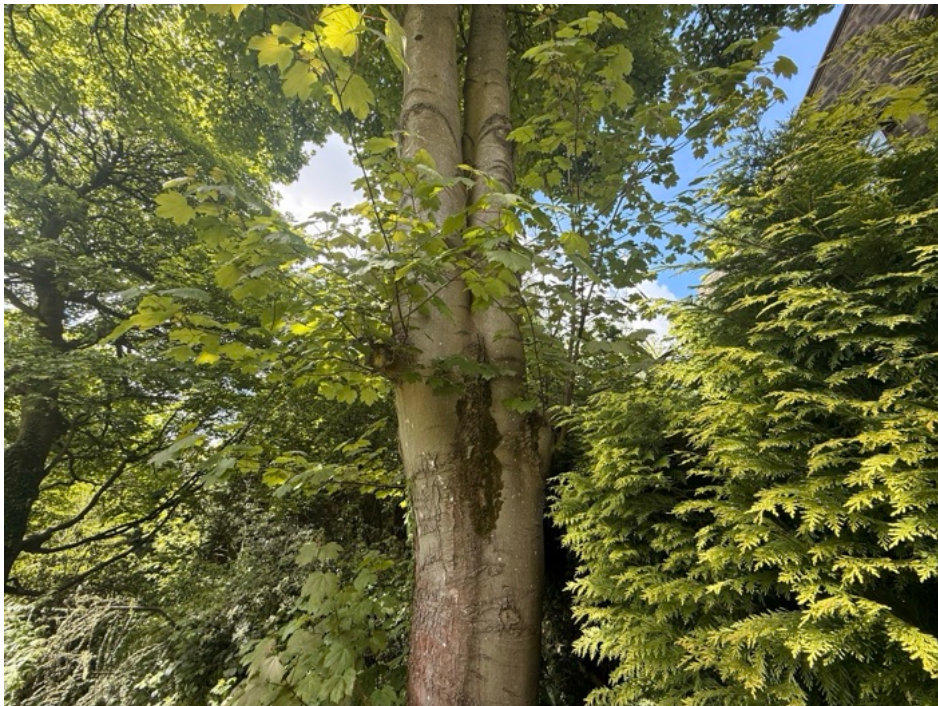
| ID | Age Class | Species | Height (m) | Crown Spread (m) | Diameter (mm) | Vitality | General Observations | Assessed Part | Target | Size of Part | PoF | Reduce Mass | Risk of Harm | Management Recommendations | Image Ref. |
|---|---|---|---|---|---|---|---|---|---|---|---|---|---|---|---|
| T2 | Mature | Sycamore ( <i>Acer pseudoplatanus</i> ) | 20 | 4, 6, 6.5, 5 | 730 | Normal | <p>A mature Sycamore with bifurcation of the main stem occurring at approximately 2.5 m above ground level, forming a tight compression union. Despite the included bark characteristics, there are currently only minimal visible signs of stress or adaptive reaction growth around the union, suggesting a limited increase in failure potential. The primary scaffold branches are generally well developed with adequate attachment points and acceptable overall canopy architecture.</p> <p><b>2026:</b> Young epicormic growth is beginning to redevelop around previous lower pruning points, although this remains of limited significance at present. No substantial adaptive growth or deformation has developed around the bifurcation union to indicate elevated loading stress. The canopy architecture remains generally adequate despite several minor rubbing branches. No fungal fruiting bodies or signs of basal dysfunction were observed around the root plate.</p> <p>At the time of inspection, no significant defects were identified which would justify remedial works on risk grounds alone. Potential management may instead focus on amenity considerations relating to shading and light obstruction.</p> | Compression union failure | 3 | - | 6 | - | <1/1M | Potential to remove lower epicormic development as part of ongoing maintenance pruning for light. | Fig 2 |

**Figure 2.** Tight union formation between the two stems of T2, with young epicormic shoots developing from previous pruning points.

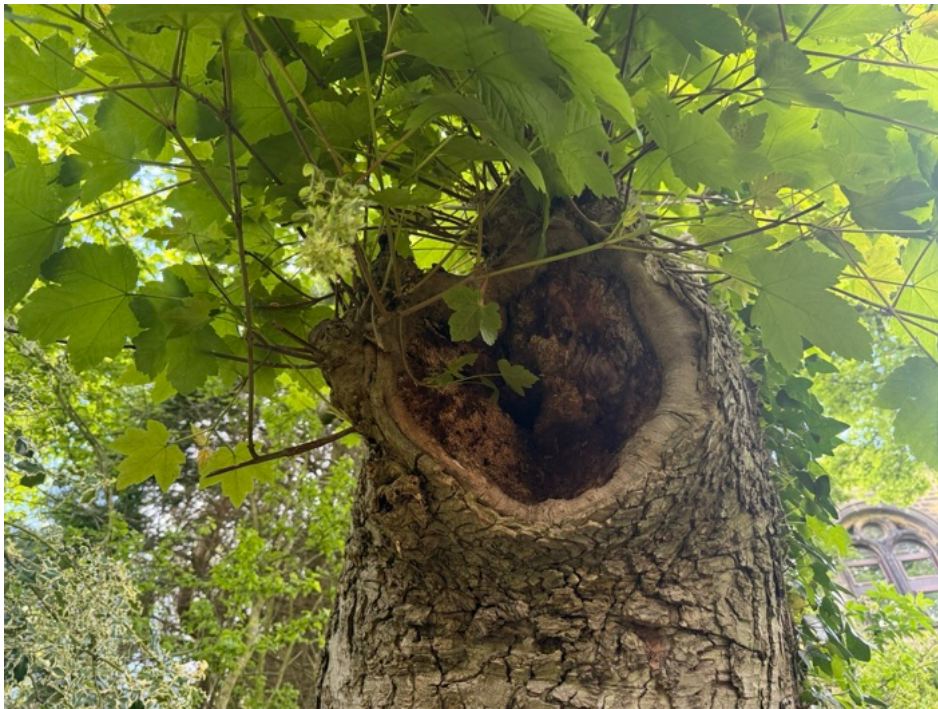
| ID | Age Class | Species | Height (m) | Crown Spread (m) | Diameter (mm) | Vitality | General Observations | Assessed Part | Target | Size of Part | PoF | Reduce Mass | Risk of Harm | Management Recommendations | Image Ref. |
|---|---|---|---|---|---|---|---|---|---|---|---|---|---|---|---|
| T3 | Mature | Sycamore ( <i>Acer pseudoplatanus</i> ) | 20 | 6, 6.5, 8, 7 | 690 | Normal | <p>A mature Sycamore displaying several historic pruning wounds throughout the main stem structure. A substantial historic limb removal at approximately 2.5 m has resulted in localised cavitation, with probing suggesting decay extends to approximately one-third of the stem diameter at this location. Two additional historic pruning wounds higher within the crown also exhibit minor cavitation. Historic limb failures are evident on the western aspect, including an older failure associated with cavity development at approximately 6 m and a more recent tear-out at approximately 8 m.</p> <p>Despite these historic defects, the canopy remains dense and vigorous with a slightly pendulous growth habit typical of mature Sycamore. Minor internal deadwood is present, and the lowest branch extends to approximately 3 m above the driveway.</p> <p><b>2026:</b> Cavitation associated with the primary pruning wound and the additional wounds above appears to have progressed slightly; however, decay still appears largely compartmentalised within branch bark ridge tissues and does not currently suggest extensive stem dysfunction. The canopy continues to display very good physiological condition with only limited deadwood present.</p> <p>At present the tree appears structurally adequate and no works are recommended specifically for risk mitigation purposes.</p> | Stem Failure due to decay progression | 3 | 1 | 6 | - | <1/1M | None. | Fig 3 |

**Figure 3.** The most significant cavity on the stem of T3 with limited occlusion growth around the wound.

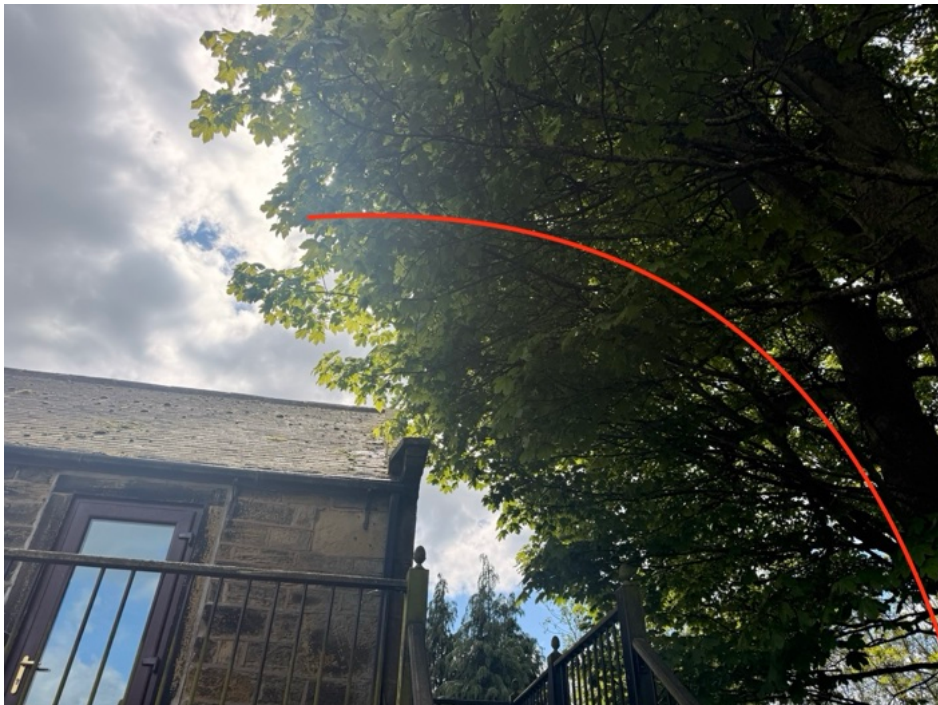
**Figure 4.** The canopy of T4 is in contact with the building. The red line denotes a potential canopy lift of the eastern aspect of the crown to create a 2m clearance from the building.

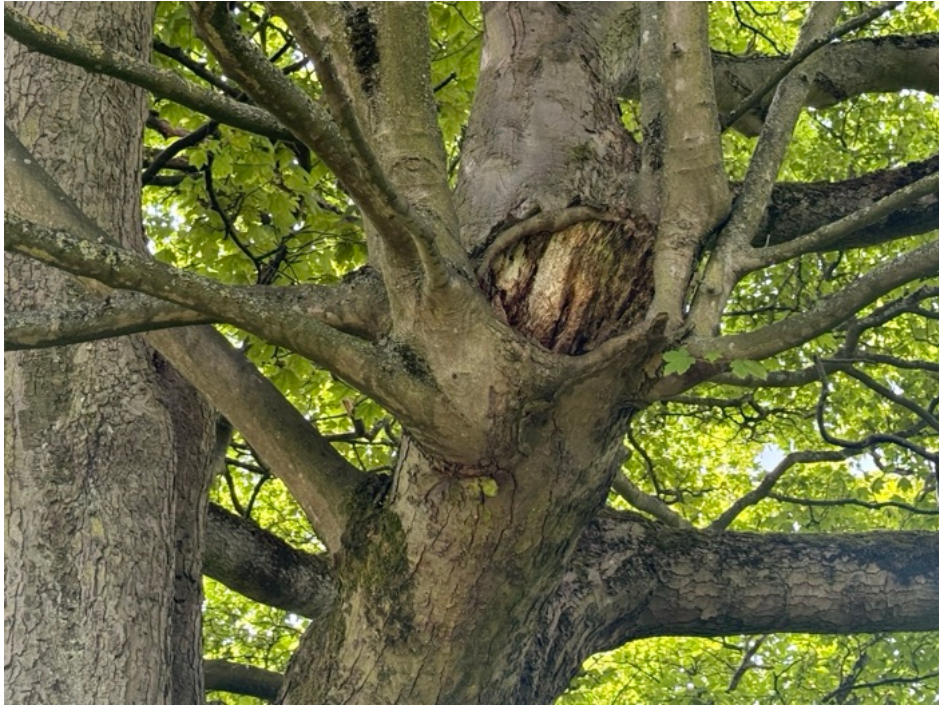
**Figure 5.** Branching is becoming significant at a historic large pruning point.

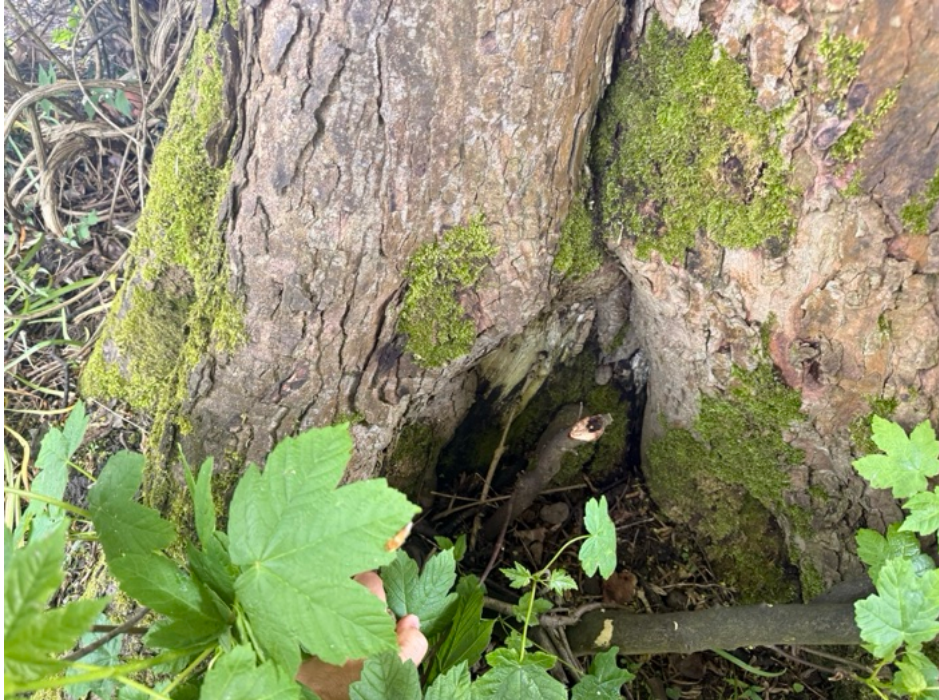
Tree T4 displays evidence of historic root severance, localised cavitation, and adaptive epicormic development associated with previous pruning wounds. Despite these factors, the tree retains good vigour and acceptable structural form overall. The principal management considerations relate to building clearance and ongoing amenity management rather than immediate risk reduction.

**Figure 6.** Minor cavitation at the base of T4.
