**Mark S Feather** BSc M Arb RfS Tech Arbor A MICFor

**Tree Inspection  
Acorn Lodge  
Pinder Oaks  
Upper Sheffield Road  
Barnsley  
South Yorkshire**

**Client  
Noble Construction Ltd  
18 – 24 Faraday Road  
Liverpool  
L13 1EH**

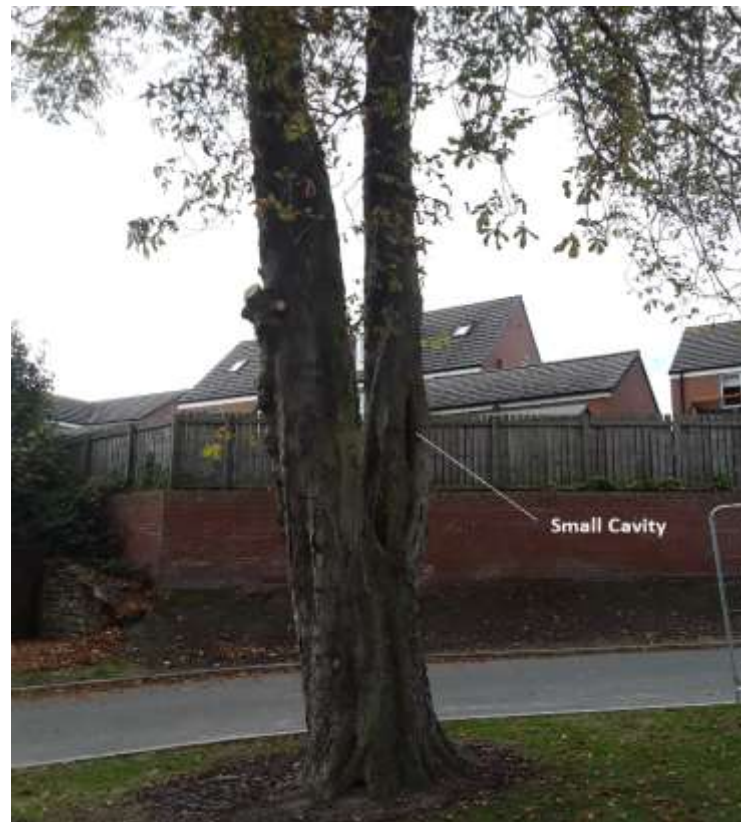
Photograph 1 - Horse Chestnut T11

Concerns had been expressed on the condition of the tree by contractors undertaking some minor pruning work on the tree. It is not known exactly what items they were referring to or at what time of year the work had taken place. In late summer many Horse Chestnuts can look in fairly poor health as they can suffer badly from scale insects (*Pulviaria regalis*), leaf mining moths (*Cameraria obirdella*) and a fungal infection (*Phyllosticta sphaeropsoides*) all of which affect the leaves, turning them brown and blotchy. This is more of an aesthetic problem and no real control measures are practical to undertake. The tree has a minor bark wound on one of the lower branches on the northern side of the tree and some slight resin bleeding could also be seen on the lower trunk, but nothing significant.

**Recommendation** - review the condition of the tree in summer when in leaf.

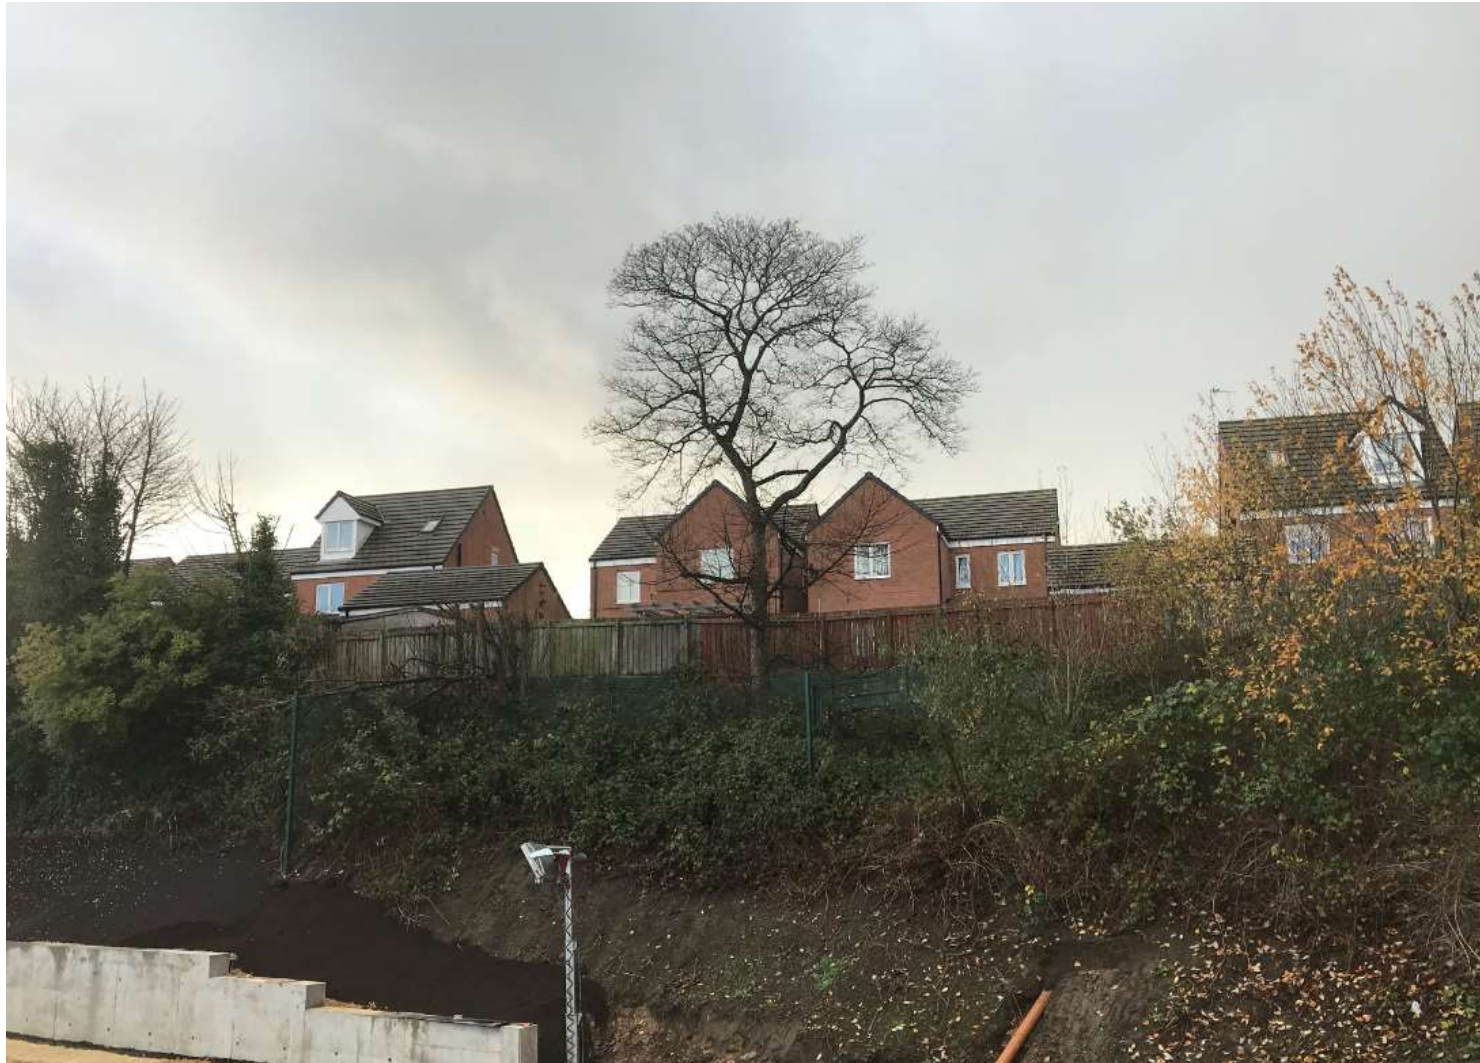
Photograph 2 - View of T2 – December 2018

The tree is located at the top of steep banking alongside adjacent housing as indicated on the photograph below. The tree is to the rear of 6 Templing Close and some lower branches have been pruned from the tree on the house side. This has created a slight crown bias over the development site, see photographs on the following pages.

The tree does not appear to be in an unsound condition although access to the base of the tree was not possible due to site vegetation. The previous survey of the trees in September 2017 by Richard Lancaster also found the tree in reasonable health. The report recommends the removal of the low limb.

However, perched on top of the embankment with a crown bias over the site this somewhat isolated tree does appear to be causing some anxiety in advance of the building being occupied. The tree is well below its ultimate height so concern are likely to increase in the future once the building is occupied. For both the new building and the existing houses it would appear that some tall growing shrubs / small trees would be more appropriate than a large growing tree. Lower growing plants would provide a better visual screening between the two development and would also not block the open views to the east for the adjacent houses as illustrated in photograph 5. Lower growing plants would also not over shadow and dominate the new development., so as to avoid the potential anxiety the tree might cause in the future. Planting along the boundary could be undertaken with material like Hazel, Hawthorn, Guelder Rose, holly, Crab Apple etc

To apply to the council for the removal of the tree T2 subject to replacement planting of low native growing trees / shrubs along the embankment. See photograph over page.
