**Arboricultural Method Statement**  
**Plus Arboricultural Impact Assessment & Tree Survey**

**Land South of Halifax Road**  
**Penistone**

Report reference: AR-4578-01  
August 2021

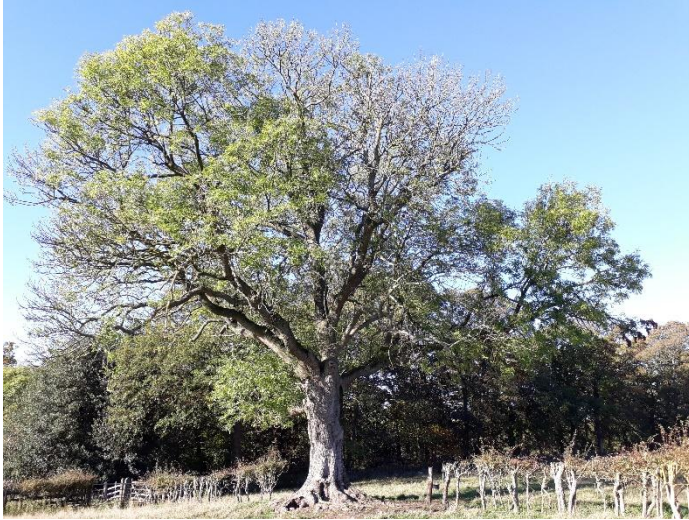
**Figure 2**

65. The largest tree in the survey and within the Site, T4 ash, has features which indicate that it qualifies as an early ancient tree or fully mature transition veteran which should be retained within development under National Planning Policy Framework 2018. Features present on T4 include rot site, dead branches, live stubs and fungal fruit bodies (Figures 1-3). Although a section of root flare is hollow

The northern side of T4 ash (with woodland outside the Site boundary in the background). Decline in part of the crown is evident.

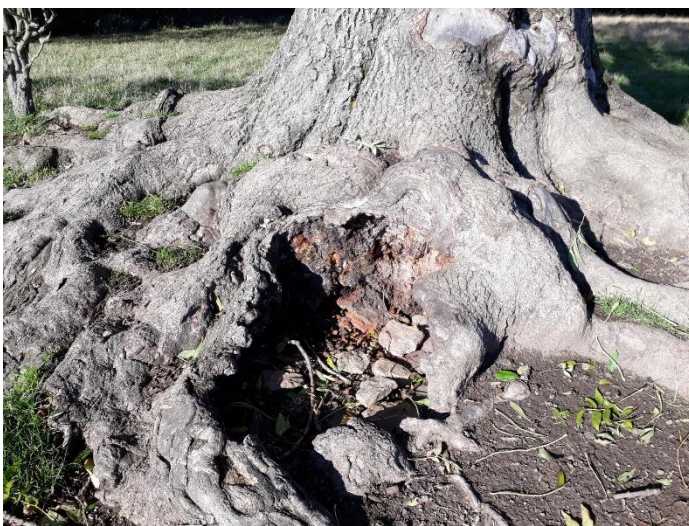
**Figure 3**

The wide root flare of T4 ash includes decayed wood with a small fungal bracket of *Ganoderma* sp. at ground level and possible rotted older brackets. The decay extends at least 30cm from the dark area towards the stem.

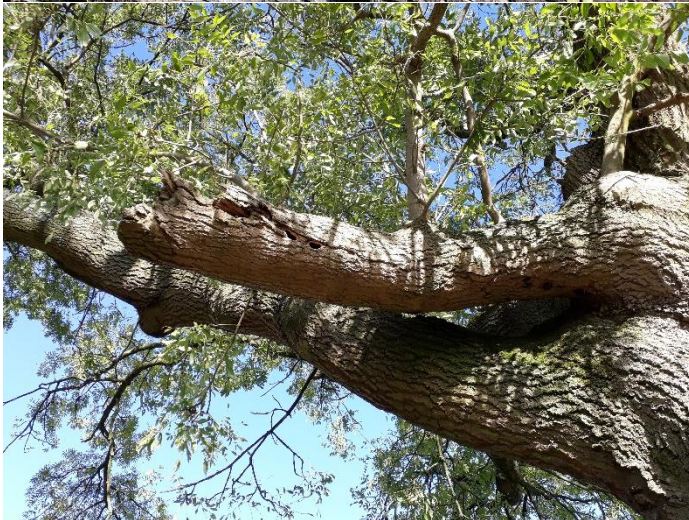
**Figure 4**

T4 ash with a stub of naturally fractured branch and live growth. Branch fungus *Daldinia concentrica* is evident on the underside.

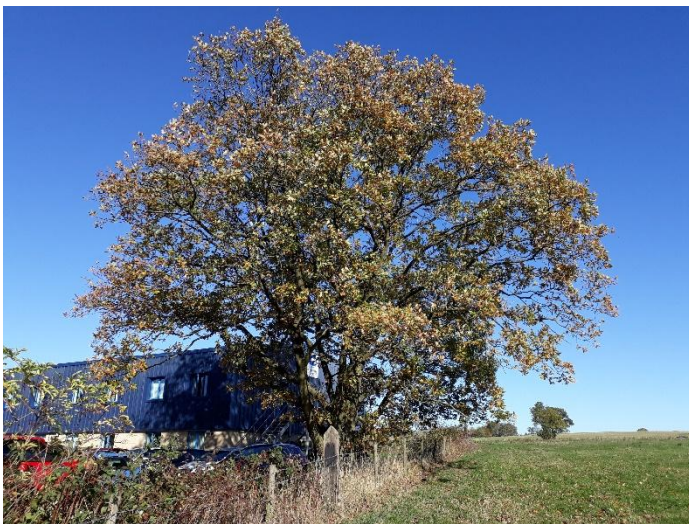
**Figure 5**

T15 oak located just outside the Site boundary fence and overhanging the Site. This tree should be protected from damage during development.
