Arboricultural Report

Assessing tree condition and management requirements at:

**Belmont House
Cote Lane
Thurgoland
Sheffield
S35 7AE**

21st March 2016

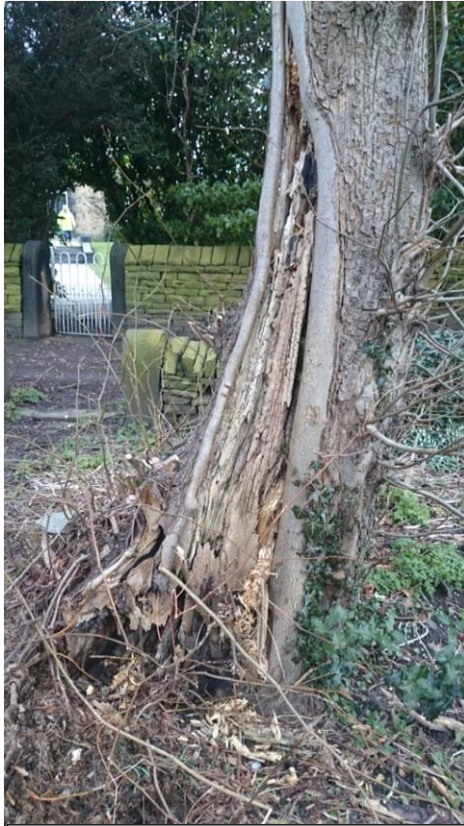
Plate 1. Tree 37, Lime. Stem base severely decayed, on tension side of stem.

Tree no.	Species	Previously approved for felling?	DBH in excess of... (mm)	Height range (m)	Age class	Condition	Recommendations	Priority
37	Lime	Yes	500	15 to 19	mature	Stem base severely decayed, on tension side of stem. No nests. SEE PHOTO 1.	Fell tree as soon as possible to avoid disturbance to nesting birds in adjacent trees.	Urgent
43	Sycamore	No	600	15 to 19	mature	Large area of necrotic bark and wood at base to 2 m height, north-east side, originating from fire damage. Extensive saprophytic fungi in this area. The result is an irreversible and ongoing decrease in safety of this tree. SEE PHOTOS 4 and 5	Fell tree. The felling itself is not yet urgent, but should be done as soon as possible due to five longstanding rooks nests in canopy - not currently active in daylight hours.	Urgent
A	Willow, Weeping	n/a	200	5 to 9	early-mature	This tree has been supported on a makeshift prop, which has prevented it developing sufficient strength in its root system. If the prop fails, the tree cannot be relied upon to not fail also.	Fell tree.	3 Months

Two trees, a lime and sycamore, are recommended for felling as soon as possible. The sycamore is not as urgent as the lime; the urgency in this case is due to a need to work before the rook's nests become active (they were not at the time of survey).

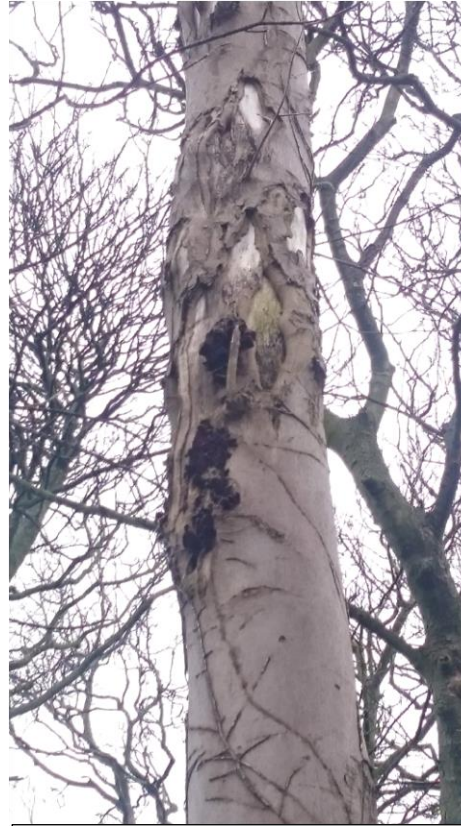
Plate 2. Tree 41, Sycamore. Damaged and necrotic bark on lower half of stem on all sides. Jew's Ear fungus at 5 m is indicative of significant decaying wood here.

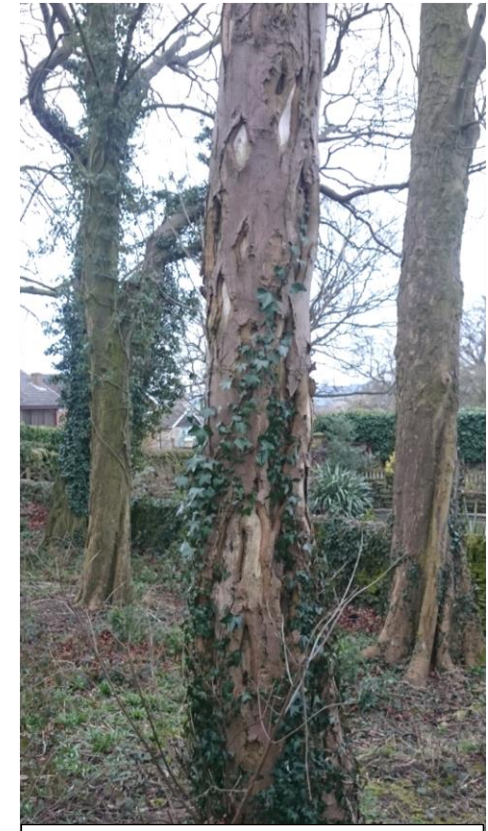
Plate 3. Tree 41, Sycamore. Much damaged and necrotic bark on lower half of stem all sides.

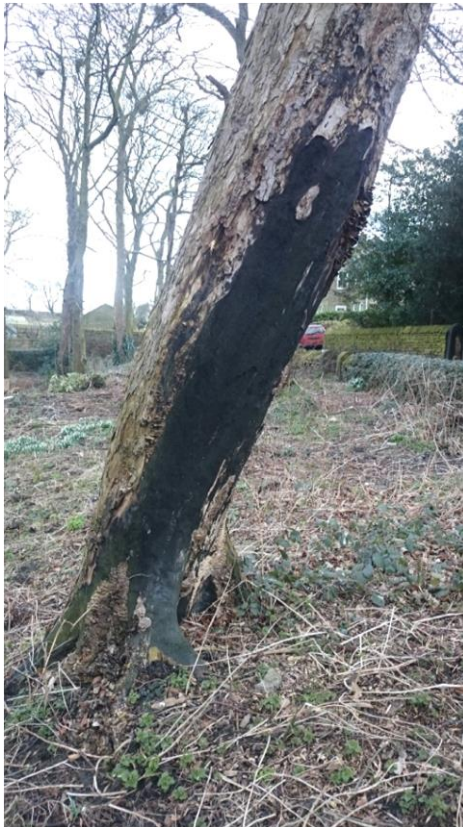
Plate 4. Tree 43, Sycamore. Large area of necrotic bark and wood originating from fire damage. Extensive saprophytic fungi in this area.

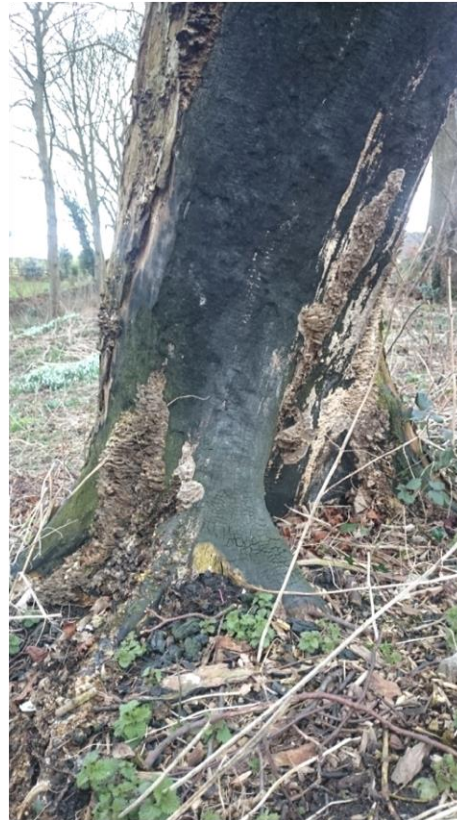
Plate 5. Tree 43, Sycamore. Extensive saprophytic fungi - at base of large area of necrotic bark and wood originating from fire damage.

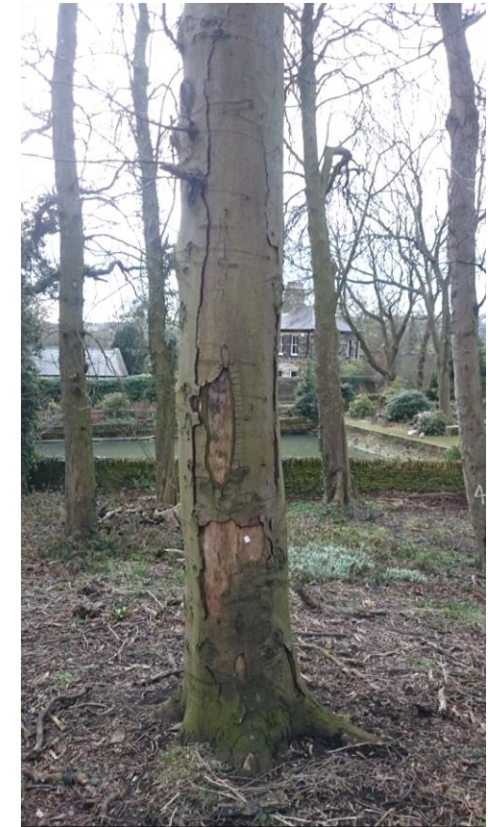
Plate 6. Tree 46, Beech. Bark damage with significant areas of exposed wood. Bark flaking suggests this extends to at least 4 m height, and around one third of stem circumference.
