**Report Title**  
BANK HOUSE FARM STRUCTURAL INSPECTION REPORT

**Report Prepared For**  
Mr Frank Charlesworth  
7 Hinton Drive  
Crowthorne  
Berks  
RG45 6JY

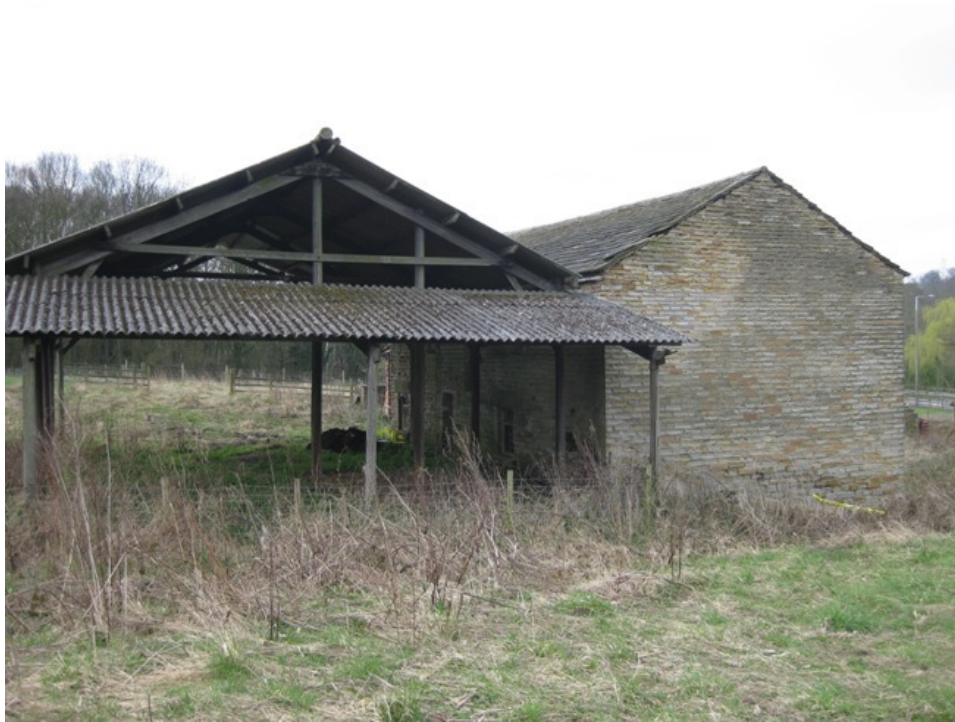
**Photograph 35:** Shows the South-East Elevation of Agricultural Building 'A'. The main masonry building is two-storey and consists of coursed sandstone masonry with a natural stone slate roof. The side structure consists of timber posts and trusses with a corrugated roof.

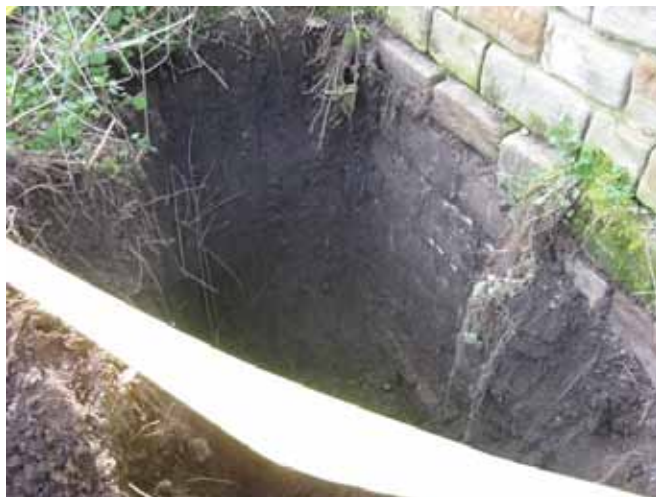
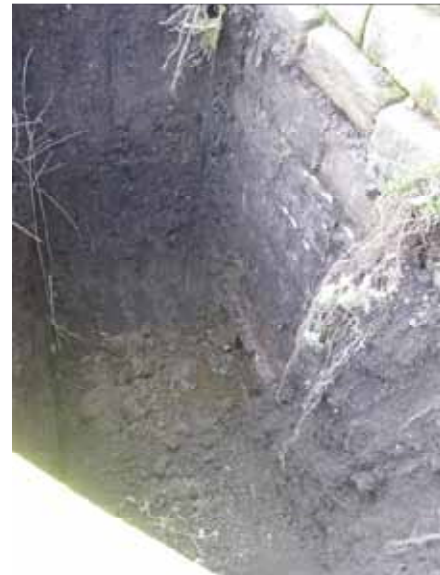
**Photographs 4 and 5:** Details the trial hole at the East elevation. The trial hole is 1.6m in depth and shows the existing foundations at this depth. The ground is made up of top soil to approximately 1.6m, with signs of stiff clay beneath. The foundations appear to be adequate in their current state, and would not need to be replaced.

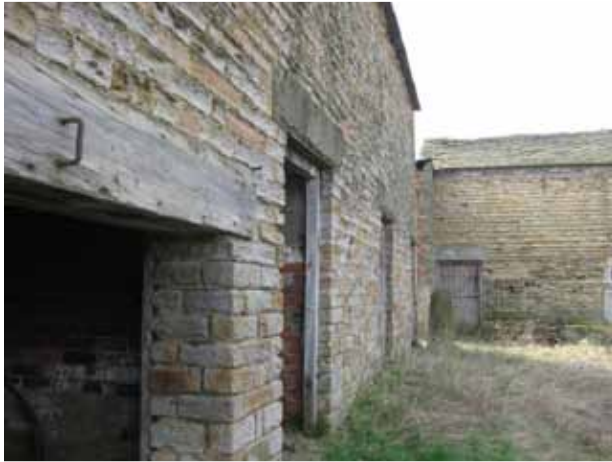
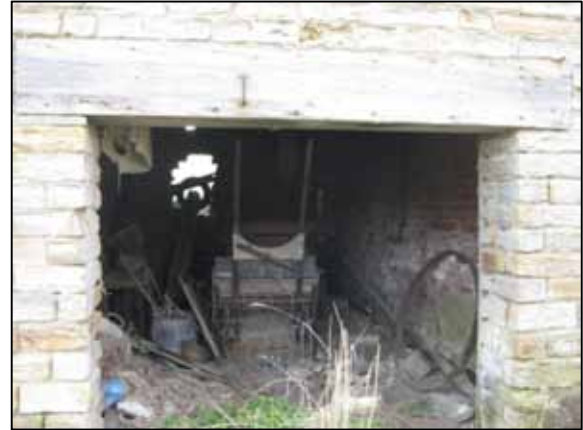
**Photographs 6 and 16:** Show the north elevation of Agricultural Building 'A'. There are 4No doorways with access into the building.

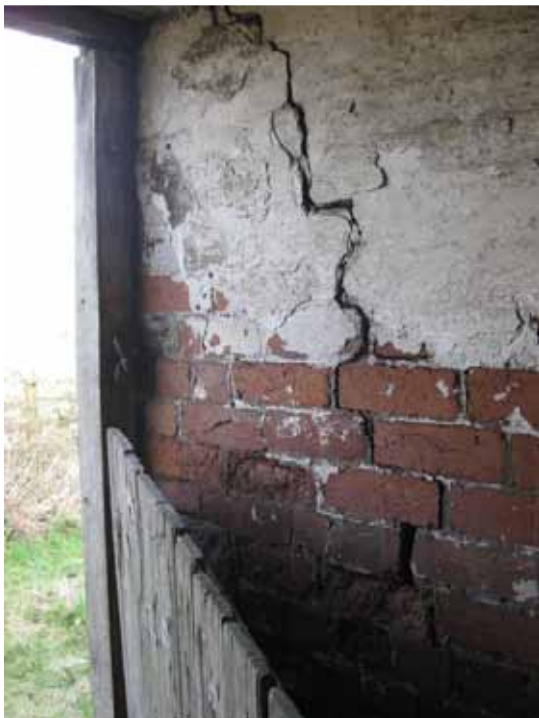
**Photograph 9:** Illustrates the large crack, 20mm in width within the internal brickwork located behind the first stone lintel. Again this suggests there has been some movement in the walls.

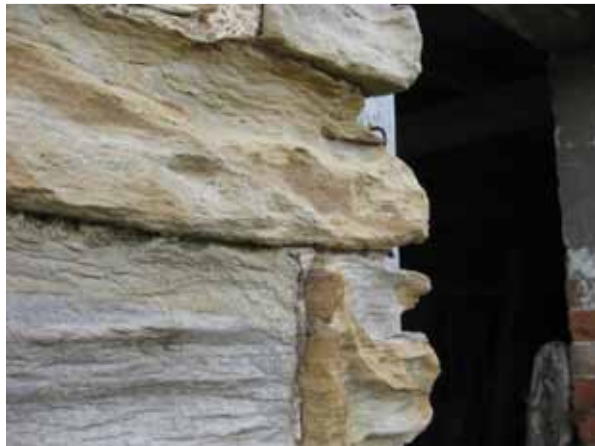
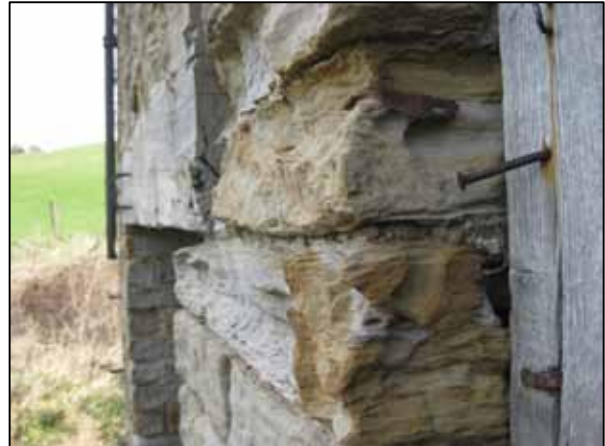
**Photographs 11 and 10:**

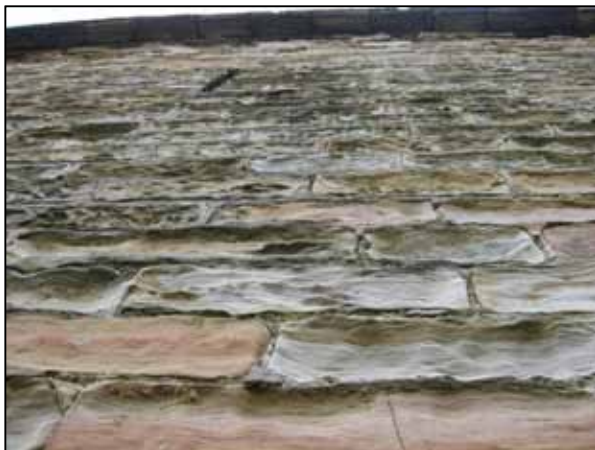
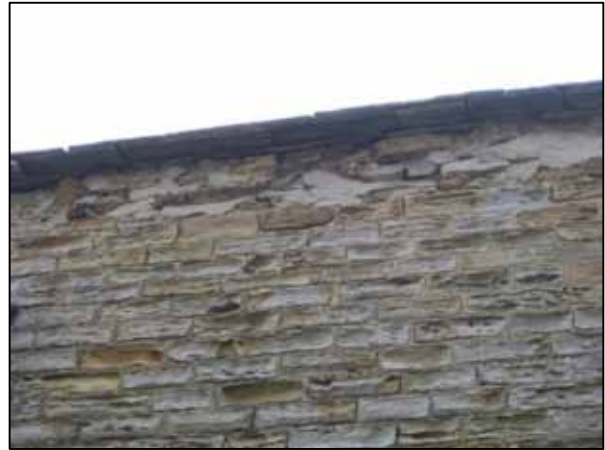
**Photographs 12 and 13:**

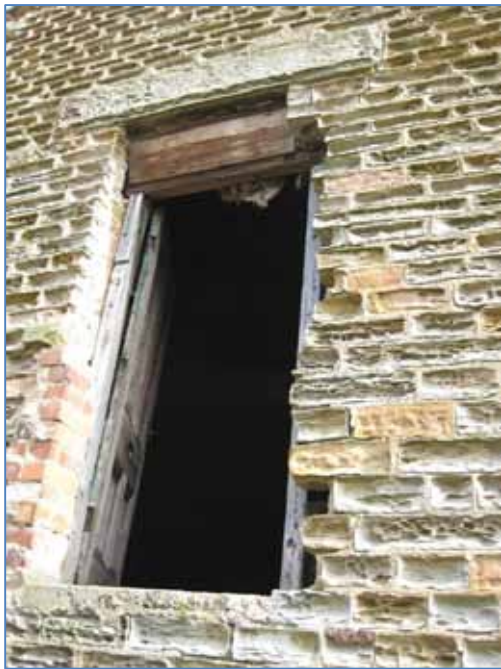
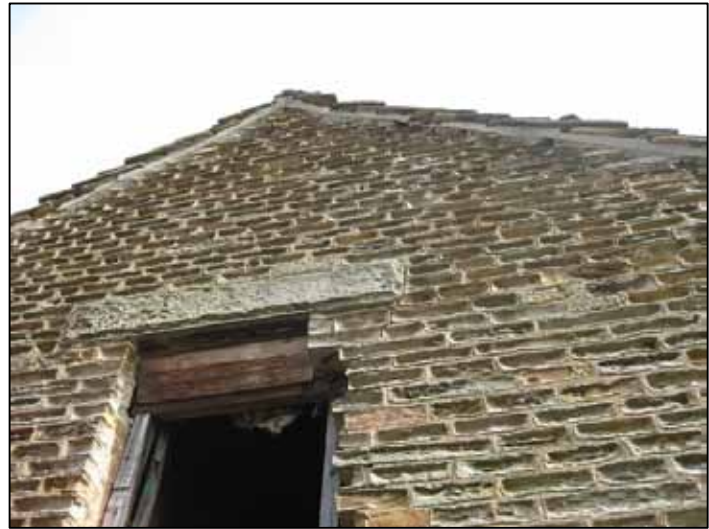
**Photographs 20 and 21:**

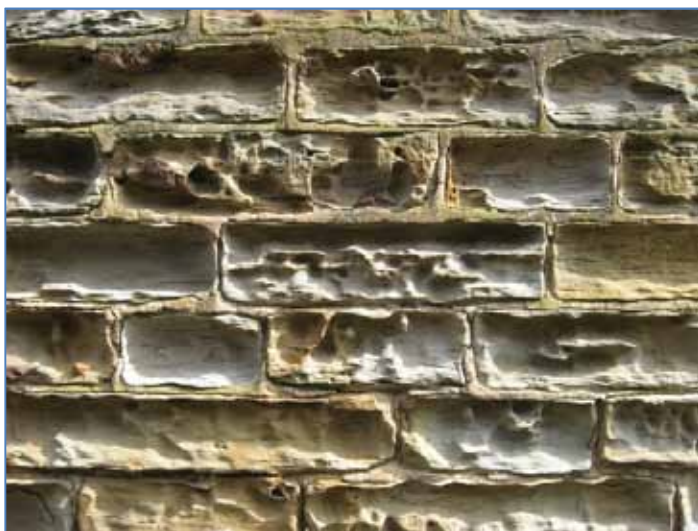
This may have occurred due to all of the walls being subjected to the elements causing saturation of the stonework. However as the three other walls are more susceptible to the winds which can effectively dry them, the west face is mostly protected from the wind by the adjacent building and therefore the walls have decayed due to the wet conditions.

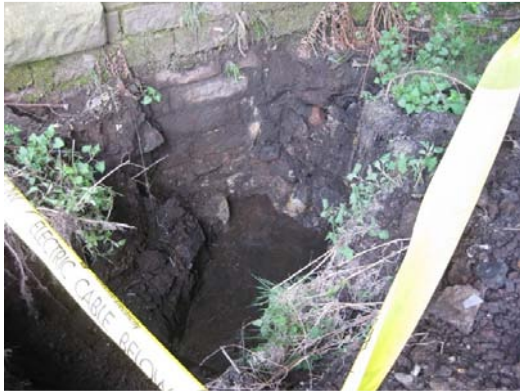
**Photograph 23:** Details the trial hole at the South elevation. The trial hole is 1.0m in depth and shows the existing foundations at this depth. The ground is made up of top soil to approximately 1.0m, with signs of stiff clay beneath. The foundations appear to be adequate in their current state.

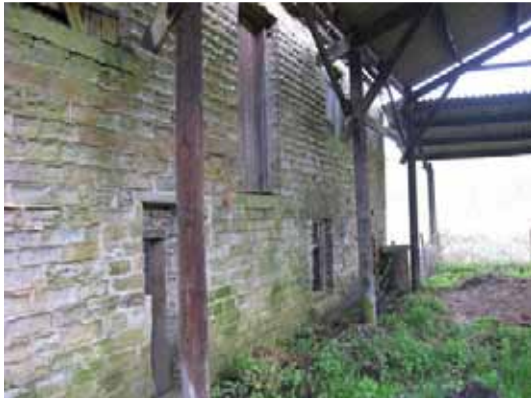
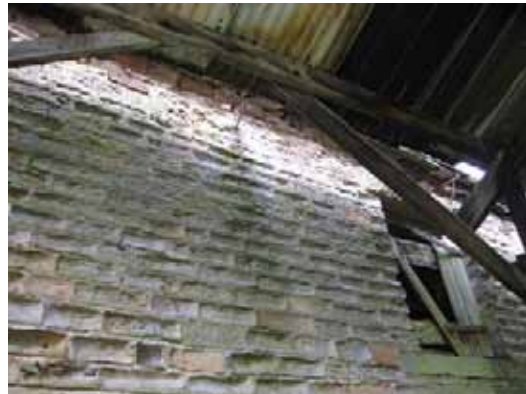
**Photographs 25 and 26:** Show the South Elevation of Agricultural Building 'A', with the adjoining open timber frame. The timber frame looks to be in a workable condition, which suggests it was erected at a later date to the main building, particularly with the corrugated steel sheet roof. There are several openings on this elevation but no significant cracking, to lintels or the stonework. However deterioration and weathering of the sandstone masonry is again apparent.

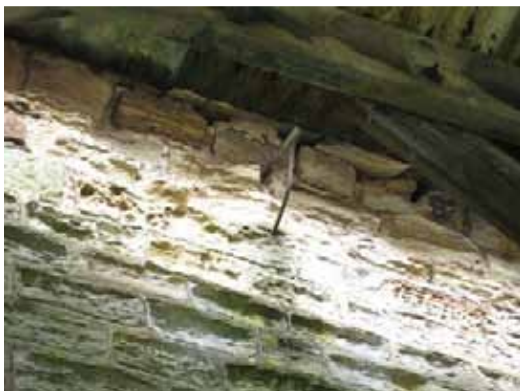
**Photograph 29:** Shows eaves level at the rear of the property (South elevation). There is evidence of frost damage to the high level sandstone masonry and mortar, with visible voids between the stonework.

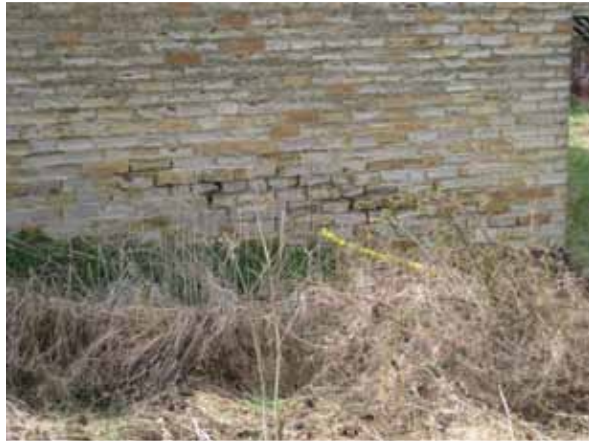
**Photograph 32:** Illustrates the extent of the open joints in the East elevation wall at low level. However this is only due to the absence of mortar between the coursed sandstone masonry

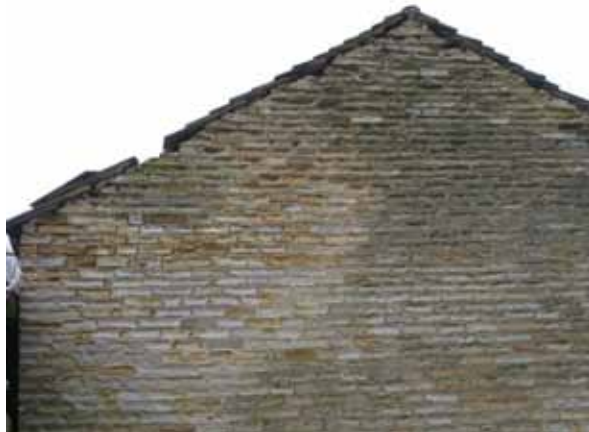
**Photograph 33:** Shows the slate roof over the East elevation gable. Frost erosion may have caused the mortar to deteriorate and roof slates to become loose.

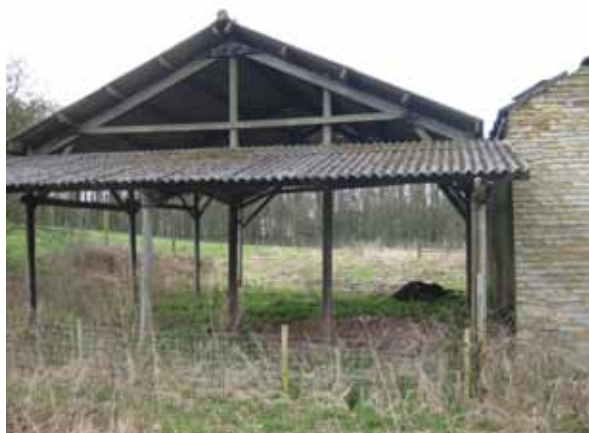
**Photograph 34:** Shows the side structure adjoining Agricultural Building 'A'. It consists of timber posts, haunches and trusses with a corrugated roof. It has no major defects, but would serve no purpose for conversion to alternative use, and should therefore be removed.

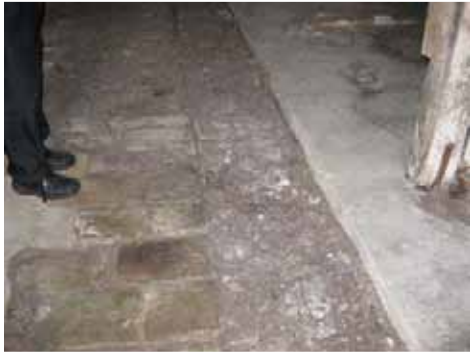
**Photograph 38:** Shows the construction of the ground floors within the building. To the left of the photo shows cobbles with a central drain run, with a concrete slab to the right.

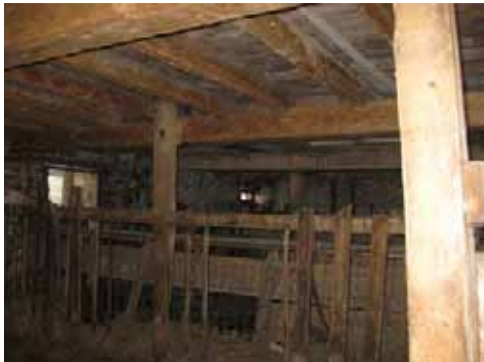
**Photograph 39:** Details the layout of the underside of first floor. The timber supporting beams and columns are softwood and are generally in a good condition; however the floor boards have aged and are decayed in some areas.

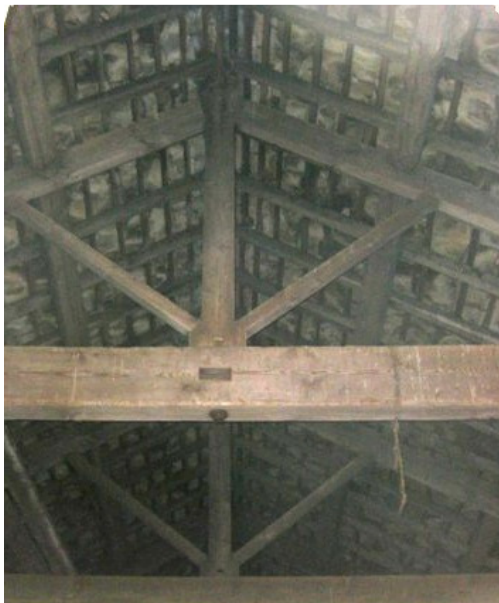
**Photograph 40:** Shows the layout of the softwood roof structure; King Post truss with purlins and rafters. These all look to be salvageable and it is our opinion that these could be re-used where possible.

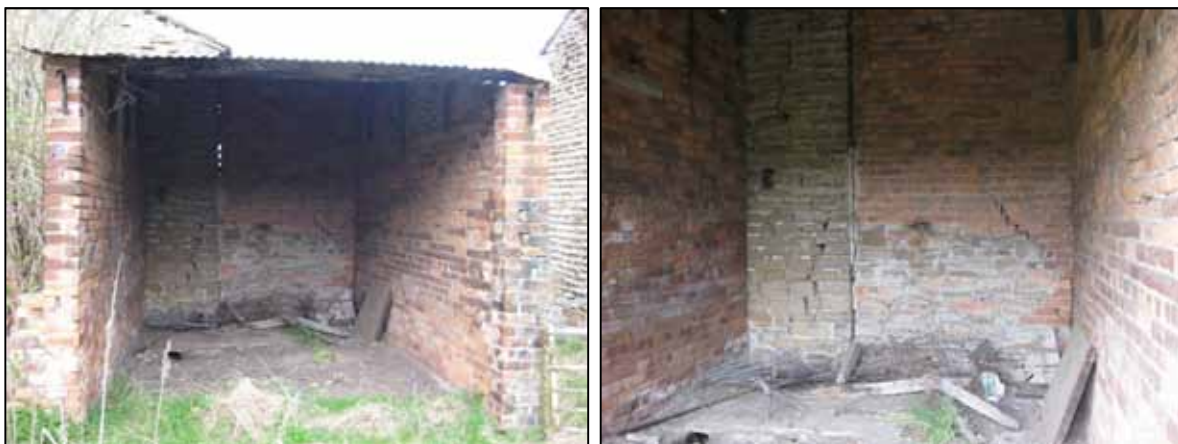
**Photographs 42 and 43:** Shows a double skin brickwork wall shelter abutting the original coursed sandstone masonry construction, built off of the existing ground which is inadequate founding material without proper footings etc. Spare pieces of timber have been used to act as purlins to support a corrugated roof. Cracking in both the brickwork and coursed sandstone is evident. A line of mortar is the only restraint fixing currently visible between the old and new construction. As such it is our opinion that this area be taken down and rebuilt with adequate fixings and adequate foundations.

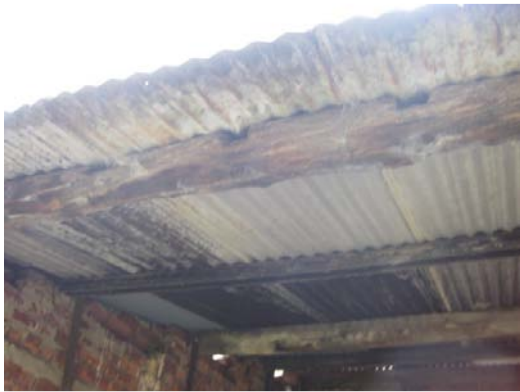
**Photograph 44:** Shows the timber pieces currently used as purlins to support the corrugated roof on the south elevation. The timber pieces are significantly decayed and should be discarded.

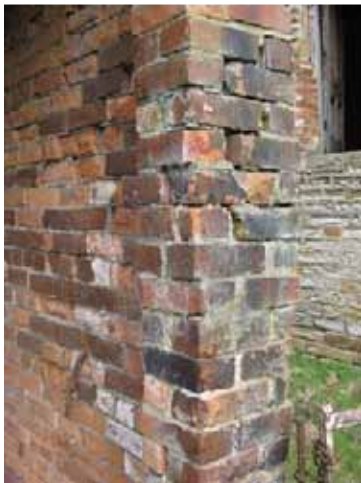
**Photograph 45:** Shows the brickwork masonry pier with considerable cracks and loose bricks. Again it is our opinion that this area be taken down and rebuilt with adequate fixings and adequate foundations.

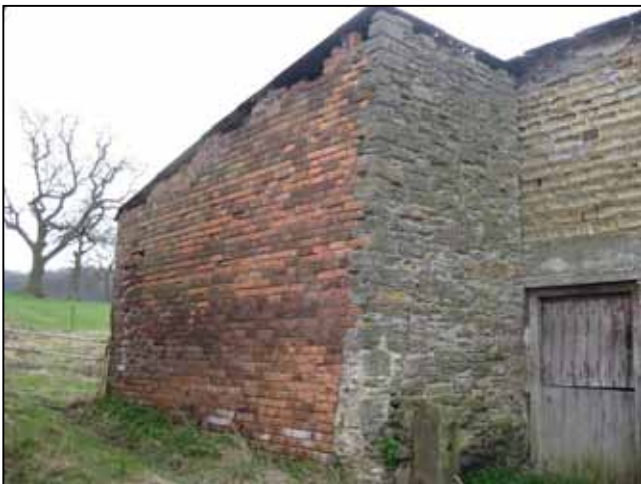
**Photograph 46:** Shows the North-east elevation, and demonstrates the connection between old and new construction. There is considerable cracking towards the bottom of the sandstone masonry and there is also signs of movement as the sandstone masonry deviates from horizontal.

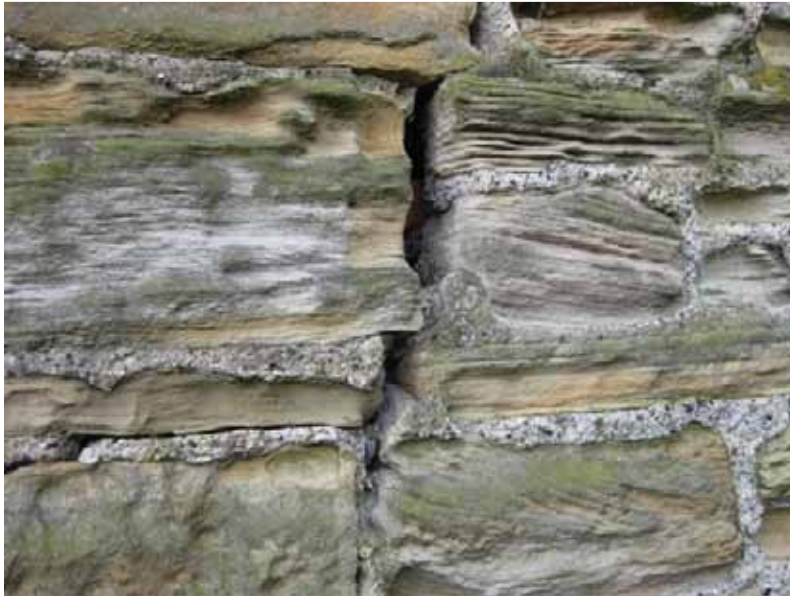
**Photograph 48:** Shows a 45mm crack in the North-east elevation, as described above in Photograph 46. There has been significant movement and therefore may suggest subsidence or inadequate foundations.

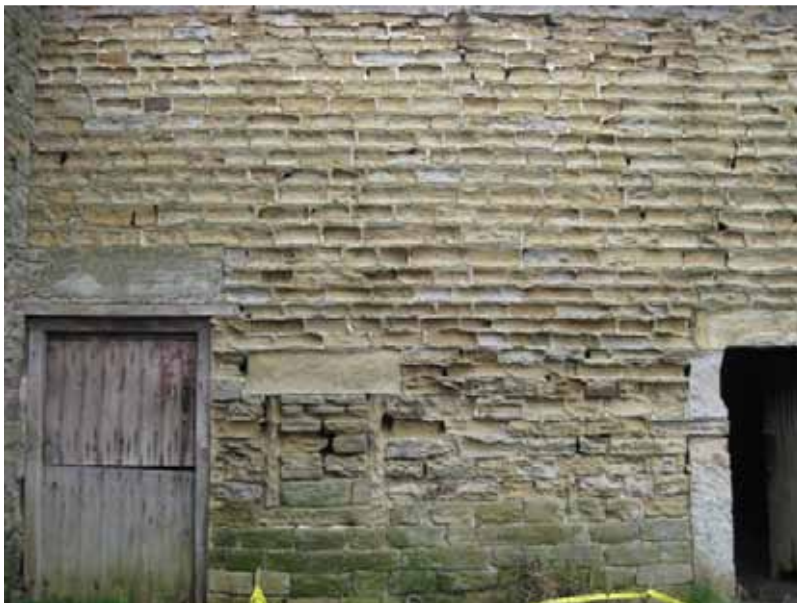
**Photograph 50:** Shows the East elevation. There are many voids present, as well as cracking and signs of movement. Deteriorations of the coursed sandstone masonry is also evident with areas of absent mortar.

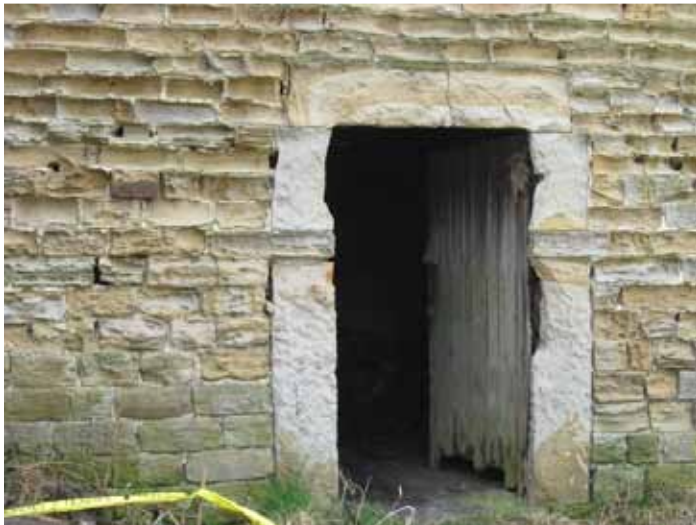
**Photograph 54:** Shows the East elevation. The lintel over the opening shown has significant cracks, which may be from movement rather than buckling. There are many voids present, as well as cracking and signs of movement in the masonry. Deteriorations of the coursed sandstone masonry is also evident with areas of absent mortar.

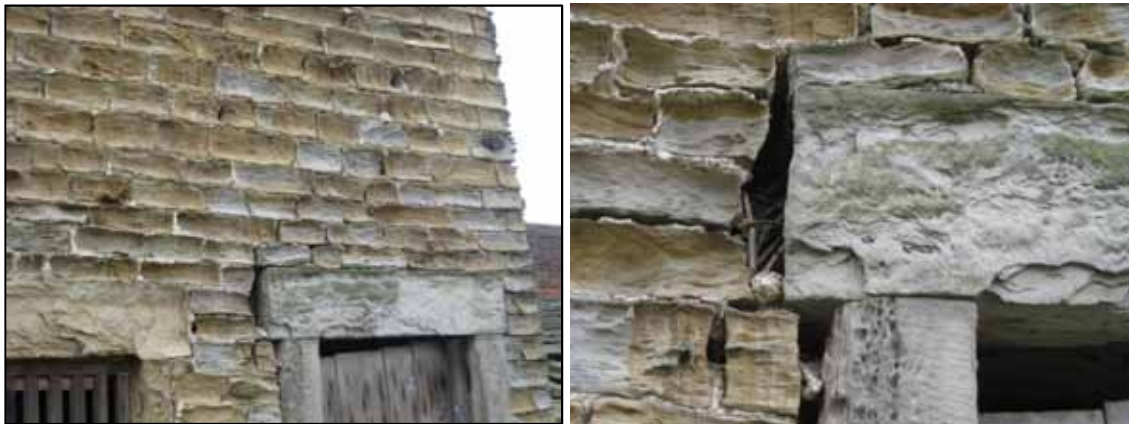
**Photographs 55 and 56:** Shows the end doorway on the East elevation. The movement in the building has resulted in 80mm cracks/voids being formed in the masonry. The existing lintels could be reused.

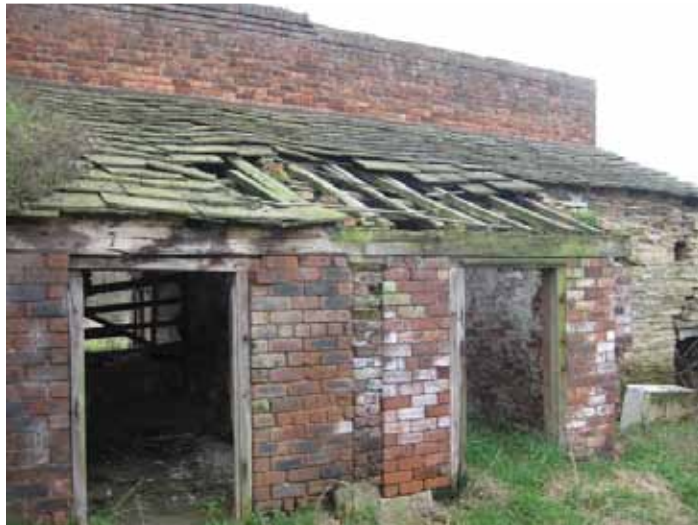
**Photograph 59:** Details the condition of the roof and existing brickwork walls to the end of the East Elevation. This area is adjoining the main coursed sandstone masonry building. It is evident that the buildings have been added to over the years due to the number of different brick types used as well as the different mortar. The roof members should be discarded as the roof is in a state of disrepair. The tying of each of the sections of the walls looks to be insufficient which would account for the signs of movement and the voids between the different wall types.

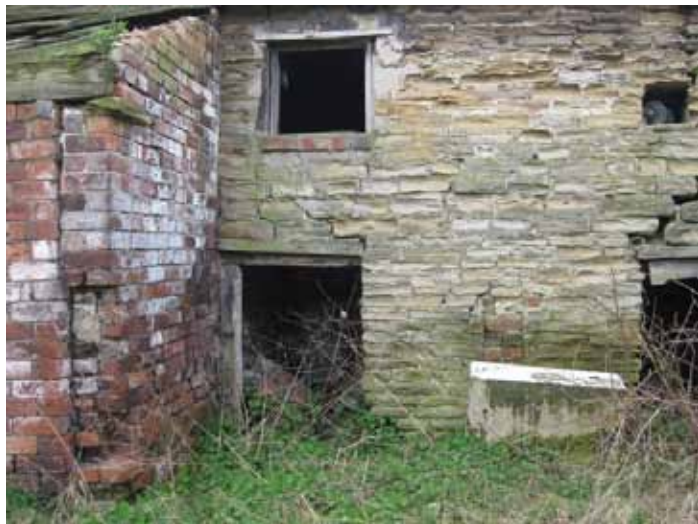
**Photograph 61:** Shows signs of movement with the lintels and masonry deviating from horizontal. The tying of each of the wall sections looks to be inadequate which would account for the signs of movement and the voids between the different wall types. There are several voids above the lintels, 80mm in width; however the coursed sandstone masonry looks to be in a comparatively good condition. Most of the masonry units could be reused.

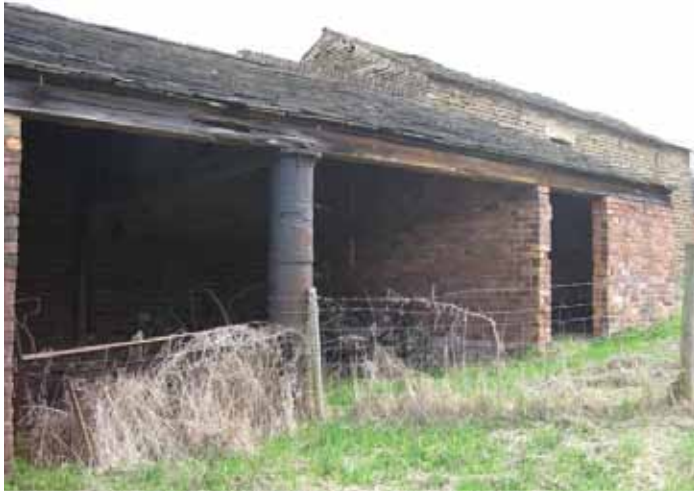
**Photograph 64:** Illustrates the west elevation of the Agricultural Building 'B'. The majority of this area is newer brickwork, which is in good condition. However the supporting eaves members are decayed and would require replacing. The cast iron stanchion is used as a column to support the timber roof, and if kept would demonstrate the diversity of building materials used in the past. The adequacy of the foundations in this area may require investigating.

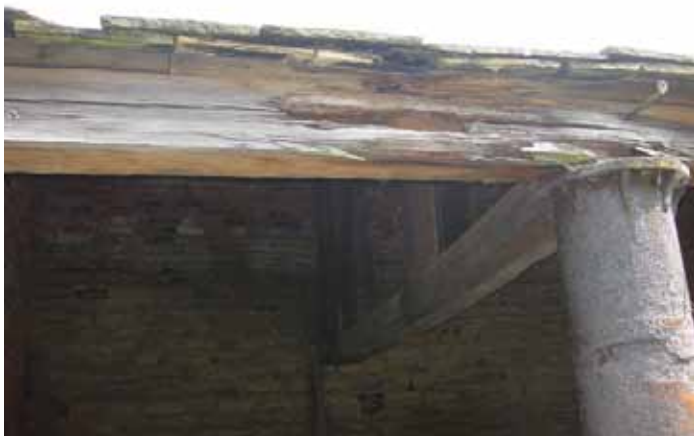
**Photograph 65:** Shows the eaves members to the west elevation supported by the cast iron haunch. It can be clearly seen that the eaves timber is decayed and would need to be replaced.

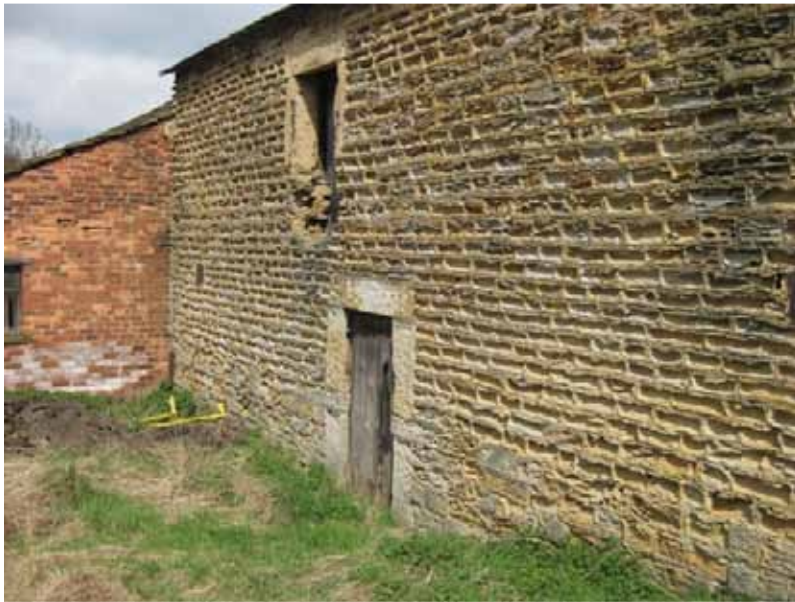
**Photograph 72:** Shows the West elevation and the extent of the soil migration of the years, culminating in the external levels immediately in the vicinity of the doorway being higher than the internal finished floor level. There are many voids present, deteriorations of the coursed sandstone masonry is also evident.

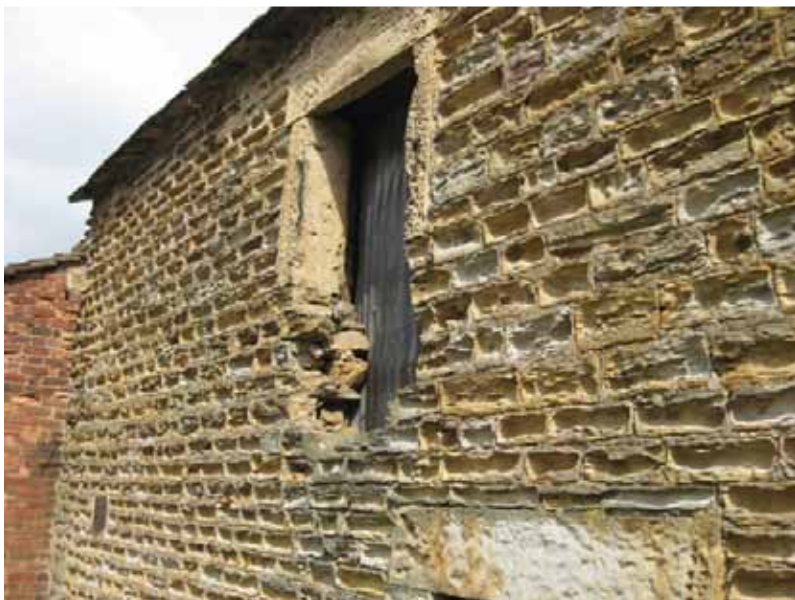
**Photograph 74:** Shows the West elevation, and the area needing repair around the first floor opening. Deterioration of the coursed sandstone masonry is again evident. We would estimate that 5% of the coursed sandstone could be reused from this elevation.

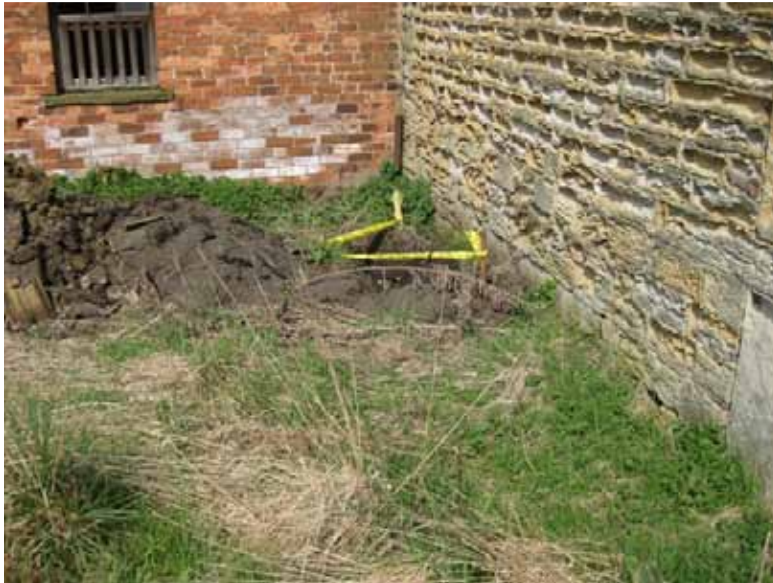
**Photograph 75:** Shows the West elevation and the extent of the soil migration of the years, culminating in the external levels being higher than the internal finished floor level. The soil characteristics are top soil down to 1m deep, with firm to stiff clay below.

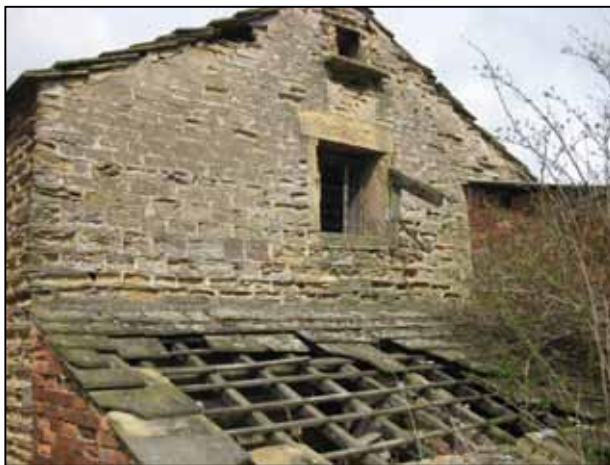
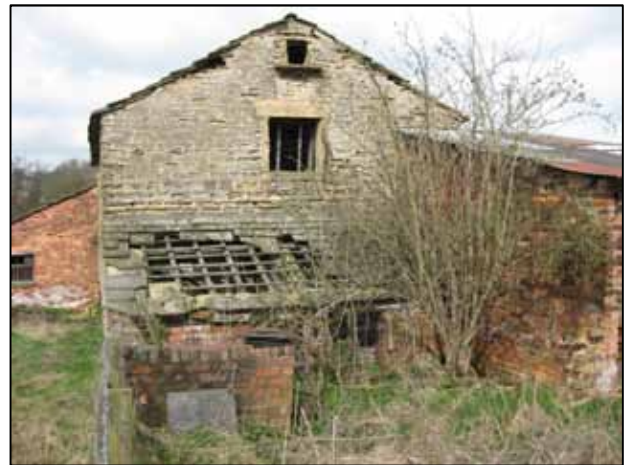
**Photograph 71 and 70:** Show the view from the south-west, and shows the end gable with the two extensions which have been added after the original coursed sandstone masonry building. There are signs of deterioration; however most of the coursed sandstone masonry could be reused in this area. It is recommended however that the brick building be dismantled and reinstated on adequate foundations, and tied adequately to the main coursed sandstone masonry building. The roof purlins and rafters on the low roof may be discarded, and so too the few remaining broken slates.

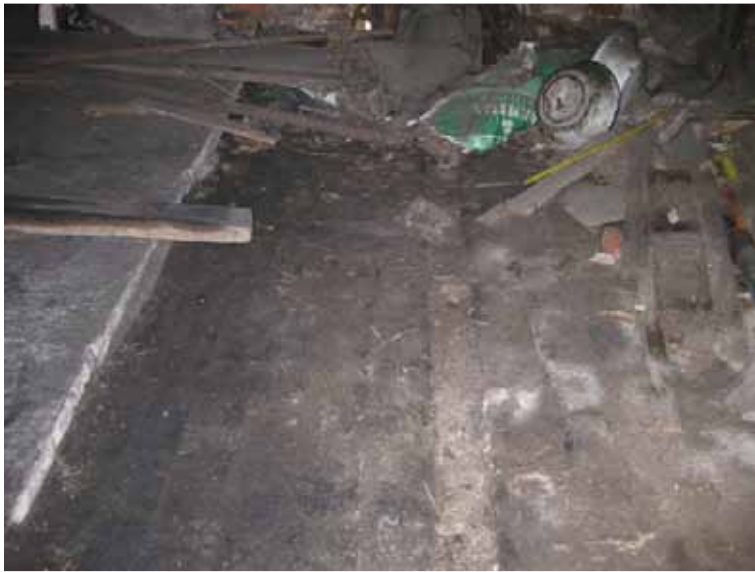
**Photograph 77:** Shows the construction of the ground floors within the building. To the right of the photo shows the cobbled floor with a concrete slab to the left.

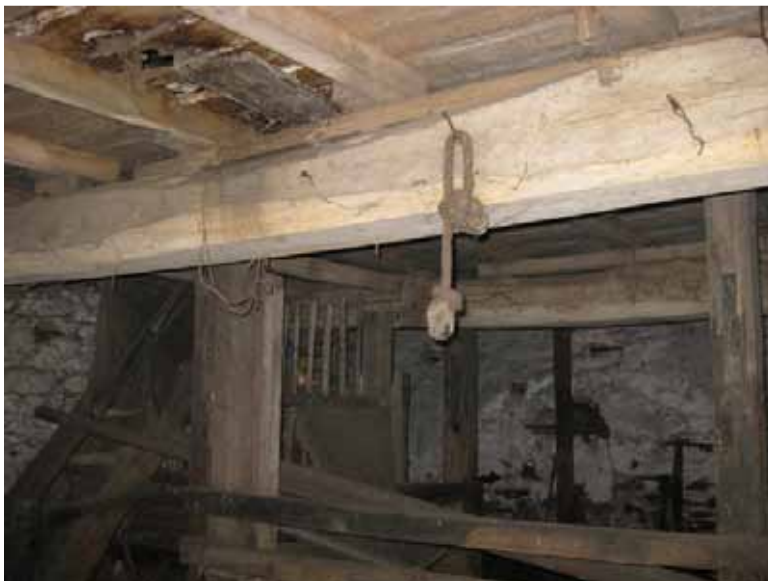
**Photograph 78:** Illustrates the first floor layout in the Agricultural 'Building B'. The first floor comprises of oak supporting beams, with softwood joists. The timber floor planks show signs of decay, and should be replaced where necessary

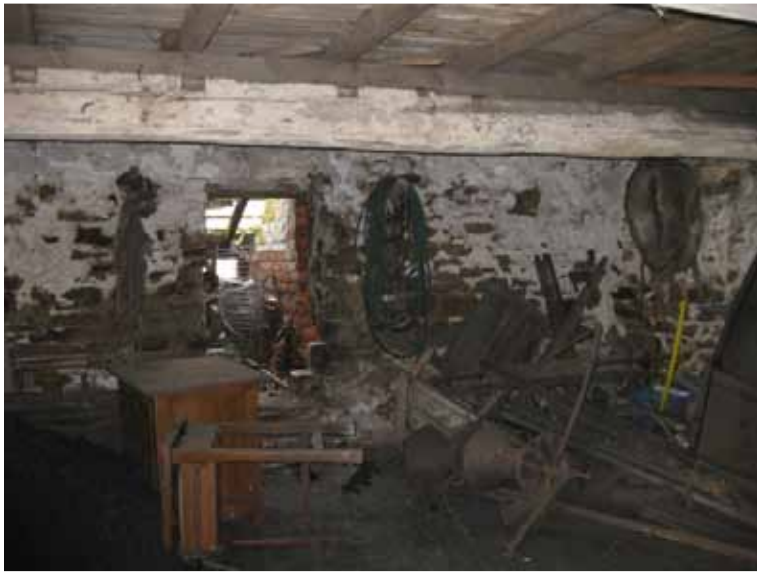
**Photograph 79:** Shows the first floor layout in the Agricultural 'Building 'B'. Lime wash walls are evident and the interior walls look to be in an adequate condition.

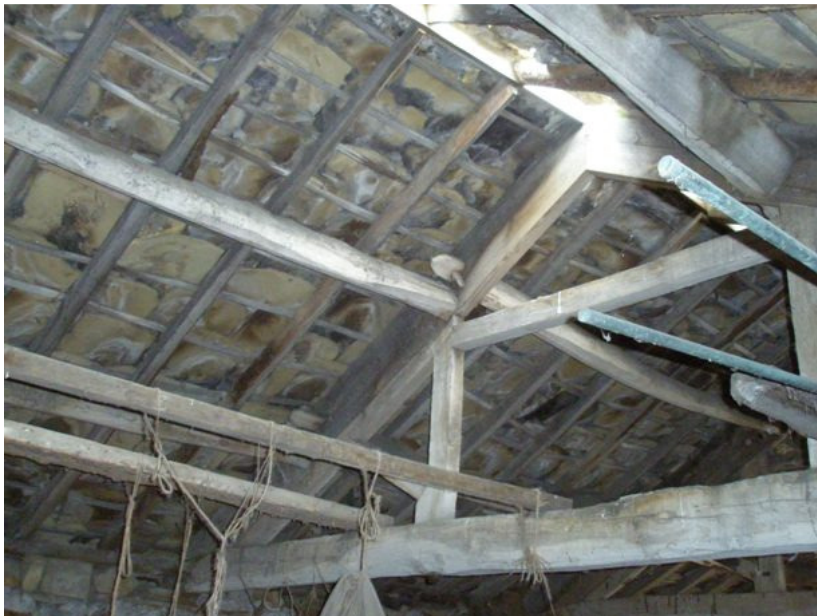
**Photograph 83:** Shows the timber roof truss layout in the Agricultural 'Building 'B'. The truss appears to be a mixture of oak and softwood. All the timber elements look aesthetically in a good condition, but further assessment may be required due to their age.
