# Arboricultural Appraisal Report

## Subsidence Damage Investigation at:

12 North Field  
Silkstone  
S75 4NQ

| REPORT DATE: | 10 July 2013 |

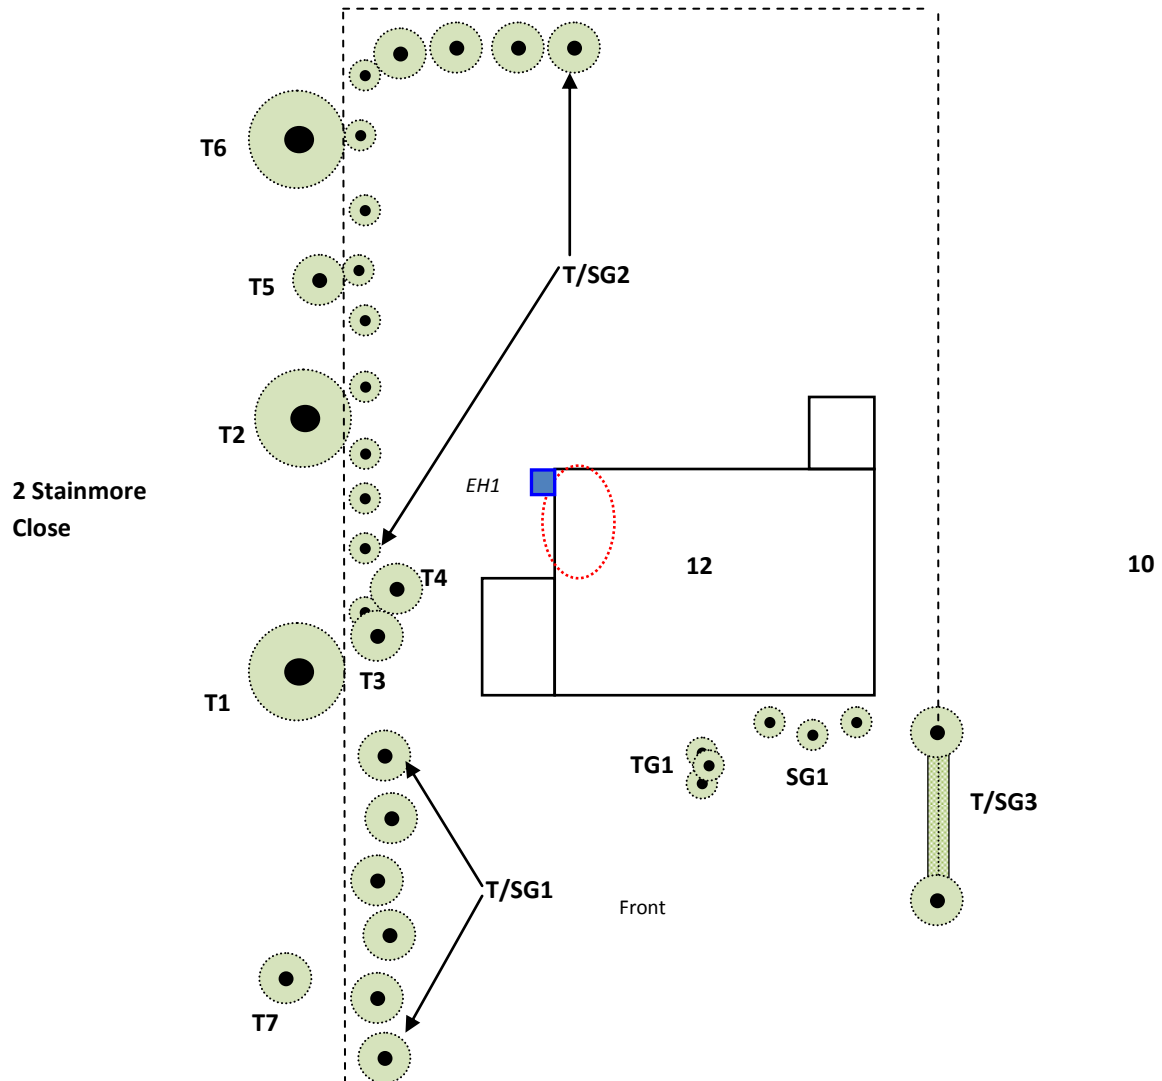
## SITE PLAN

Approximate areas of damage

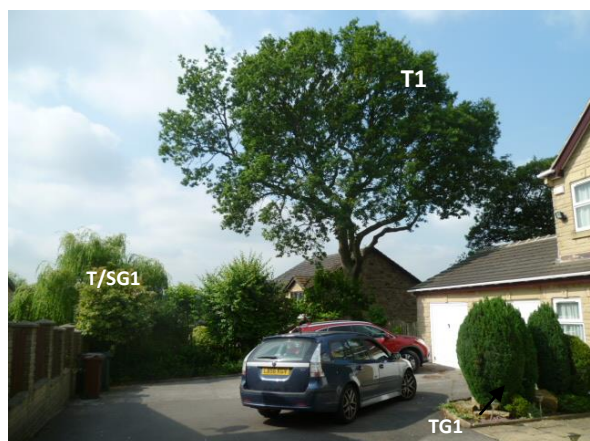
View of Front

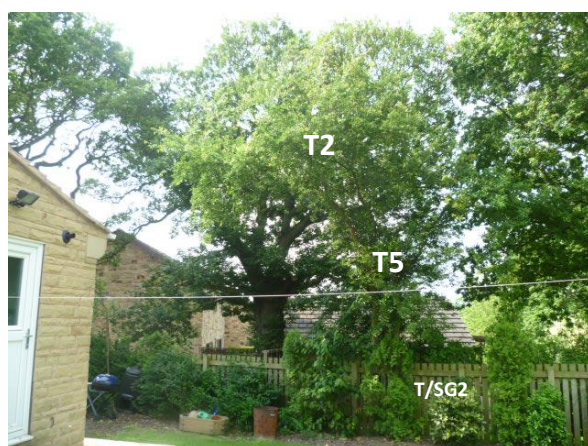
View of left of garden

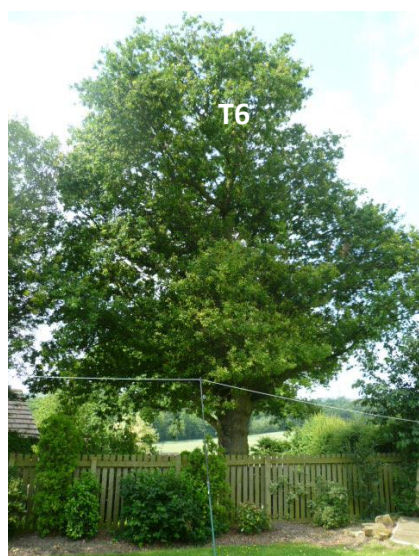
View of rear left of garden
