**PHASE 1  
GEOTECHNICAL AND GEO-ENVIRONMENTAL  
SITE INVESTIGATION**

**KERESFORTH ROAD, DODWORTH,  
BARNSELY**

**KEEPMOAT HOMES LTD**

**46631-001**

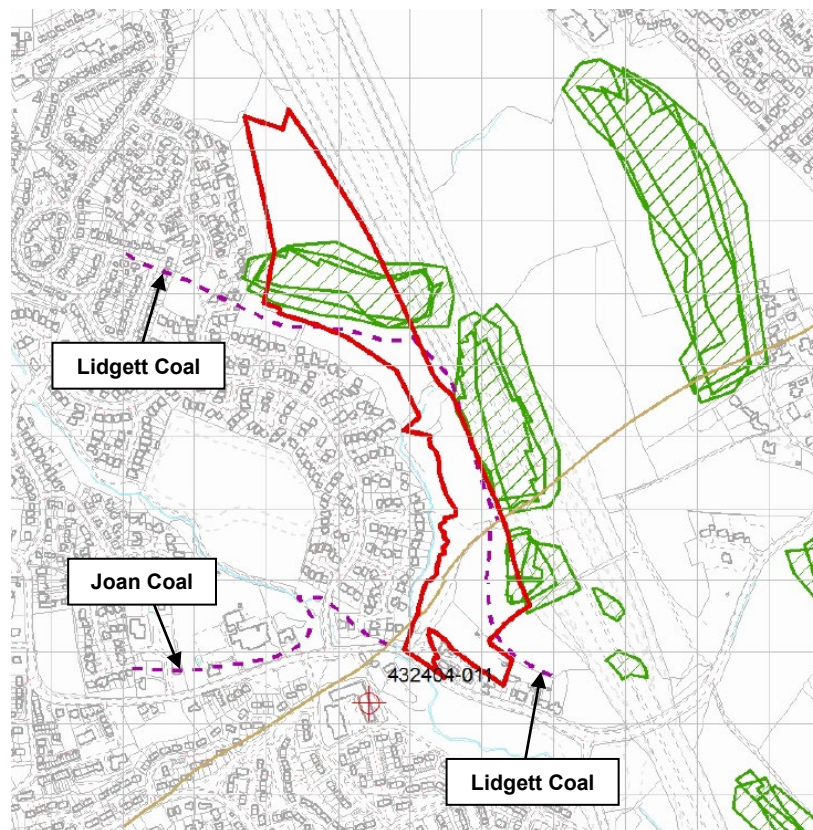
*Extract of plan from Consultants Coal Mining Report showing location of coal outcrops (purple dashed lines), fault lines (yellow solid line) and historical opencast sites (green hatched areas).*

The CA record backfilled opencast workings to be present in the north and south east of the site, and also immediately beyond the eastern boundary. There is broad correlation between the recorded extent of the opencast workings and the mapped extent on the geological map. Numerous abandonment plans are noted to be available. During the previous site investigation, Eastwood & Partners reviewed abandonment plan NE277 for the opencast areas which extend onto the site. This plan detailed opencast workings for the Lidgett coal which took place in 1949, backfilled in 1950. The Lidgett coal was recorded to be 0.6 m thick, and no underground workings were recorded during opencast, which extended up to around 12 m below original ground level. The seam was noted to dip to the north east and east at around 1 in 10 to 1 in 13.

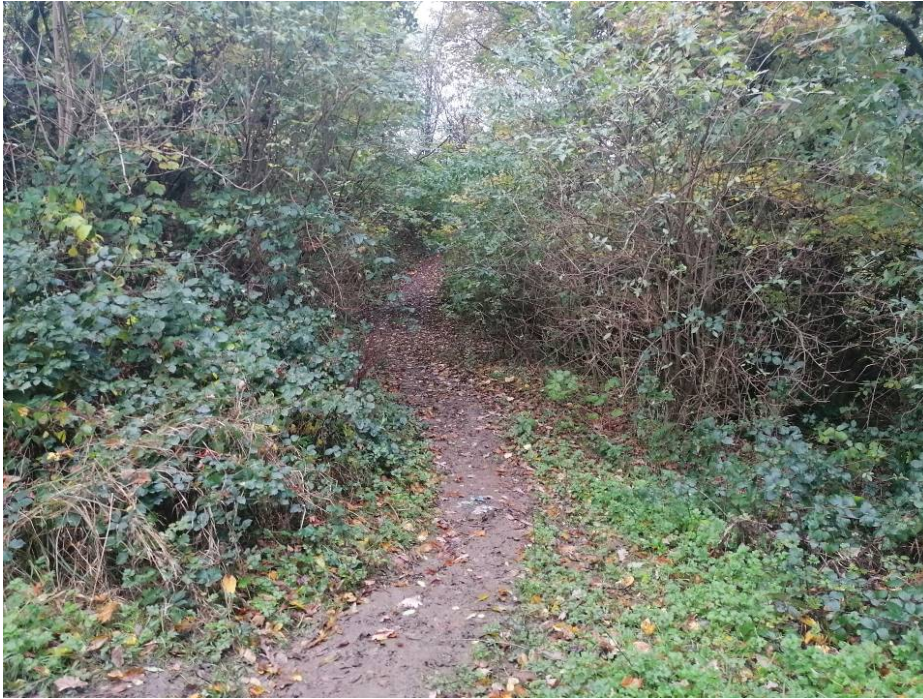
**Wooded area with Culverted stream between centre and northern fields**  
 (view south from northern field into woodland)

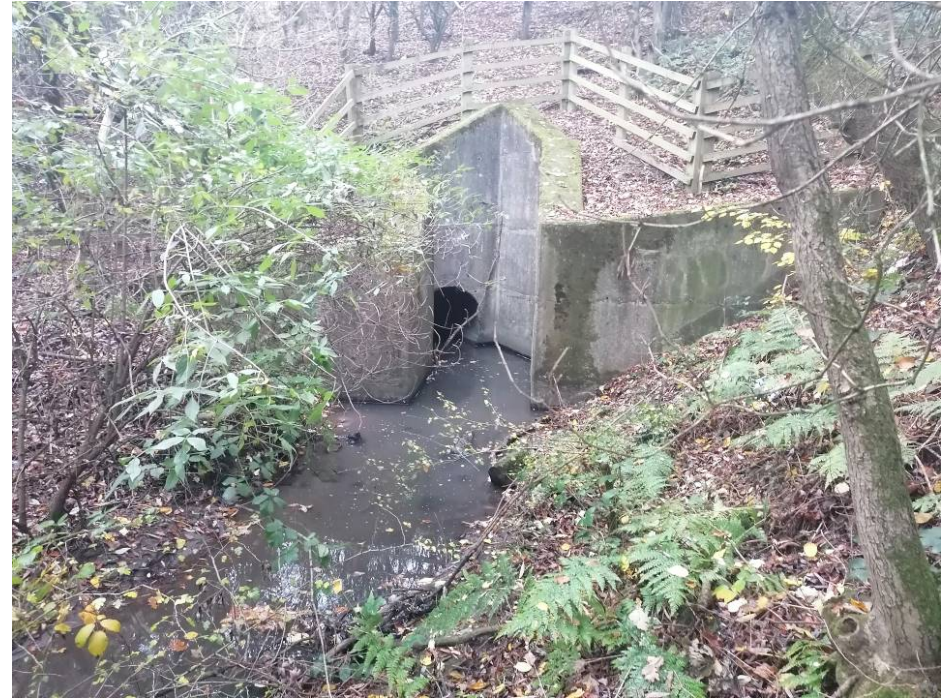
**Culverted stream beneath M1 carriageway**  
 (view east towards M1 from wooded area)

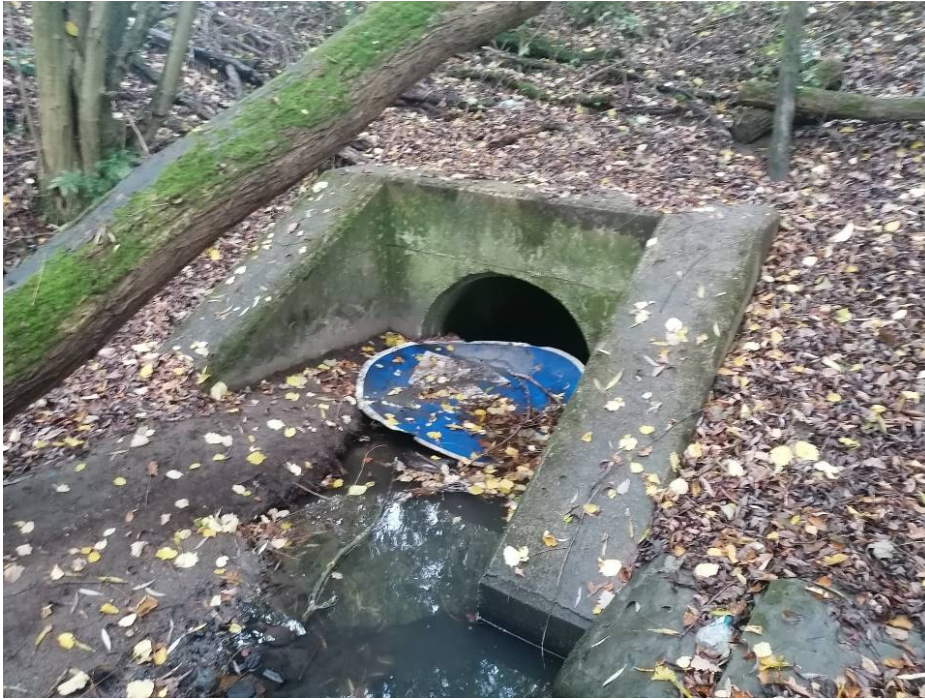
**Culverted stream beneath footpath in wooded area between centre and northern fields**  
 (view west from wooded area towards footpath)
