APPENDIX A

- 01.** Further to **Background** set out in the preceding document, this section sets out the initial detailed recording of the fabric and structure of the building as opened up, so as to inform the detailed constructional changes needed to achieve both fire and acoustic compartmentation/separation of the additional guest accommodation which is to be formed for the current unused attic ranges.

Andrew Shepherd, Dip. Arch (Manc.), Dip. Cons. (A.A.), R.I.B.A., I.H.B.C., F.R.S.A. carried out a visit on 6th December 2017 to survey the existing floors now they had been opened up, so as to devise a methodology of producing the necessary fire precautions and acoustic separations required for the residential use of the rooms.

ADWS/TJC/TAM/03.22.15-16
13th February 2018
Rev 1 22nd May 2018

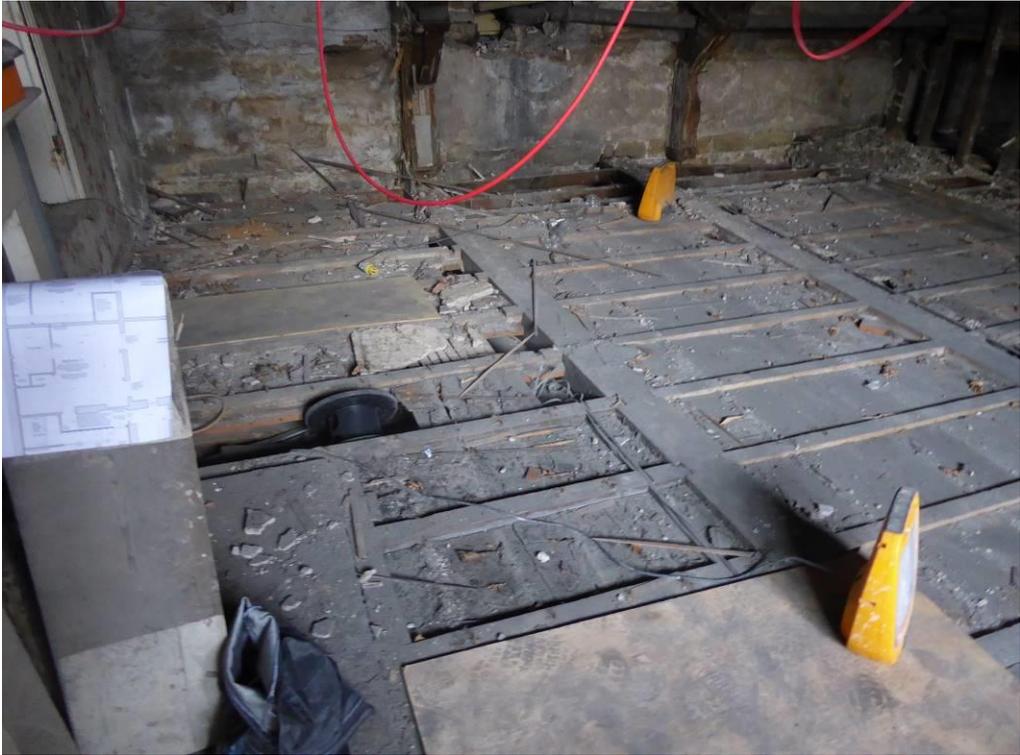
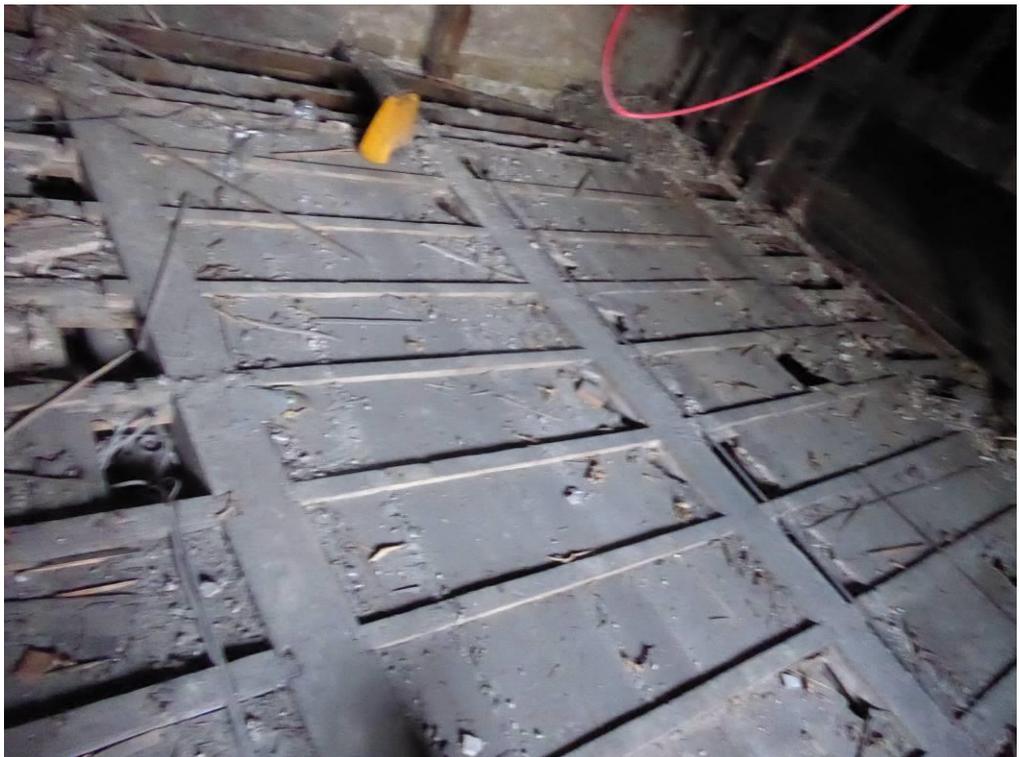
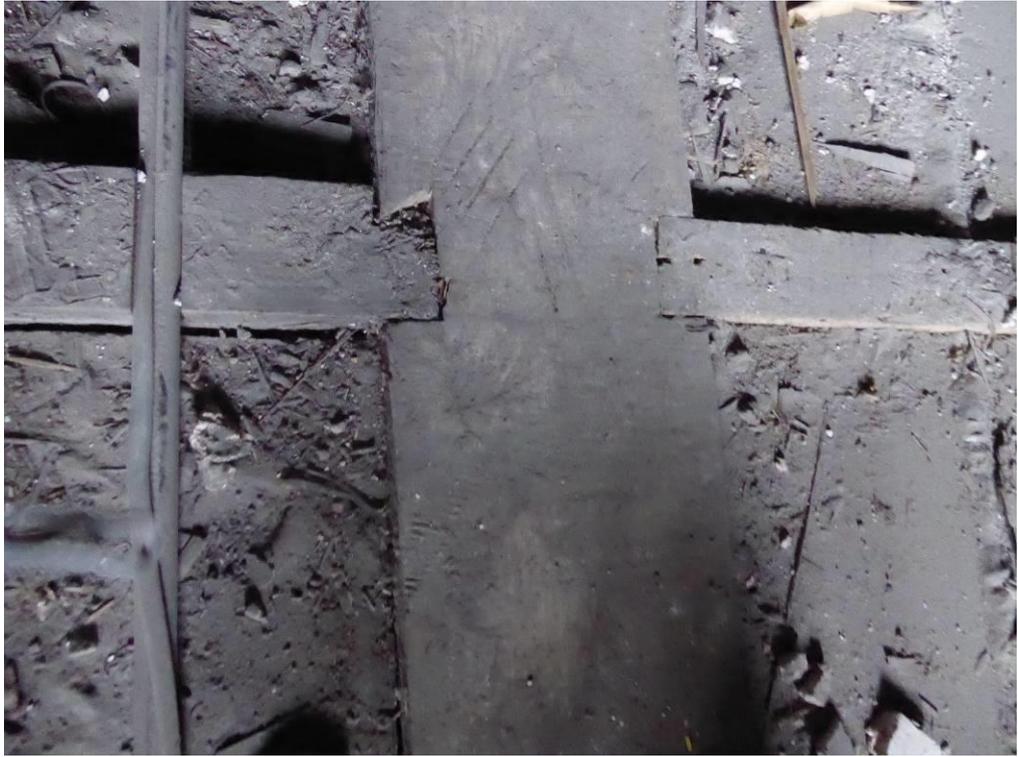
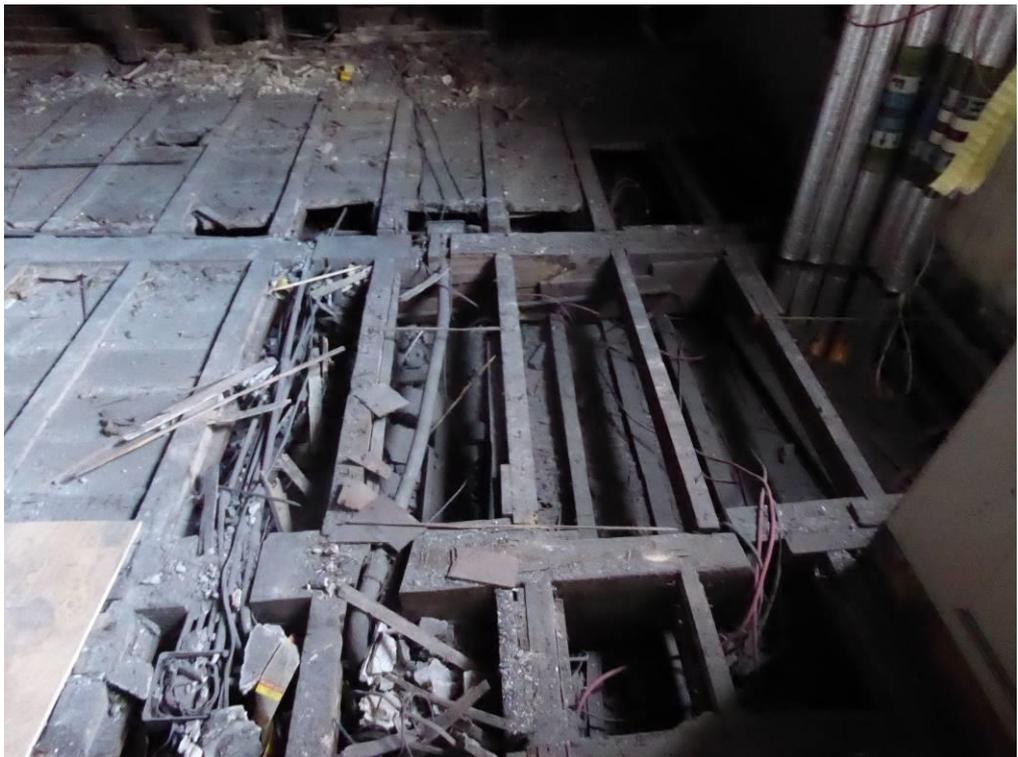
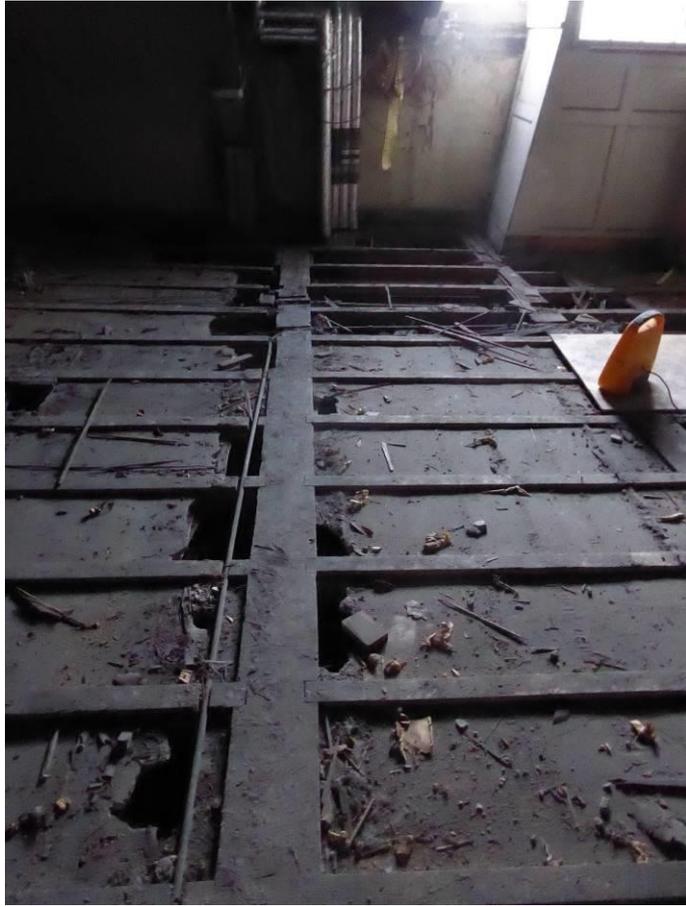
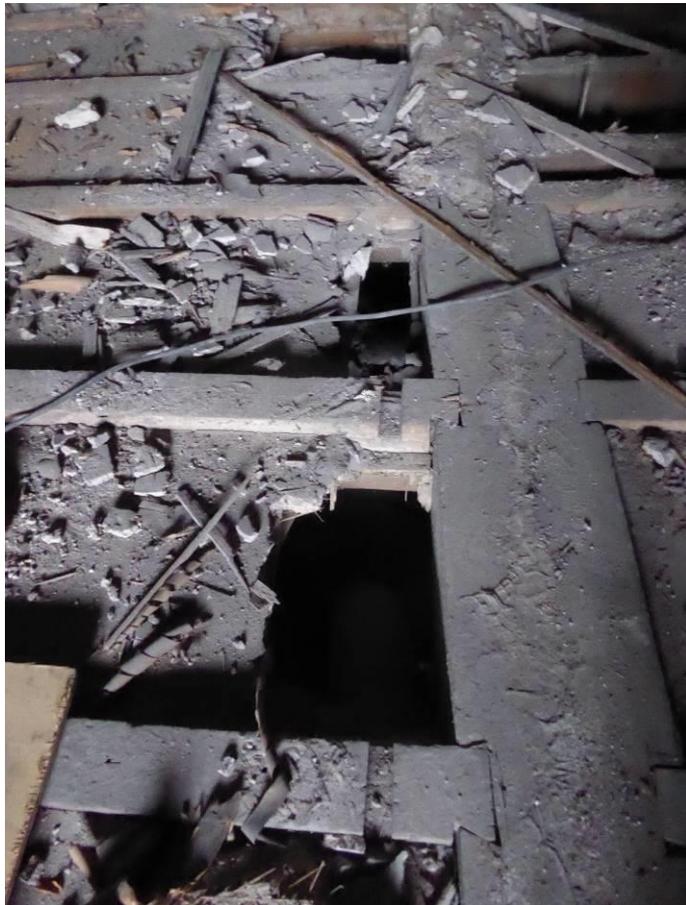
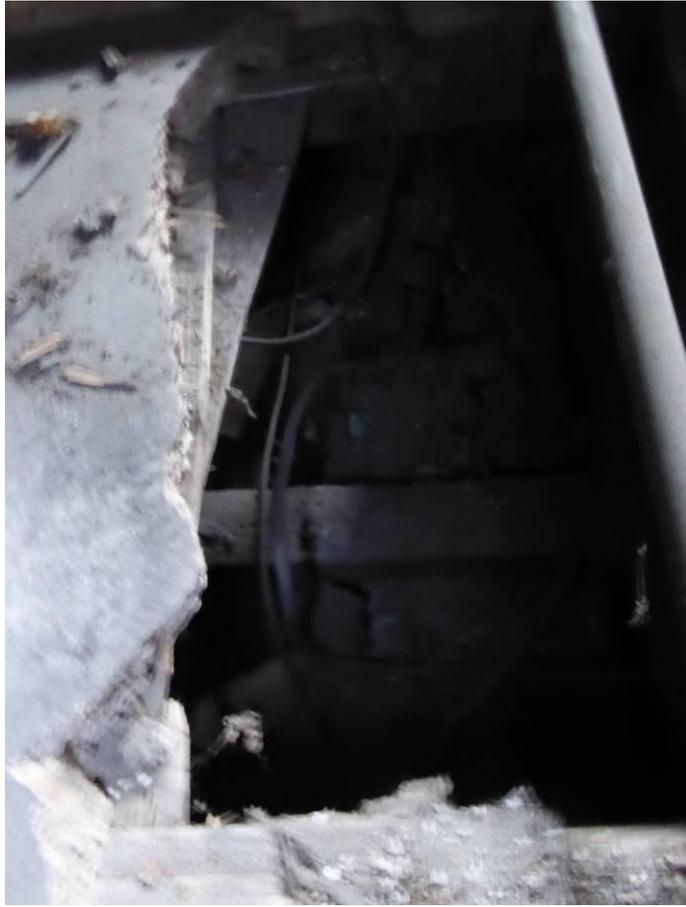
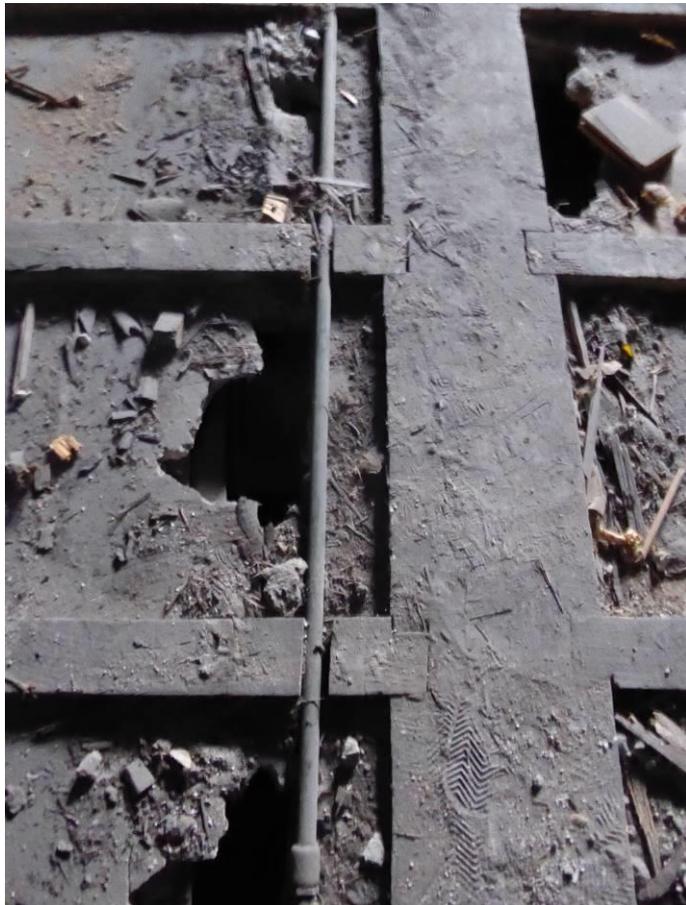
In general terms, the existing floor decking has been stripped out. This shows existing lime ash pugging over lath between the **joists** spanning between substantial floor **beams** which span North to South. There is a void, and then to the underside of the substantial beams, is a further set of **joists** (also spanning East to West) supporting the ceiling below. The pugging has been broken out in places, normally where there have been services installations. Otherwise, it appears to be generally in sound condition. There are a number of panels where it has gone completely and others where it is partly damaged.

The **roof structure** shows signs of previous change with what appears to be the strut of a former truss being cut out and replaced with a boded system leaving a post.

The next beam is some 1750 mm from that to its centre. This is an archaic beam with some evidence of beetle infestation, not sawn like the other two, but probably adzed. It has a shake to it. It was not possible to obtain access to find out its depth because of infilled debris. It, in turn, is 900mm from the similarly 300 x 200 mm collar to the truss which was formerly the wall partition to the West of the space. The joists between those two beams are again older 100 x 70 mm but laid over on their side so they are only 70 mm deep but they are at 330 mm centres. They are part morticed over the truss collar.

There has been some damage to the top of joists with services chases made in them, but they do not generally exceed 25 mm and are generally close to the beam fixings of the joists rather than midspan.

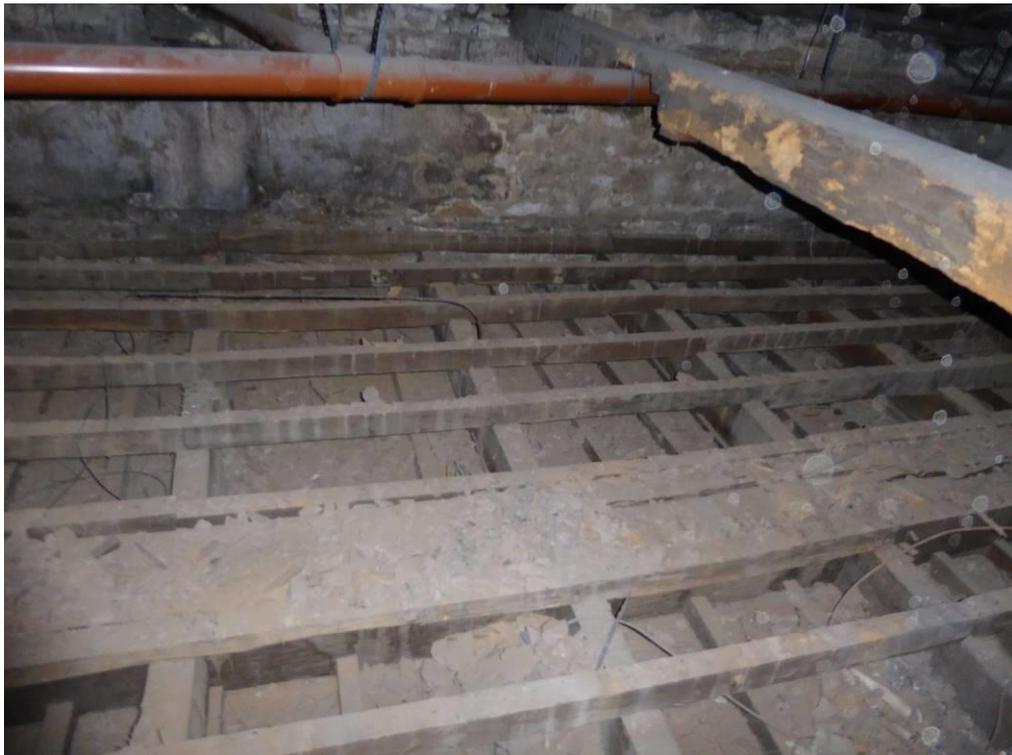
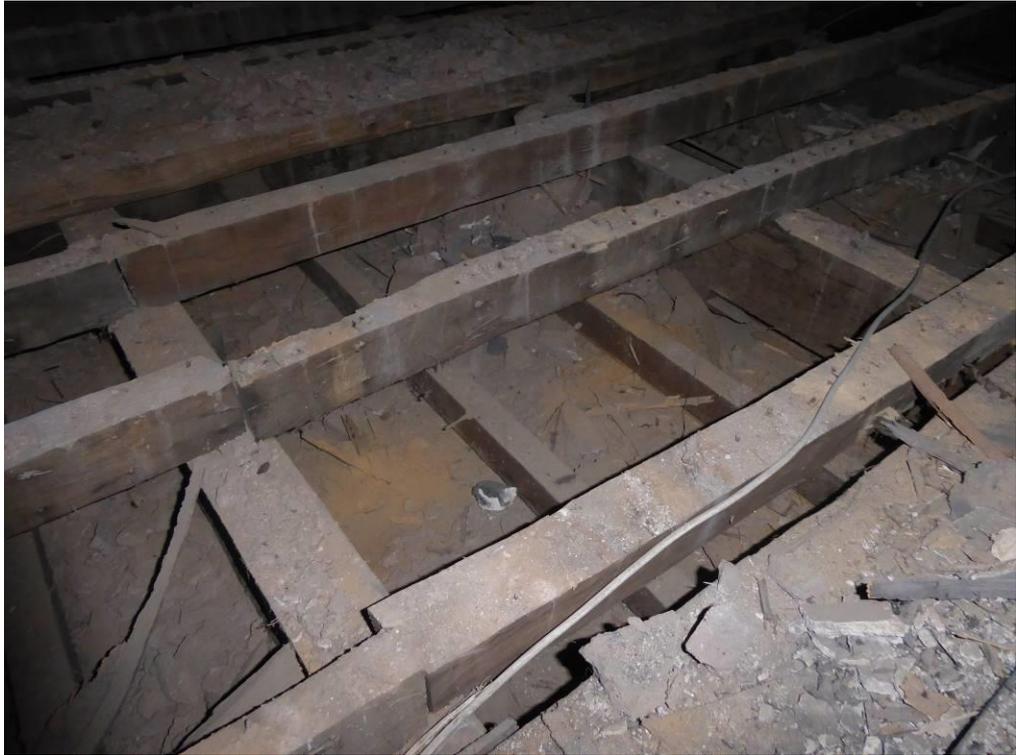
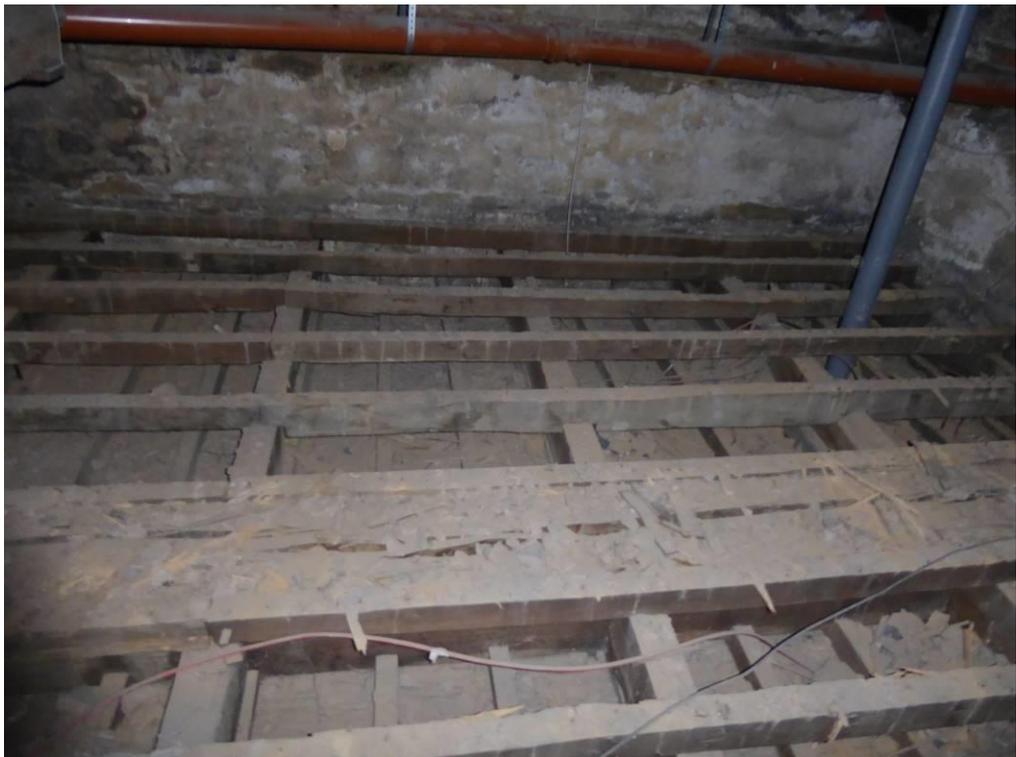
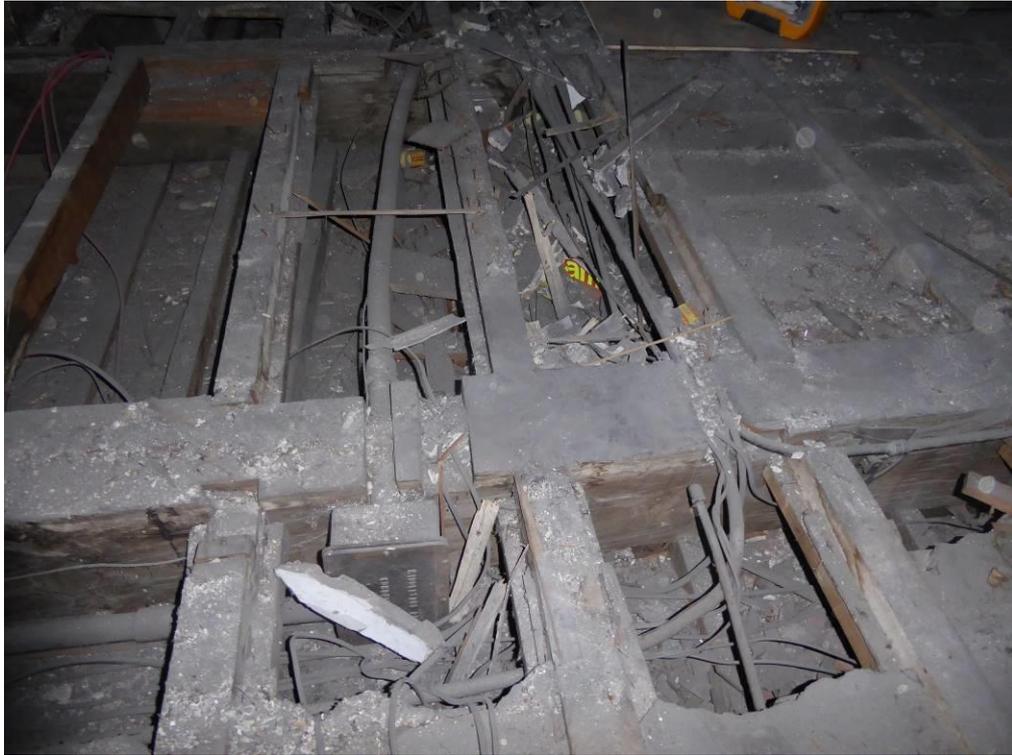
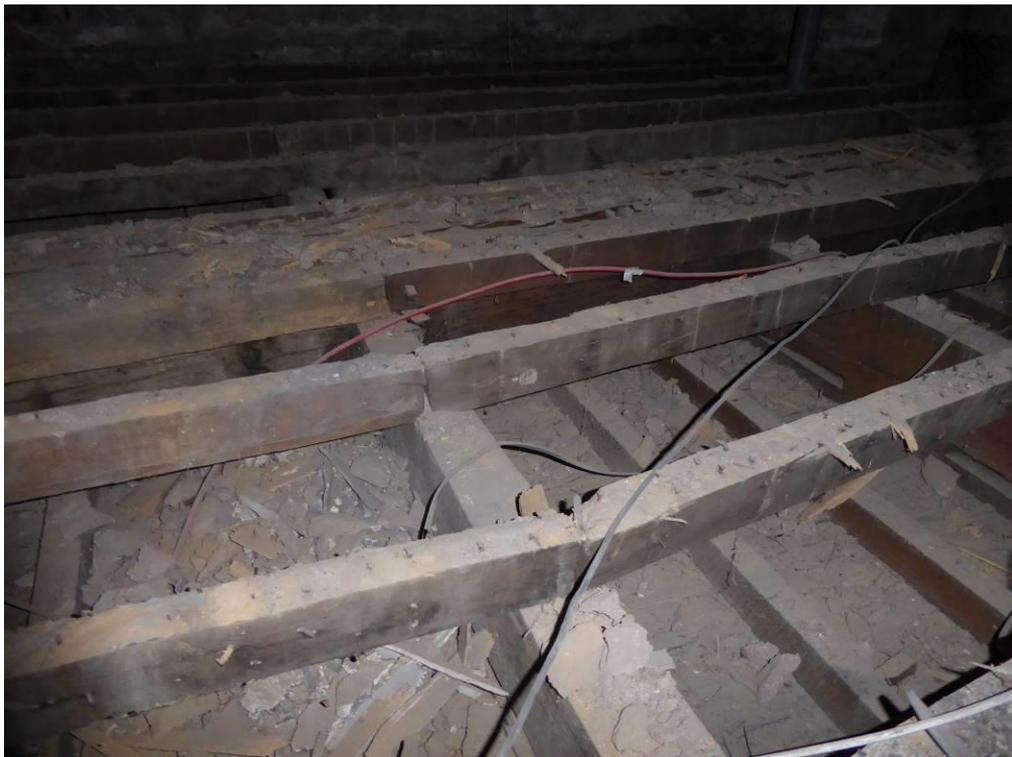
There is collapse of the flooring joists in the South West corner of the space which will need to be investigated and presumably joist hangers or replacement timbers.

In the **Roof Void** beyond this truss to the West, the floor structure comprises **joists** to a lower ceiling being 200 deep x 100 mm wide at approximately 1000 mm centres. The **joists** running North South across those are 85 x 75 mm at 400 mm centres. The **ceiling joists** to below (defining a void from the top of the floor joists to the top side of the plaster of 360 mm) are 75 x 50 mm at 300 mm centres. In the space there is also a section of substantial beam which looks like a composite of some sort about midspan. The **floor joists** are 1 third/2 thirds morticed bearing onto some of the substantial timbers. The principal beams run East/West.

Debris will need to be cleared from the void. There is no pugging or anything of this nature here. Certainly there is parging debris from the underside of the roof slates which has been just left in the void.

Clear all debris, then over the back/top surface of the laths supporting the ceiling plaster to the room/space below, shape and fit Karma TMF70. Stone fibre batts between the joists, sealing the joists between the batts and sides of the joists (as possible) with Karma EX240 sealant.

Over the retained top surfaces of the joists lay new floor decking system to lag. Lag over the joists 100 mm wide strips of resilient foam, and then overboard complete, spanning across the joists with 40 mm thick Karma Masspanel available from SIG or CMS Danskin Refurbishment. Rebate underside over joists to achieve floor level as existing.

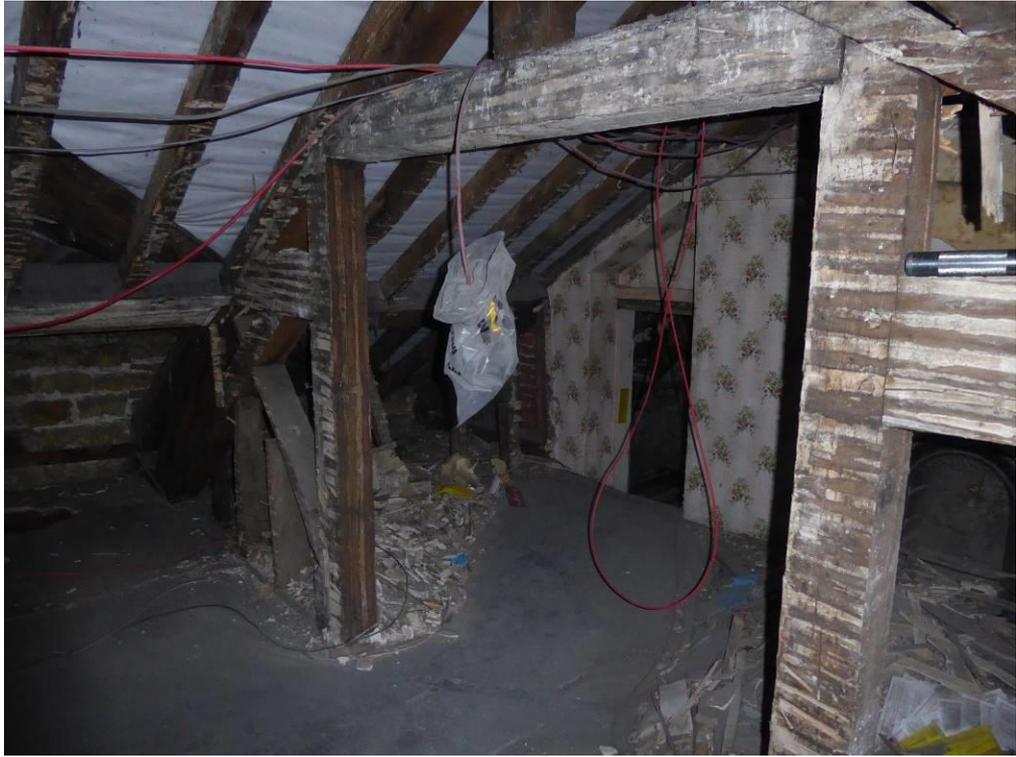
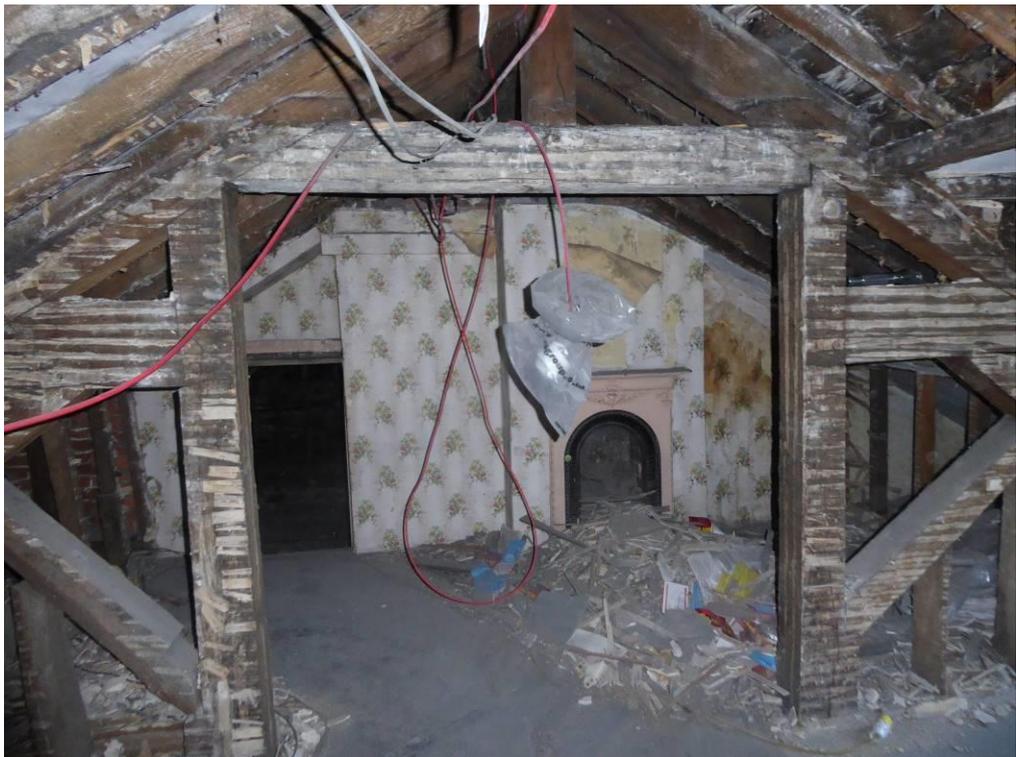
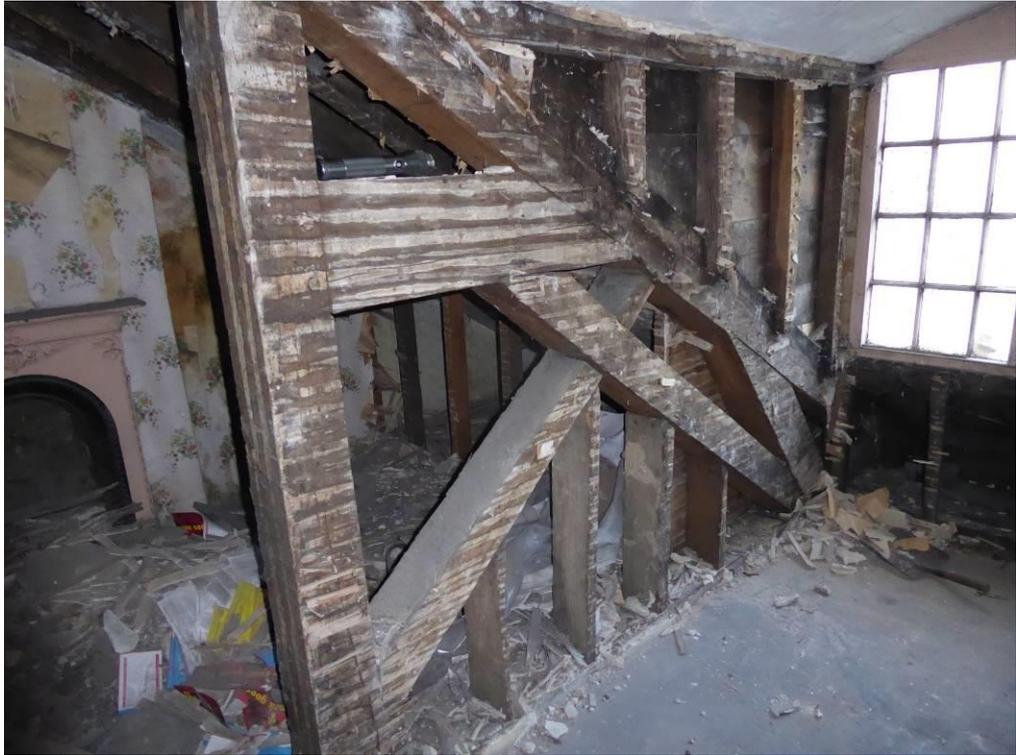
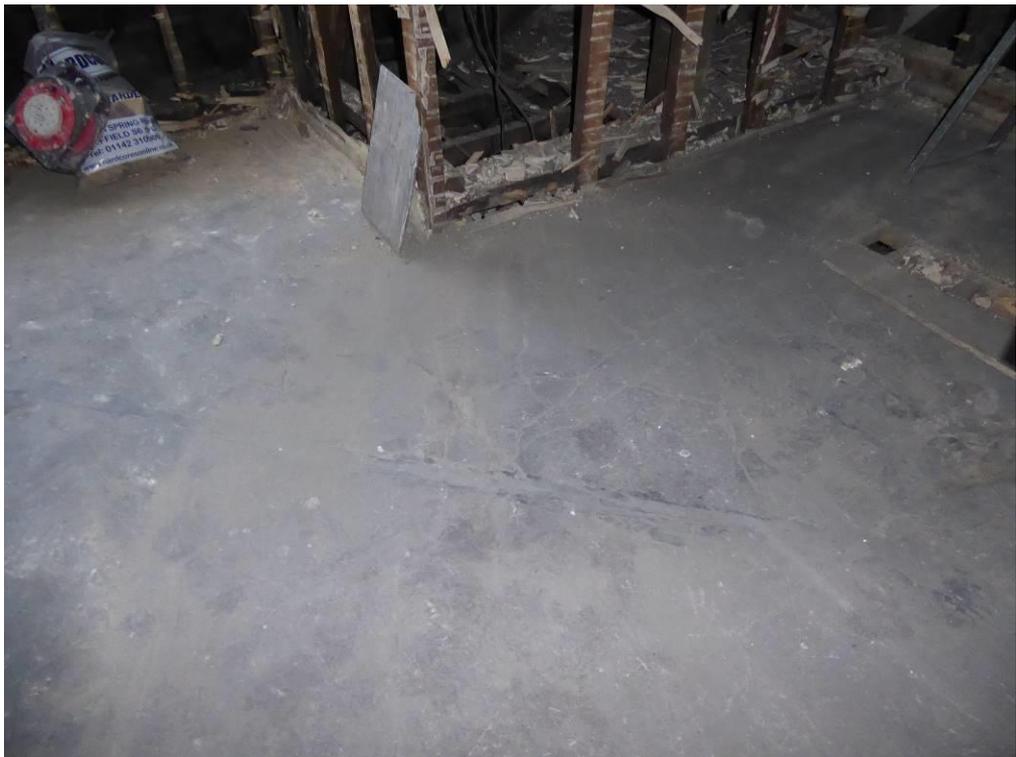
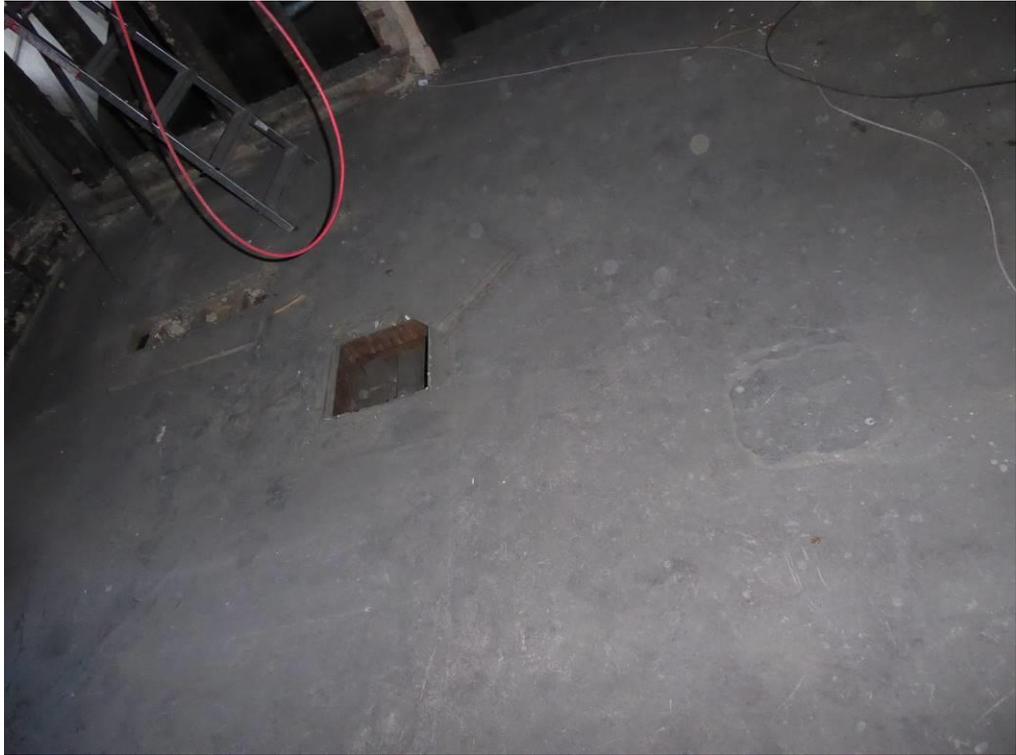
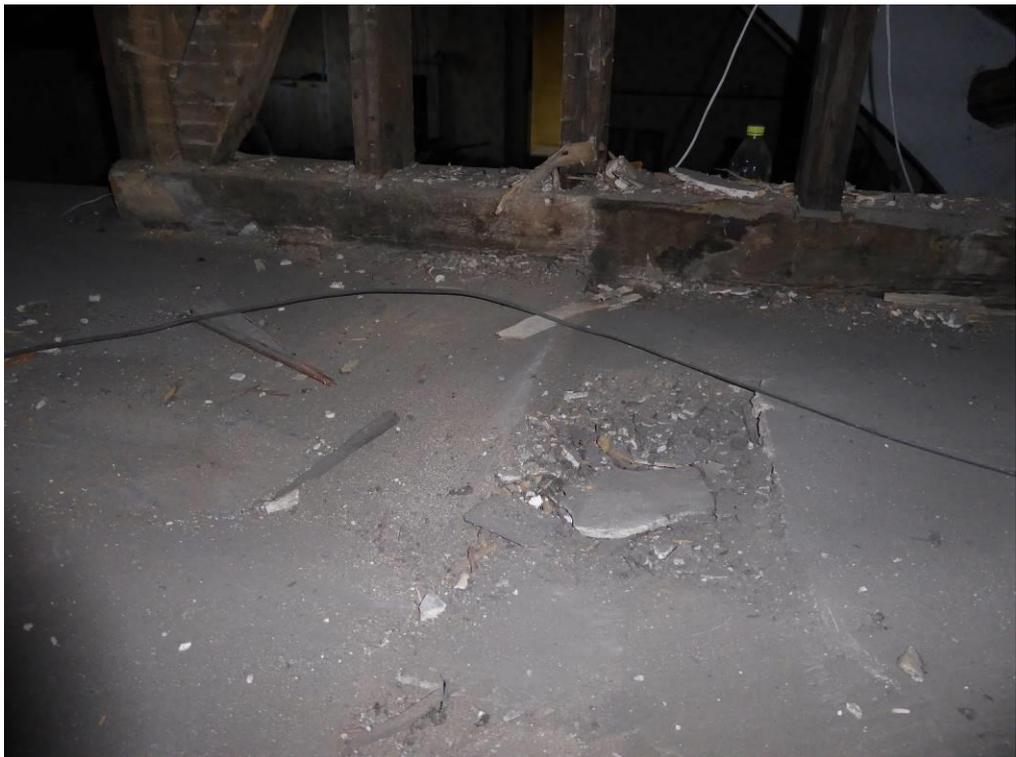
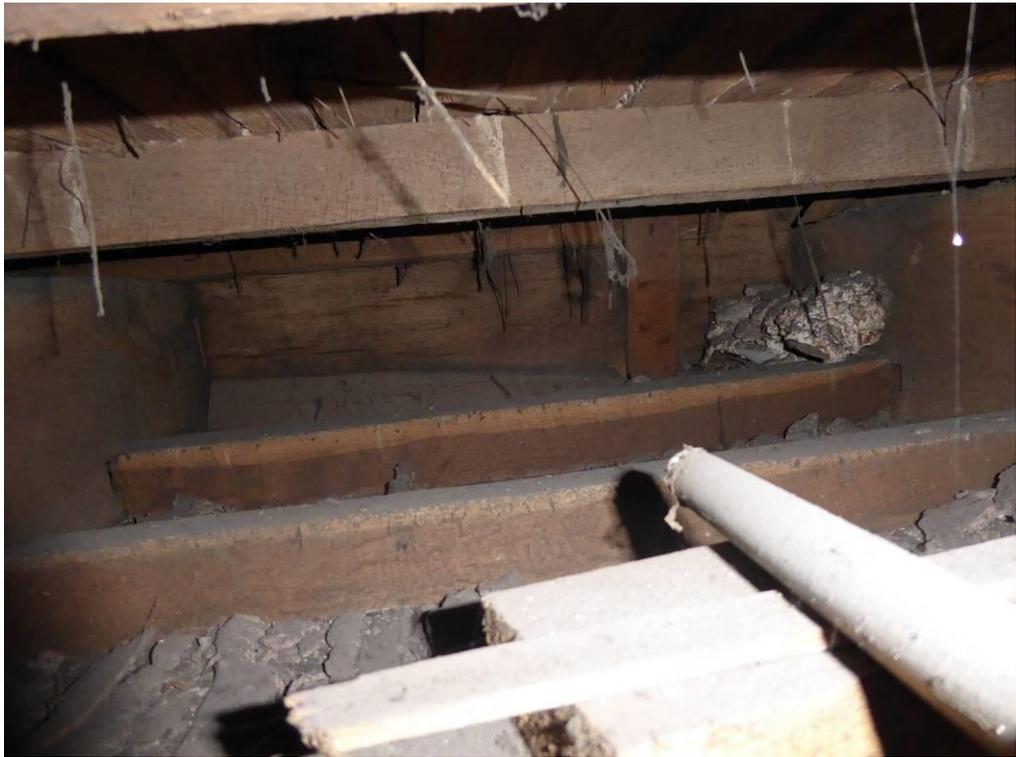
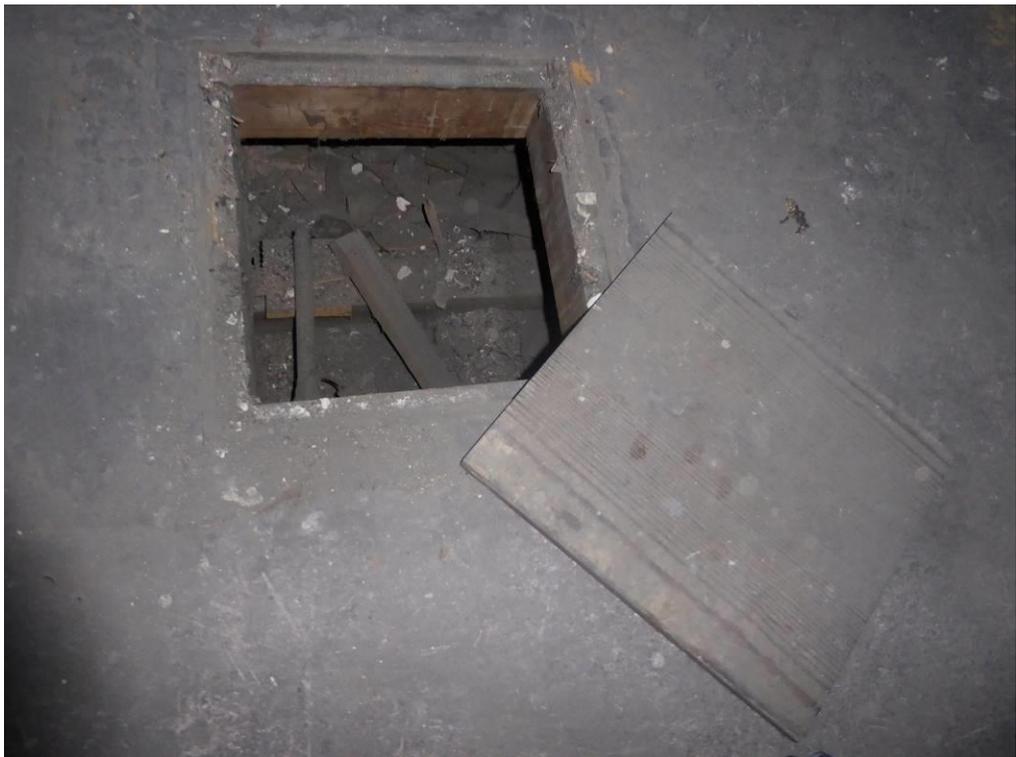
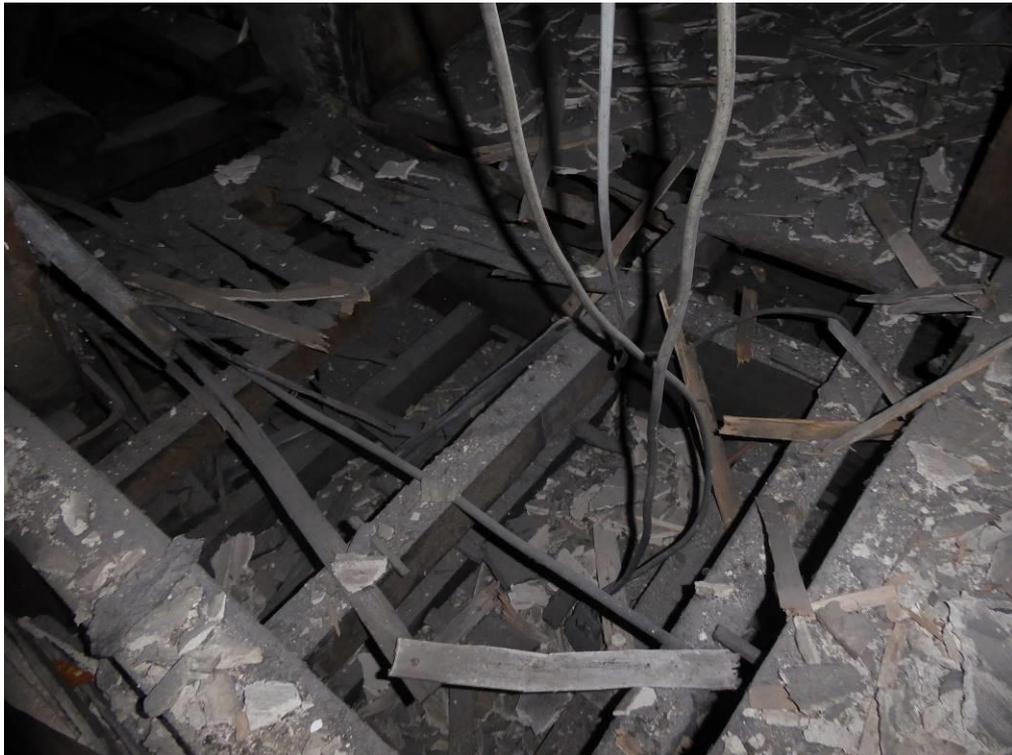
The South roof slope, including over the pediment of the principal elevation, has got sarking felt to the West side, but not to the East. Very substantial water penetration has occurred though the under sarking boarding which is leached with salts, but in fact through a hole, it can be seen that there is in fact sarking felt above. This presumably is therefore all historic decay.

As a result of that damp, there is beetle infestation in a number of these timbers but no evidence of any deathwatch beetle infestation can be seen. They will all need to be cleared and cleaned.

The chimney is exposed with stonework built into the brickwork. There is some salting. There has obviously been water penetration as the plaster below is damaged.

The lime ash floor finish itself does bow and dip about a bit and there is a substantial cracked area which has previously been repaired with cement running from an infilled service trench. This material appears to have been overlaid on the original work below, so presumably this is actually some sort of Victorian insertion of sand screed cement very much like that in Bedroom 3. The original work in the South side of the room is broken up where it comes to the wall and presumably there has been damp and when it has been enclosed behind plaster in the modern era.

All as Bedroom 5, and additionally reparging the timber floor structure and on a like for like basis as required.

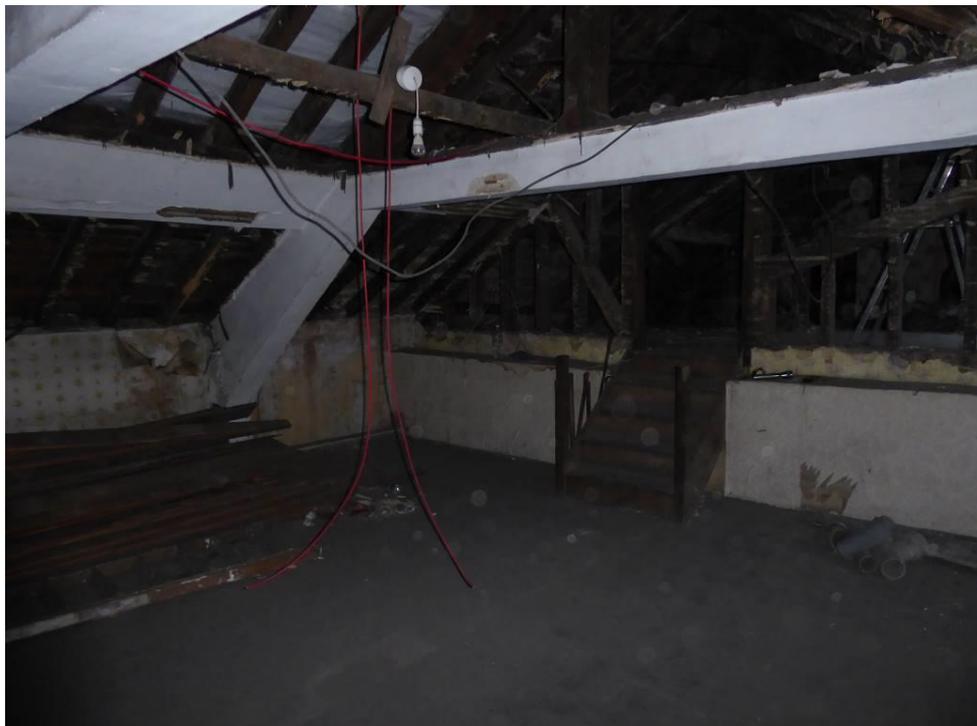
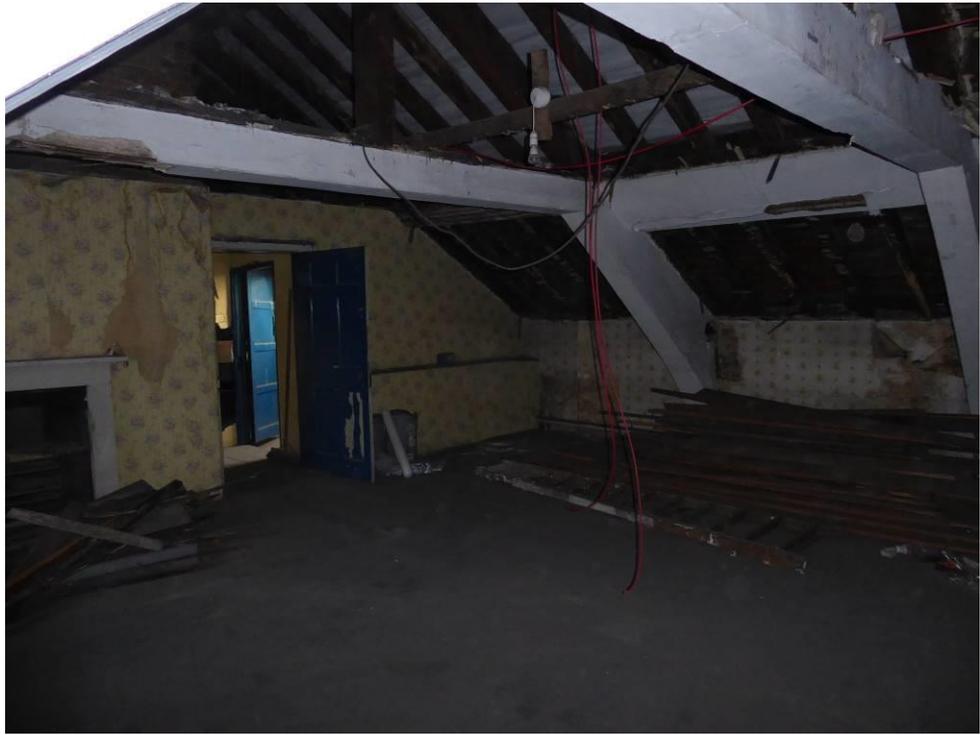
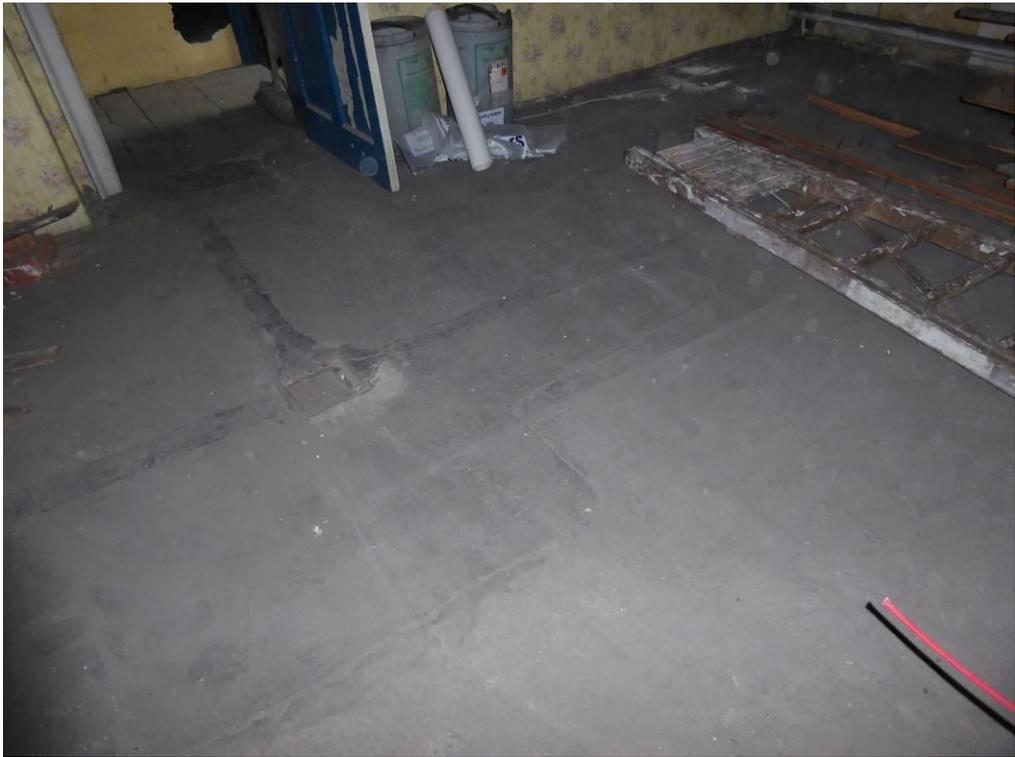
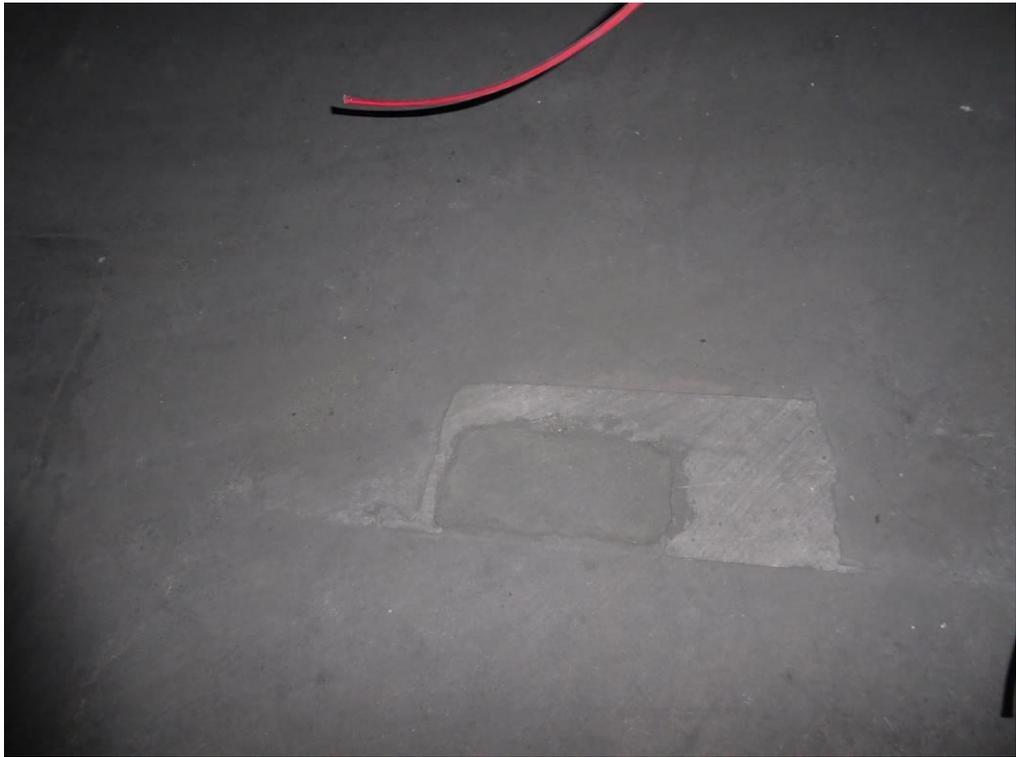
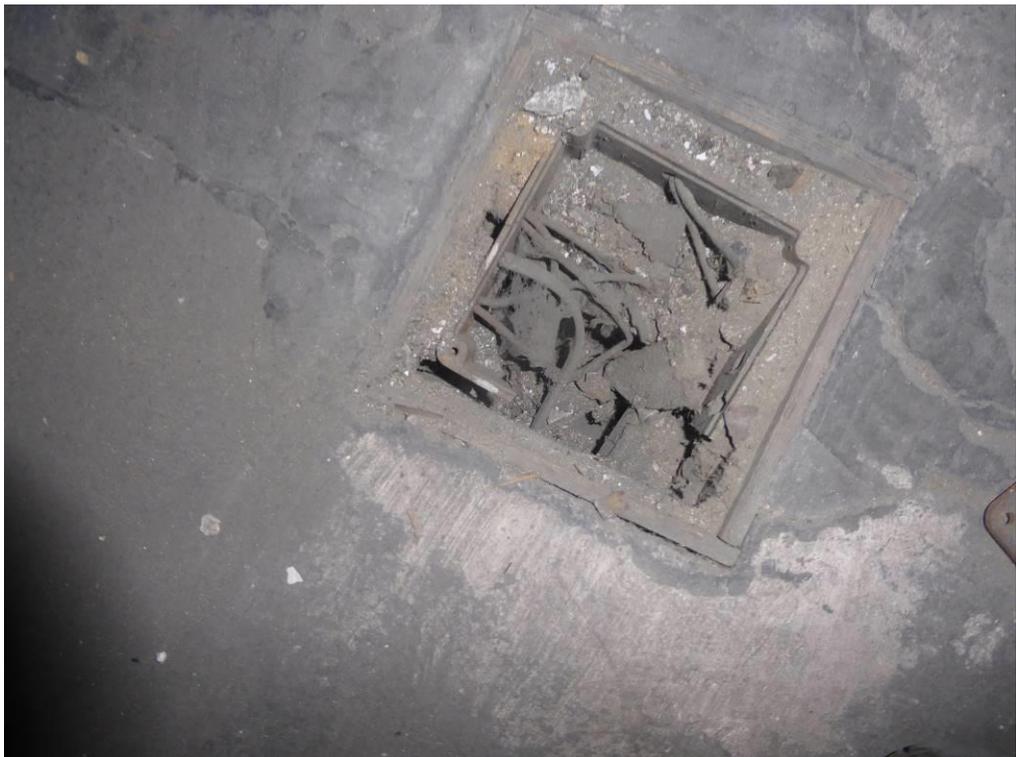
it was thought initially that the lime ash **floor** was in generally adequate condition. It is believed to be Victorian overlaying of the original floor pugging. When the room was cleared it could be seen that the two "generations" of floor "screeding" were damaged in a number of places, and there were part of the floor which could be "bounced", presumably denoting some failure of the subfloor structure.

The **roof** timbers are generally all enclosed with lath and plaster over the mid-span purlin. On the South side there is an area, now stripped out, exposing the rafters and undersarking boarding. There is deathwatch beetle infestation in these areas. We presume the **truss** members are the same as in the adjacent Bedroom 5 with the plastered collars not actually supporting the truss but a corbel in the wall does the task. This cannot be proven until some more casing is taken out.

The floor finish is to be taken up complete to allow for the same new fireproofing and acoustic separation system as Bedroom 5.
