APPENDIX A

- 01.** Further to **Background** set out in the preceding document, this section sets out the initial detailed recording of the fabric and structure of the building as opened up, so as to inform the detailed constructional changes needed to achieve both fire and acoustic compartmentation/separation of the additional guest accommodation which is to be formed for the current unused attic ranges.

Andrew Shepherd, Dip. Arch (Manc.), Dip. Cons. (A.A.), R.I.B.A., I.H.B.C., F.R.S.A. carried out a visit on 6th December 2017 to survey the existing floors now they had been opened up, so as to devise a methodology of producing the necessary fire precautions and acoustic separations required for the residential use of the rooms.

ADWS/TJC/TAM/03.22.15-16
13th February 2018
Rev 1 22nd May 2018

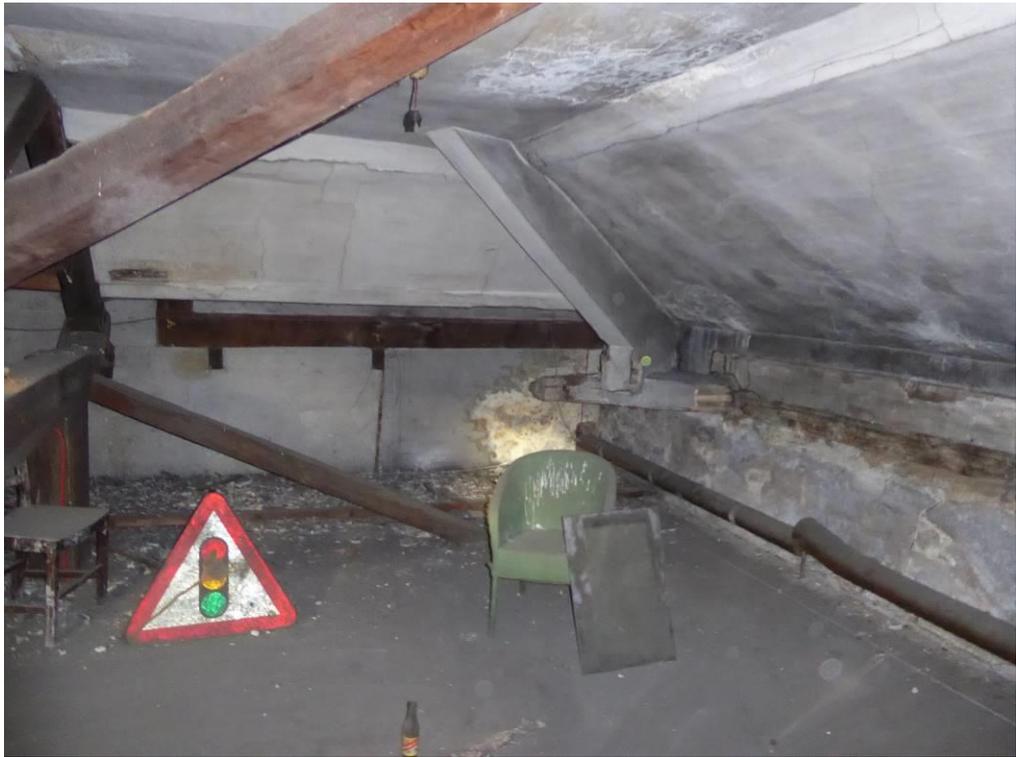
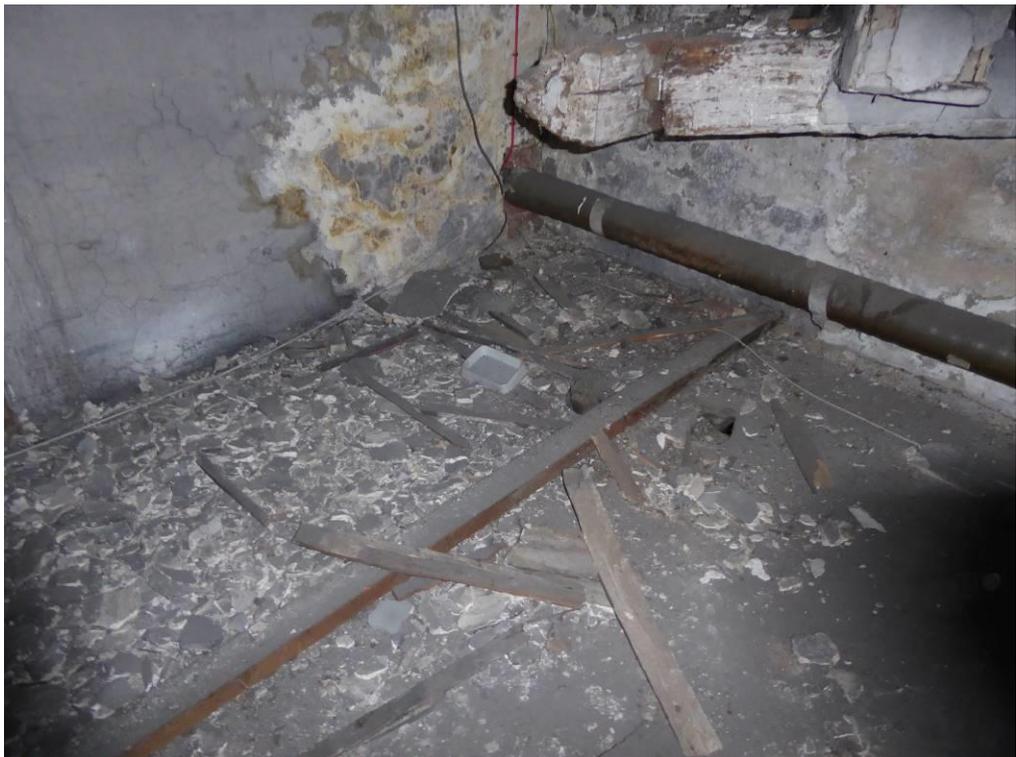
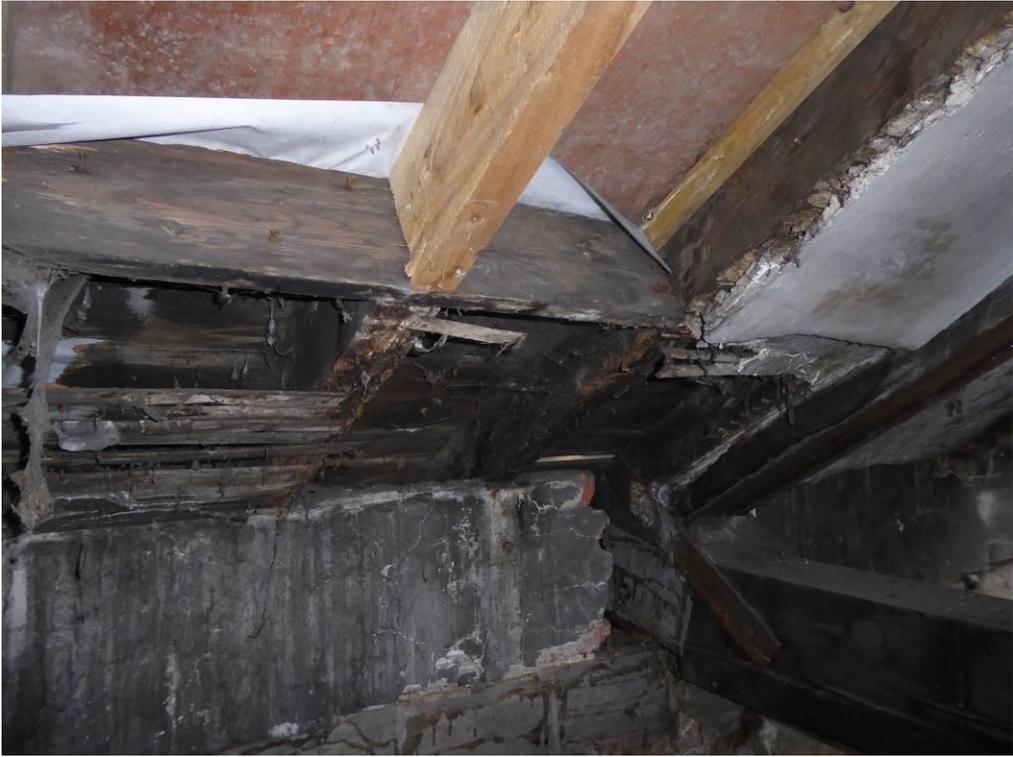
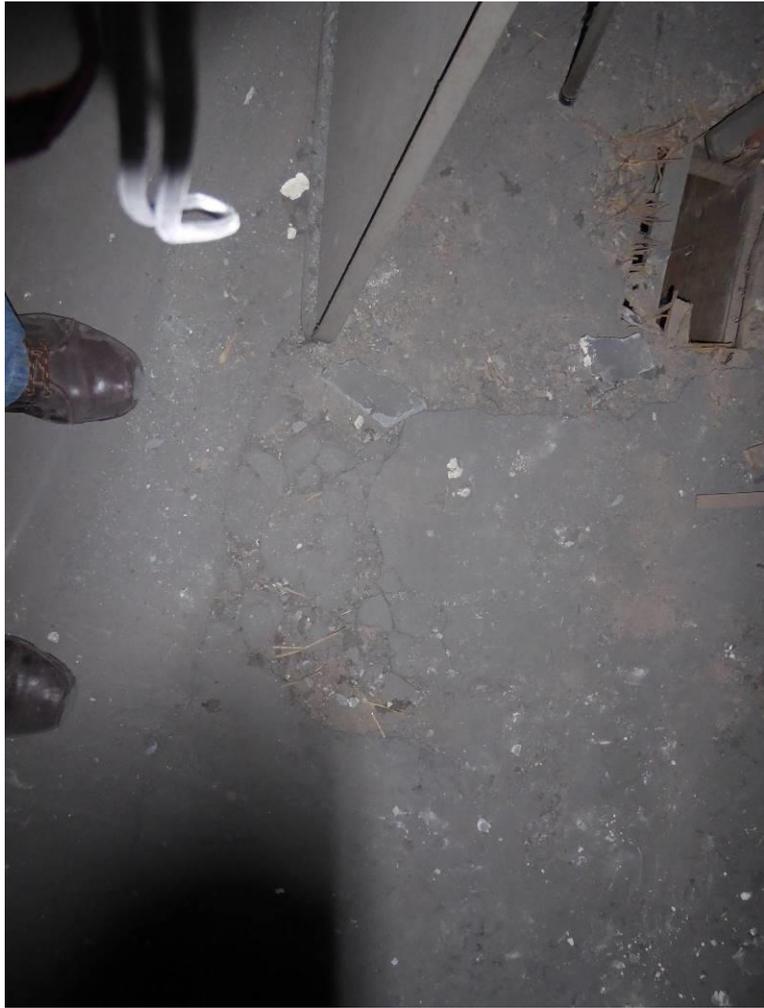
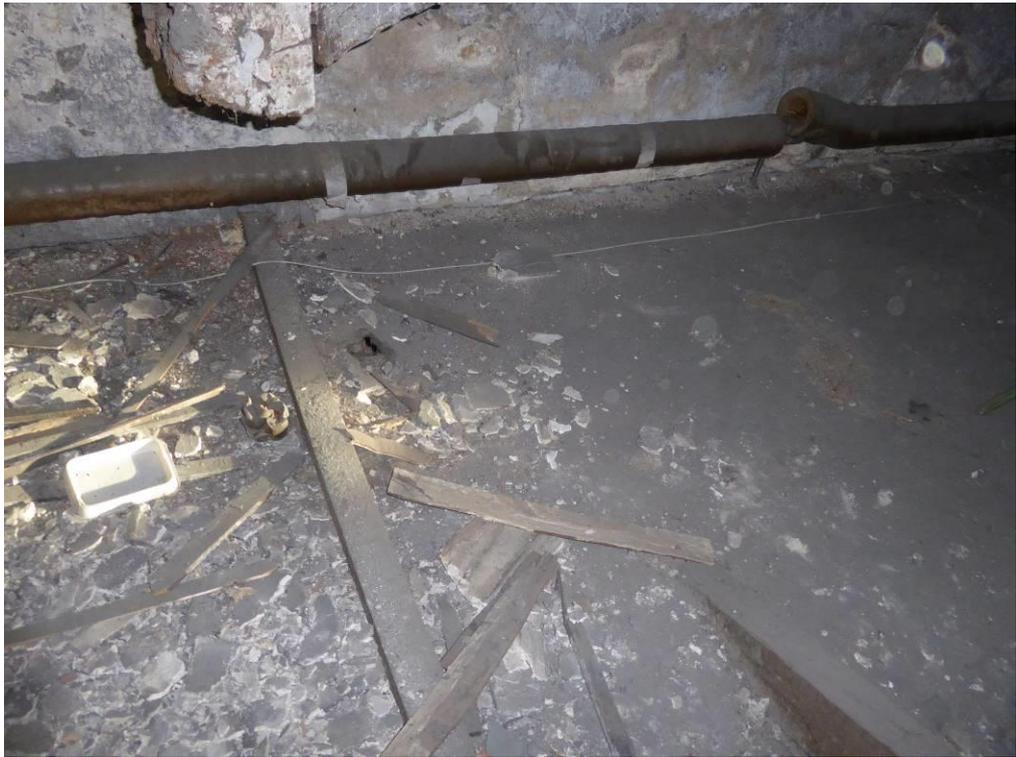
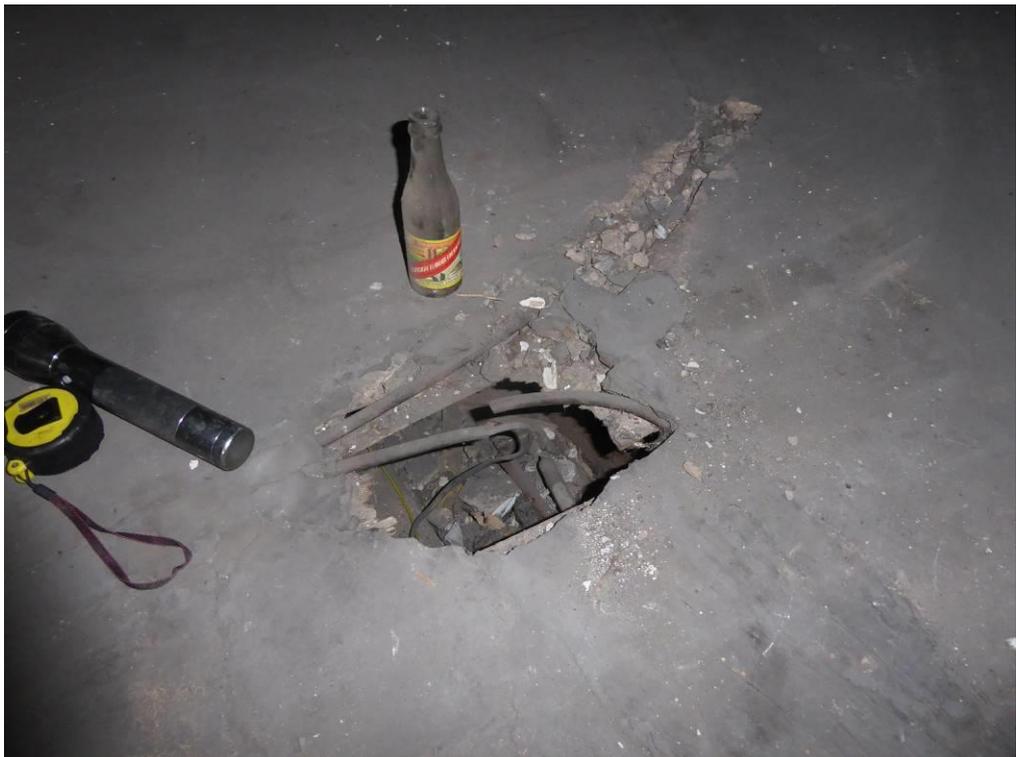
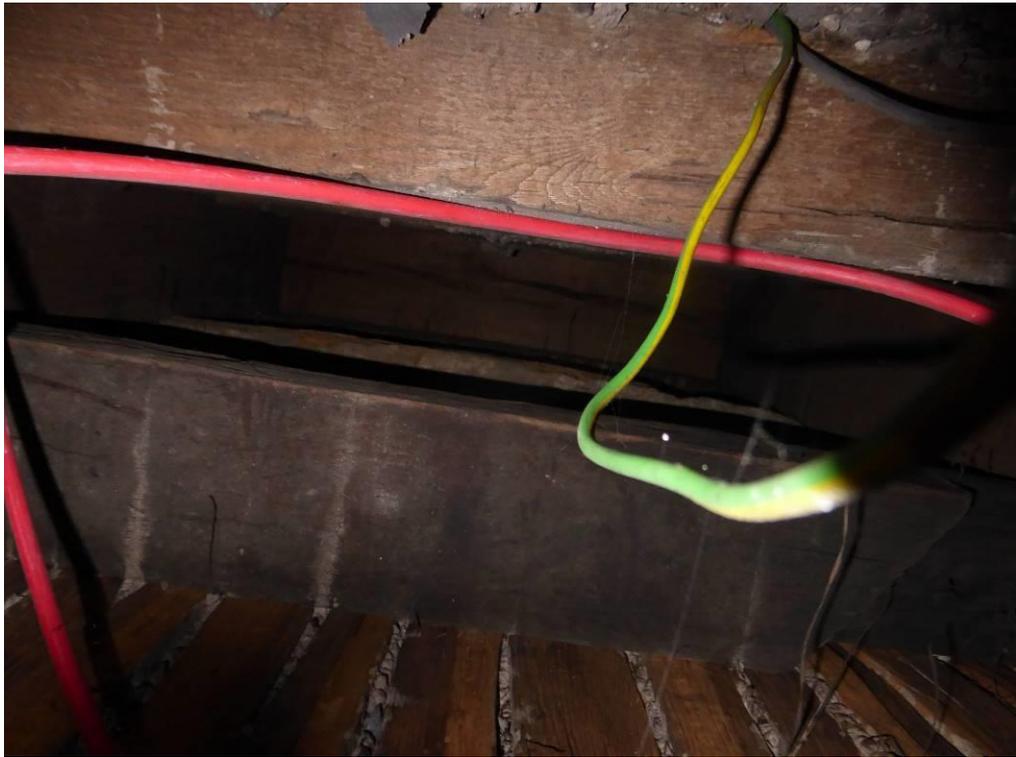
This is certainly a part of the original earliest phase of the construction of the house. The fabric is in very poor condition following a lot of water penetration in the South East corner leading to deathwatch beetle infestation of the timbers. There is decay of the original plaster which had been limewashed. The wallplate is in poor condition. The wall is directly underneath a gutter. There is deathwatch beetle infestation around the existing rooflight. Part of the ceiling is still underdrawn. The sagging ceilings need underboarding. New rooflights are to be introduced.

The **floor** construction with its lime ash finish is not in better condition than initially believed. There is a lot of debris from reroofing presumably in the North area. A decayed dragon tie now not supported any more. The collar onto a post is to come down to create level access and to remove part of the canopy there.

Inspection of the floor void could only be made by "hidden" photographs taken into openings, as the pugging is mostly still in position. The lime ash is in bad condition, with cracks in it, historic services installations causing trenches through it, and defective subfloor support all requiring its complete removal.

The floor finish is to be taken up complete to allow for the same new fireproofing and acoustic separation system as Bedroom 5.

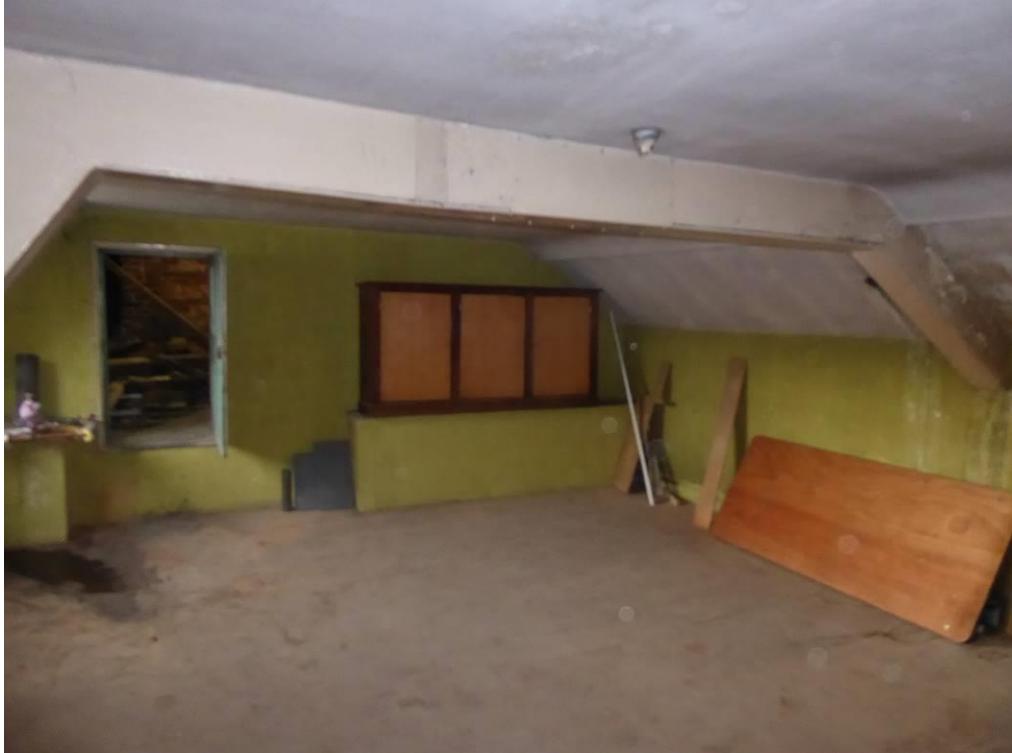
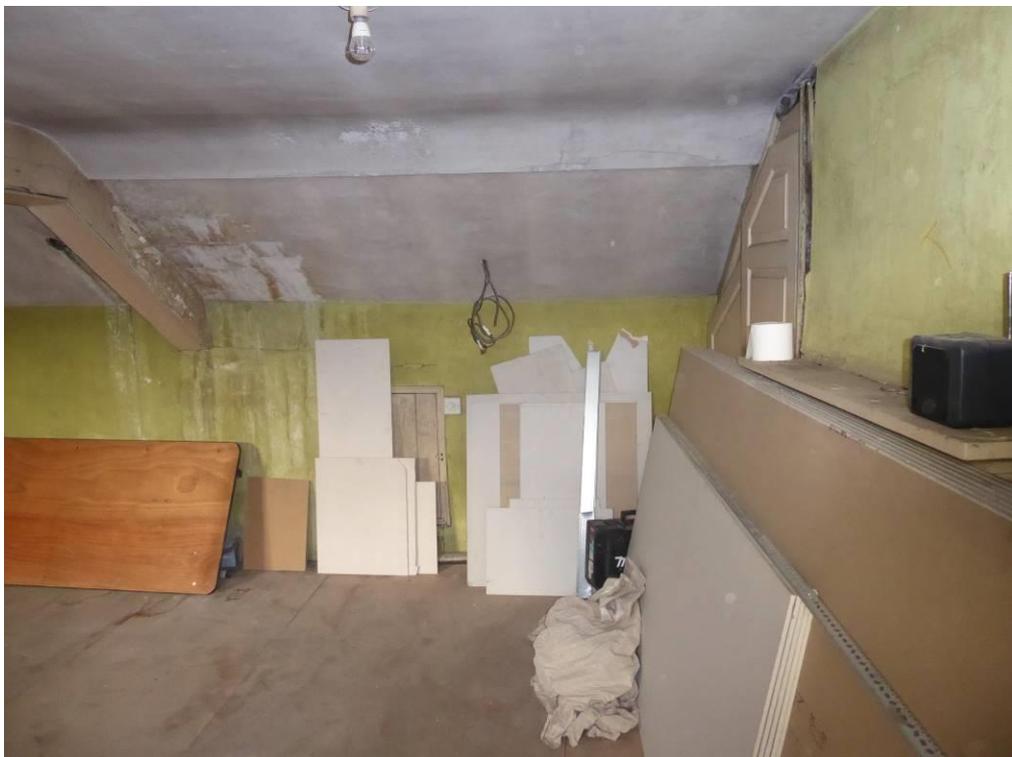
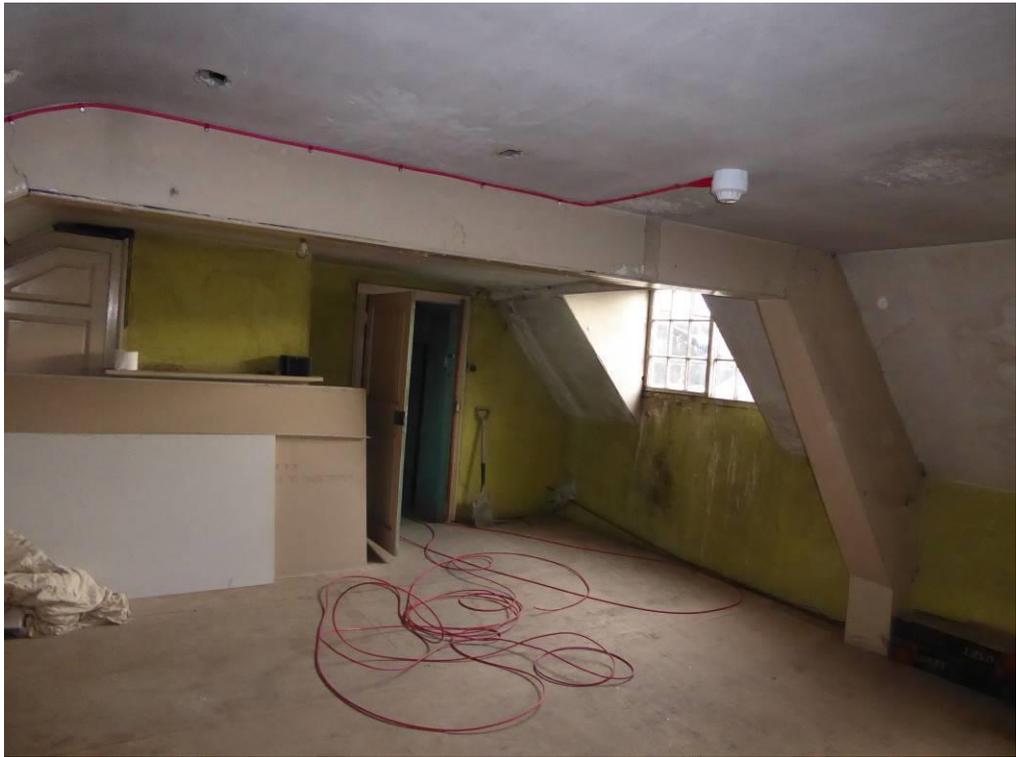
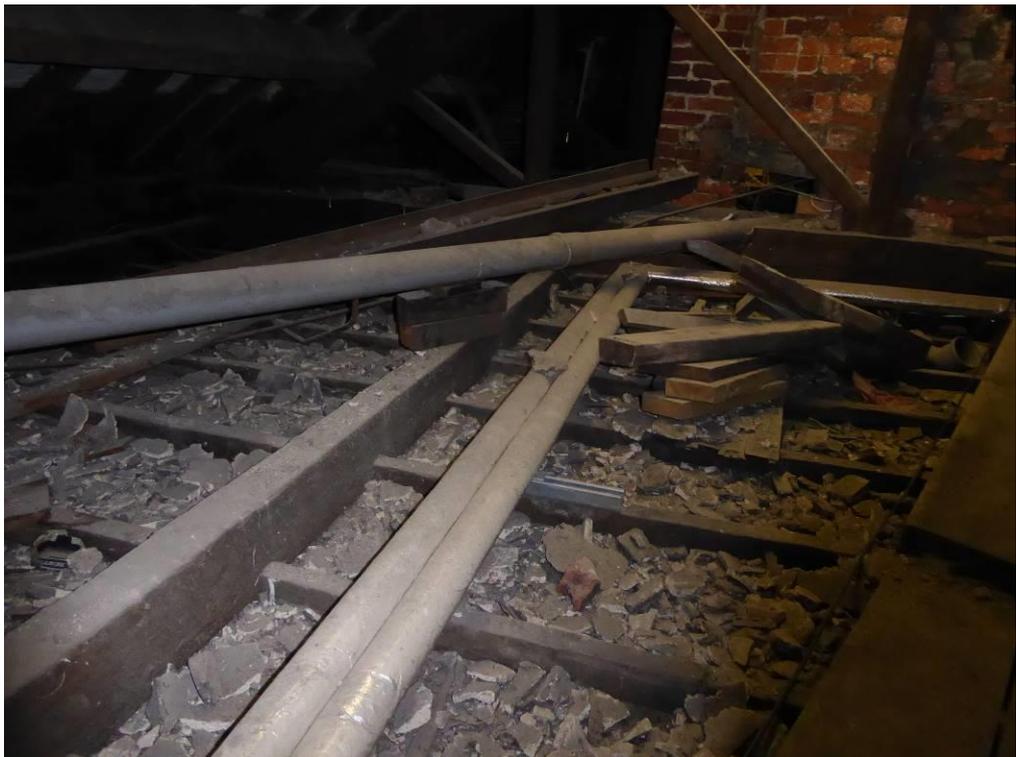
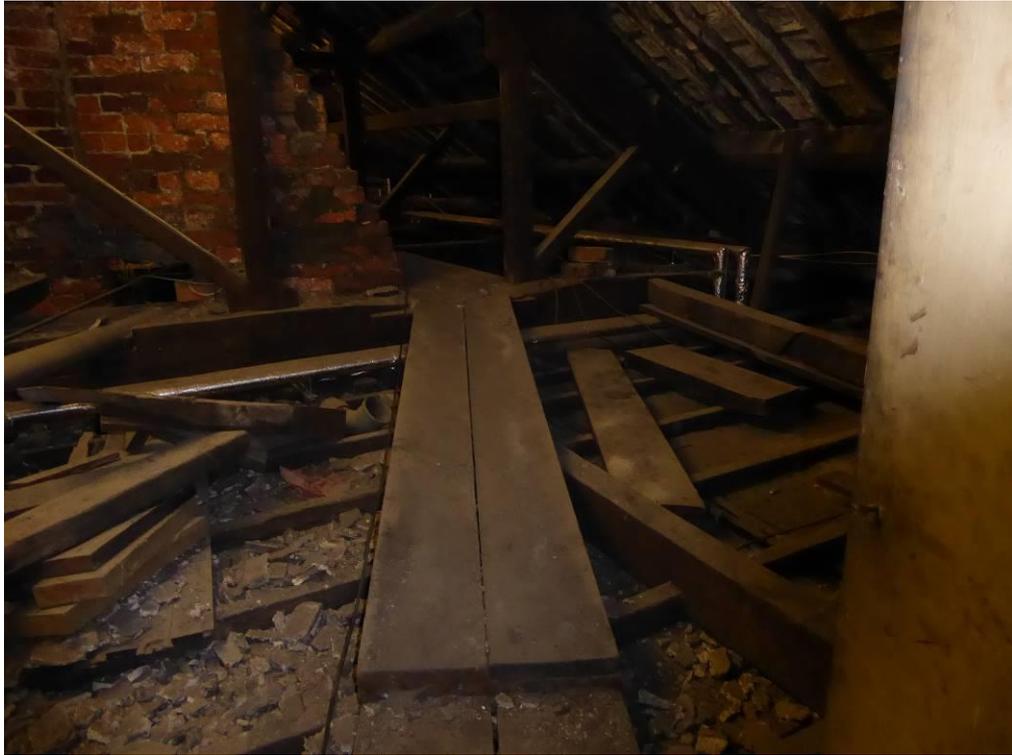
The existing lime ash **floor** in this room had been overboarded with plywood. After the removal of that overboarding it was very apparent why it had been introduced! The lime ash (and subfloor) were raddled with holes and "soft spots" where the subfloor structure had obviously failed.

The pincipal issue in this room is the floor to ceiling height underneath the central truss collar which at present time is 1825 mm. This is a problem. If the beam casing is removed to expose the timber it is going to be something in the order of 1840 mm. This is to be retained "as existing".

There is a hole in the **ceiling** underdrawing of the roof plane, showing it is fixed directly to lath and plaster directly to the underside of the timber sarking board to the roof cladding.

The floor finish is to be taken up complete to allow for the same new fireproofing and acoustic separation system as Bedroom 5.

Additionally: On site discussions with representatives of the Building Control body suggested that the entrance door from the access corridor be relocated, and that fire breaks be established in floor voids under existing partition walls, which were also to have their fire resistance improved by the application of fireproof boarding and skim on their "room" faces.
