Rachel & Megan Shelton
Manse Farm
Structural Inspection Report

Rev01 | 8 March 2024

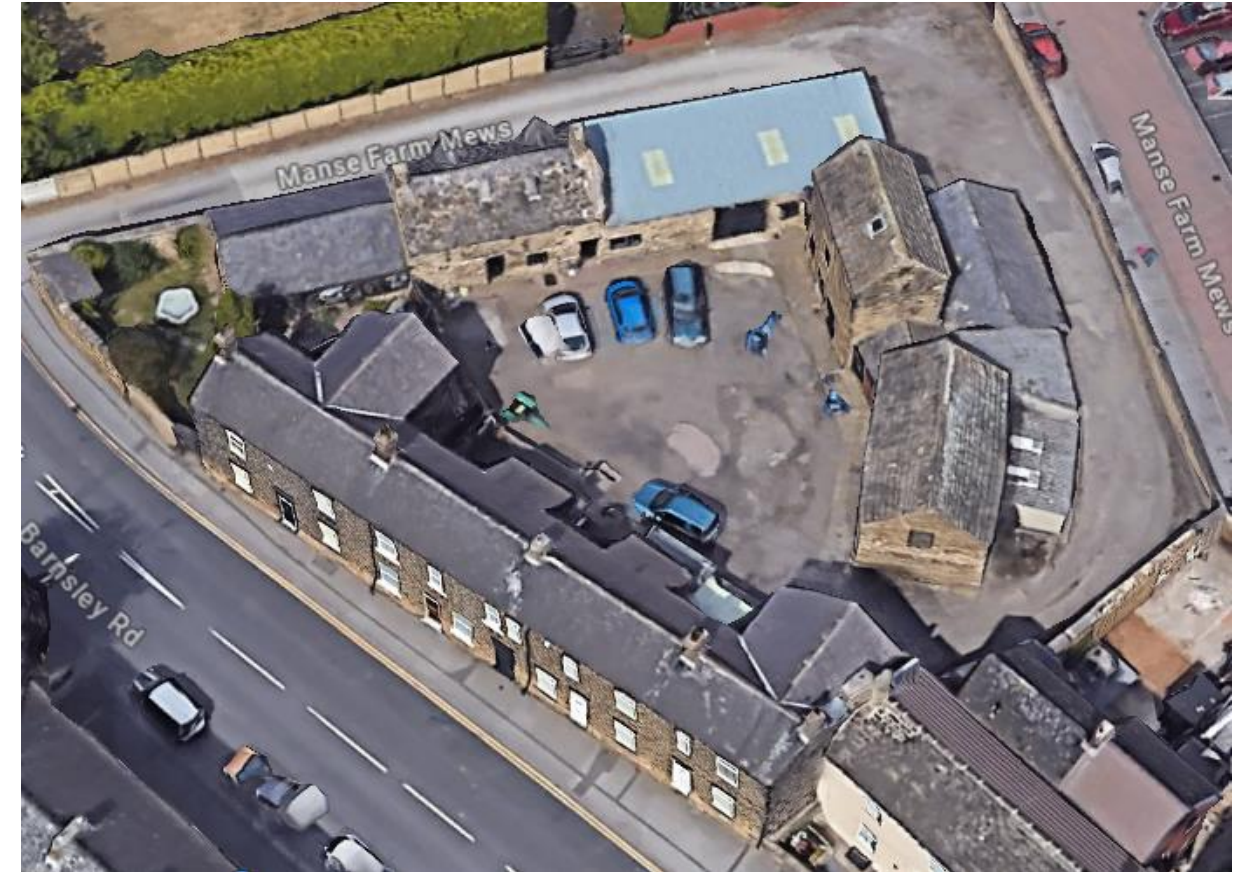
Figure 1 Overview of Manse Farm (Source: Google Maps).

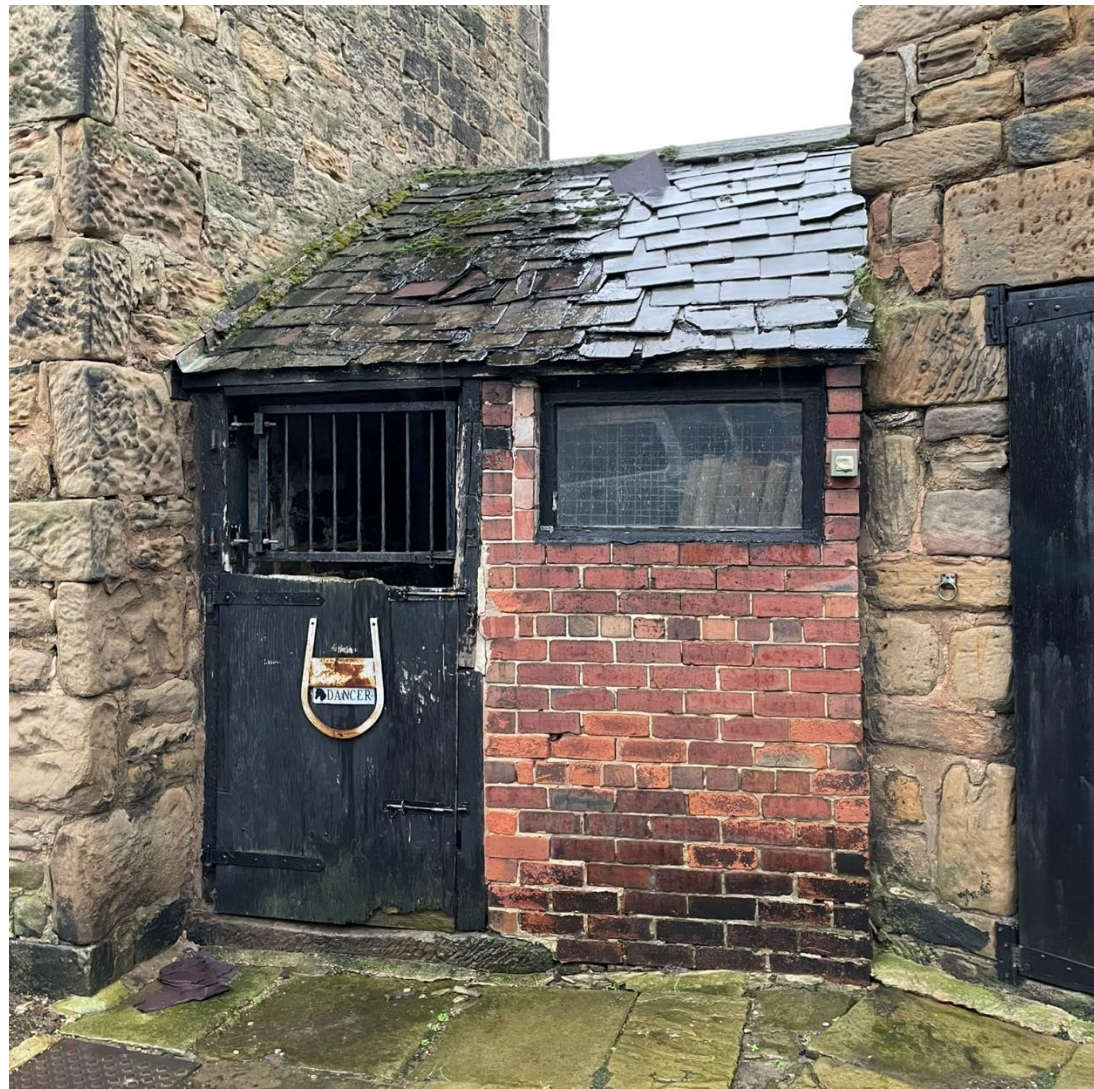
Figure 10 View of west elevation of The Stable, with slate half of the roof visible.

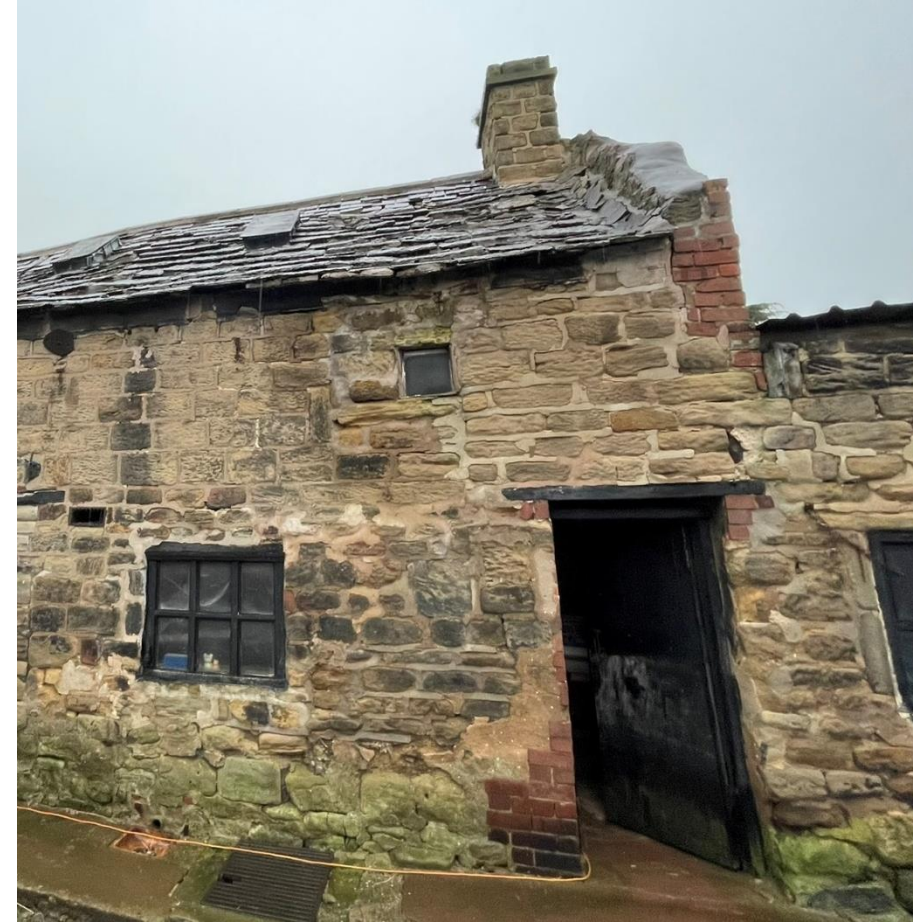
Figure 11 Cement-based mortar, brickwork repairs, and brick gable all visible to south elevation of The Cottage.

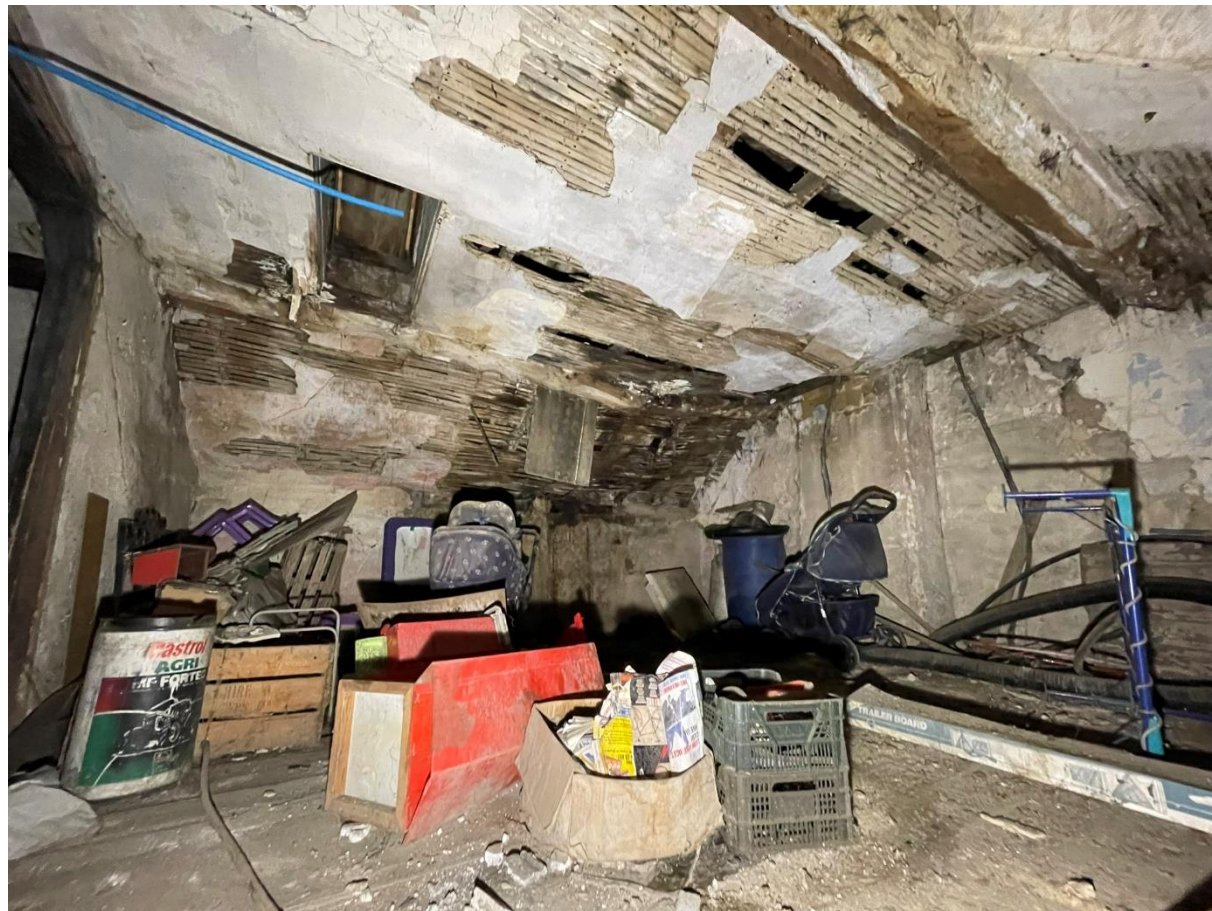
Figure 12 Failure of purlin visible to rear of image.

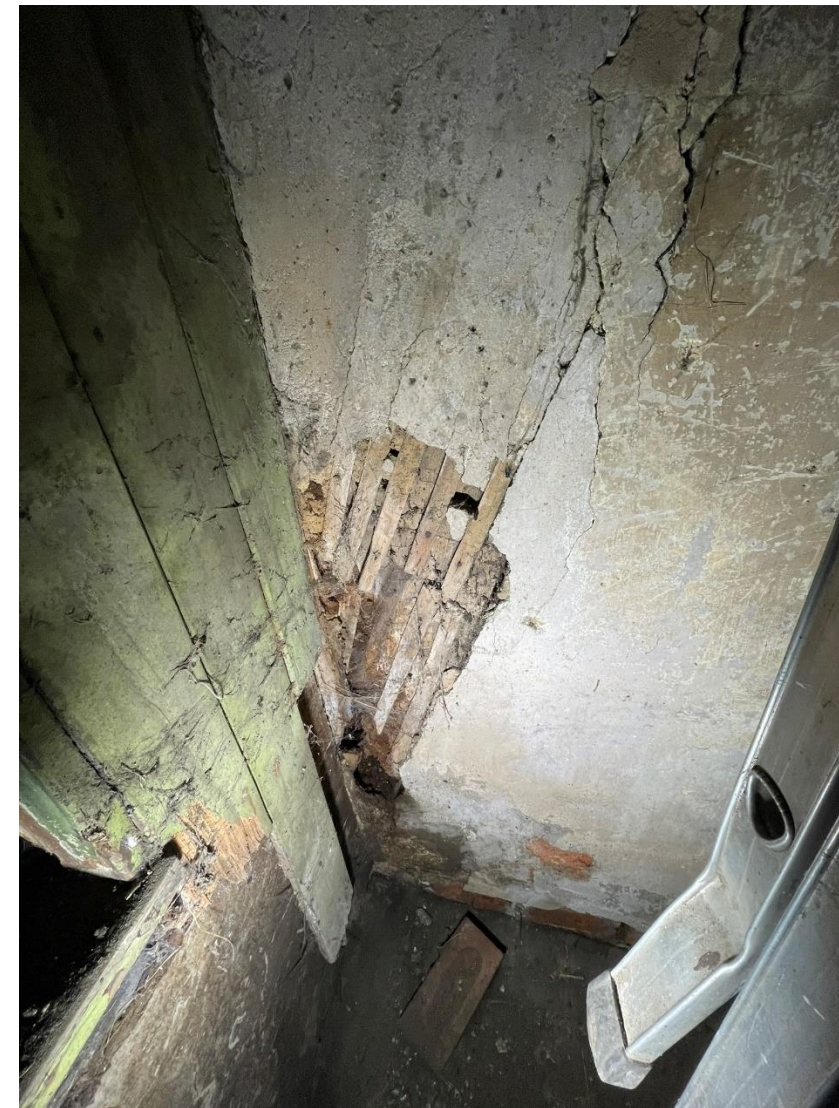
Figure 13 Base of internal timber cruck frame visible through plaster.

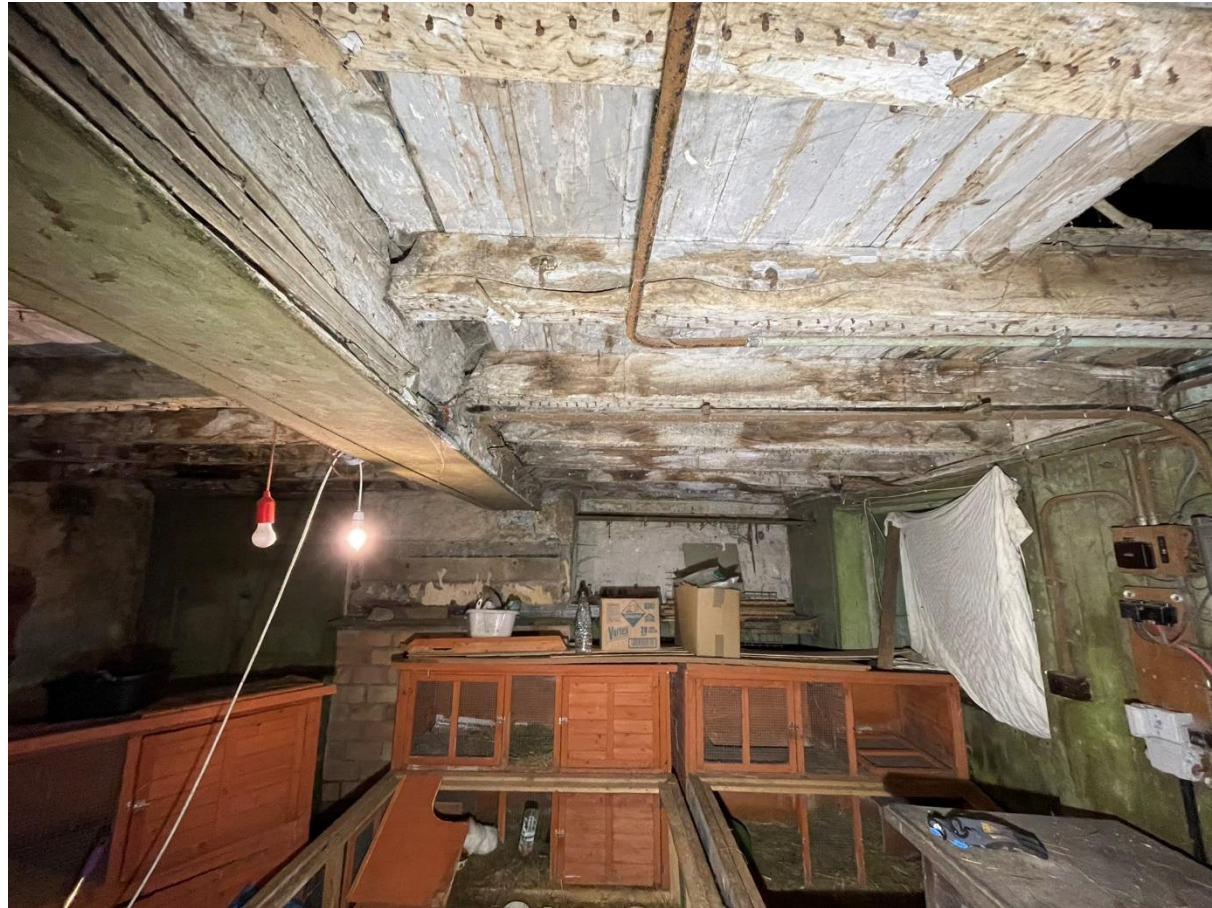
Figure 14 View of the underside of the first floor.

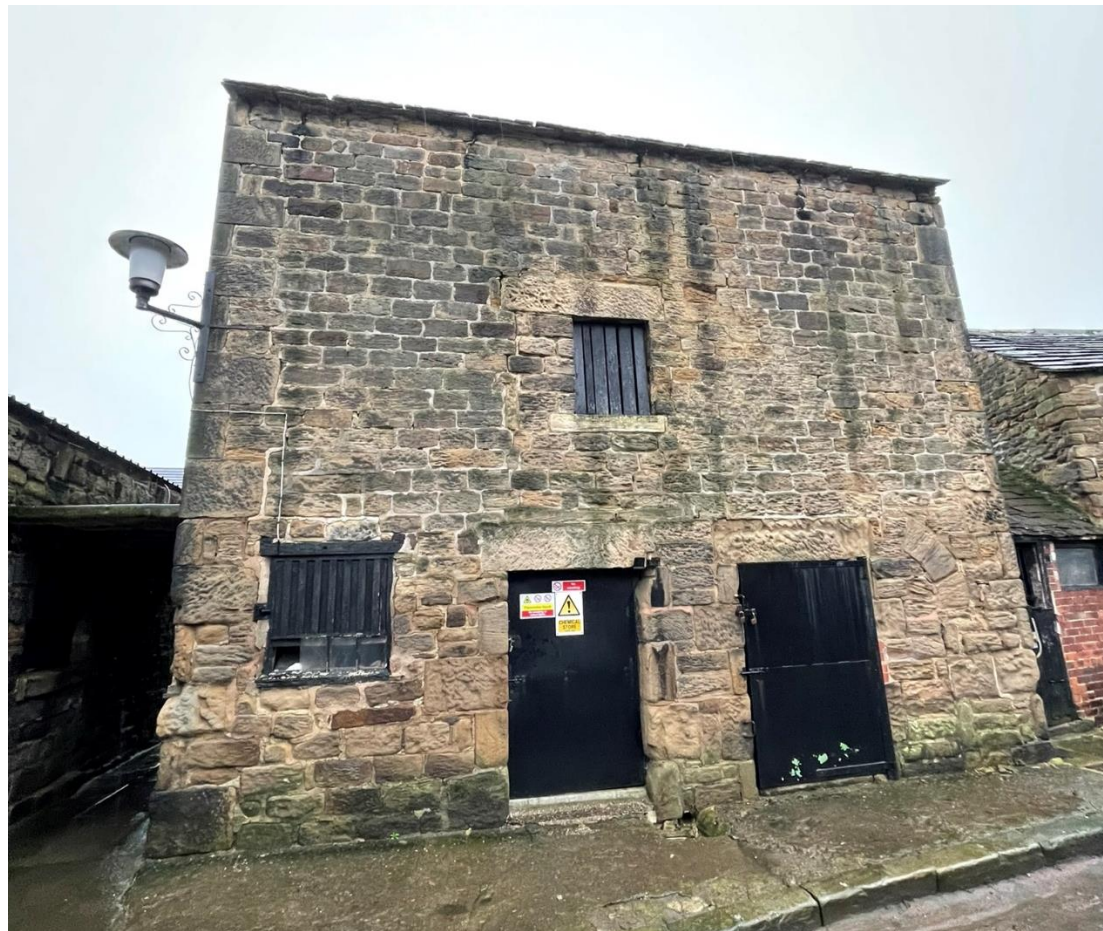
Figure 15 West elevation of main building. Partially infilled first floor window visible.

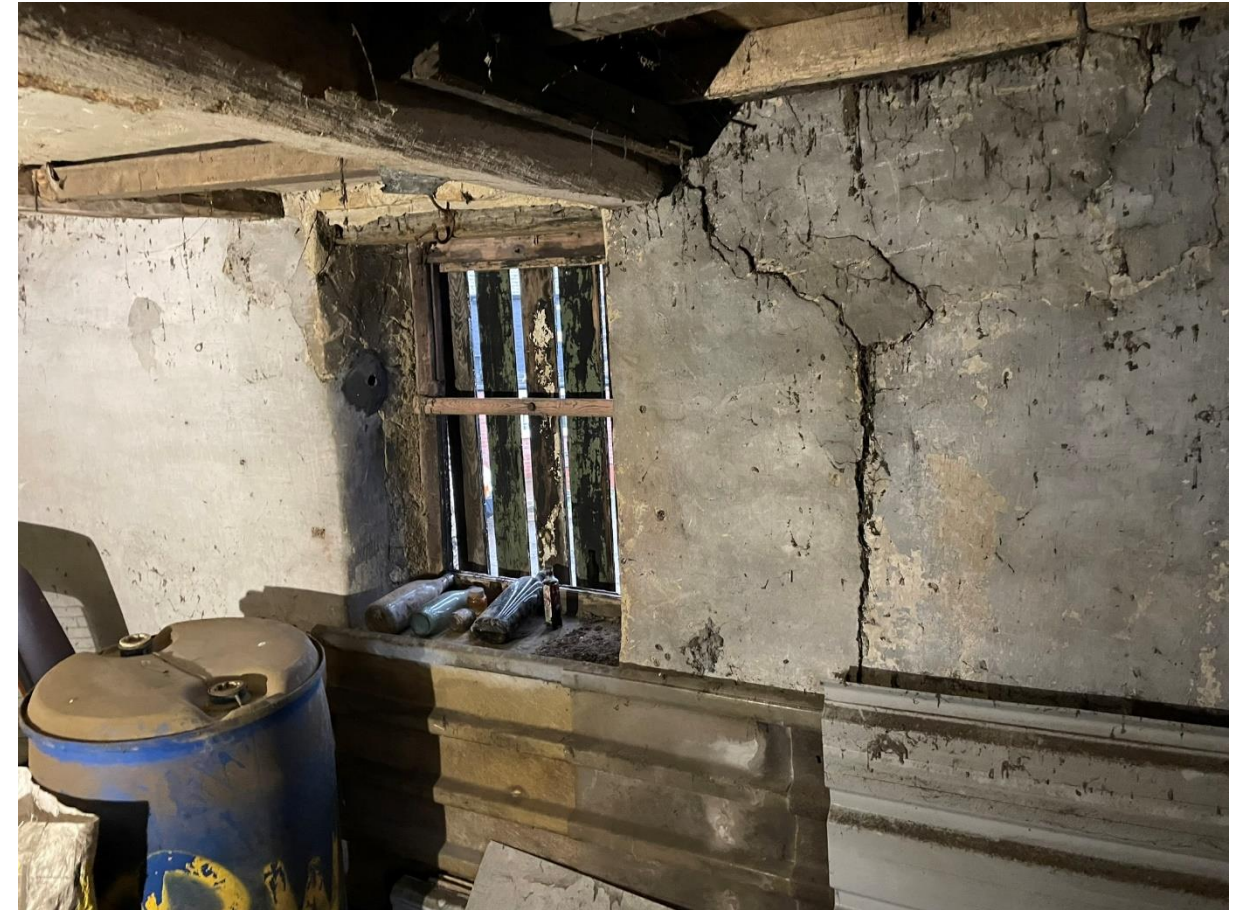
Figure 16 Crack in plaster at first floor level adjacent to window on west elevation corresponding with partial infill of window.

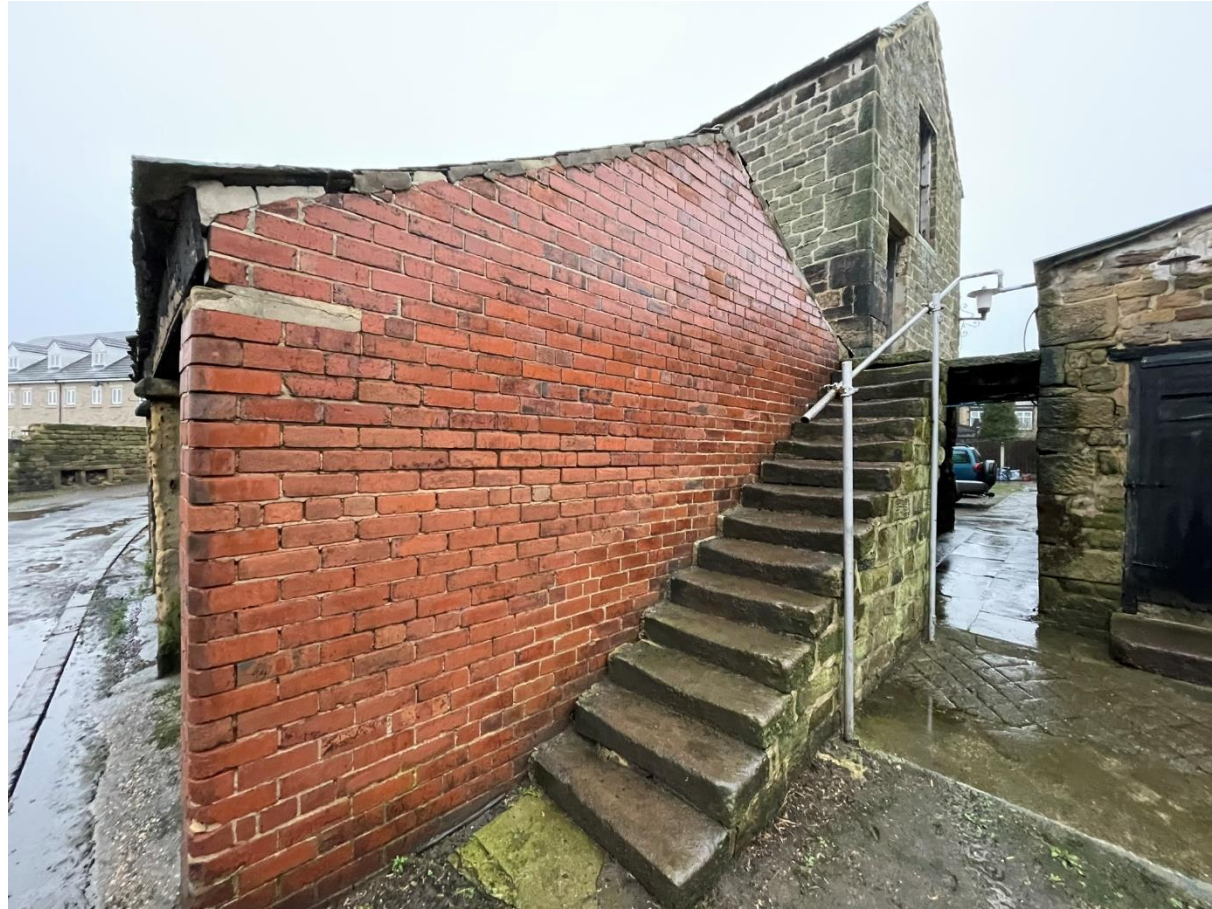
Figure 17 Brick wall to north elevation of covered area.

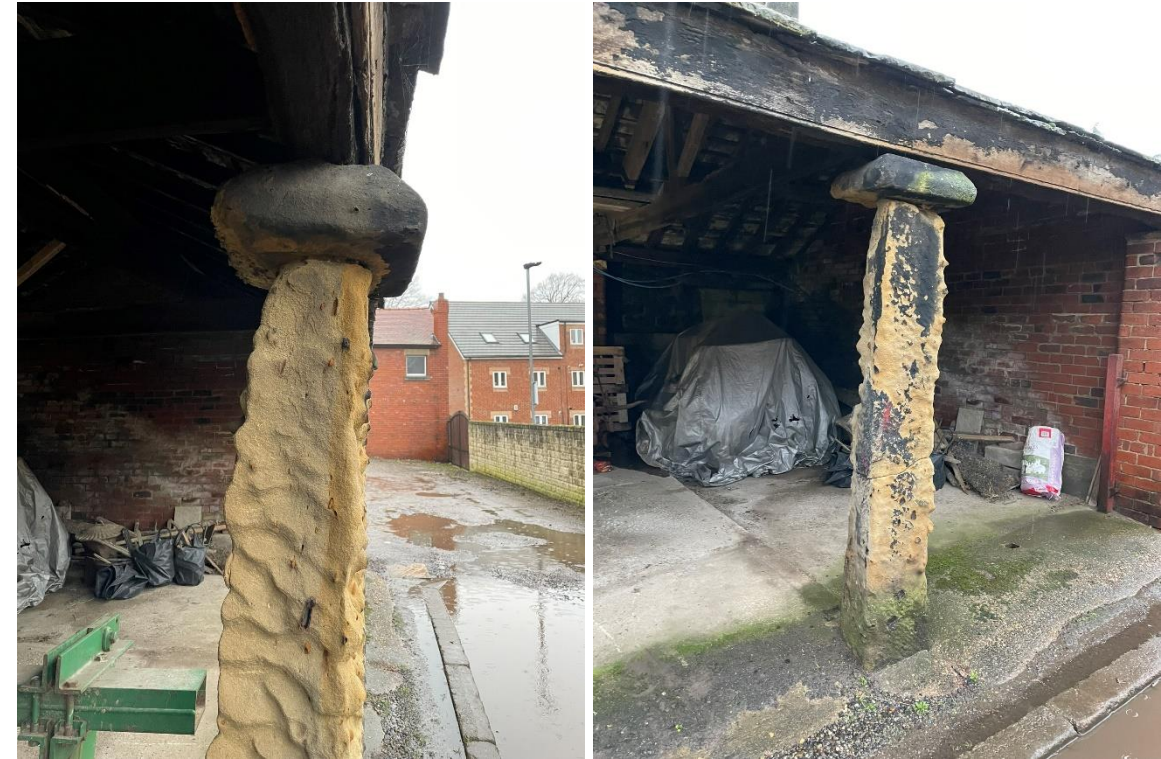
Figure 18 Stone columns to east elevation of covered area.

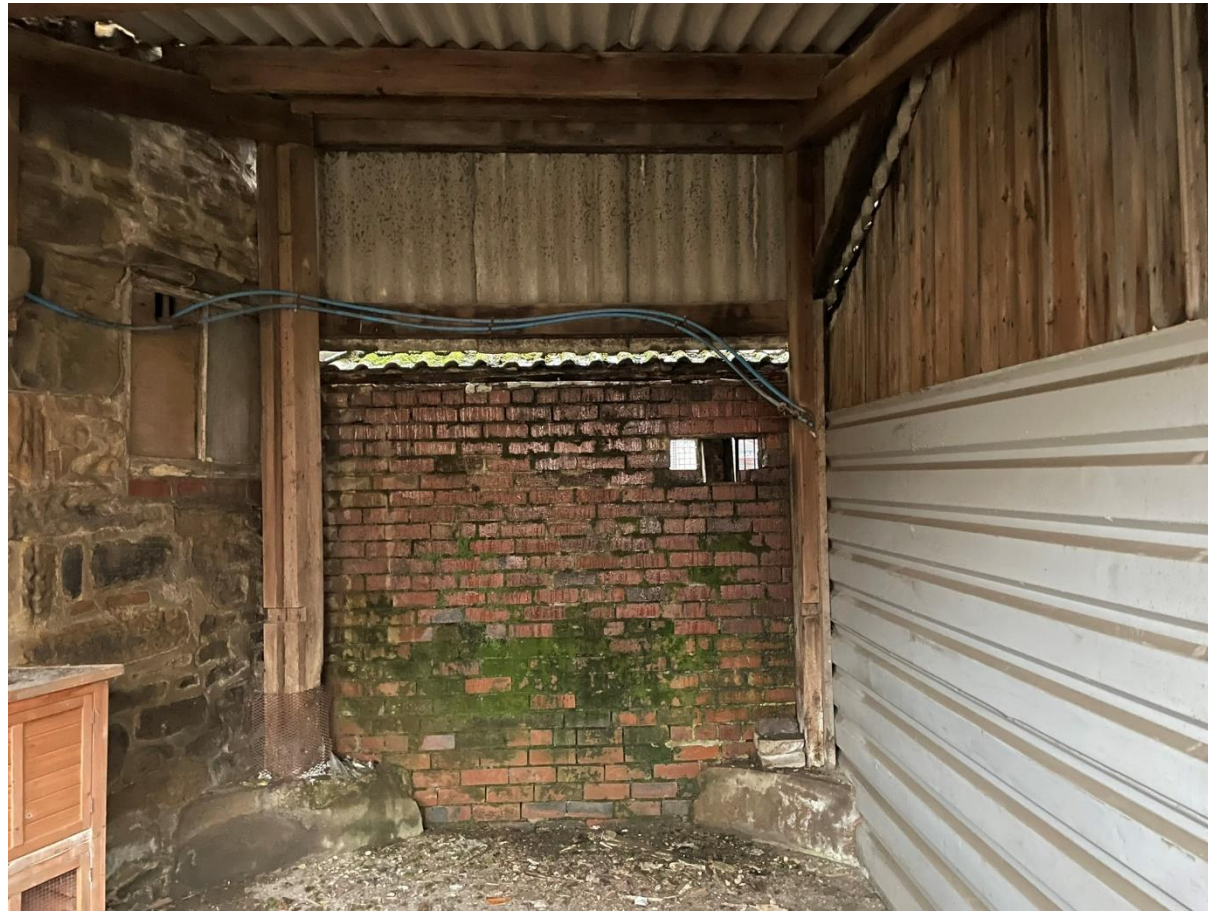
Figure 19 East elevation of The Stable with brickwork missing from external wall.

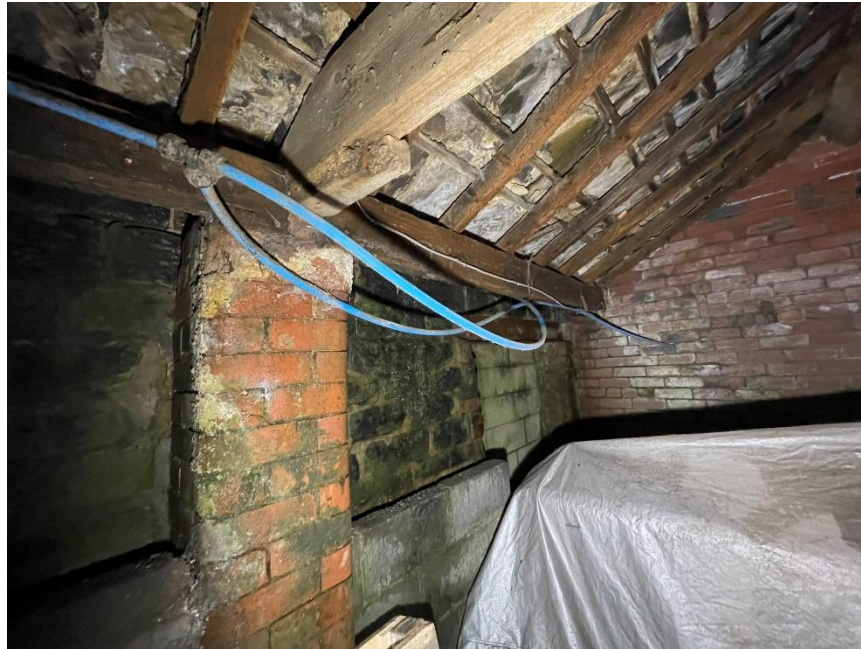
Figure 20 Water ingress from valley gutter between covered area and main building.

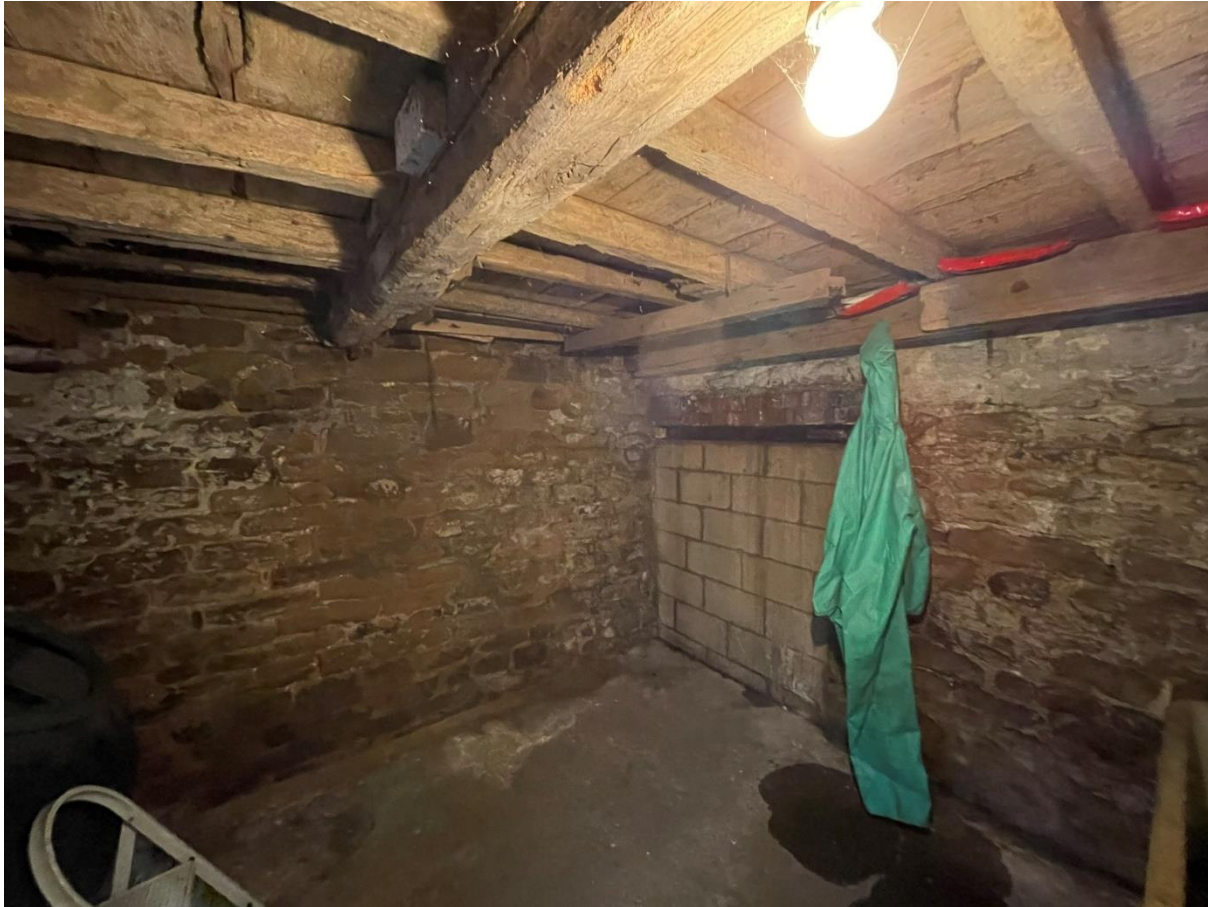
Figure 23 View of underside of first floor in main building.

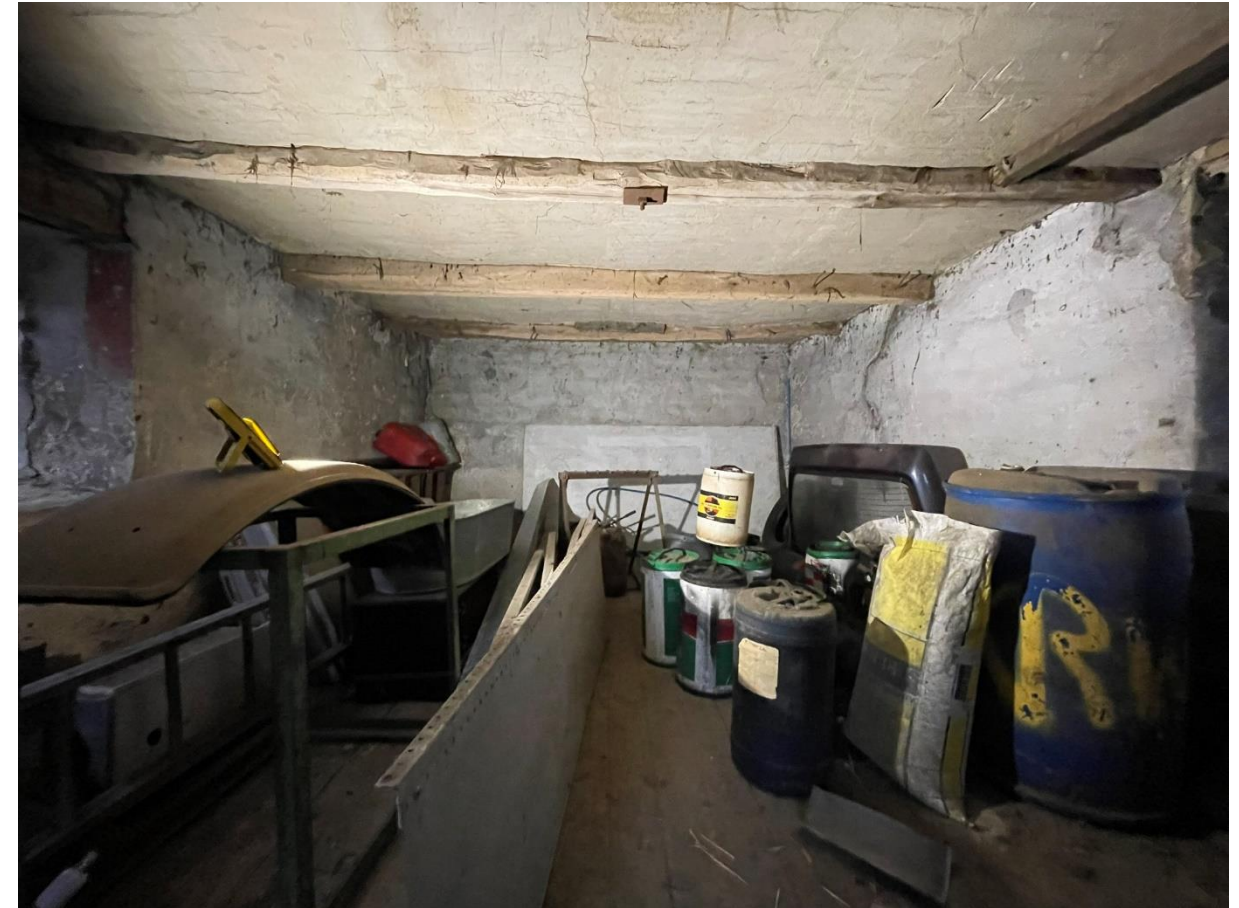
Figure 24 View of underside of second floor in main building.
