**CROW EDGE.**

**BAT SURVEY.**

**Ref No:- 100939**

**Date: 30<sup>th</sup> September 2010.**

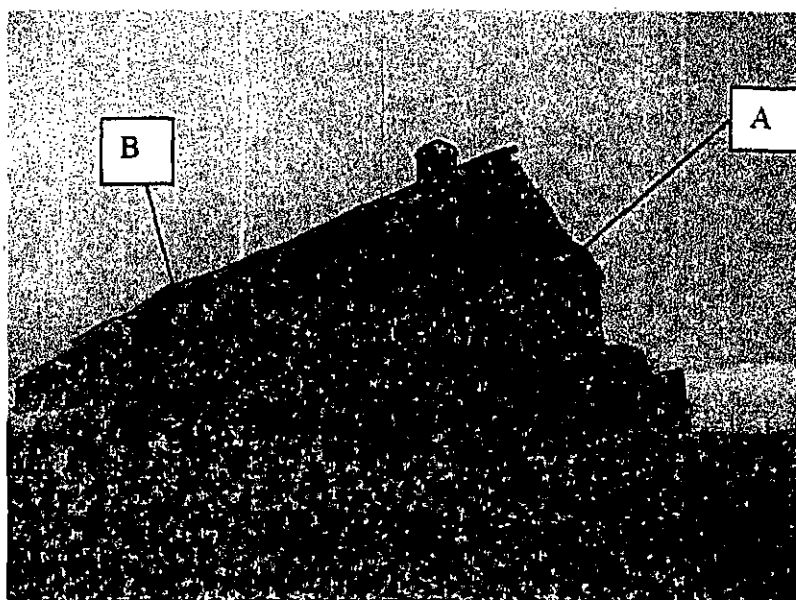
3.3.1.1. Building A is the old farm house on the southern end of the site.

3.3.1.2. The building is constructed with close fitting coursed stone external walls with random stone on the inside and a rubble fill. The external walls are in remarkably good condition for the state of the building although there are a number of open joints where the pointing is missing. The building appears to have been tile clad at some point in time but all that remains are the timber lathes that fixed the cladding to the stone walls. All windows and doors are missing and open.

3.3.1.3. The roof of the building is supported on a king post timber frame. The roof covering is stone slates with no lining and is in a poor state of repair with numerous missing and displaced slates.

3.3.1.4. Internally the middle floor has rotted and is mostly missing and the entire building is very wet as a result of being open to the elements.

3.3.1.6. No bats or bat field signs were identified anywhere inside or outside this building.
