# **ARBORICULTURAL REPORT**

## **& Impact Assessment**

***402 Pontefract Road,  
Lundwood,  
Barnsley  
S71 5JZ***

Reference: *AWA5573*

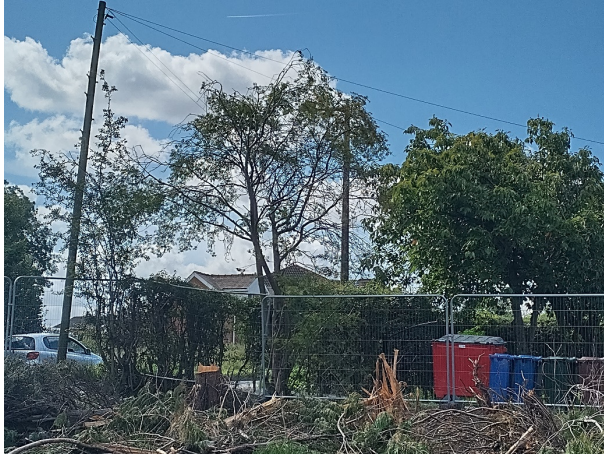
- 3.2.8 T1 is an adjacent moribund Rowan with decay and dieback, the tree has limited long-term prospects but it does not pose any risk in the current site context.

Photo 1: T1 looking south

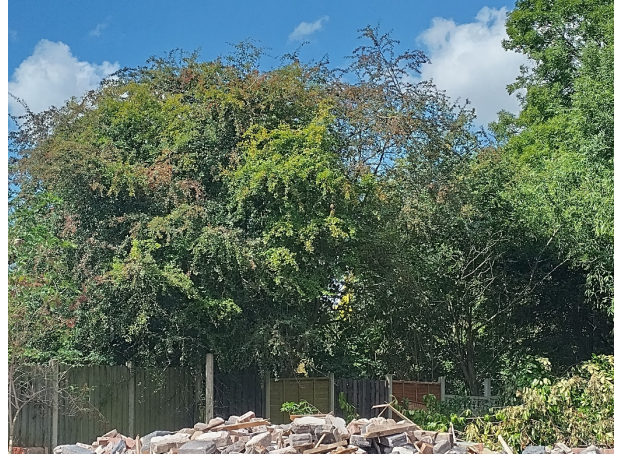
- 3.2.9 Trees T2 and T3 are adjacent multiple stemmed Hawthorns of little arboricultural interest, however, as a feature they do provide moderate screening value from the adjacent property.

Photo 2: T2 and T3 looking west

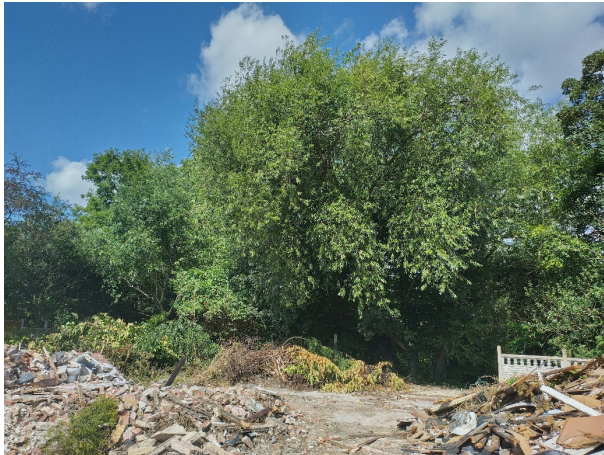
- 3.2.5 Most of the trees are young or semi-mature with only occasional early mature trees.
- 3.2.6 The site's most significant trees are those within tree group G5, situated on the northern boundary of the site. Most of the trees within G5 are situated on banking and lean to the south towards the site. Occasional trees within G5 appear to be within site boundaries, but most of the trees within the group are adjacent, with the group extending further off site to the north. These trees are individually of low value but provide some screening value from an adjacent footpath. G5 is predominantly comprised of Crack Willows, which while suitable for retention in the current site context would be unsuitable for retention close to a new development at the site due to their species characteristics.

- 3.2.7 Crack Willow T6 is also situated on the adjacent banking on the northern boundary of the site. T6 is particularly poor condition and likely has limited future prospects regardless of development at the site.

- 3.2.10 T4 is a low value semi-mature Ash tree of little significance. The tree has Ash dieback symptoms and likely has limited long-term prospects as a result.

Photo 3: Tree group G5, and trees T4 and T6 looking north west

4.2.2 The trees which require removal to facilitate the development are T4 and T6.

4.2.4 T4 and the trees within G5 within site boundaries require removal to facilitate the development as they are situated within the footprint of the development.

4.2.5 T6 and occasional trees within G5 outside of site boundaries require removal to facilitate the development as they would be unsuitable to retain close to the proposed new development. The Crack Willows within G5 outside of site boundaries would be unsuitable to retain close to the proposed new development due to their species characteristics.

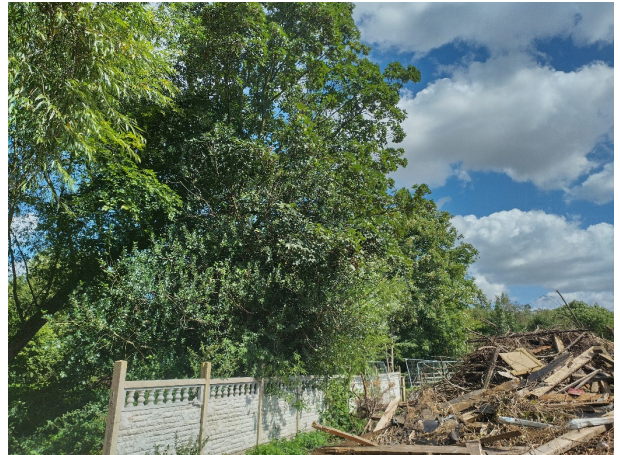
Photo 4: G5 looking east

4.2.8 The trees within tree group G5 are all low value trees but as a whole the group does provide some screening value from a public walkway.

4.2.9 Occasional retained adjacent trees within G5 will require pruning works to facilitate the development, lifting and reducing their crowns from the south to provide adequate clearance from a proposed new residential property, not pruning beyond the site boundary. The retained trees would likely

tolerate the required pruning works, but the pruning works would likely be required on a regular basis in future to maintain adequate clearance between the retained trees and the proposed new residential property.

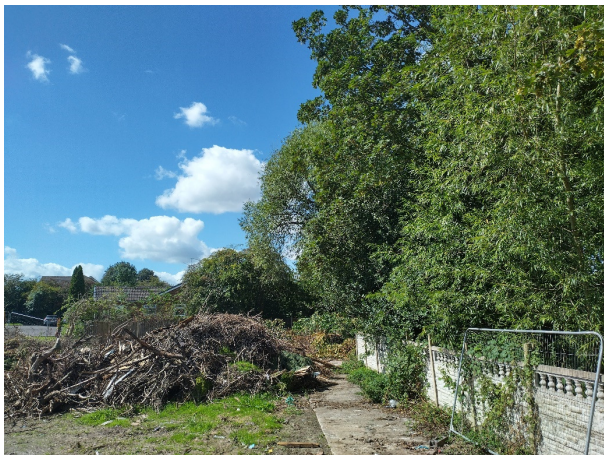
Photo 5: G5 looking west

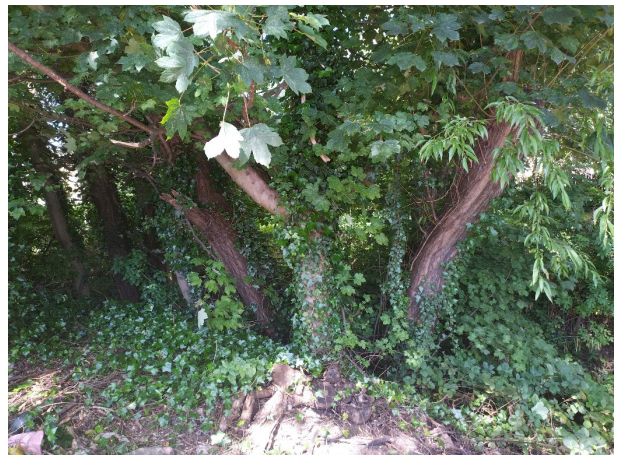
- 3.2.11 T7 is an adjacent semi-mature Sycamore situated to the north east of the site. T7's lower crown has been lifted to provide clearance for access to the site, leaving some flush cut wounds on the stem. The tree is of little Arboricultural value, though it is mostly in good condition.

Photo 6: Stems within G5 and T7 looking north

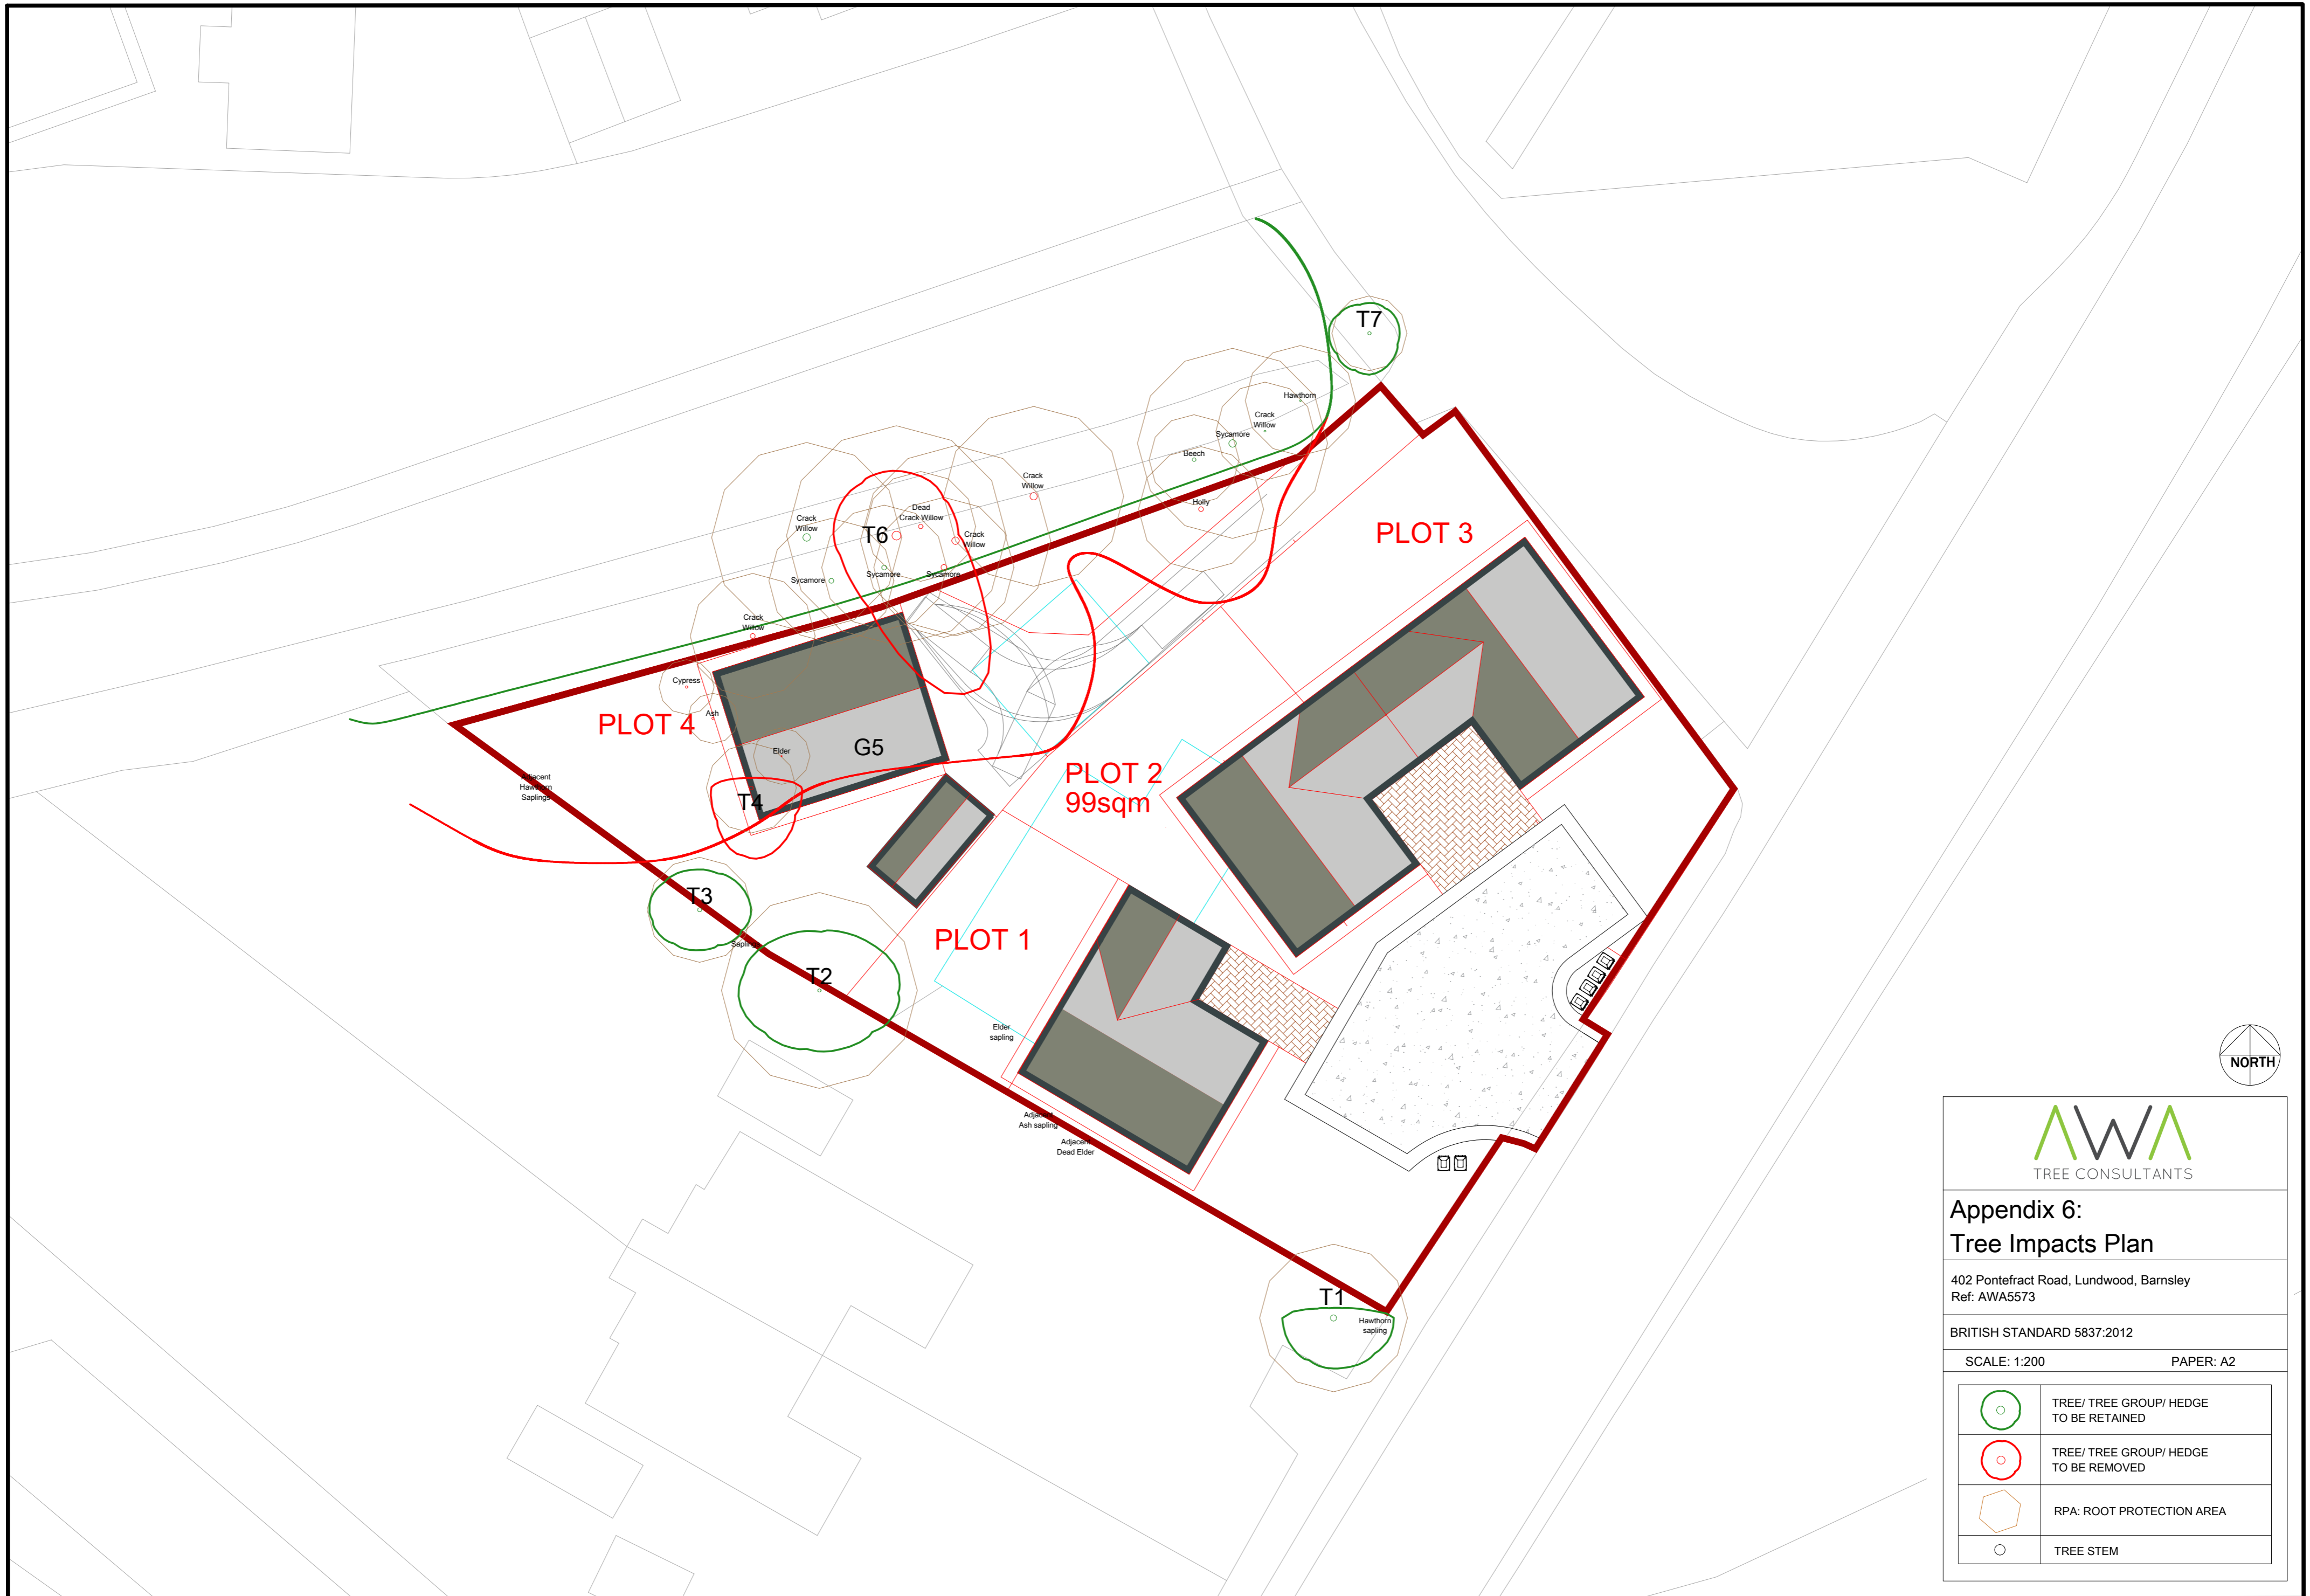
**Appendix 6:**  
**Tree Impacts Plan**

4.2.1 From assessing the new development proposals, 2 trees will require removal to facilitate the development and 1 tree group will require partial removal to facilitate the development as they are situated in the footprint of the development or their retention and protection throughout the development is not suitable.

- 4.3.2 A proposed new access drive is situated within the RPAs of adjacent retained trees at the eastern end of G5, however, there is already existing hardstanding within the RPAs of the retained trees at the location of the proposed new access drive, therefore, provided the existing hardstanding sub base can be left in place with the new access drive surface laid on top, with no excavation lower than the existing hardstanding sub base, the retained trees should remain largely unimpacted by the works provided care is taken during construction.
