**GEOTECHNICAL AND GEO-ENVIRONMENTAL  
SITE INVESTIGATION**

**BONDFIELD COURT, WOMBWELL**

**STRATEGIC TEAM GROUP**

Job No. : 42937  
Report Status : Issue 1  
Document Date : 24 September 2018

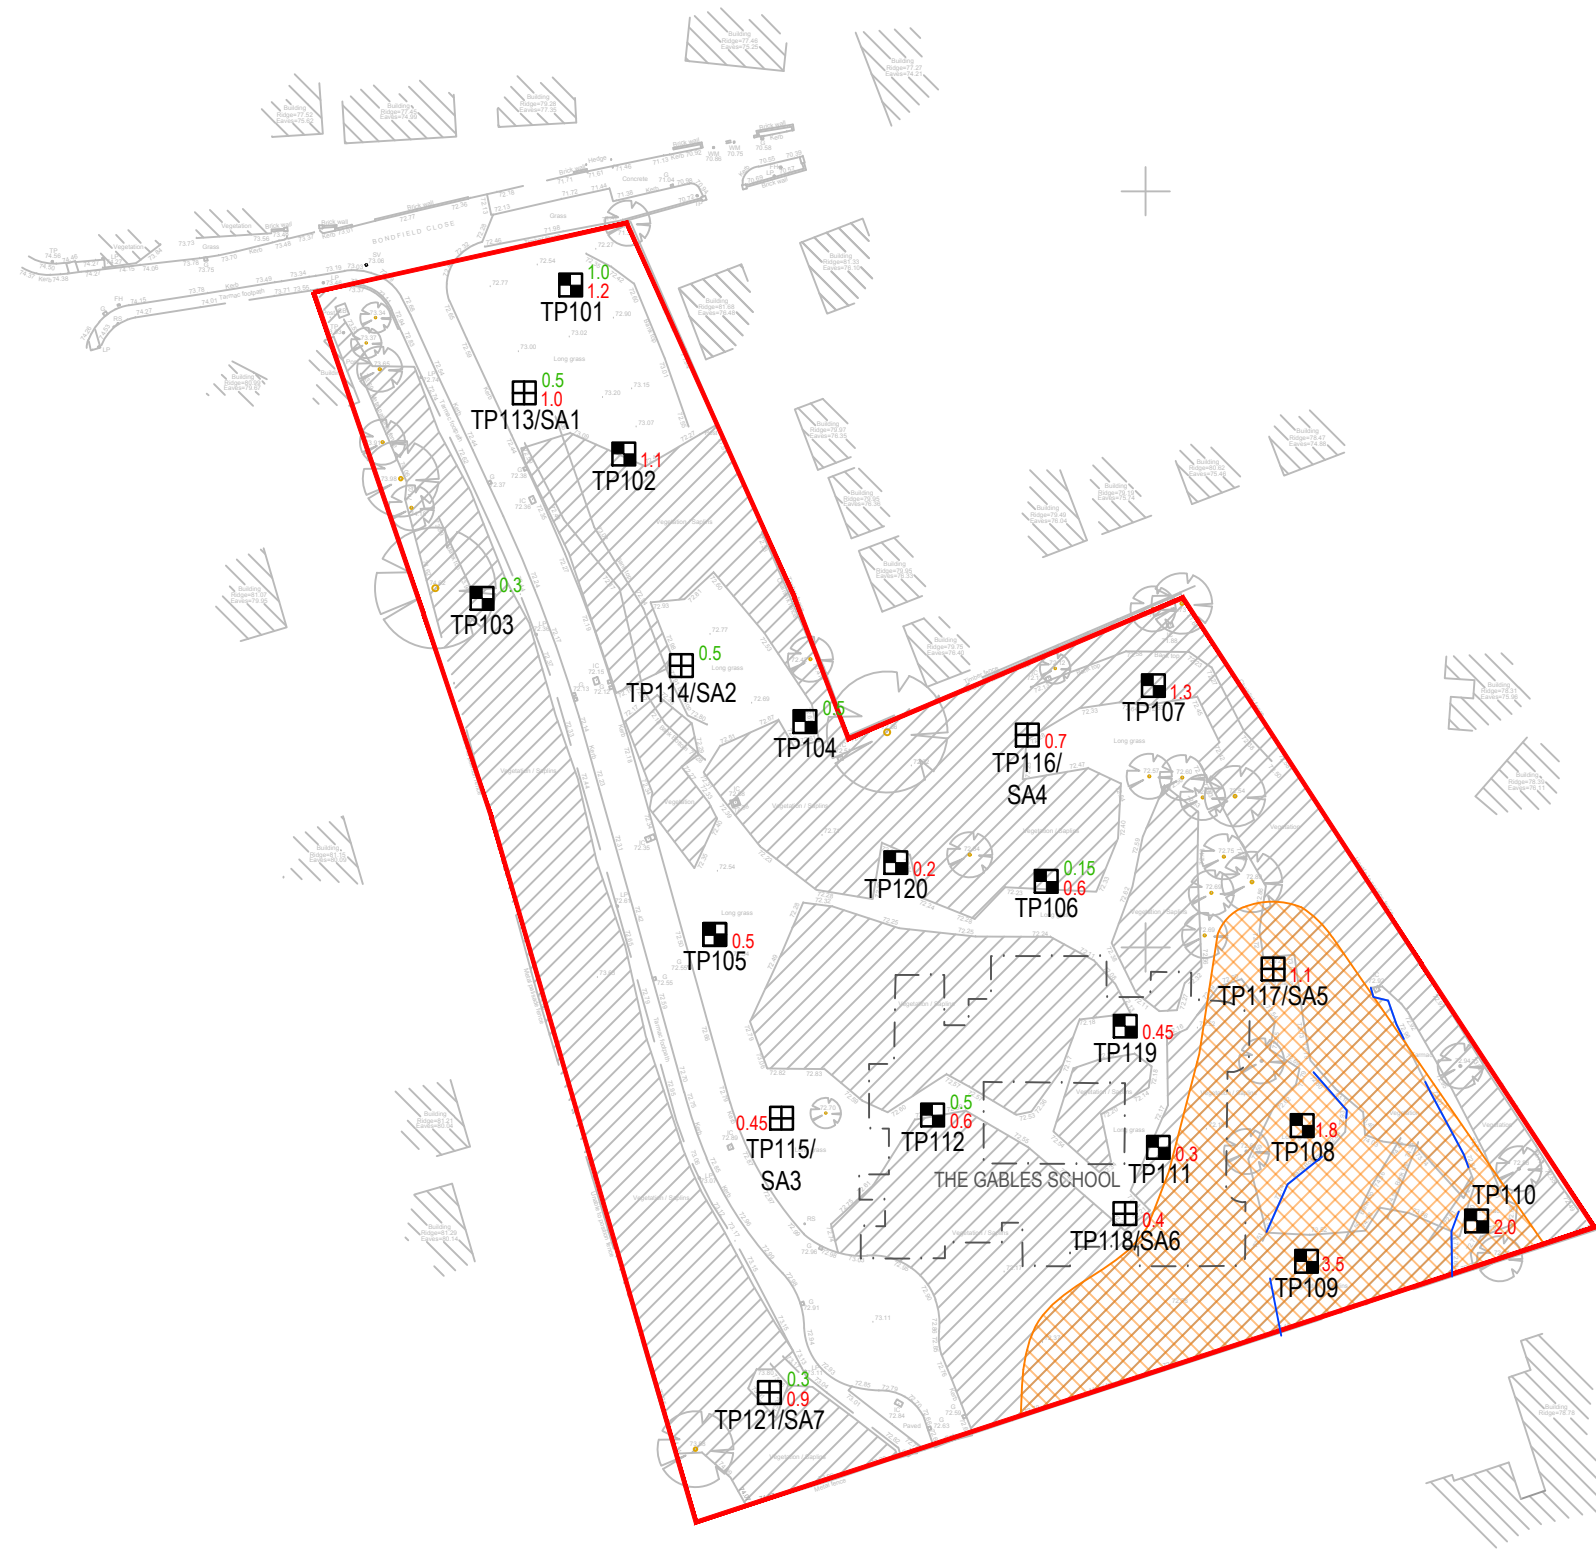
‘Exploratory Hole Location Plan’, Drawing Number 42937/001

Eastwood & Partners visited site on 22 and 23 August 2018 and excavated twenty one trial pits, TP101 to TP121, to determine the underlying ground conditions. The trial pits reached depths of between 1.3 and 3.55 m below ground level (bgl).
