ARBORICULTURAL REPORT

to **BS5837:2012** at:

Land at
**Wakefield Road,
Mapplewell,
Barnsley,
South Yorkshire
S75 6FZ**

Reference: AWA1887

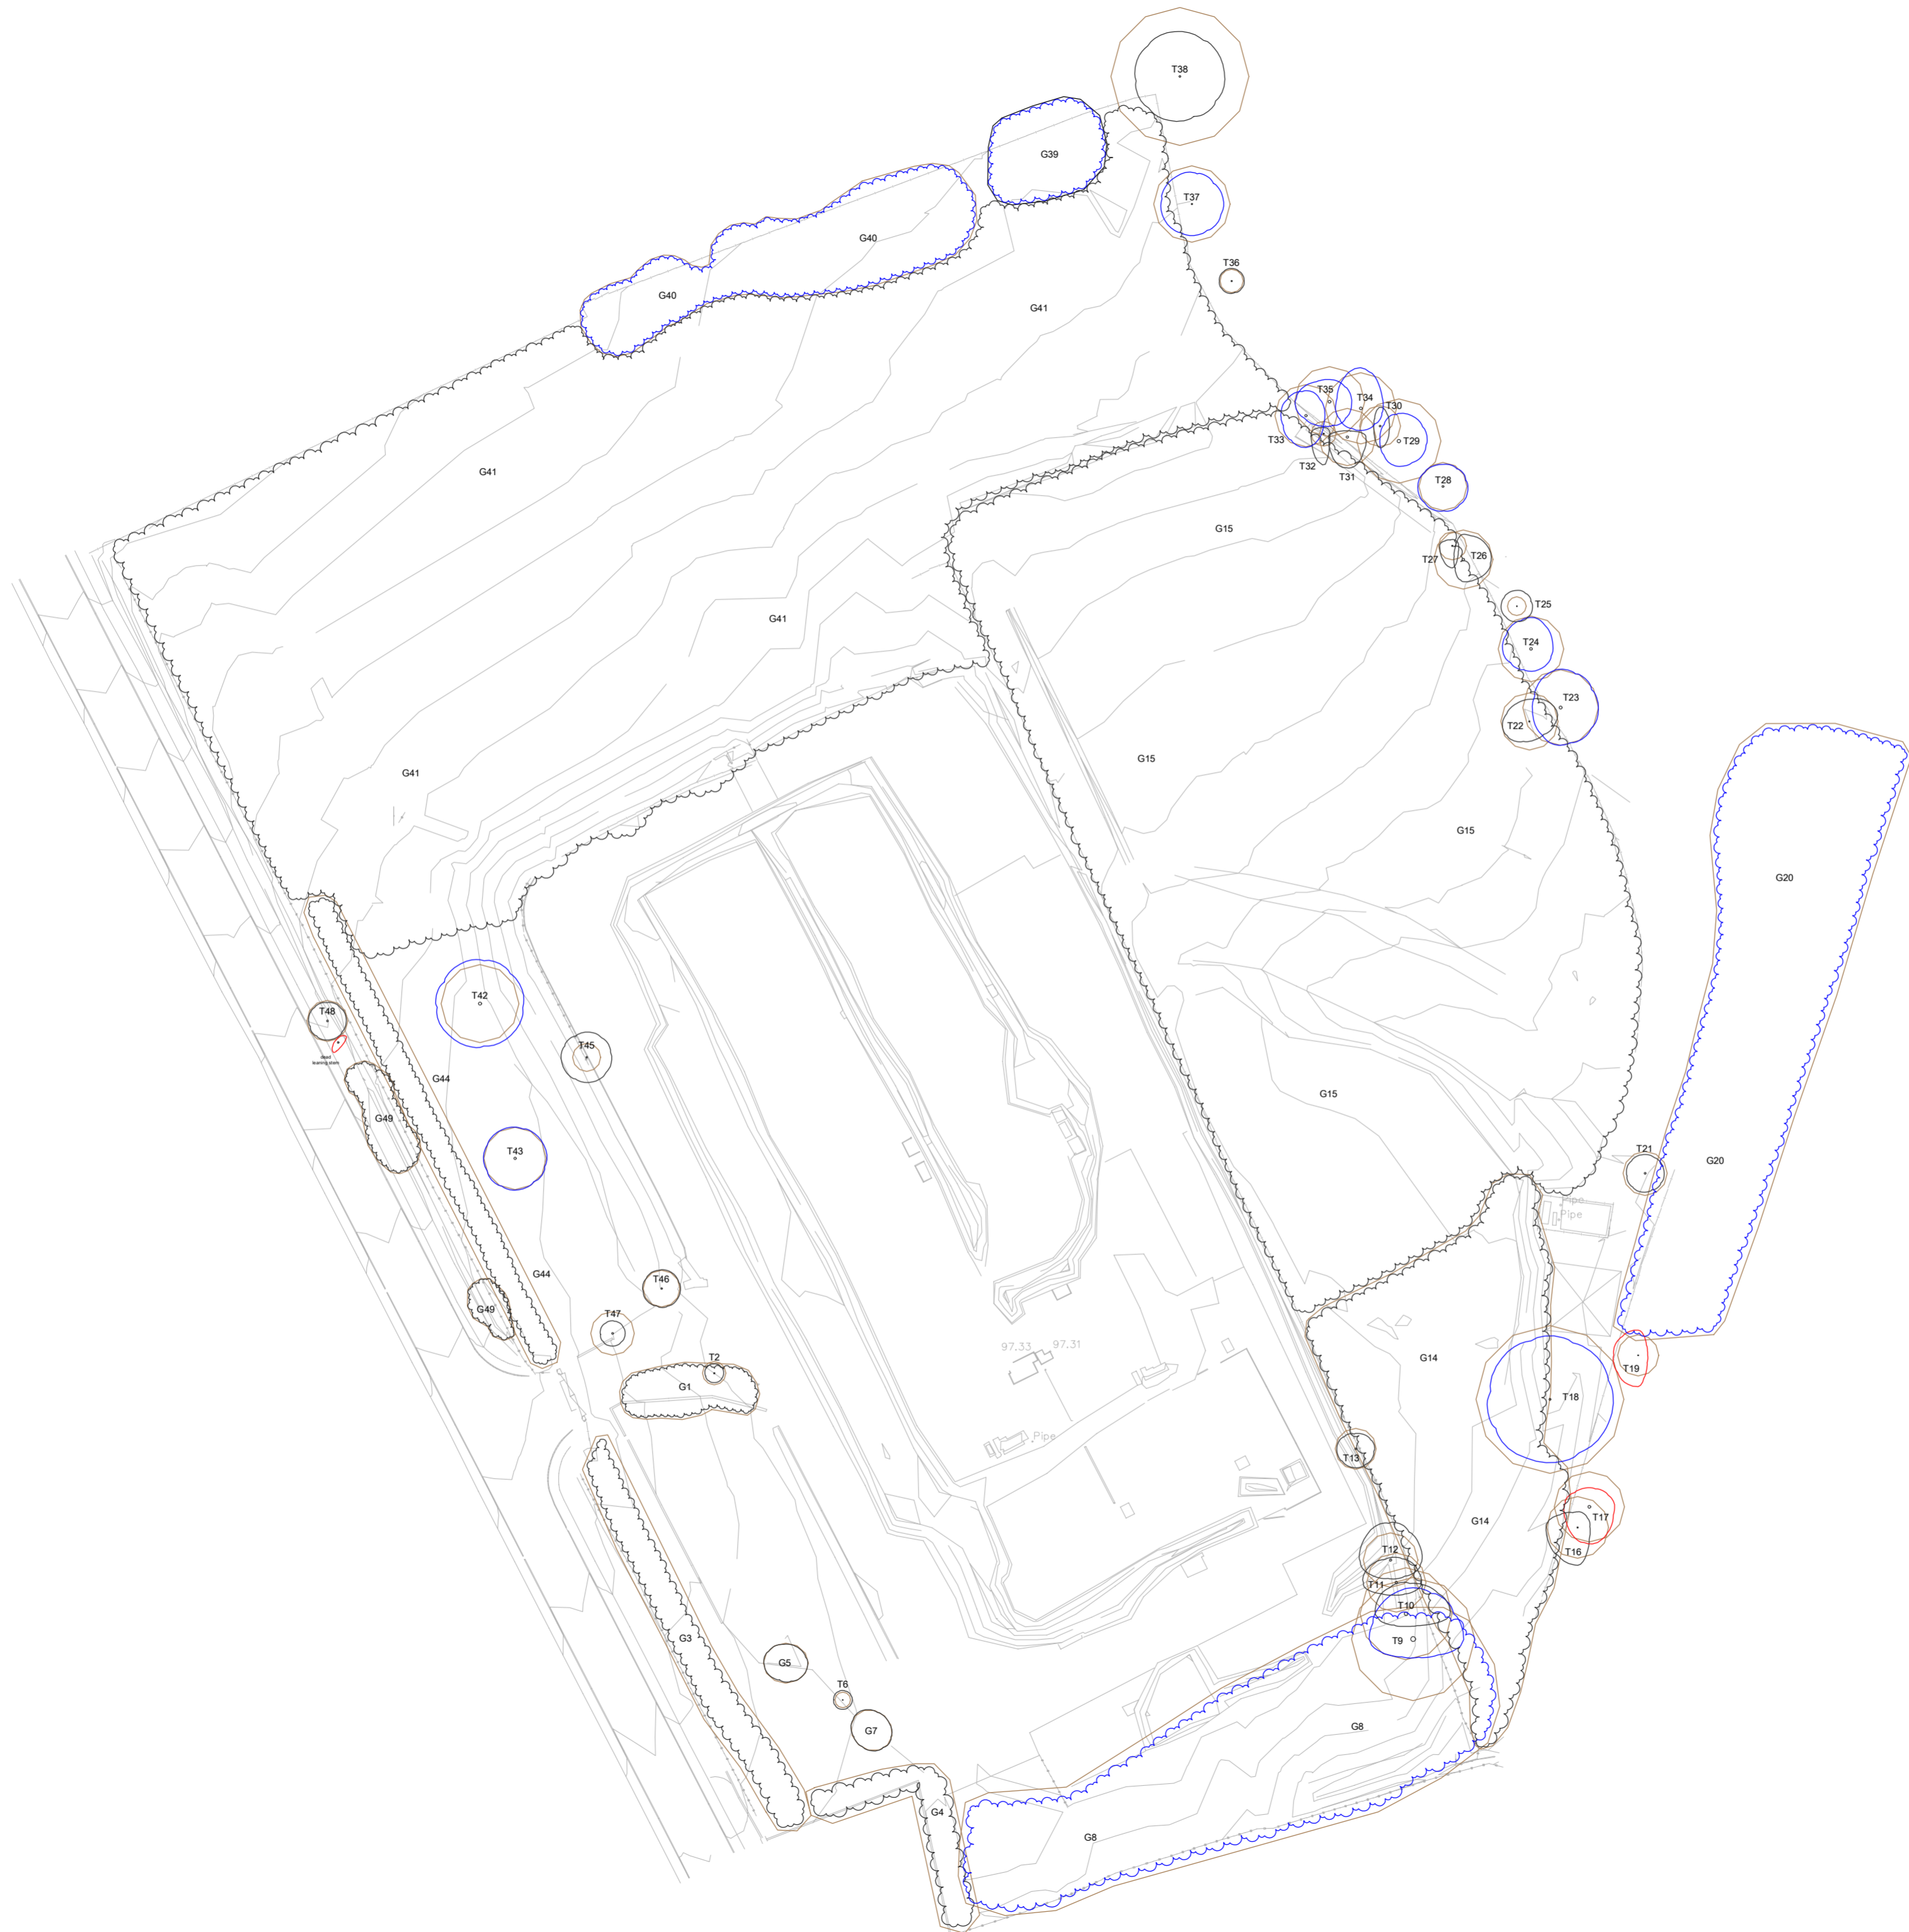
Appendix 5:
Tree Constraints Plan
 Wakefield Road, Mapplewell, S75 6FZ
 Ref: AWA1887

- 3.2.15 The tree Root Protection Area (RPA) detailed on the Tree Constraints Plan at Appendix 5, has been used as a layout design tool, to inform on the area around a tree where the protection of the roots and soil structure is treated as a priority.
