**Developments by Boutique
50 Hoyland Road
Hoyland Common
Barnsley
South Yorkshire
S74 0PB**

Date: 11th November 2024

My Ref: SI 00313

**COAL MINING RISK INTERPRETATION REPORT – FOLLOWING THE SITE
INVESTIGATION FOR PROPOSED RESIDENTIAL DEVELOPMENT AT 120 B THE
BUNGALOW, ST. GEORGES ROAD, BARNSELY S70 1HA**

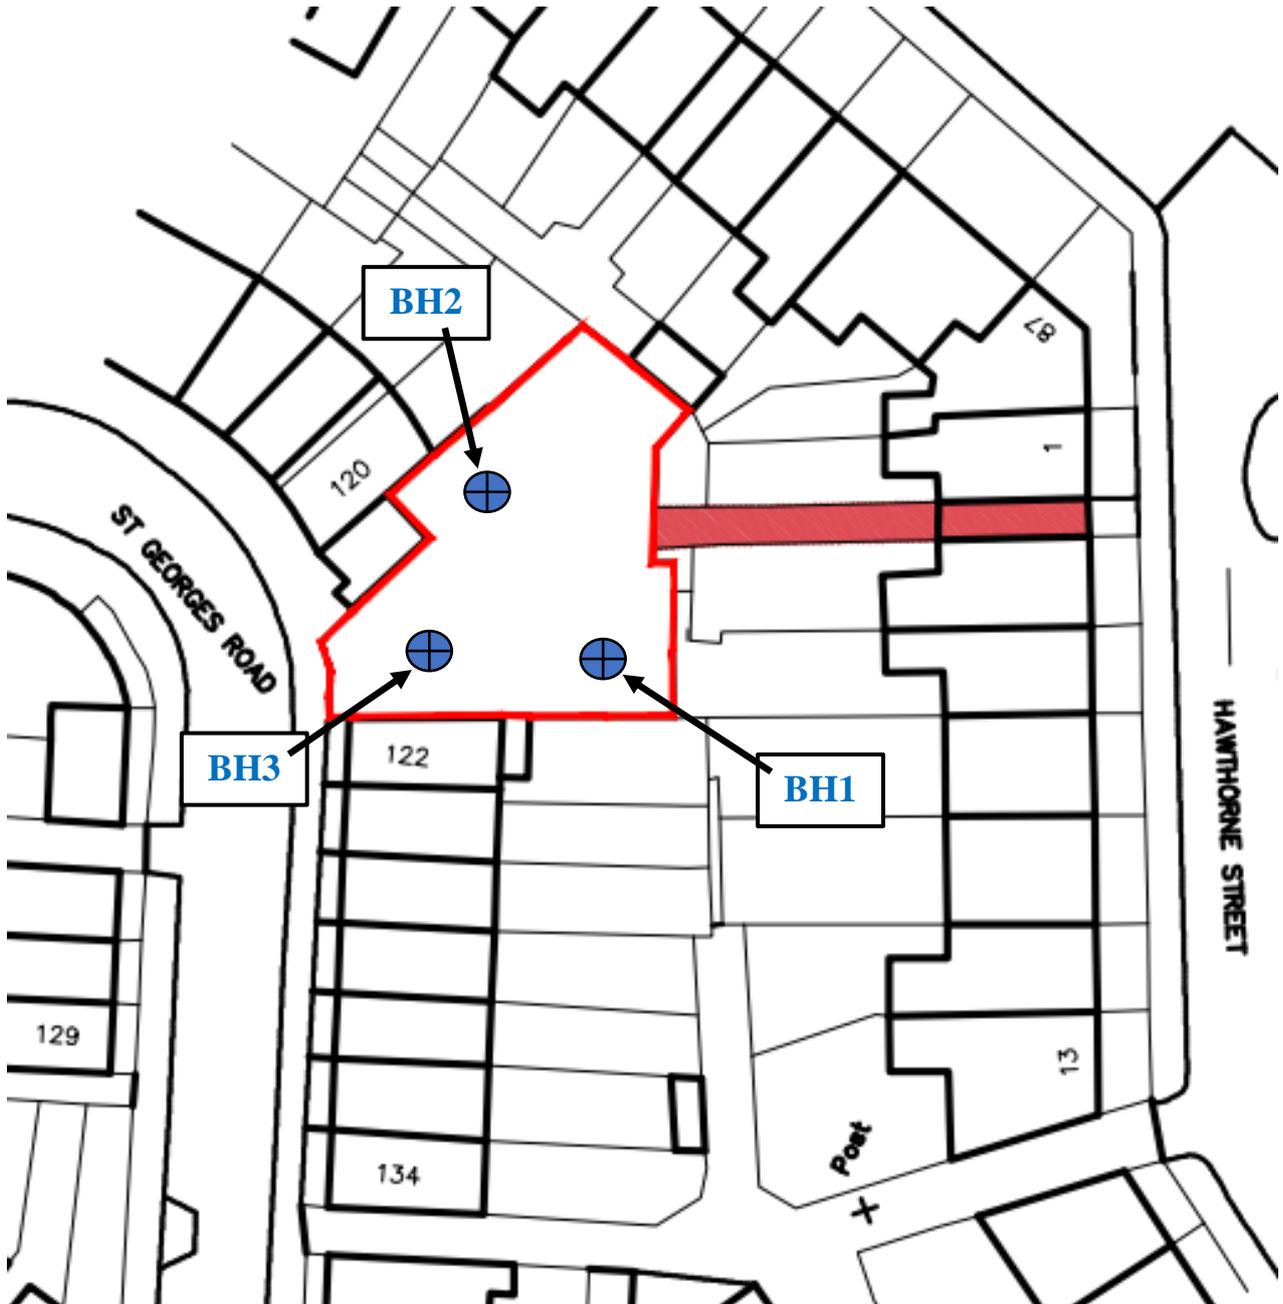
5.2 Borehole Location Plan No. 00313/B

Planning permission is being considered to develop a detached dwelling at the above location subject to the mining legacy risks been fully realised and mitigated from on site, if necessary. Cape Site Services has now undertaken this work via an intrusive site investigation of 3 boreholes, the location of which is outlined on plan no. 00313/B – as attached and illustrated in appendix 5.2.

Boreholes numbers 2 and 3 proved 0.4m of made ground before natural weathered sandstone bedrock to 1.2m deep & 1.0m deep respectively, at which point the sandstone became firm. Borehole (BH) number 1 encountered the weathered sandstone from the surface to 0.8m deep before becoming firm. It was noted in BH3 that the weathered sandstone became wet and then the firm sandstone above the coal was very wet, possibly suggesting water tracking along the fault plane.

An in-tact coal seam of 0.8m thickness (quite poor quality – weak/weathered) was then encountered beneath the sandstone at: 2m to 2.8m deep in BH1; 5.2m to 6.0m deep in BH2 and 2.4m to 3.2m deep in BH3. As such, it is considered that BH2 is on the north-western side of the fault (the downthrow side).

- 2) It appears very likely from this investigation that the conjectured fault will travel beneath the proposed dwelling. As such it would be advised that either a) further works/inspections of footing trenches are carried out to determine the surface position of this feature to enable strengthening of foundations to span; or b) foundations are suitably designed/strengthened throughout the entire footprint to fully safeguard stability; for example by utilising slightly thickened strip footings with two layers of appropriate grade mesh top and bottom.
