STRUCTURAL REPORT FOLLOWING VISUAL INSPECTION

For Monfredi Builders

Former Fitzwilliam Arms PH, 42 Hill St, Elsecar, Barnsley S74 8EL

| Date | Revision | Reference |
|---|---|---|
| Mar 2025 | P01 | K150-CHG-XX-XX-RP-S-0001 |

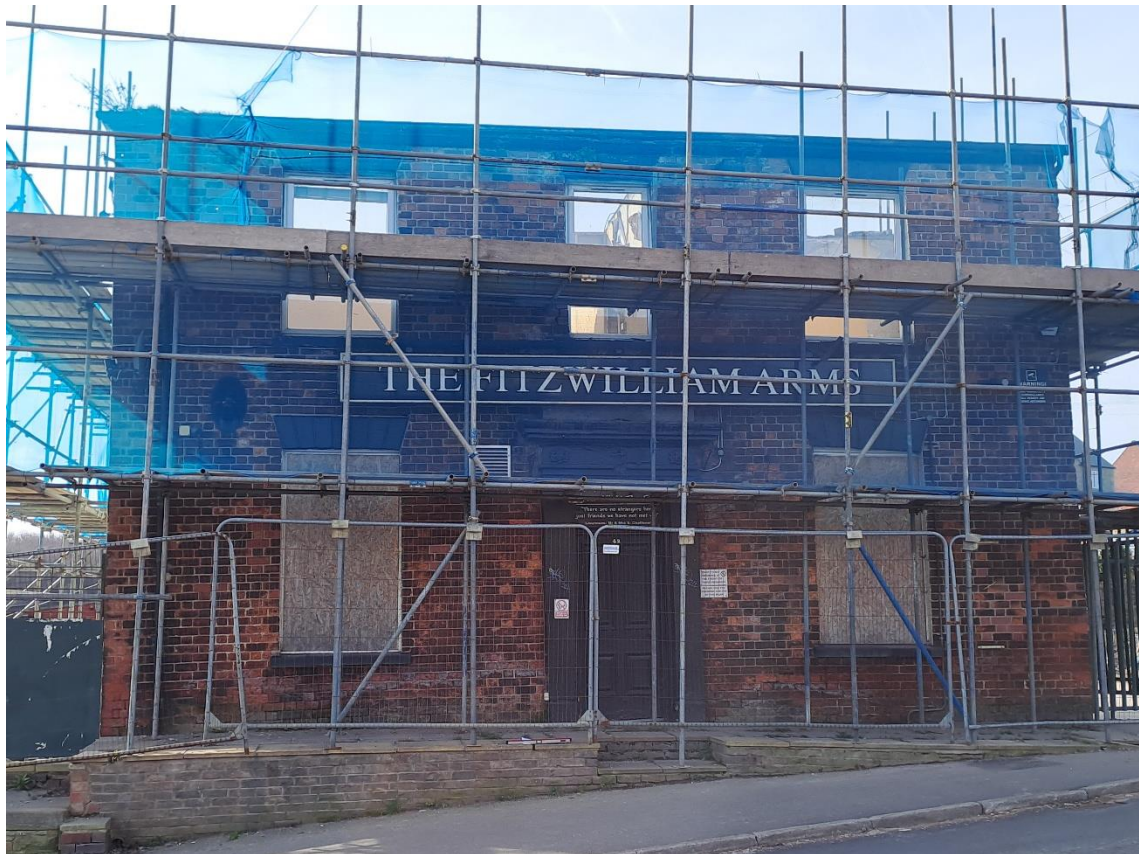
Front Elevation showing the extent of the tilt.

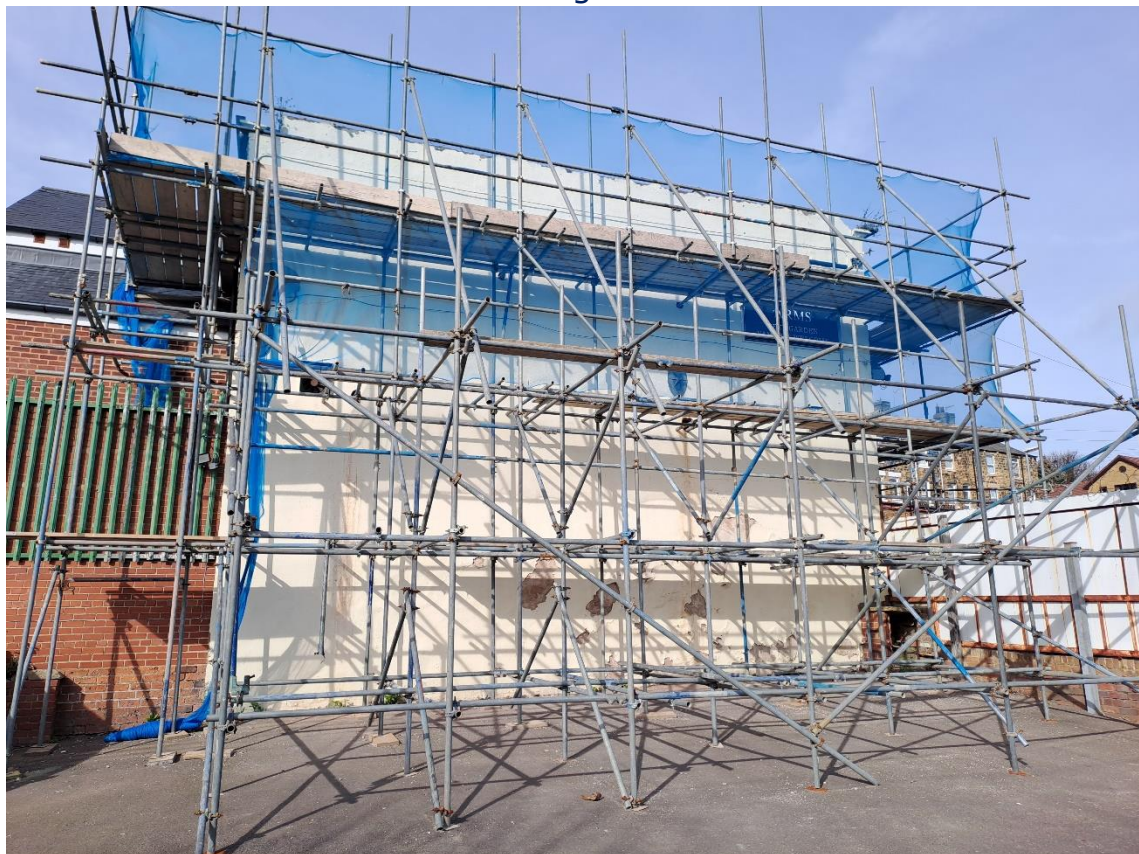
Side Elevation showing the scaffold bracing.

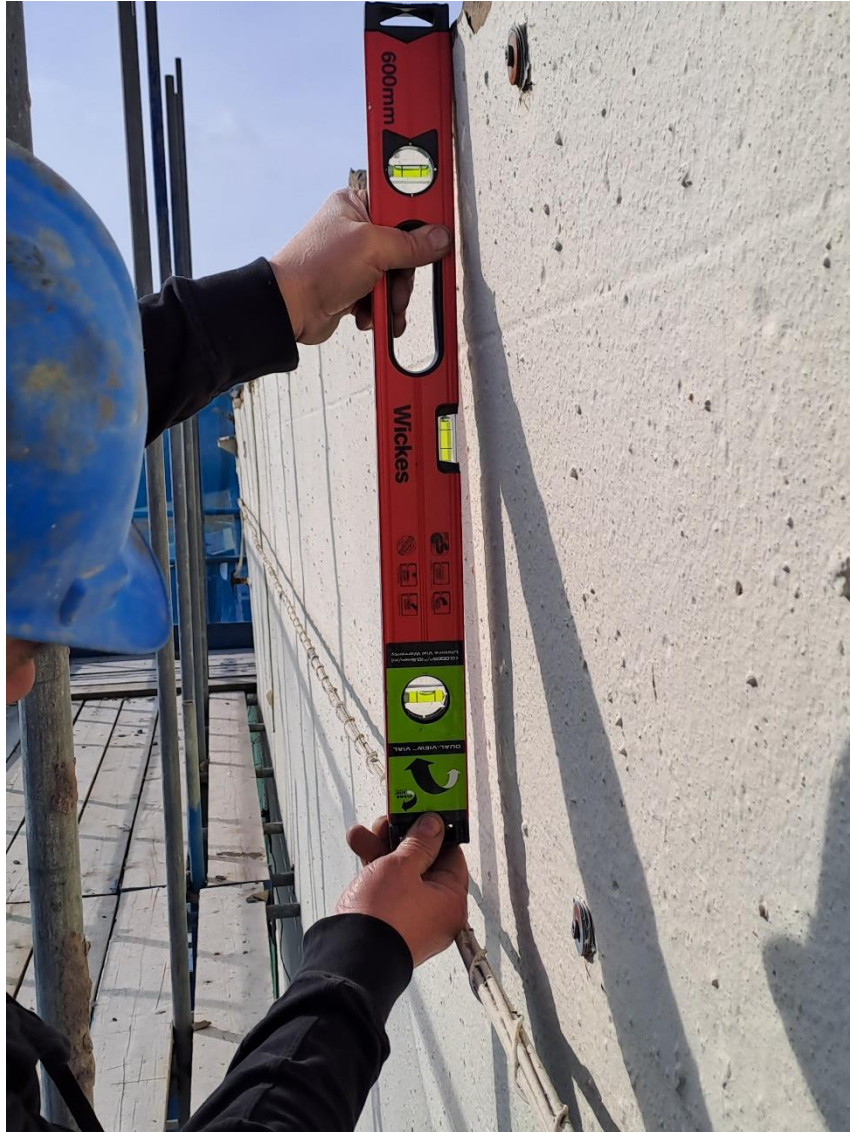
Side Elevation showing the significant out of plumb.

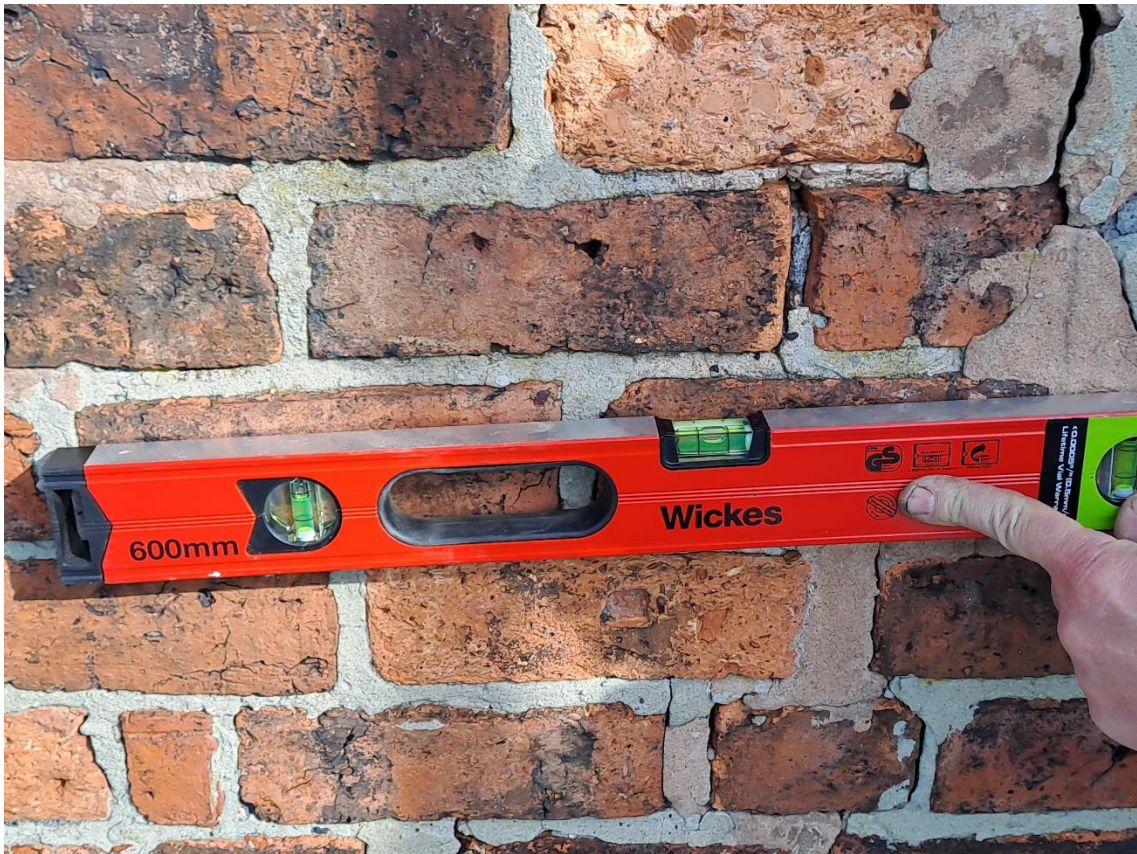
Front Elevation showing the significant out of level.

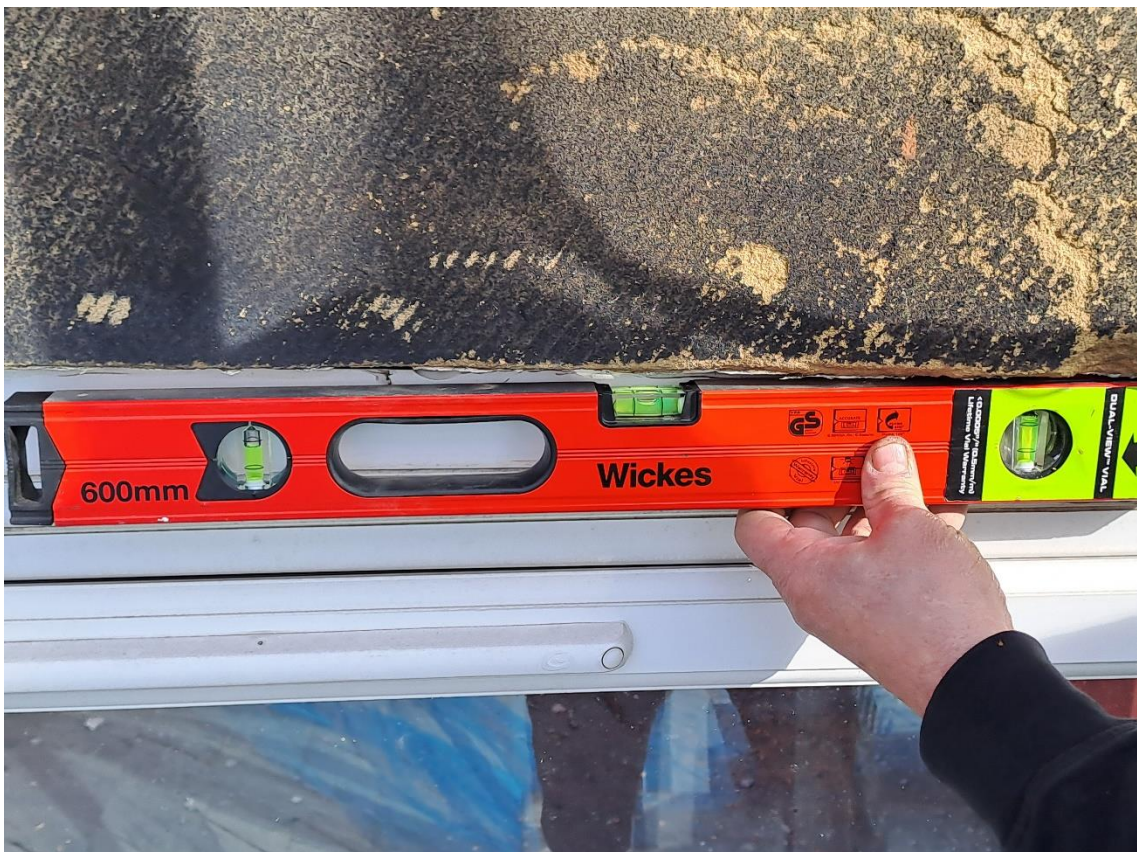
Front window head showing the significant out of level.

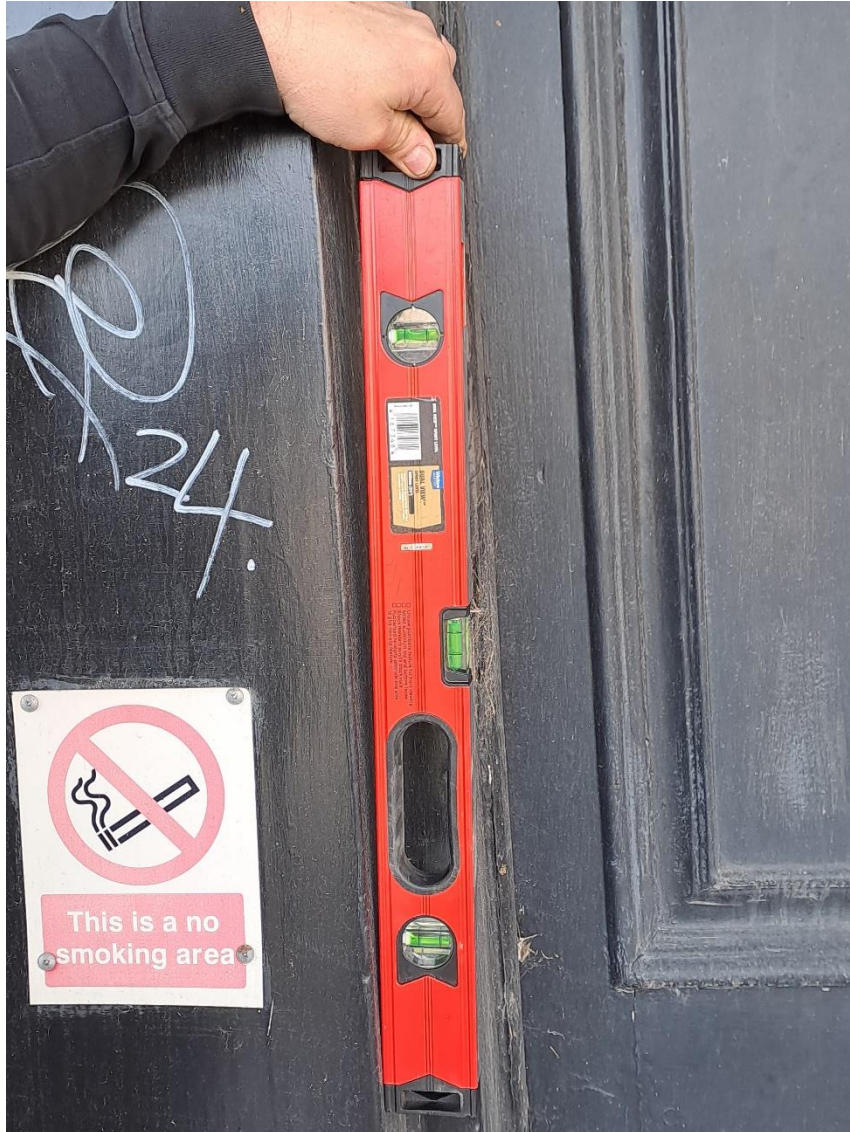
Front door reveal showing the significant out of plumb.

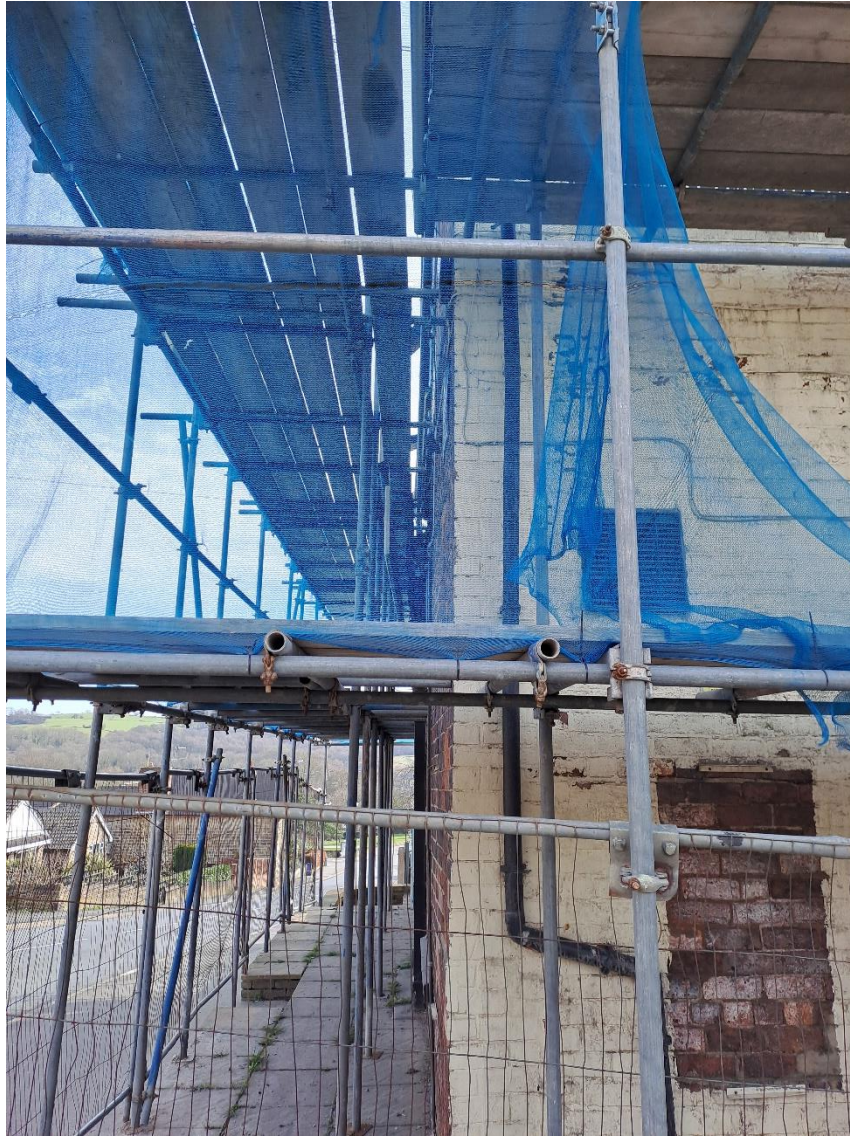
Front Elevation showing the significant out of plumb and bowing.

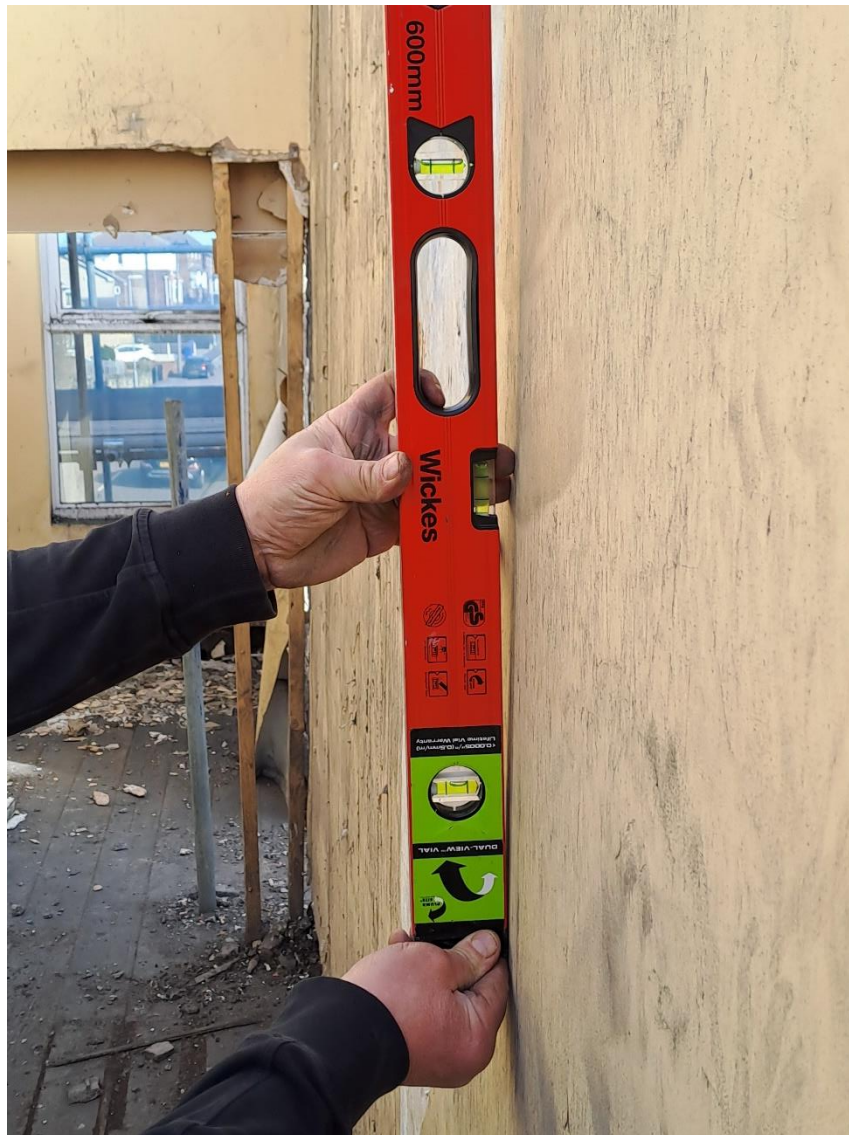
Internal wall showing the significant out of plumb.

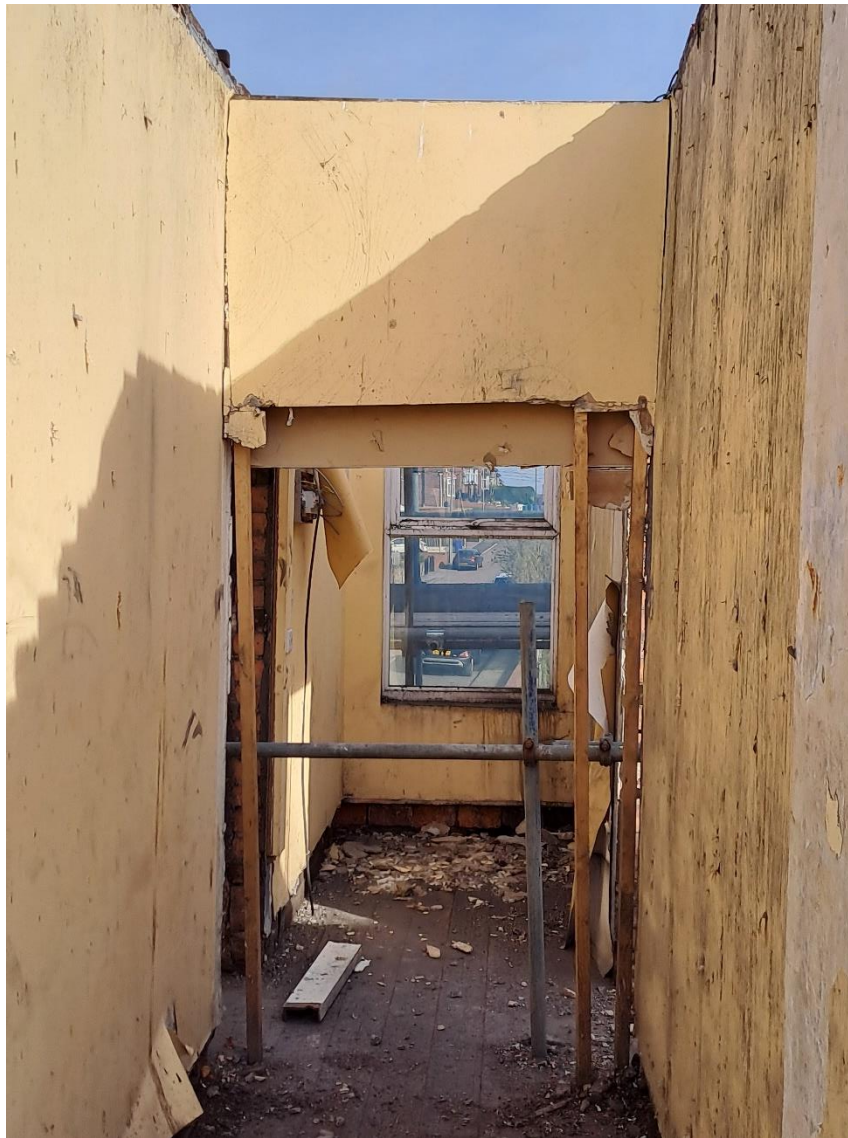
Internal corridor showing the significant out of plumb adjacent to the door and cracking.

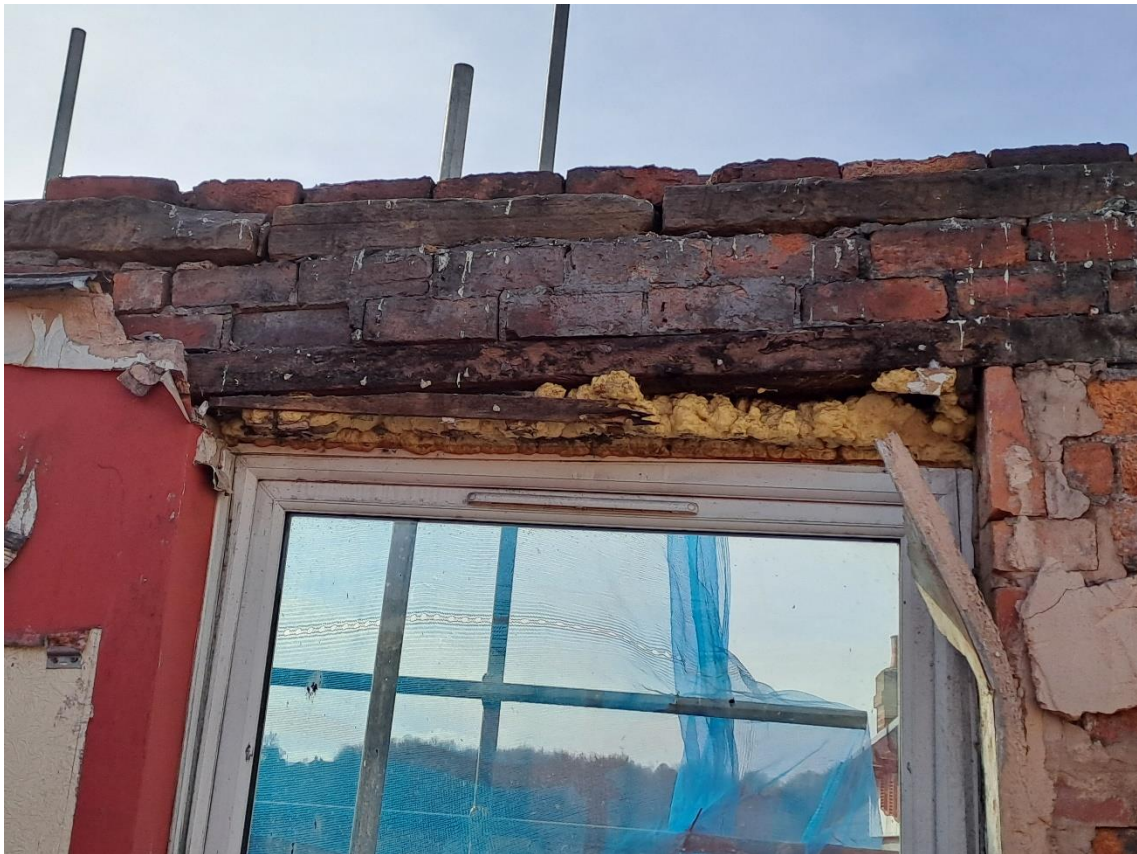
Internal Side Elevation window head showing the significant out of level.

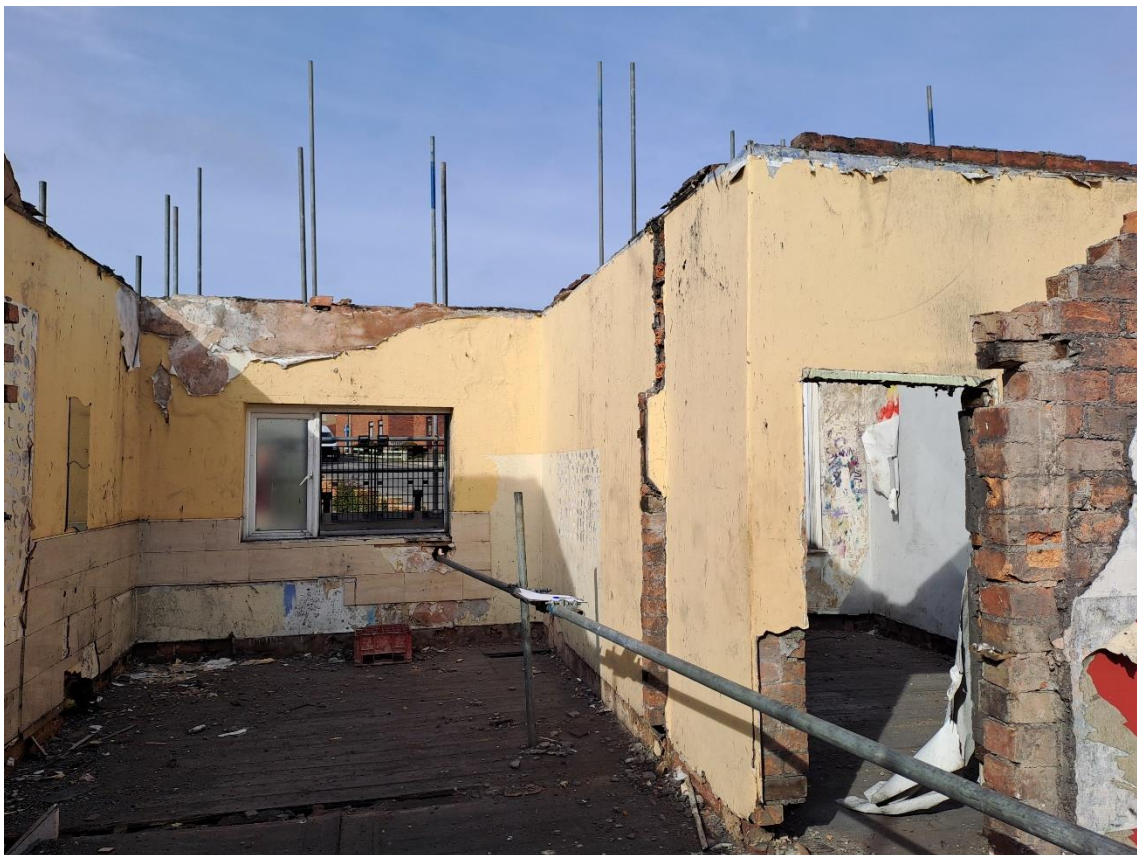
Internal view showing the significant out of level floor and cracking.

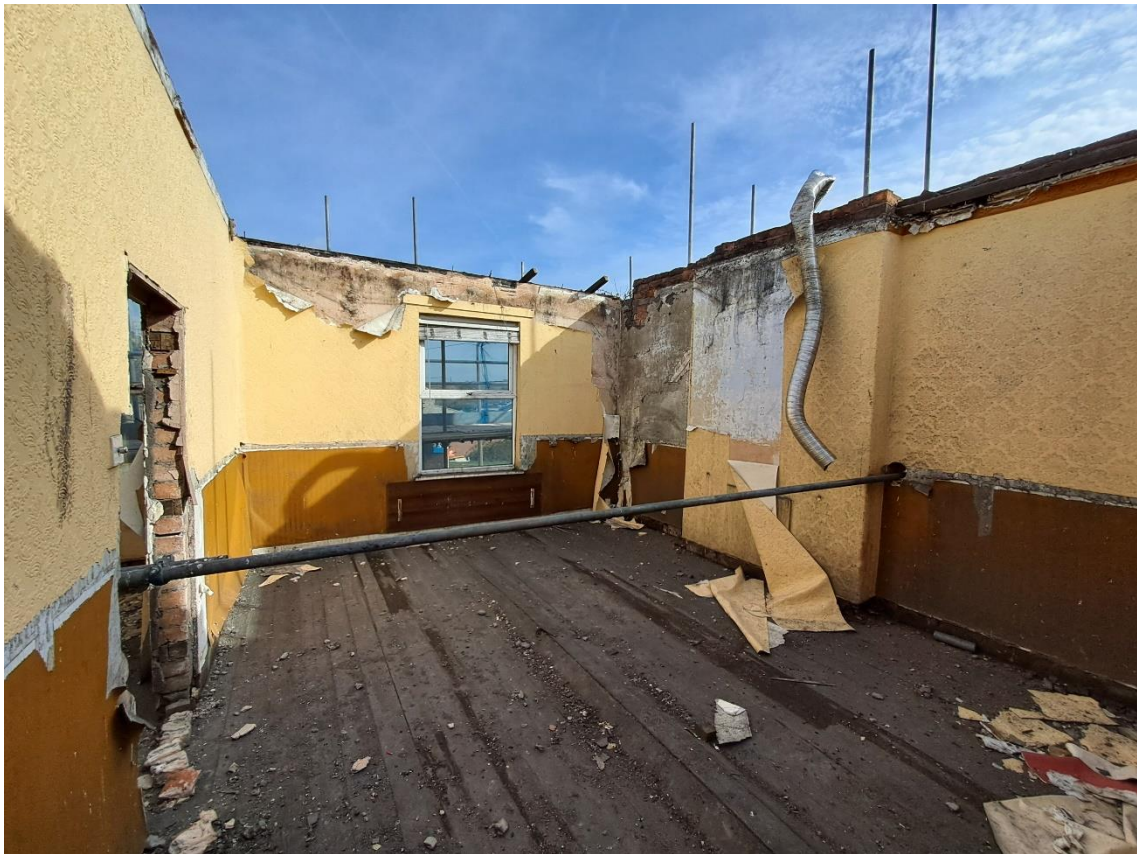
Internal view showing the significant out of level front window.

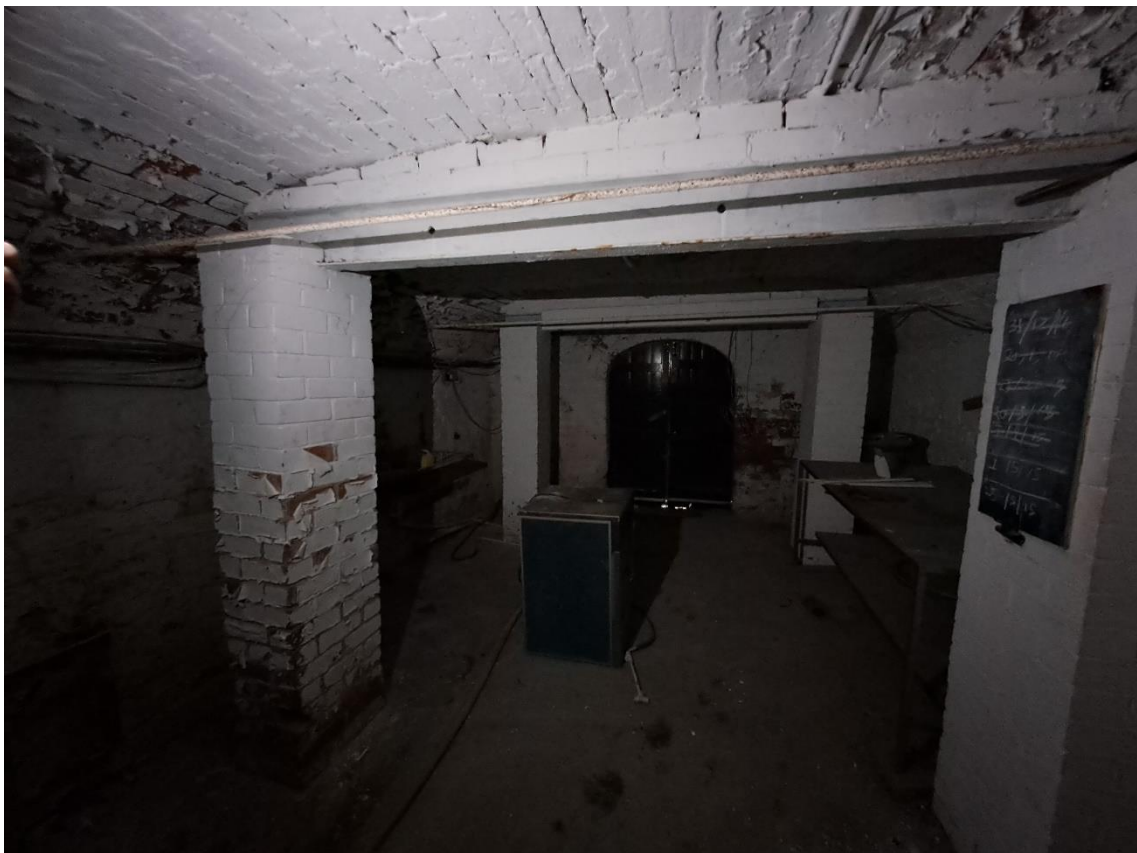
- The rotation of the building noted externally is clearly evident internally, with out of plumb internal walls, sloping floors, sloping window heads and out of plumb door reveals.
- Cracking in internal walls at intersections and at junctions with external walls is evident at each floor level.
- The brick arch in the section of basement adjacent the south wall has failed and flattened due to outward spread of the springing points.

Basement view showing the flattened arch.

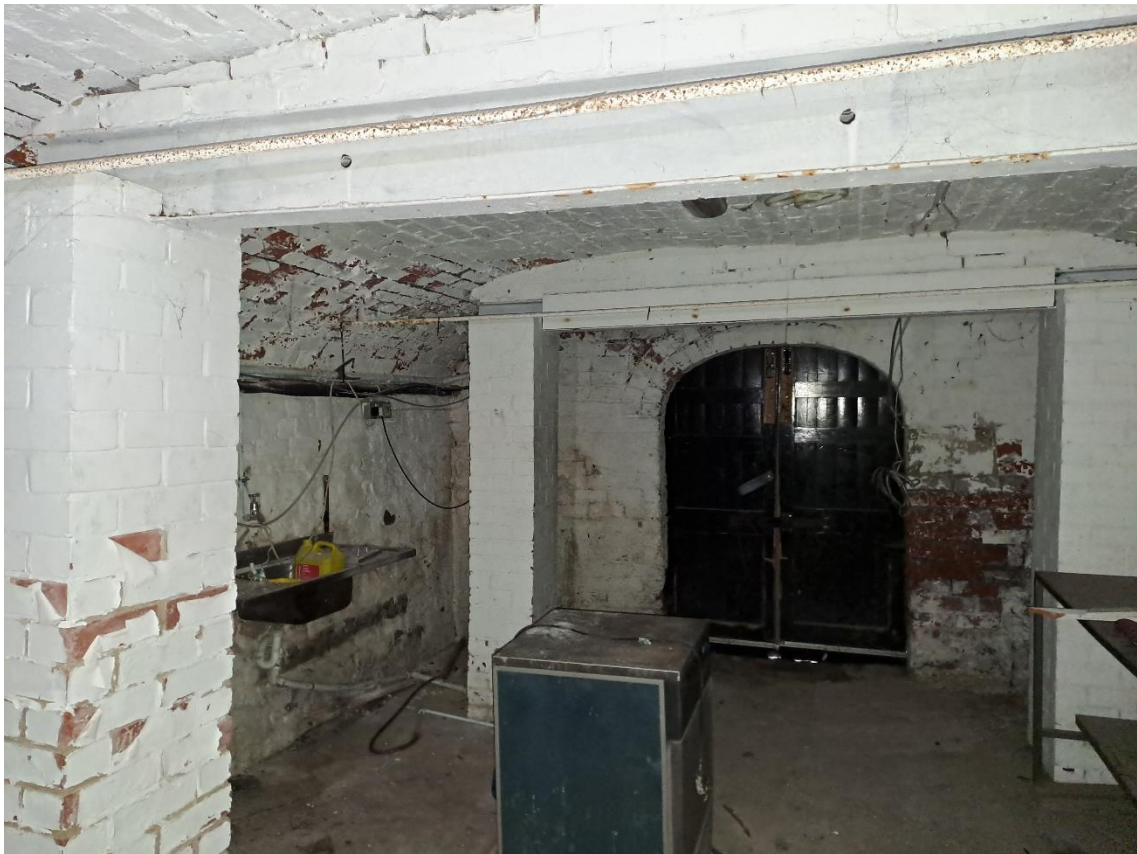
Basement view showing the flattened arch and steel support beam.

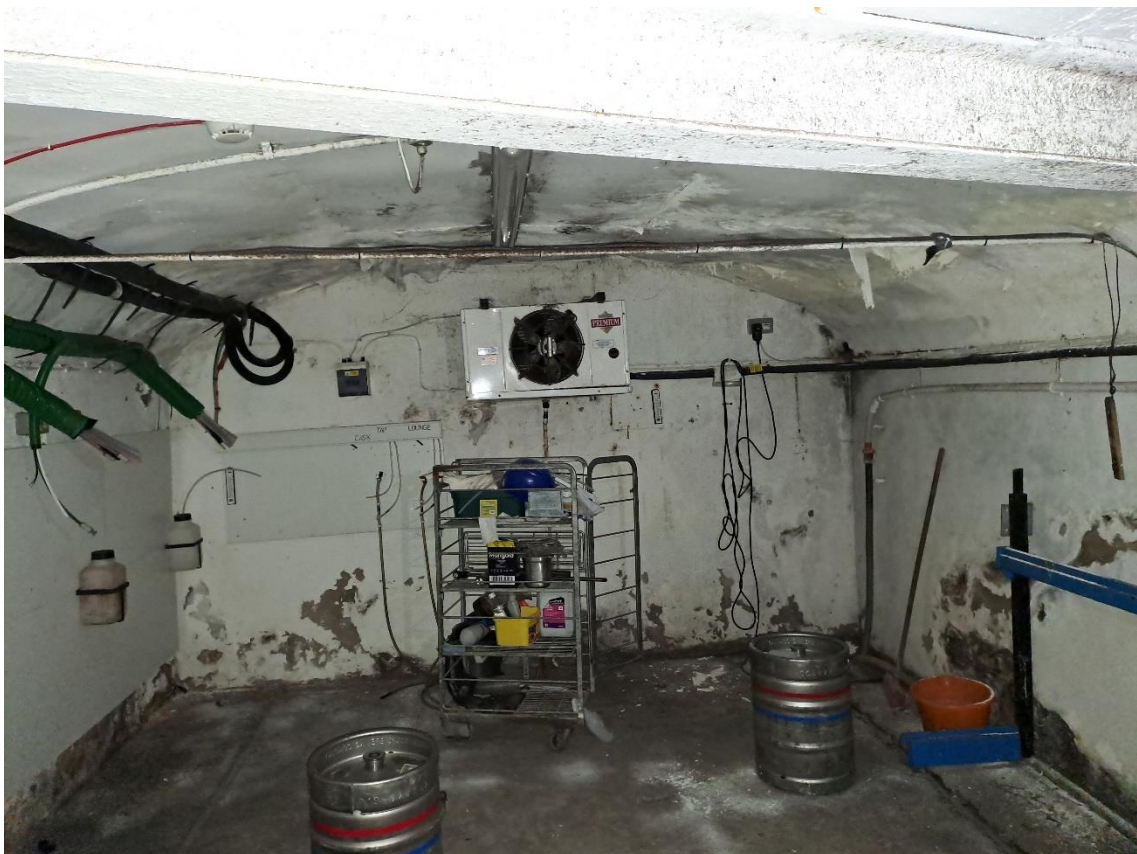
Basement view showing the steel support beam.

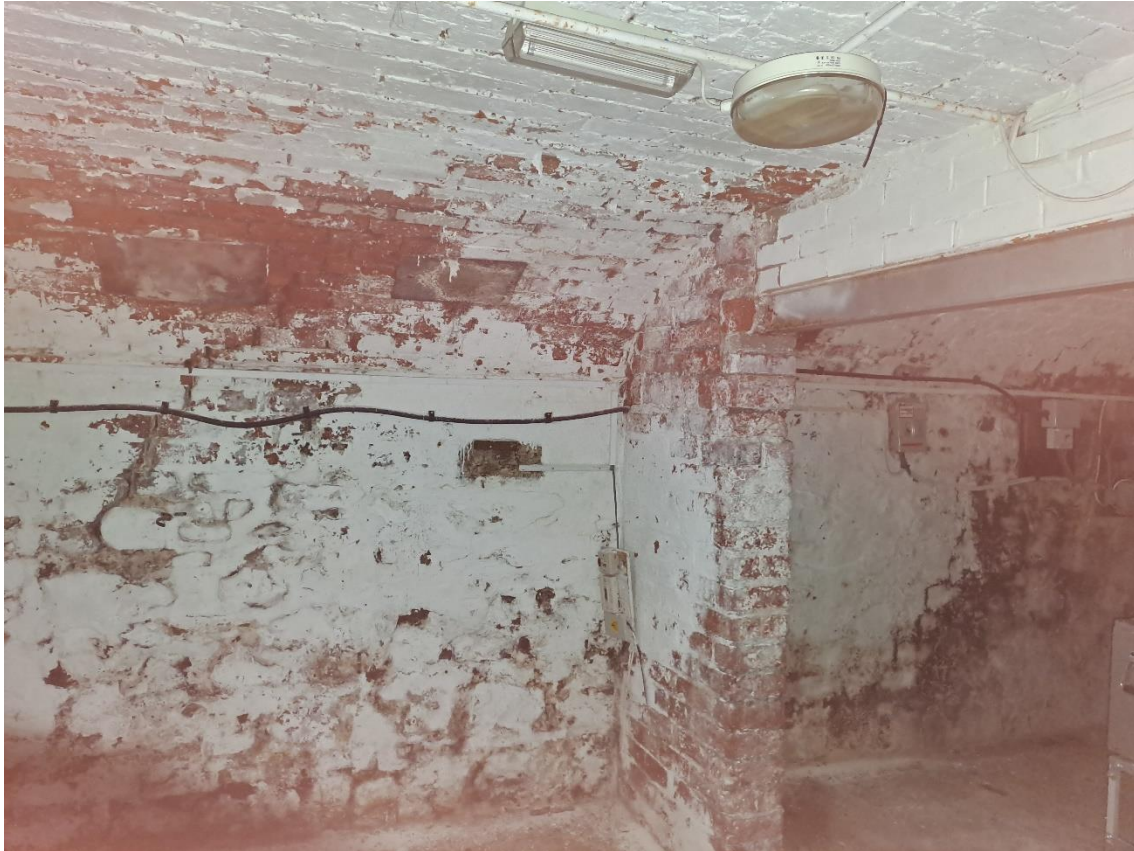
Basement view showing the flattened arch and damp.

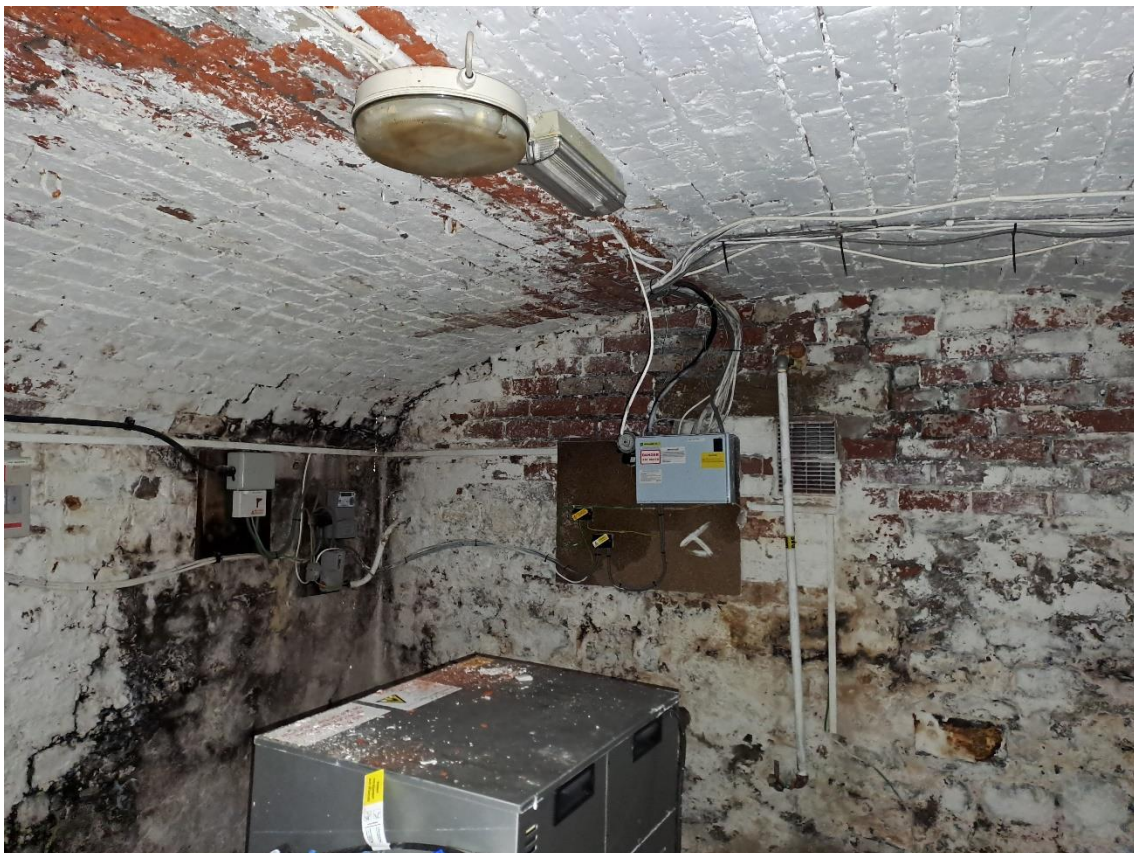
Basement view showing the flattened arch and damp
