# STRUCTURAL REPORT

Bank House Farm, A628  
Silkstone, Barnsley  
S75 4FZ

NE5559

**STRUCTURAL REPORT ON** Bank House Farm, A628, Silkstone, Barnsley, S75 4FZ

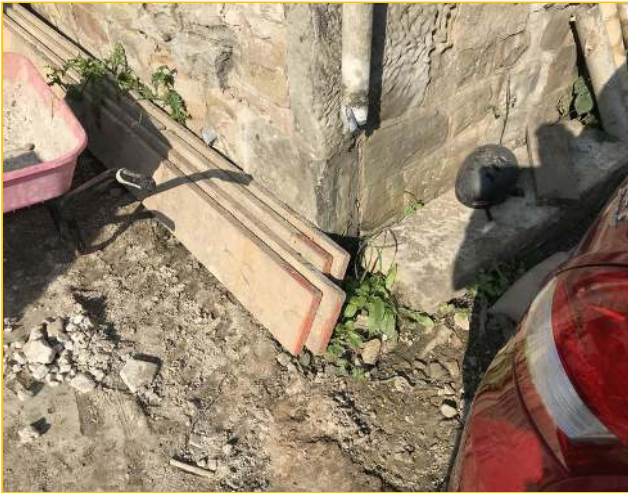
It was noted that the rain water downpipes to the building generally discharge direct to ground, typically local to the building corners. This is not considered to be a good detail and can put the property at risk of structural movement. Such an arrangement increases the risk of a concentration of water to enter the ground local to the foundations and cause wash out of fines from within the granular soils. This discharge arrangement will require altering to ensure the water is diverted and discharges away from the walls of the property into the underground system or suitably sized and located soakaways.

A property of this age is likely to have the original, vitrified clay pipes, which are brittle and susceptible to damage. Ground movements throughout the life time of the property can cause cracking to the pipes and also displacement of the pipe joints. Both forms of damage will allow escape of water into the surrounding soils, which in turn can cause localised softening of clay soils below adjacent foundations, or washing away of granular soils such as sand, if present.

Photograph - 6 - Typical discharge to ground

In view of this, it is recommended that the condition and integrity of the underground drainage system is further investigated by a specialist CCTV survey.

- 2** C. The rainwater pipes which presently discharge directly to ground should be re-directed to discharge at least 5m away from the foundations of the building and 2.5m from a boundary into a soakaway(s). Soakaway to be excavated 1m x 1m x 1m and lined with a geo-textile membrane, prior to infilling with broken brick. Top of infill to also be covered with a geo-textile membrane, prior to topping over with turf. Gulley pot, with rodding access to be installed at foot of the rainwater down pipe, and connected into the new soakaway using 110mm diameter UPVC, buried pipe.

- 2** D. Appoint a specialist drainage contractor to carry out a detailed CCTV survey of the underground drainage system to confirm the extent and location of any defects, and to carry out any associated repairs to eliminate the risk of escape of water from the drains into the surrounding sub-soils.

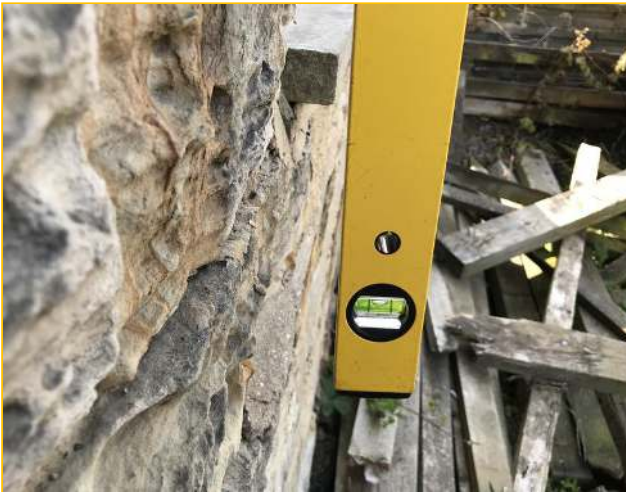
As a result of the leaf separation and lateral displacement, the walls of the rear extensions generally tilt to varying degrees. On the right hand wall of the right extension this tilt was quantified using a spirit level as being up to 50mm over a vertical height of 1000mm.

The Building Research Establishment (BRE) Digest 475 - Tilt of Low-Rise Buildings, provides classifications for tilting to buildings. Tilting will generally become noticeable when it reaches around 1 in 250 to 1 in 200. Tilts of this magnitude are unlikely to have adversely affected the structural integrity of the house, however at the point of re-sale, they are likely to attract attention. Greater tilts than this are likely to affect the verticality of furniture, cause doors to swing open and possible issues with the falls to the internal plumbing and under ground drainage. As a guide, Digest 475 indicates that remedial works may be necessary for tilts around 1 in 100. As the tilt approaches 1 in 50, the building may be regarded as being in a dangerous condition.

In this instance, the measured tilt is 1:20.

Photograph - 28 - Extent of tilt

- 3** B. It is recommended that the extensions are carefully taken down and the materials recovered, sorted and stock piled for reuse. Rebuild the extensions on new suitable foundations. Allow for importing any additional local materials to replace the highly weathered masonry units / defective materials.

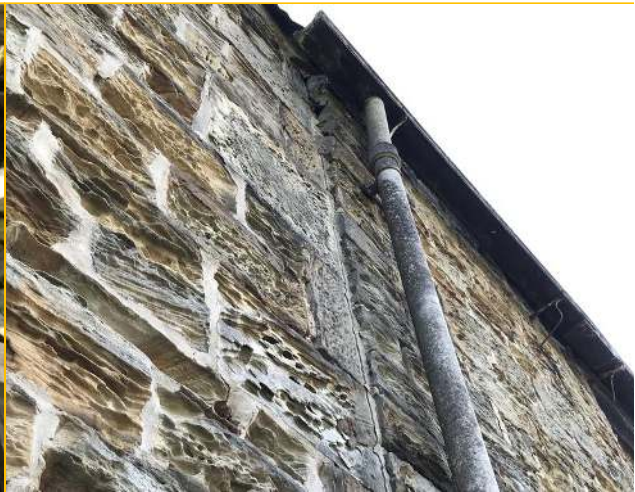
The vertical construction interface along this elevation has also displaced laterally in relation to the rear right hand corner of the original building.

Photograph - 29 - Lateral distortions

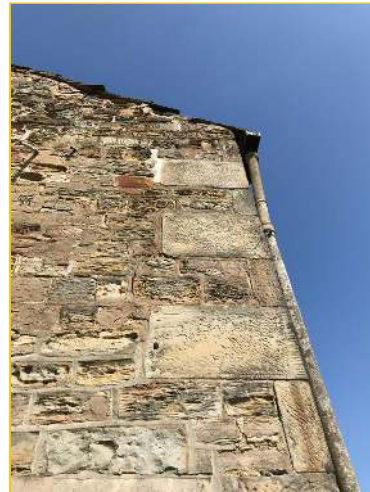
On the rear wall corners of the two extensions there is evidence of past and more recent movement (shown by reopened repairs), between the wall panels and the corner quoin stones. The recent movement is not significant at this time but will progress with age.

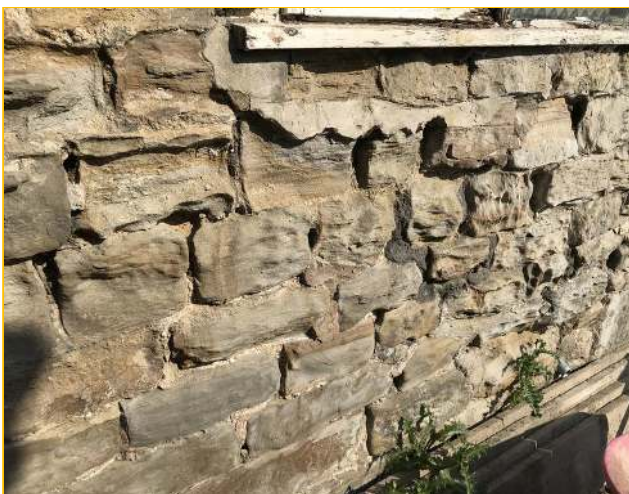
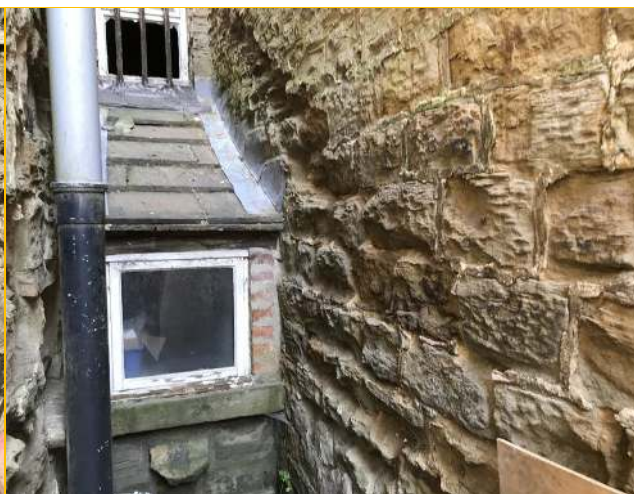
The mortar pointing to all elevations is noted to be badly weathered. This has adversely affected the long term durability of the bed joints and perpend joints on the wall. The mortar has two functions. Firstly to bond the masonry together for strength purposes and secondly to provide a weather tight wall. As the joints weather, they will become susceptible to rainwater ingress, which may result in internal dampness and accelerate the overall deterioration of the wall.

The external masonry of the extension walls is highly weathered in areas with areas of past and non sensitive mortar render repairs. The stonework is generally friable to the surface where weathered.

Photograph - 37 - Weathered masonry

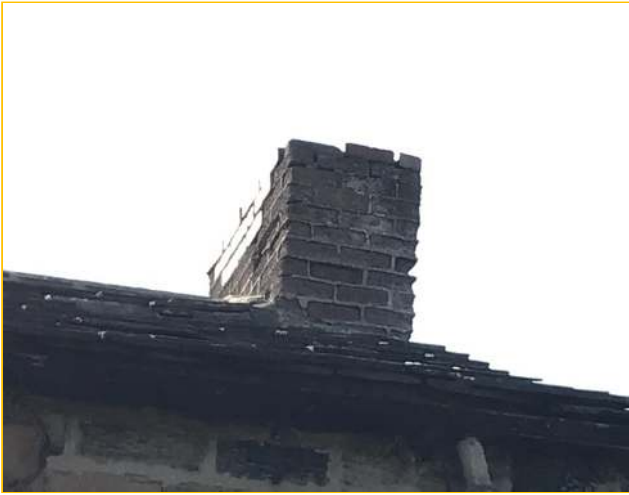
Although beyond the scope of this specific defect inspection report, we would draw your attention to the poor condition of the brickwork masonry stack along the right hand gable wall of the original building. This stack is highly weathered with areas of loose material and significant distortions. We would recommend that you consider taking down and rebuilding this stack.

Photograph - 42 - Brickwork stack

- 3** A. Due to extensive weathering, loose masonry and distortions to the brickwork chimney stack of the main building, we would recommend that future refurbishment of the property allows for taking down and rebuilding the stack.

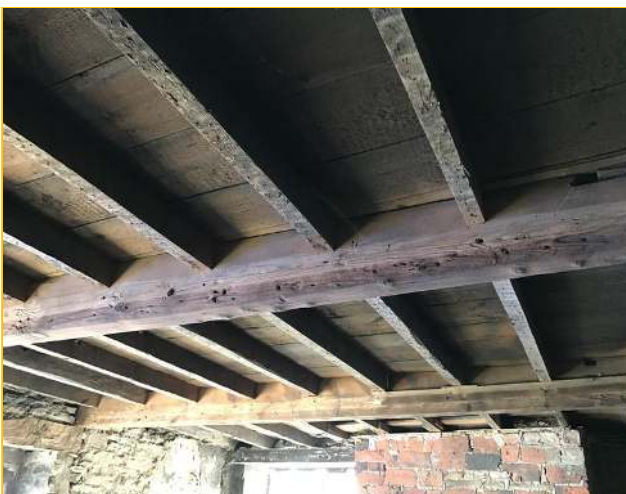
The first floors are of suspended timber construction with joists supported by intermediate beams. These floors were generally found to be reasonably robust underfoot, however there were generally out of level and uneven.

Part of the floor to the left hand extension has been subject to historic fire damage, however the damage was minimal charring and the overall integrity of the floor structure has not been compromised.

Several joists in the left hand extension were provided with insufficient bearing due to historic movements within the property.

Photograph - 48 - Limited bearing

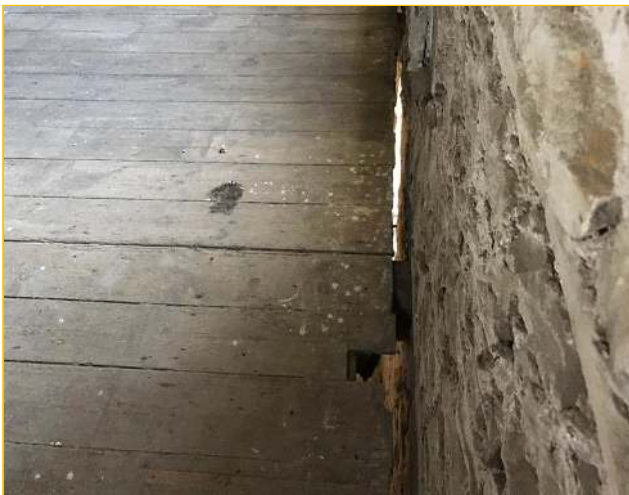
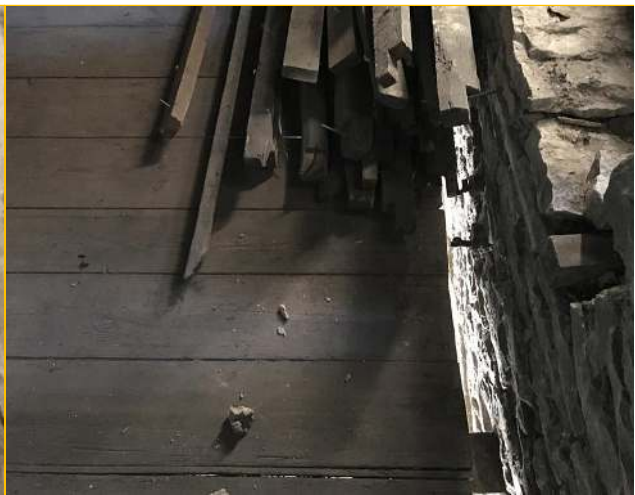
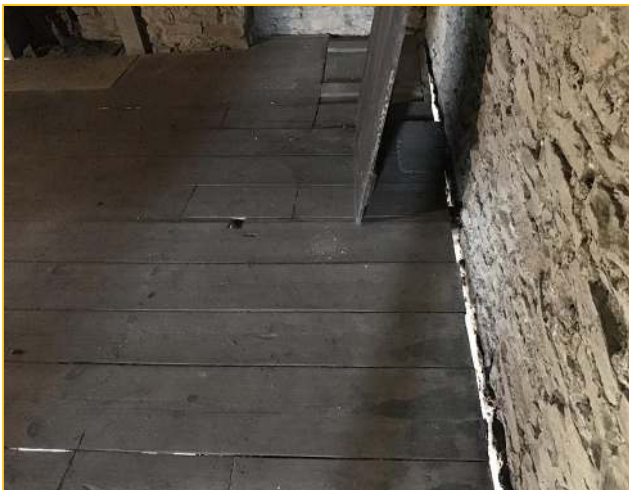
The internal walls within the rear extensions have been stripped of the internal finishes. Observations around the first floor room perimeters identified evidence of lateral movement of the external walls. This was shown by separation between the walls and the floor boards.

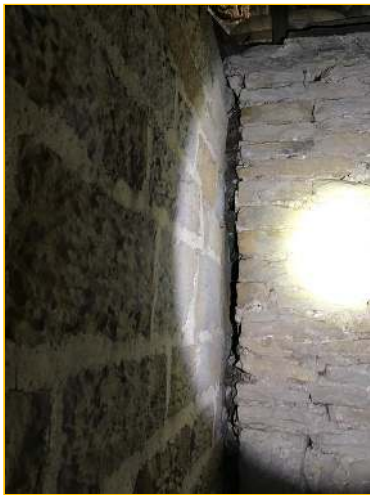
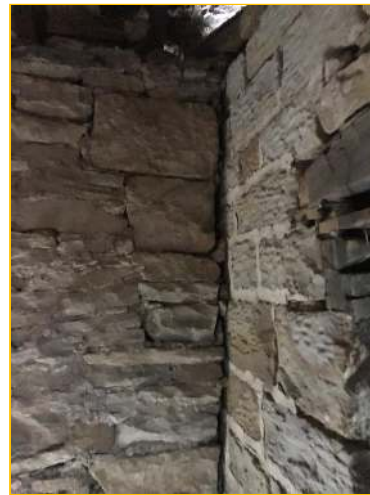
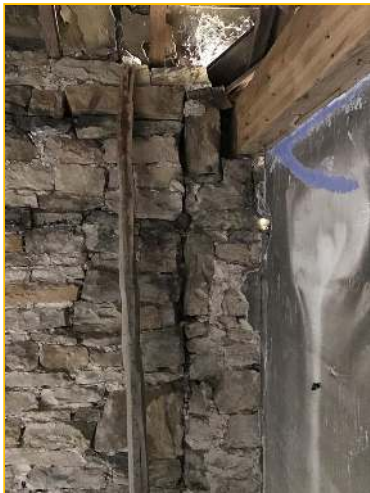
At the construction interface, between the main original rear elevation wall and the flank walls of the extensions, identified separation fractures, up to 50mm in width. No structural bonding was apparent at the interfaces.

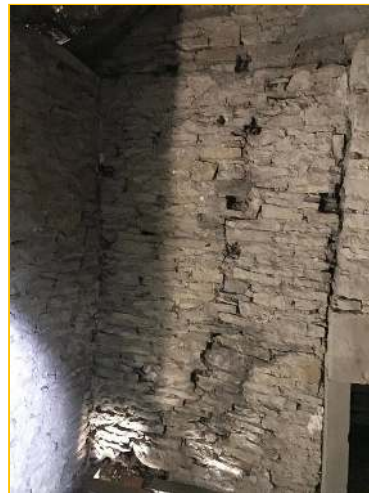
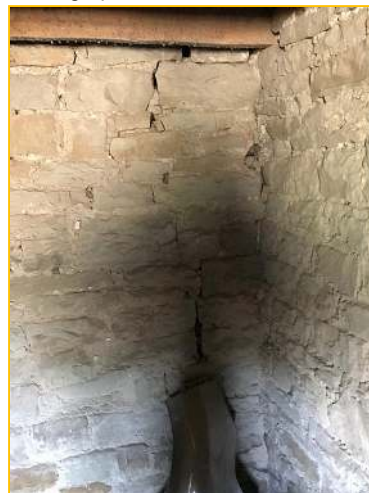
At the rear wall corners there is a degree of vertical fractures that generally trend to reflect those noted externally at the quoin to wall panel interfaces. This shows full depth fractures.

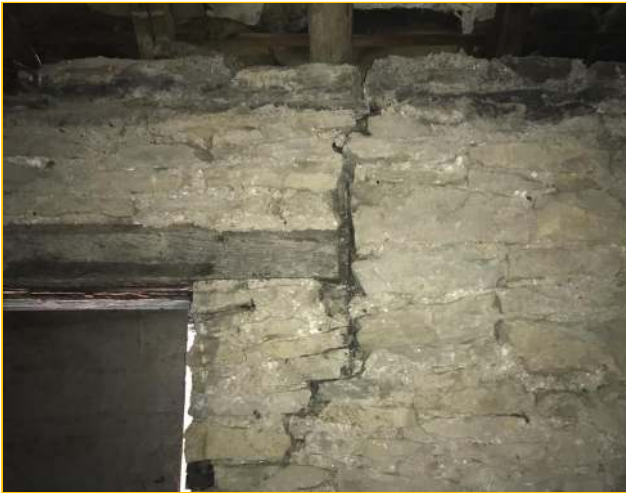
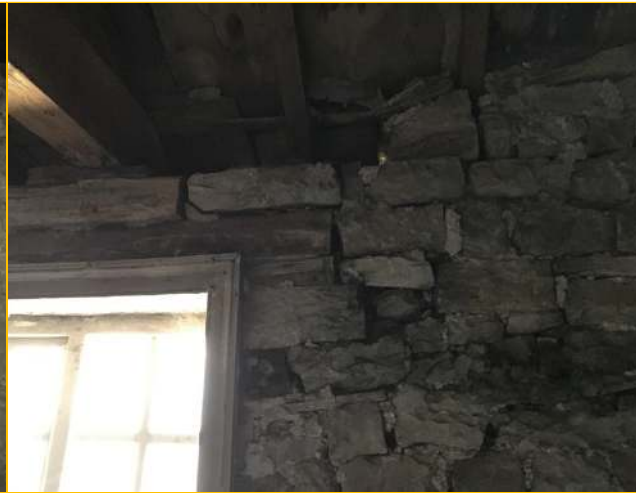
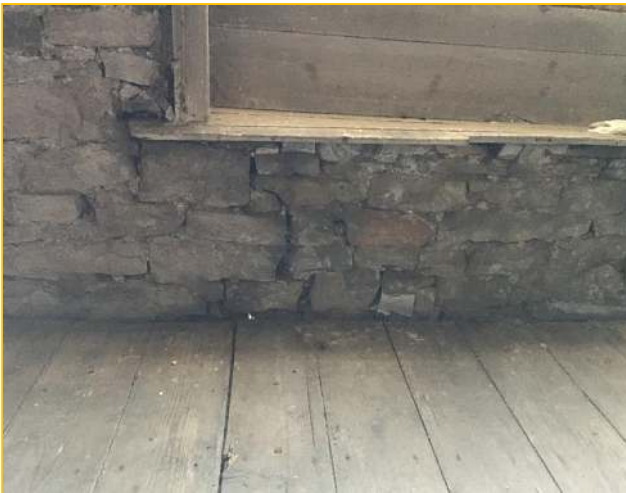
Looking throughout the first floor areas of the extensions there are fractures and separations to the internal stonework, general extending from the various openings. Some areas of the masonry are loose locally.

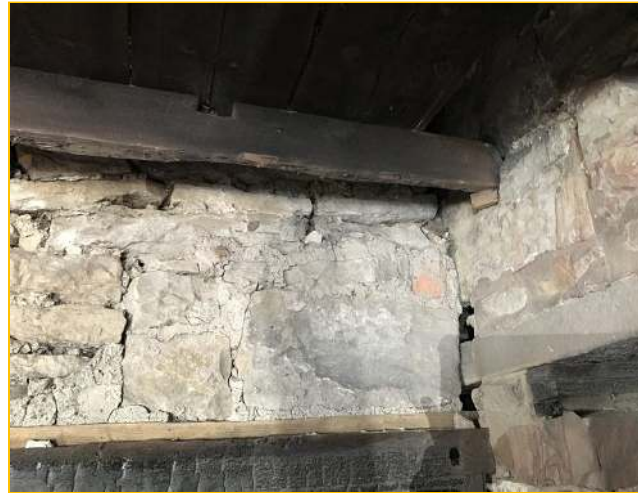
Similarly at ground floor level fractures are evident to the internal faces of the external walls that trend to reflect the fractures noted externally.

Photograph - 64 - Reflected fracture

Photograph - 65 - Reflected fracture

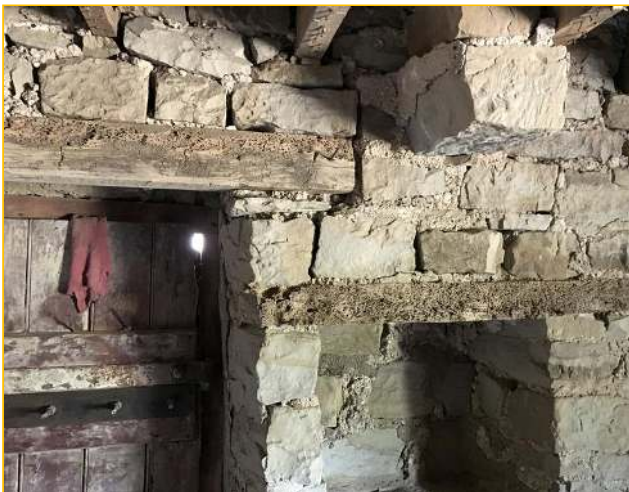
The timber lintels that spanned the external window openings were generally noted to display evidence of wood destroying insect damage and areas of historic decay. Allowances should be made for replacement or treatment of the timbers as part of any future property refurbishment works.

Photograph - 66 - Wood destroying insect damage
