**Tree Survey: Former Pheasant Inn site, 88-90 High Street,  
Dodworth, Barnsley.**

**Client: Eldwick Estates Limited.**

**Date of Survey: May 12<sup>th</sup> 2015.**

**File reference: Pheasant Inn 01**

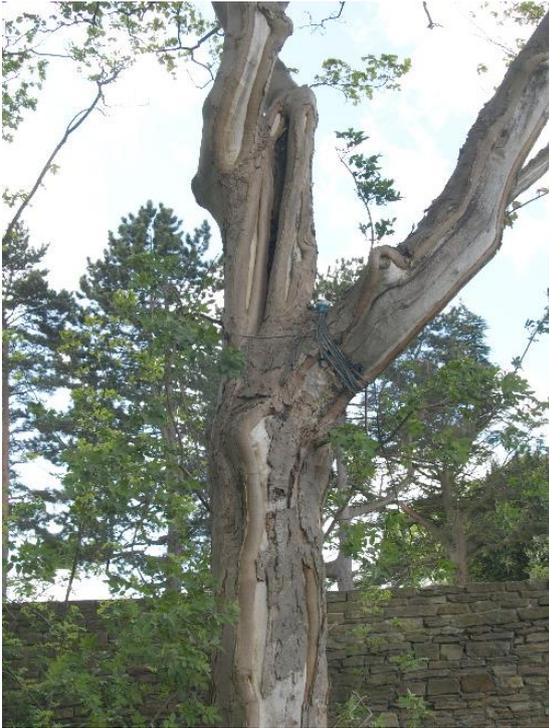
Photograph 1.

8.	Sycamore	14	610	M	U	Severely damaged and dying back, has clearly been abused over many years.	0
9.	Horse Chestnut	16	650	M	C1	Has suffered similar damage to tree 8, but hasn't died back to the same extent. Probably best removed.	191

Photograph 1 shows tree 8, it has clearly been in poor condition for some time. While the TPO might be a very old one if it was a recent imposition it should have excluded this tree. Photograph 2 shows a wire for a floodlight fastened around the branch.

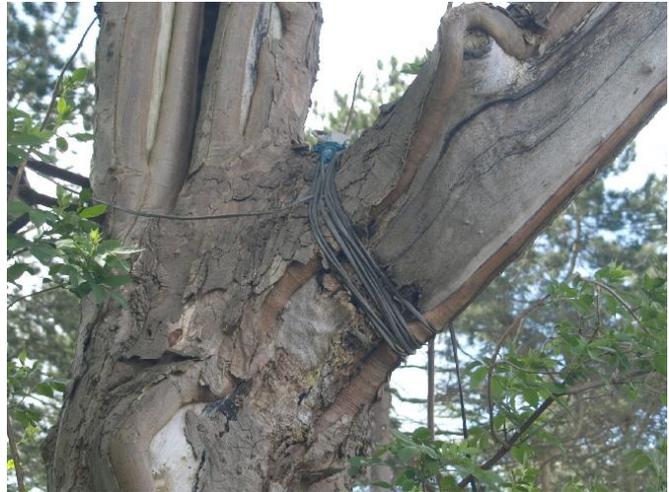
Photograph 2

Once the bark has been killed it eventually drops off leaving the heartwood exposed, which leaves an increased risk of infection. In photographs 1 & 2 there are examples of the heartwood having been decayed away presumably it was infected with a decay-organism, while elsewhere the heartwood still seems solid. Exposed heartwood clearly does not always become infected with anything, but the bark that would ordinarily protect the heartwood is missing so the tree is at risk.

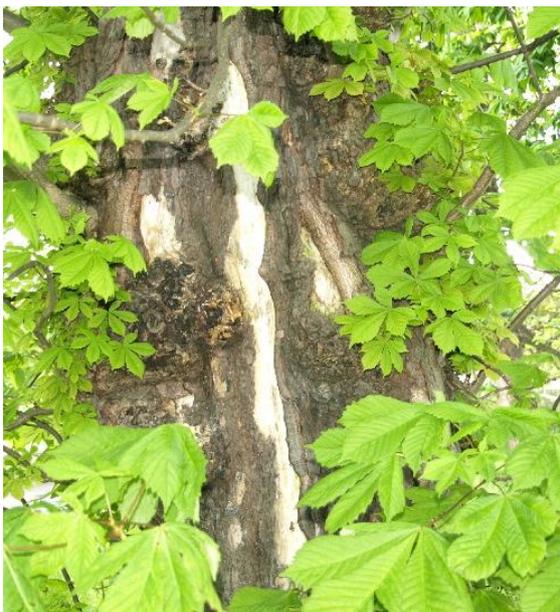
Photograph 3.

This may sound somewhat far-fetched but the damage here is almost certainly caused by a bonfire. Bark lost in this way is a common sight where a fire has scorched a tree.

The same fire also scorched the nearby Horse Chestnut, tree 9, although that tree does not seem to have suffered quite as badly as the Sycamore. Photograph 3 shows the damage albeit partially hidden by foliage.

Tree 9 has also had a floodlight fastened to it.

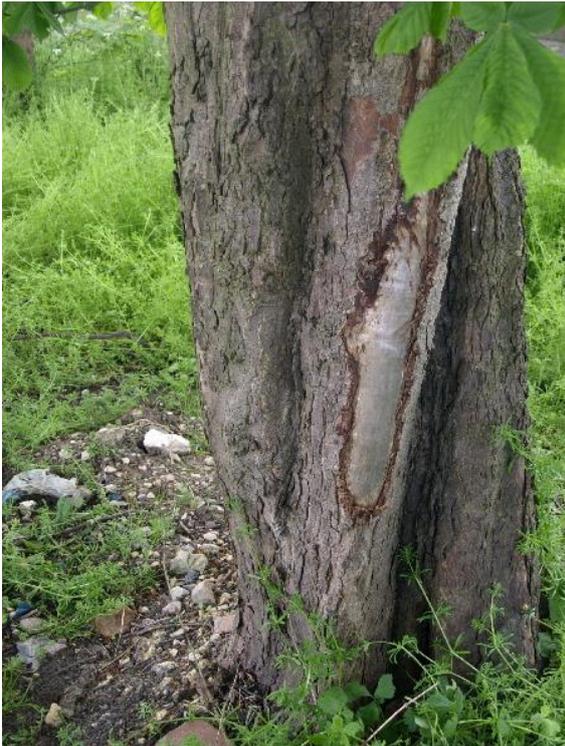
Photograph 4.

Photograph 4 shows the base of Horse Chestnut tree 11. This has suffered bark damage more recently; I imagine that the machinery that demolished the building caused it, probably while levelling the ground around the tree.

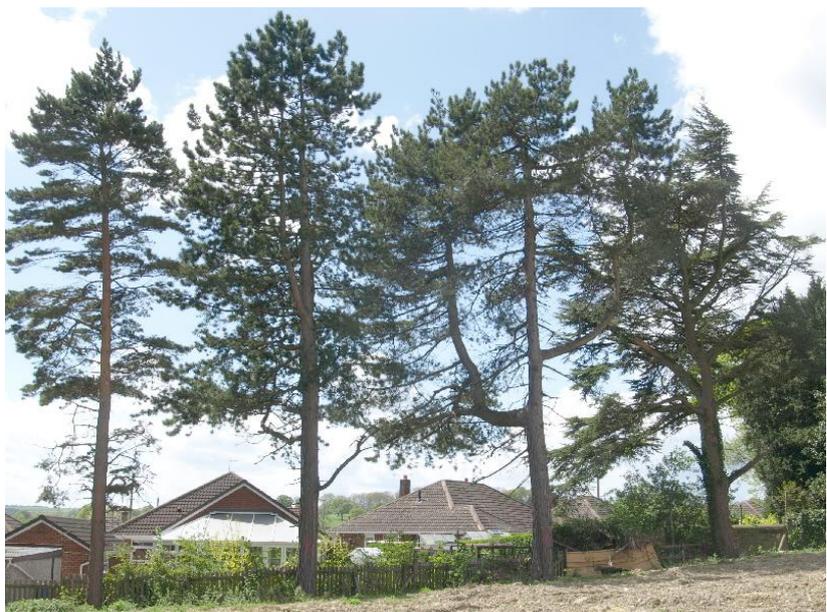
Photograph 5.

Photograph 5 is a view of trees 3 to 6. Tree 3 is at the right. Note also the way these trees tower over the houses to the rear fortunately they are to the north of the houses, so shade (there) is not a major consideration. They will be to the south of the proposed buildings so shade may well be more of a problem there. That said none of the trees are particularly densely foliated.

It is obvious that the ground has been disturbed at the base of these trees. While trees 3 to 6 appear reasonable specimens I noted that tree 3, the Deodar (a species of Cedar) has suffered some damage in the upper crown. Unfortunately Deodars of this age are somewhat prone to damage caused by snow; being evergreen they manage to catch more snow than might be anticipated and as a result branches are ripped off by the weight.

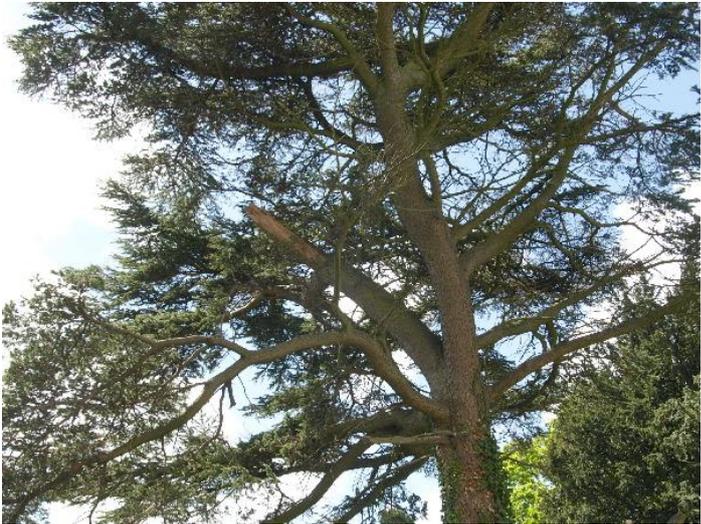
Photograph 6.

Photograph 6 is a view of the crown of tree 3 showing a large broken branch. This is almost certainly damage caused by snow, which is very common in Cedars.

Ideally this tree would be climbed and the damage pruned out in an attempt to leave a tidier, more aesthetically pleasing tree.

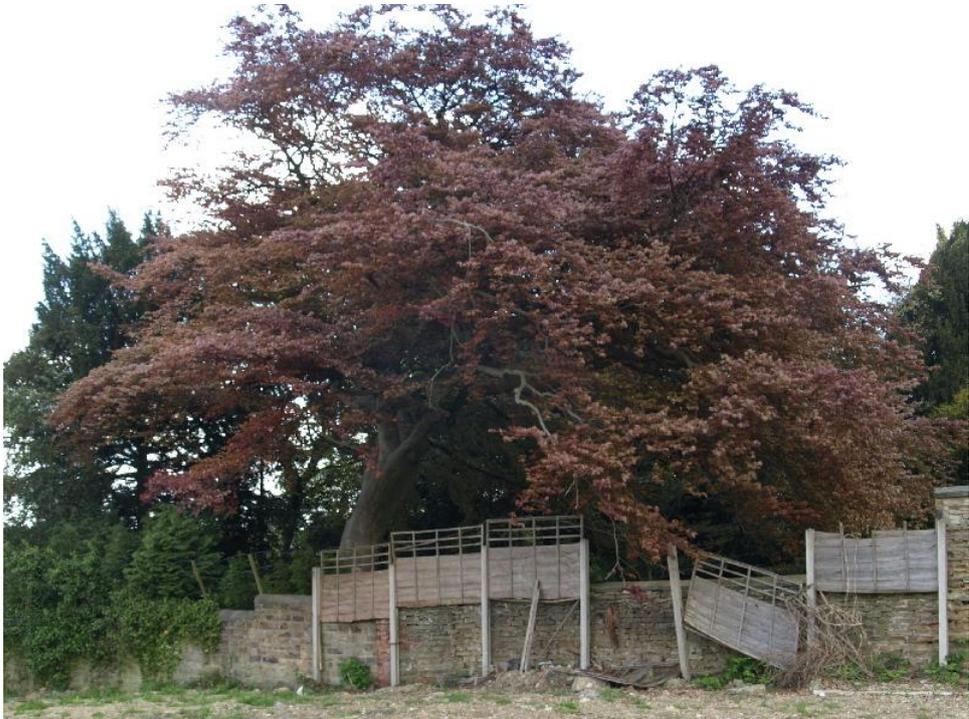
Photograph 7.

Photograph 7 is a view of the Purple Beech tree 2. While it is close to the site it does not reach very far into the site.

I note that this tree was mentioned in the Planning Officer's e-mail, concern was expressed about its bearing on the proposed development.

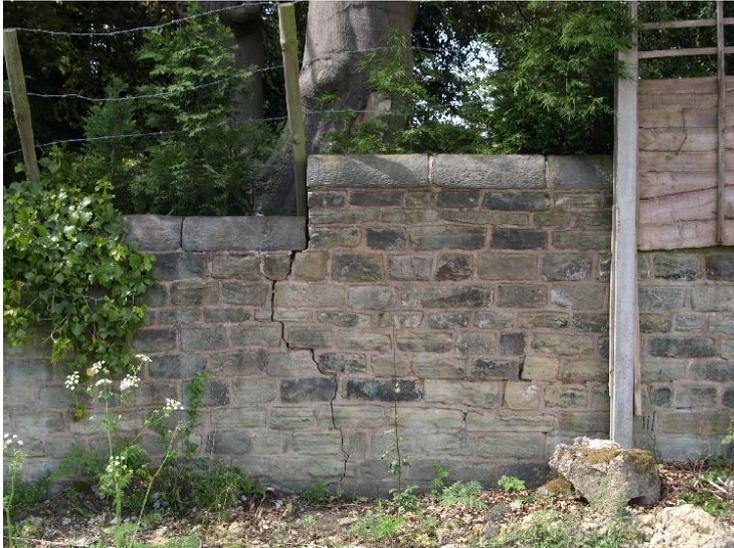
Photograph 8.

While I appreciate the Officer's concerns about the proposal's effect on the tree, it is fair to point out that the tree is already likely to be accused of nuisance. Photograph 8 is a view of the wall at the base of the tree.

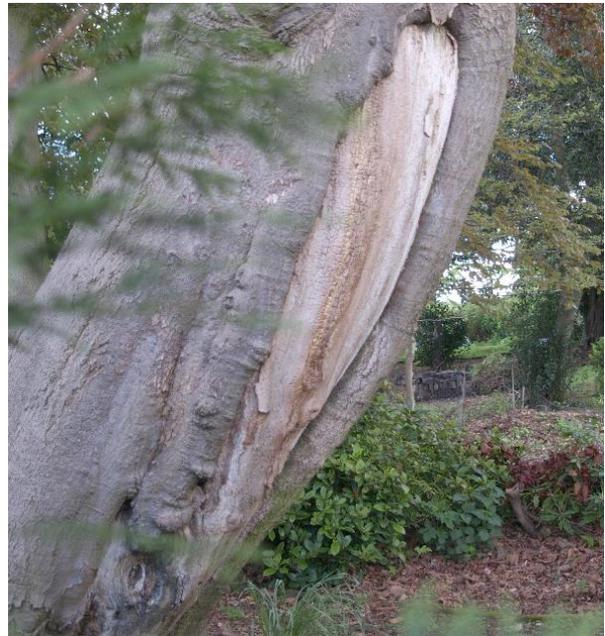
Photograph 9.

It would also be reasonable to note the condition of the tree; photograph 9 shows the base of tree 2. It appears that this tree has suffered damage in much the same as trees 8 & 9. While this damage is probably not structurally significant (being off-site I have not inspected it closely), it would be perverse to oblige a neighbour to pay a tree more heed than the owners do.

The Officer also refers to the canopy of the "large Copper Beech (TPO'd) that substantially overhangs the site at plot 5." In my opinion the tree does not overhang too badly although being to the west of the proposed building, evening sunshine will be interrupted. The overhang can be reduced by pruning which would not be detrimental to the tree's appearance, but my main concern with regard to this tree would be potential root damage should the boundary wall require rebuilding. I realise I've not closely inspected the tree beyond noting the large wound (photo 9), but I think this matter is a minor issue.

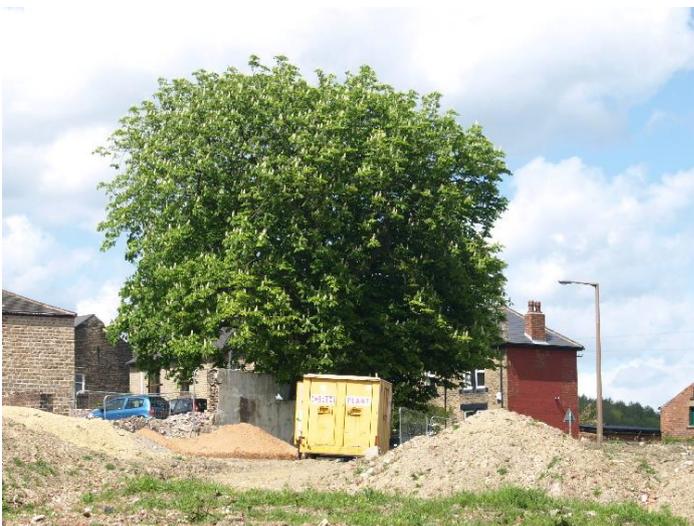
Photograph 10.

Photograph 10 shows tree group 1, three Horse Chestnuts. These are also off-site and even closer to a wall than tree 2.

This wall is in poor condition, although being rendered the condition is not immediately obvious. The main consideration here is whether such a wall could be rebuilt without damaging the trees' roots.

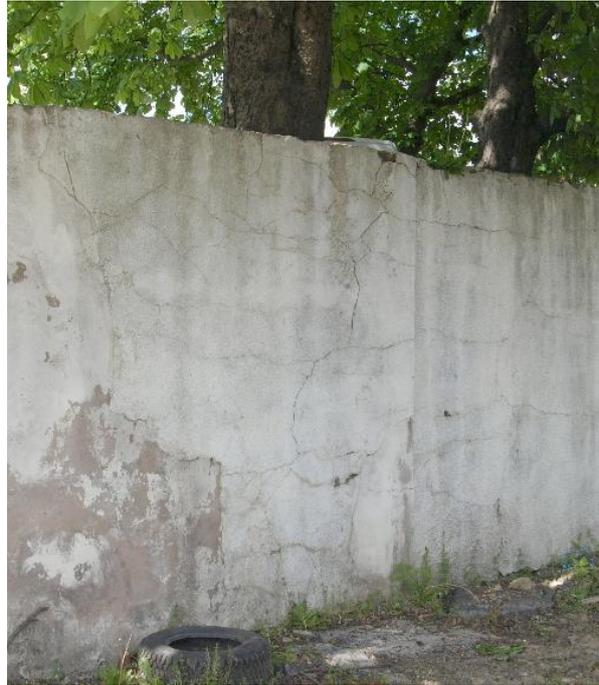
Photograph 11.

Photograph 11 shows the wall at the base of group 1. The render has hidden the wall's structure but elsewhere it is obvious that not only does it retain a difference in soil levels but it is of a construction that is not really suitable for retaining a difference in soil levels. (Please bear in mind that I'm not a builder or structural engineer and my comments about a wall's solidity (or otherwise) should be confirmed by someone with appropriate expertise.)

While these things are difficult to predict, rebuilding walls close to trees like this is almost certain to cause root damage. Although this might not immediately destabilise a tree, the main concern is whether the wounds caused to the roots, which are inevitable, become infected with some sort of decay organism that spreads to weaken the roots and reduce a tree's vigour.

I mention this because if it is decided to rebuild the wall in photograph 11 then I consider it would be pragmatic to remove the 3 Horse Chestnuts. It would be wisest to simply remove them and replant new trees.
