Longsight Design Consultancy Ltd

Our Ref : LDC/20-029
Your Ref :

Date : 28 June 2020

Darley Cliff Hall – Structural assessment of damage caused to boundary wall

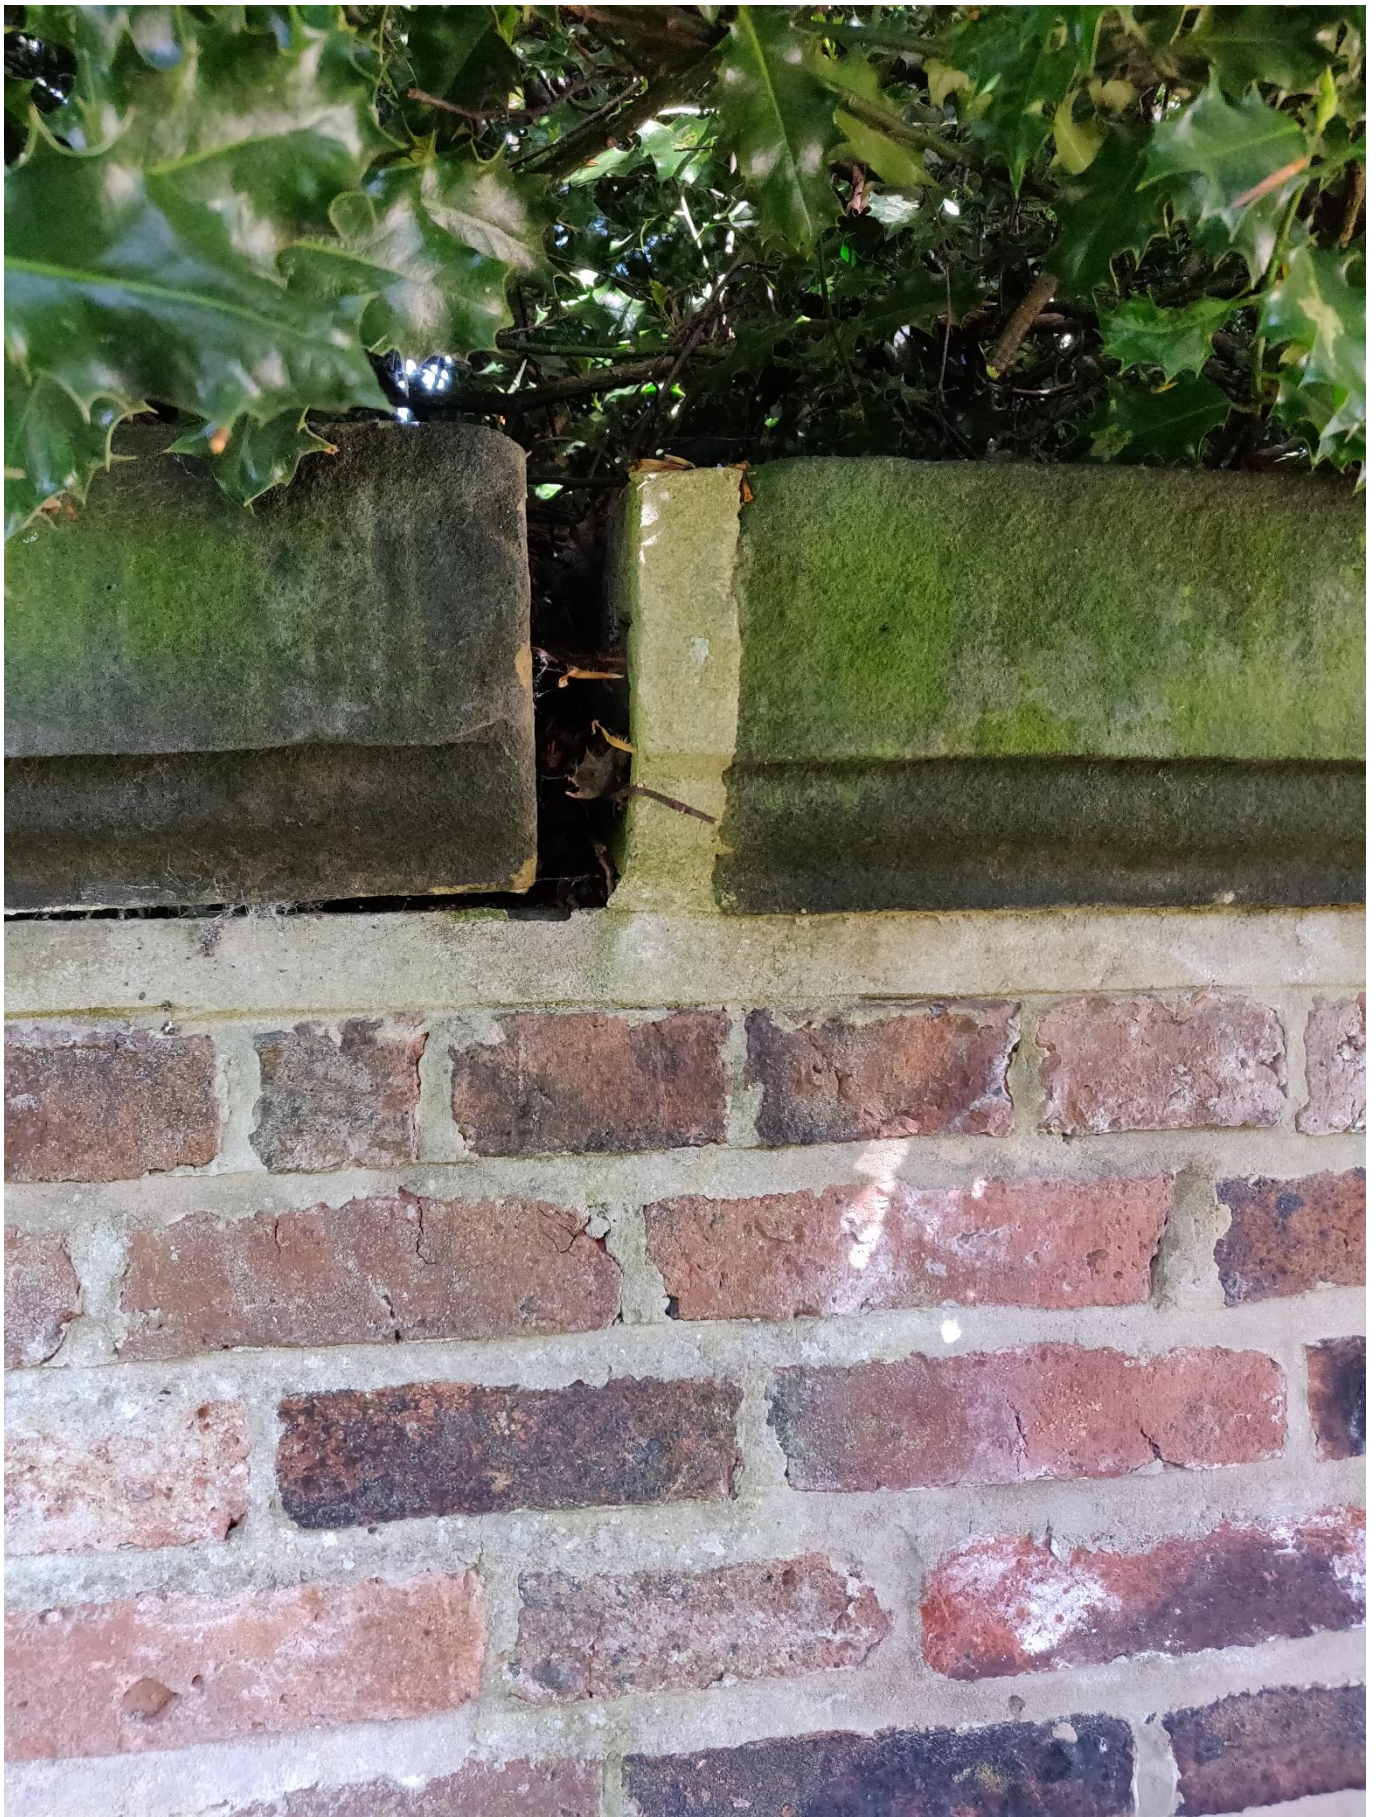
The joint between two adjacent coping stone has moved laterally by 30mm and has lifted upwards 25mm at the location of the tree. There is also an outward lean of approximately 10-15mm into the neighbouring garden

As such the movement observed in the wall has been caused by growth of the tree and its root system. This is also noted in the Arboricultural Safety Survey. The pattern of large cracks and lateral movement at the top of the wall are consistent with movement caused by uplift caused by tree root growth. The Arboricultural Safety Survey also notes that the tree is not at final maturity and that continued movement will occur. This continued growth is evident in the opening of a previously repaired crack.

Photograph 1 – View of lateral and uplift movement of coping stone adjacent to Copper Beech Tree

From the above observations and conclusions, it is considered necessary to safely fell the Copper Beech Tree to ground level and treat the stump to prevent further growth. Consent to remove the tree will need to be gained from the Local Authority due to its TPO status.

Repairs are to take the form of stitching and repointing of the cracks with Helifix stainless steel bars and relaying any loose coping stones

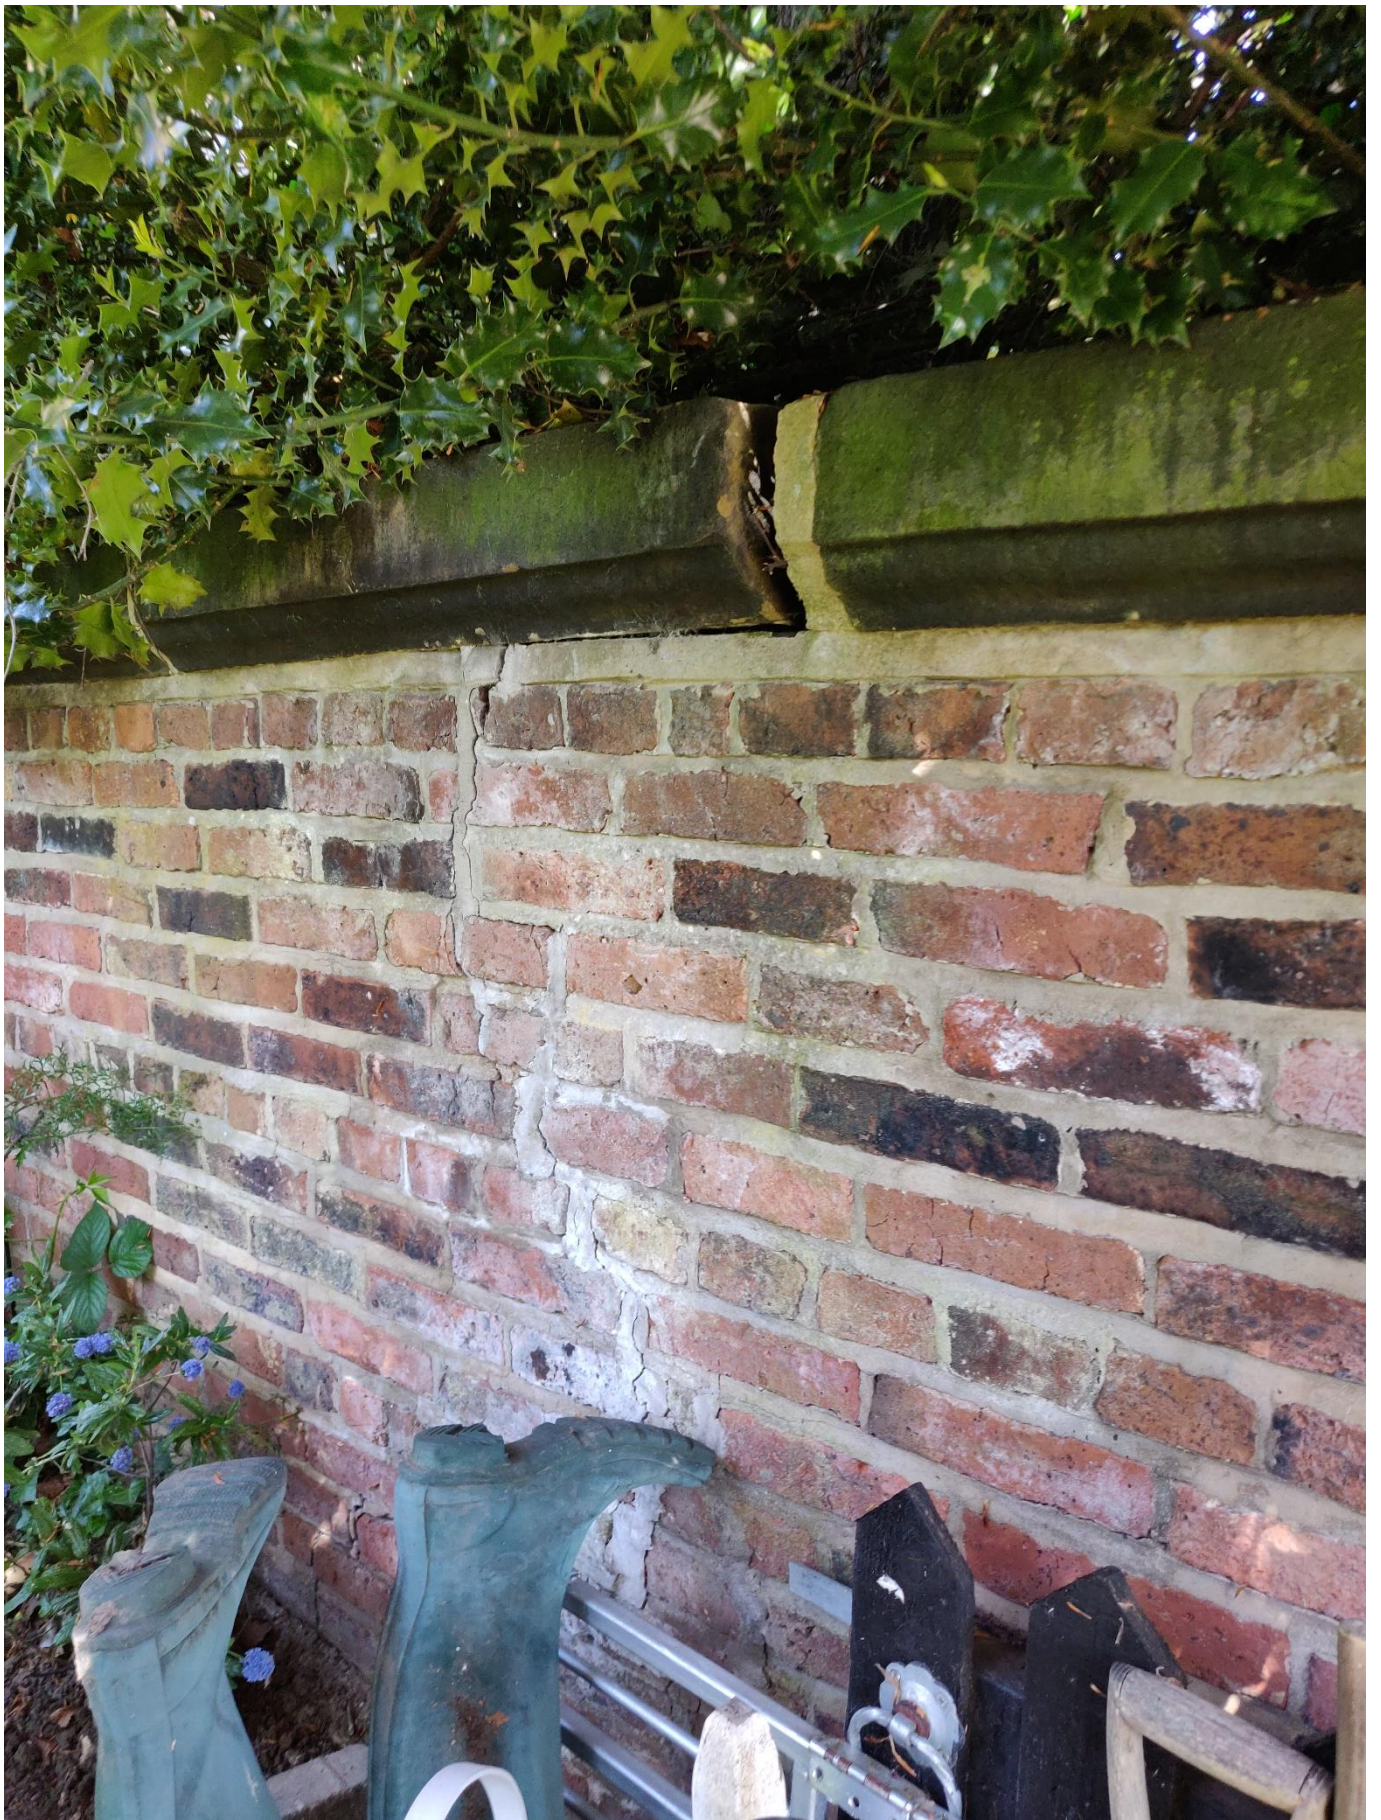
There are two vertical cracks running the full height of the wall. The first is approximately 500mm from the lateral movement in the coping stones. It generally follows the line of the mortar joints but does pass through bricks in several locations. A repointing repair has been carried out to historic cracking which has now opened up again and varies from 5mm in width at the top of the wall to 2mm at ground level. The second crack is approximately 1.50m away from the large tree and closer to the two properties. Again, the crack is generally vertical following the mortar joint lines and passing through occasional bricks. This crack is again varying from 5mm in width at the top of the wall and 2mm at ground level. No previous attempts at repairs have been undertaken.

Photograph 2 – View of cracking close to movement in copings
(note prevent point repair of crack and wider joints)

Once the tree is removed it is recommended that the cracks and movement noted are made good to prevent further deterioration of the wall.

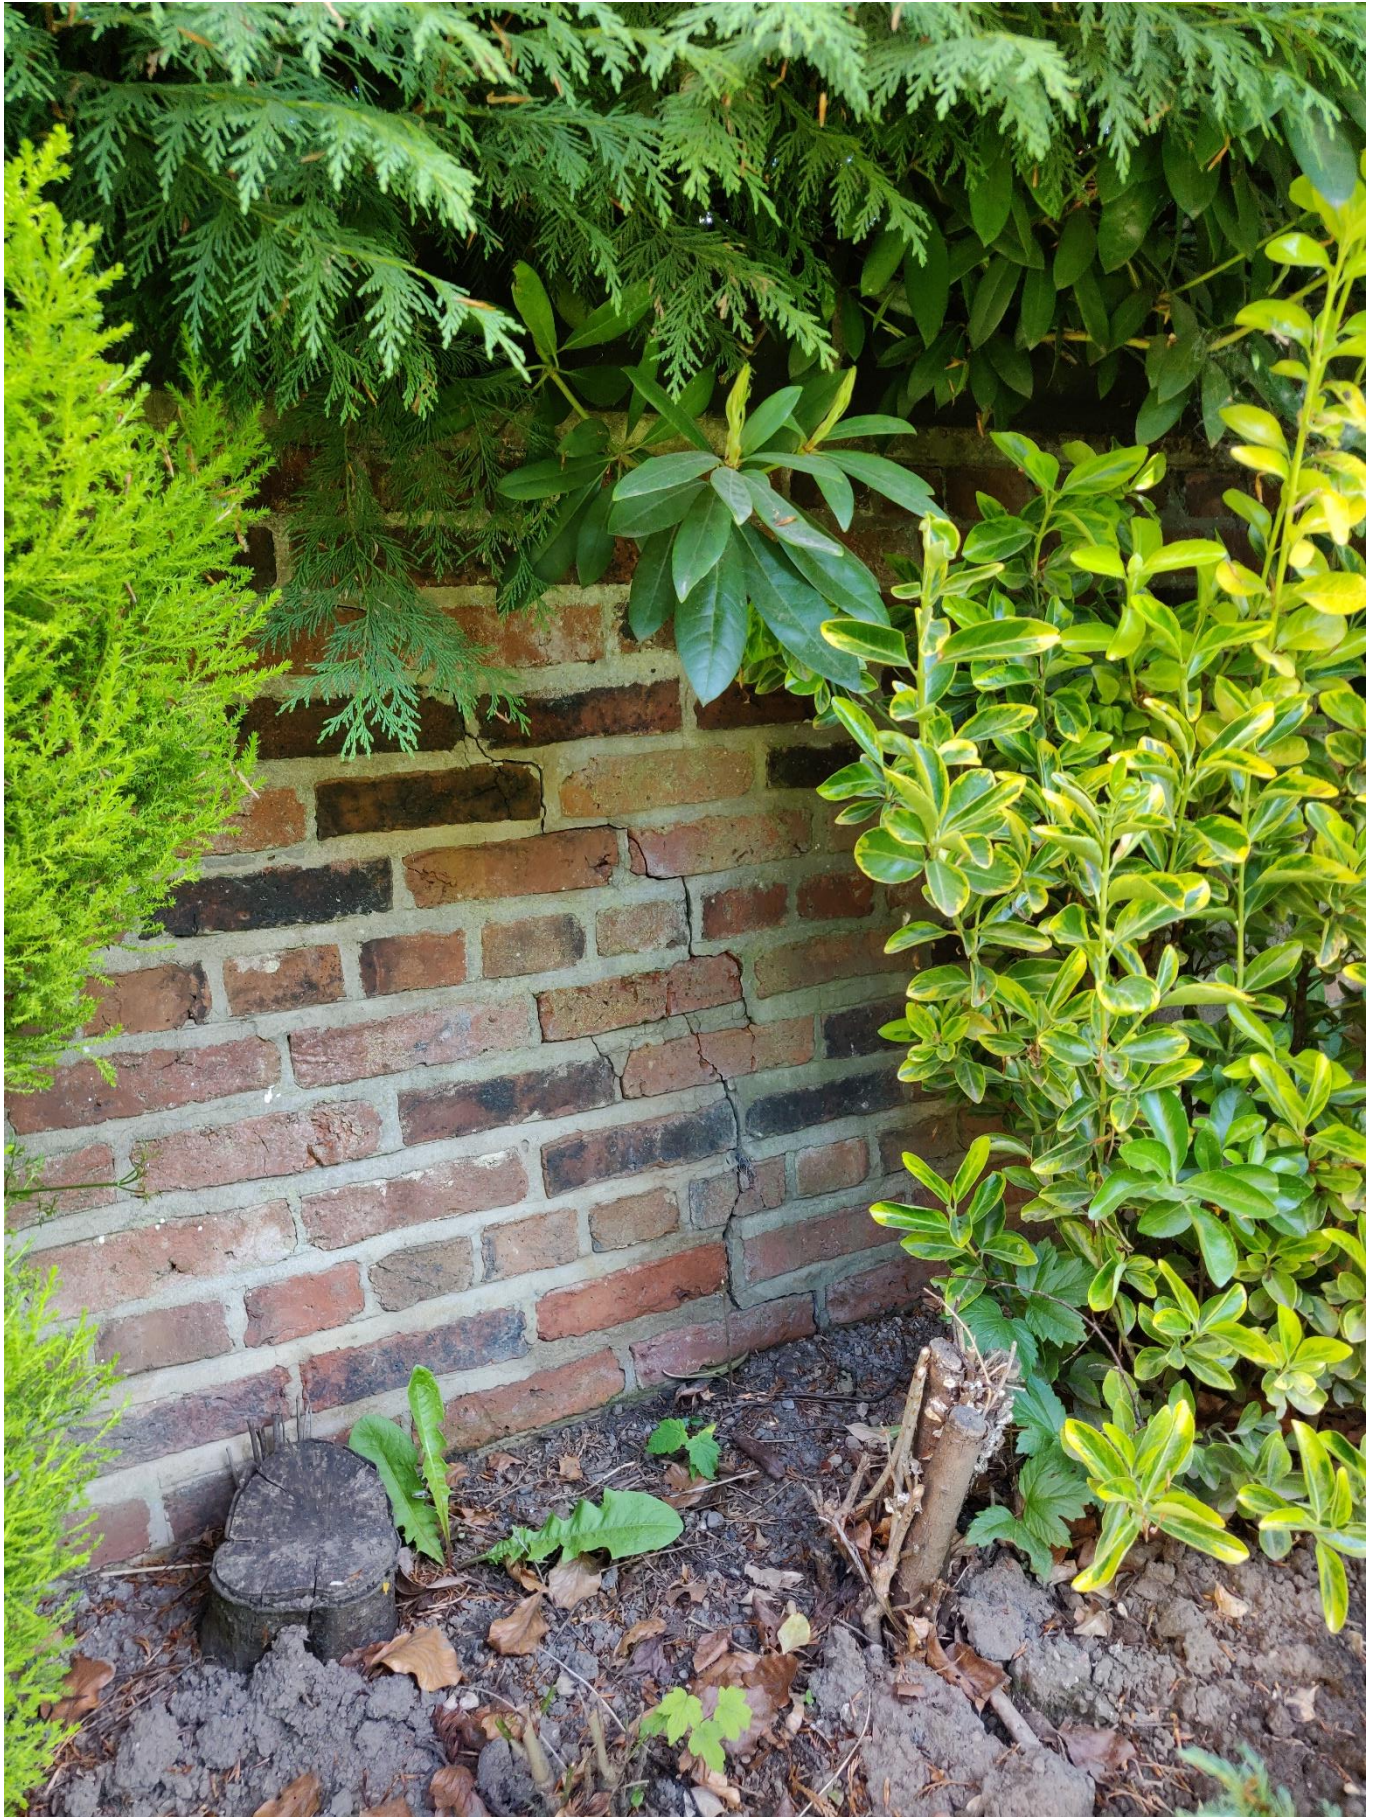
Photograph 3 – View of cracking 1.50m from Copper Beech Tree

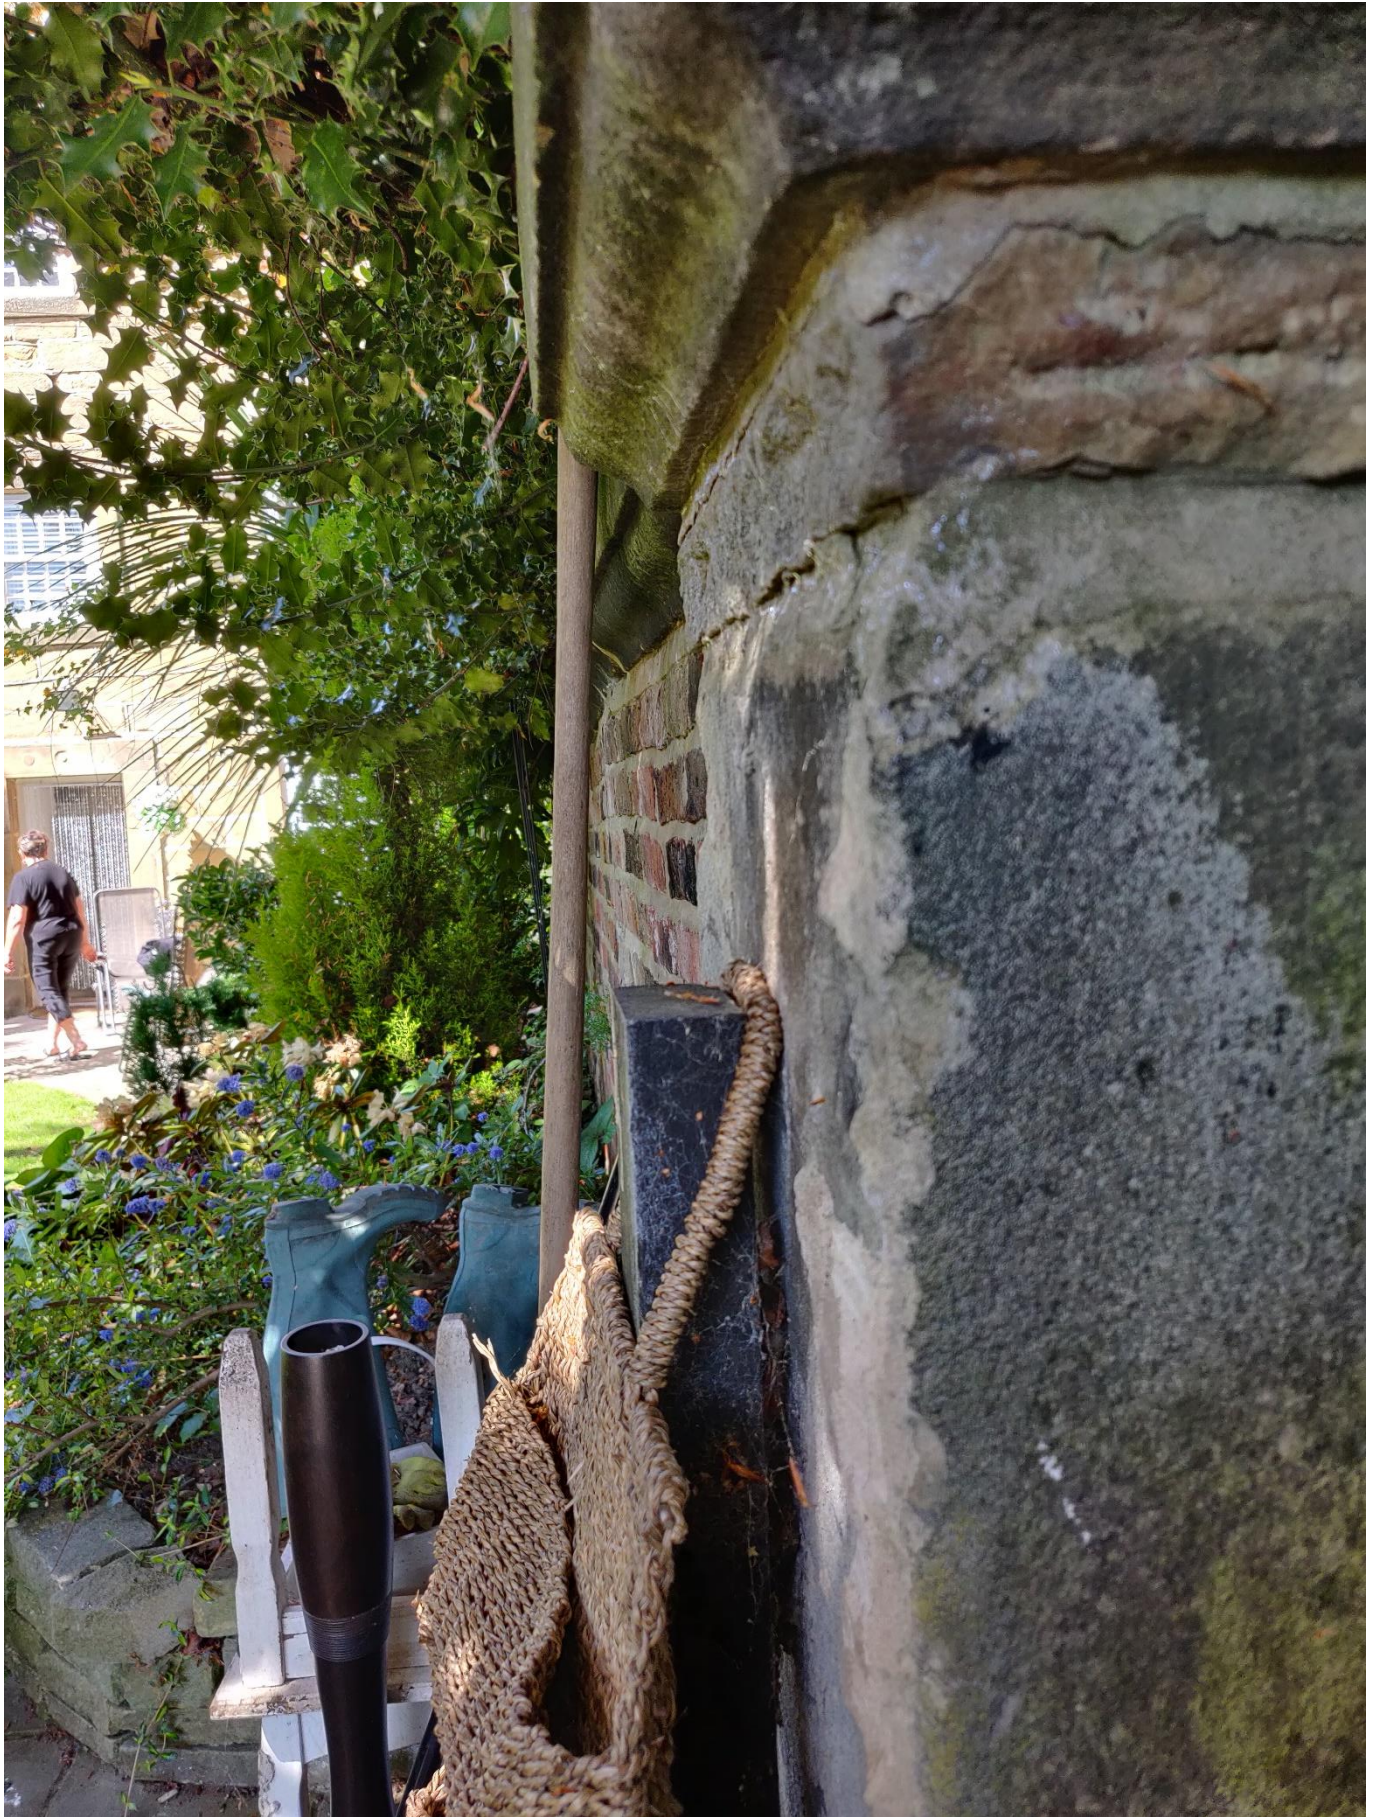
There is a significant risk that as further growth continues the uplifting and outward lean of the wall will continue to a point where copings could be dislodged, or complete collapse of the wall could occur. As the outward lean is into the neighbouring garden this poses a third-party injury risk. In addition, there is also potential damage to a Grade II listed building.

Photograph 4 – View along wall showing outward lean into neighbouring garden
