**PHASE 1 & 2 GEOTECHNICAL AND  
GEO-ENVIRONMENTAL SITE INVESTIGATION**

**THE OLD QUARRY, COMMON ROAD  
BRIERLEY**

**MR C. GROOM**

10 March 2016

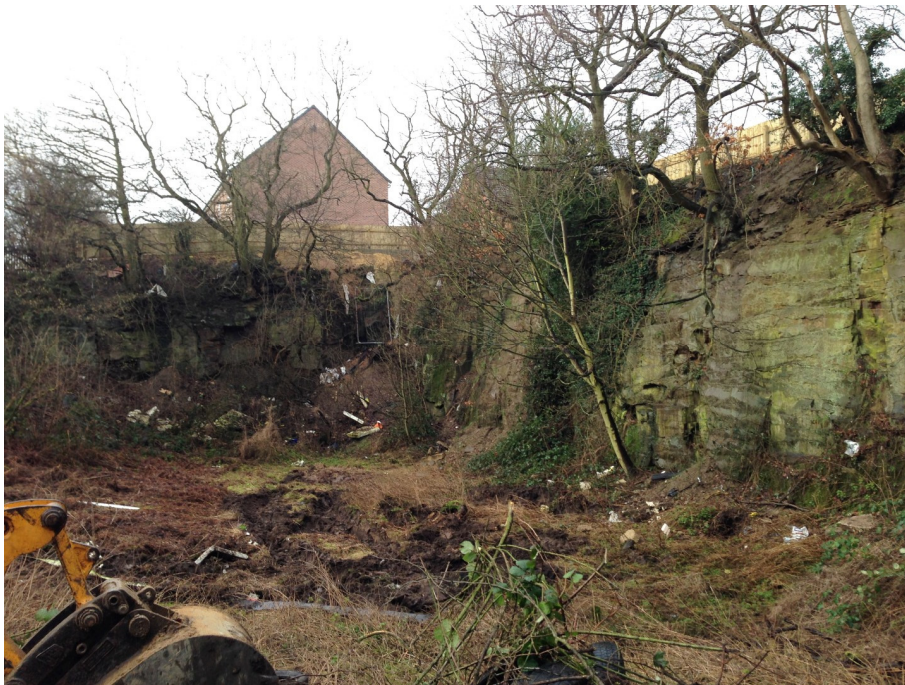
Overview of the north-west corner of the site and the retaining wall at the northern boundary of the site.

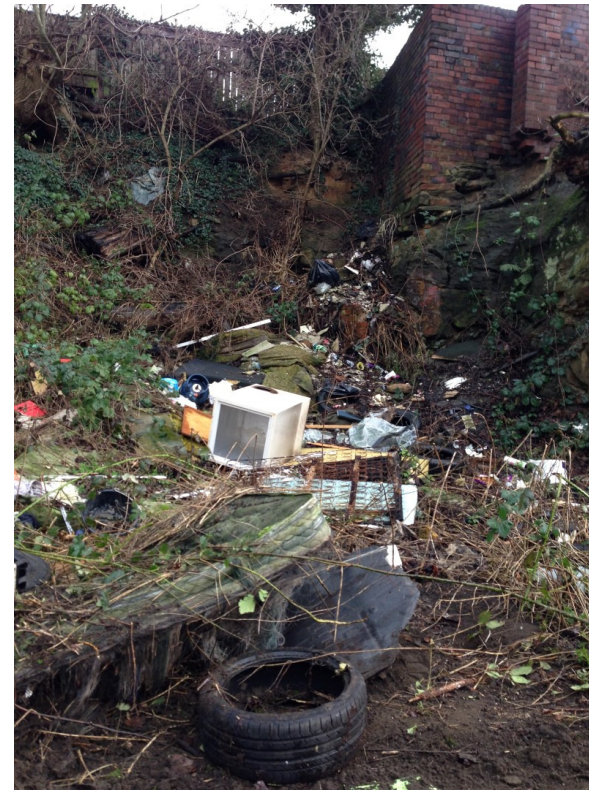
Tipped material at the north-east corner of the site.
