# ARBORICULTURAL REPORT & Impact Assessment to BS 5837:2012 at:

***Carlton Road,  
Carlton,  
Barnsley  
S71 3JE***

Prepared for: *White Agus*

Reference: *AWA6579*

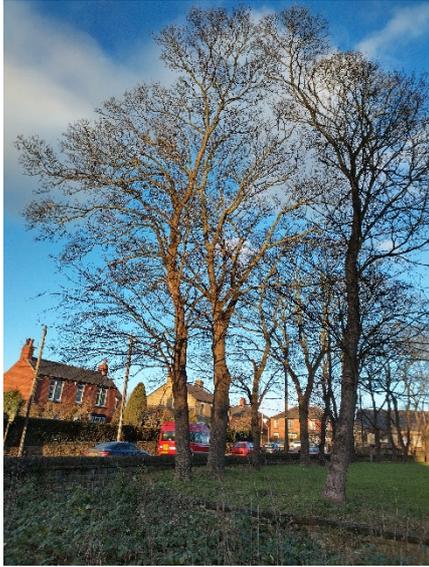
Photo 1: T1 and T2 from southwest

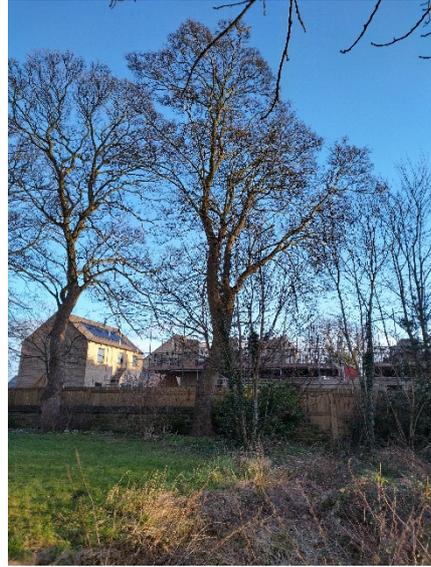
- 3.2.6 Ash T5 has symptoms of the fungal disease Ash Dieback and is recommended for removal regardless of development at the site. The Ash within G6 and G8 also likely have limited future prospects due to Ash Dieback.

Photo 2: G3, T4 and T5 from northwest

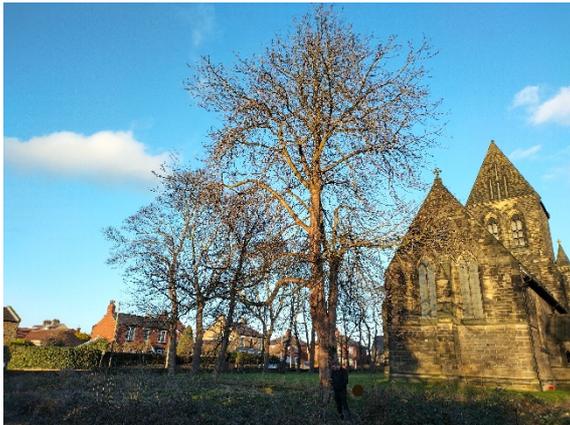
- 3.2.4 The most significant tree within site boundaries is Horse Chestnut T9, a mature tree in good condition and of high value.
- 3.2.5 T5 to G8, G11 and T12 are also situated within site boundaries. T5 to G8 border the site's southeastern boundary and G11 and T12 border the site's southwestern boundary. These trees and tree groups are of low value but provide some screening between the site and the adjacent land.

Photo 3: T9 from southwest

trees. The new development encroaches close to and into the edge of the RPA of T9 and T12. Construction within the RPA, can have negative impacts on tree roots. However, the encroachment is very minor, and the detailed RPA for these trees is likely to be a slightly exaggerated representation of the trees actual rooting area. As such, it is unlikely that significant roots will be within these areas and the retained tree should remain largely unaffected by the works, provided care is taken during construction.

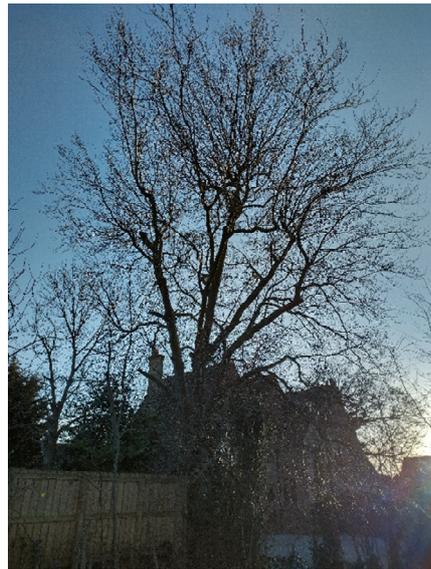
Photo 4: T10 from northeast

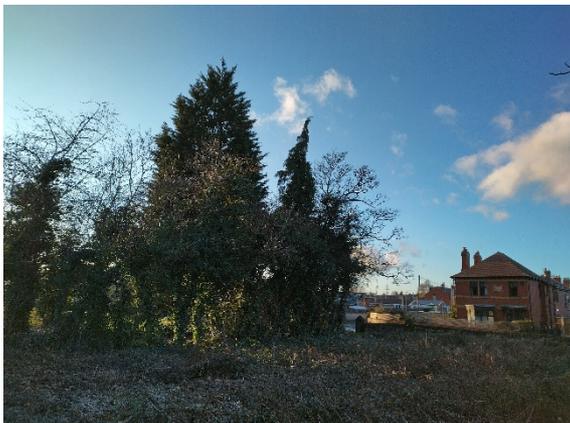
Photo 6: G11, T12 and T13 from southeast

4.2.3 G11 is a linear group of Hawthorn forming a boundary hedge along the western site boundary. It appears to be a lapsed hedge, having developed into a taller, more tree-like form due to lack of regular management. Assessment of the proposed development indicates that G11 will require management to facilitate construction, as part of its extent lies close to the development footprint. Retention and protection are feasible, but work will be necessary to allow adequate working space.

4.2.4 Restoring G11 through traditional hedge management would be appropriate and beneficial. This could include selective coppicing of stems within the central section to allow working space during construction, with retained sections trimmed and laid to reinstate a managed hedge structure. Coppicing will enable the hedge to regrow naturally following completion of works, while gap replanting with native Hawthorn (and occasional Blackthorn or Field Maple for diversity) can be used to restore continuity where needed. Once re-established, the hedge should be maintained on a 2–3 year trimming cycle to promote dense, healthy growth and retain its value as a boundary feature.

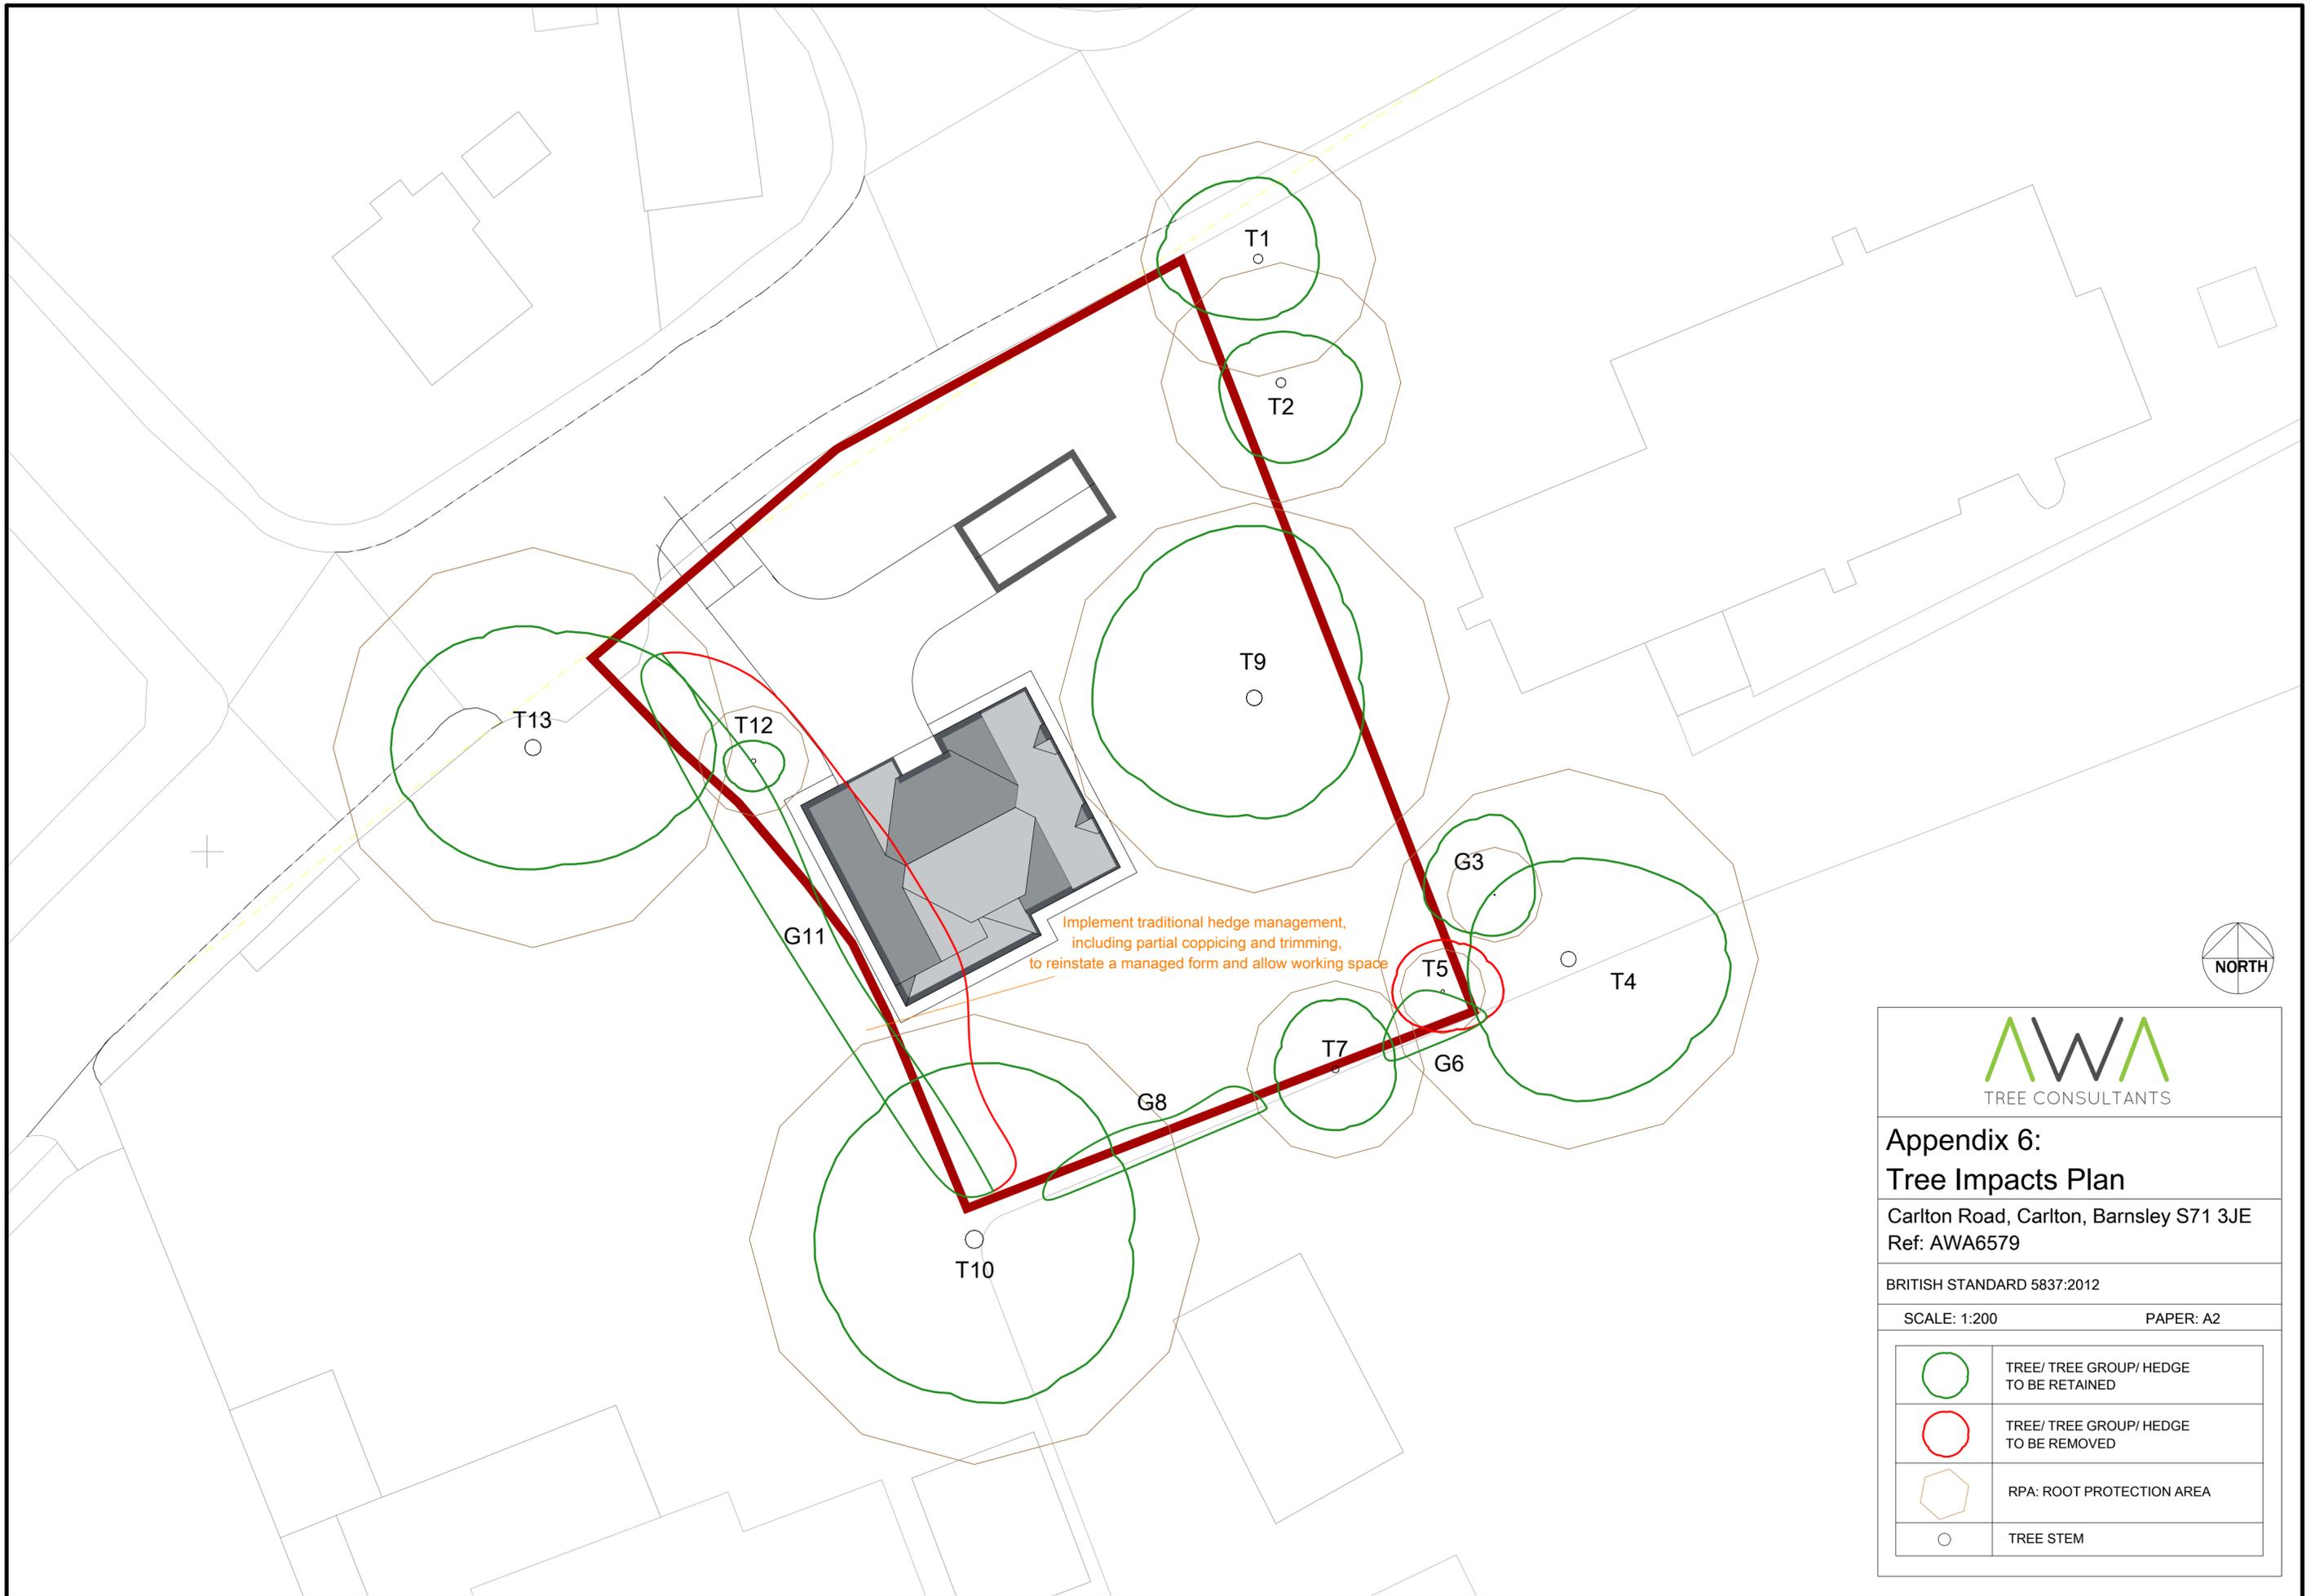
**Appendix 6:  
Tree Impacts Plan**

4.2.1 From assessing the new development proposals, 1 tree group will require partial removal/ management to facilitate the development as it is partially situated in the footprint of the development or their retention and protection throughout the development is not suitable.

4.2.2 The hedge that requires partial removal/ management to facilitate the development is G11.
