# **Barnsley Dilapidation Survey**

VCS Report

**Project:** Barnsley Dilapidation Survey

**Job No:** PTS20335-02

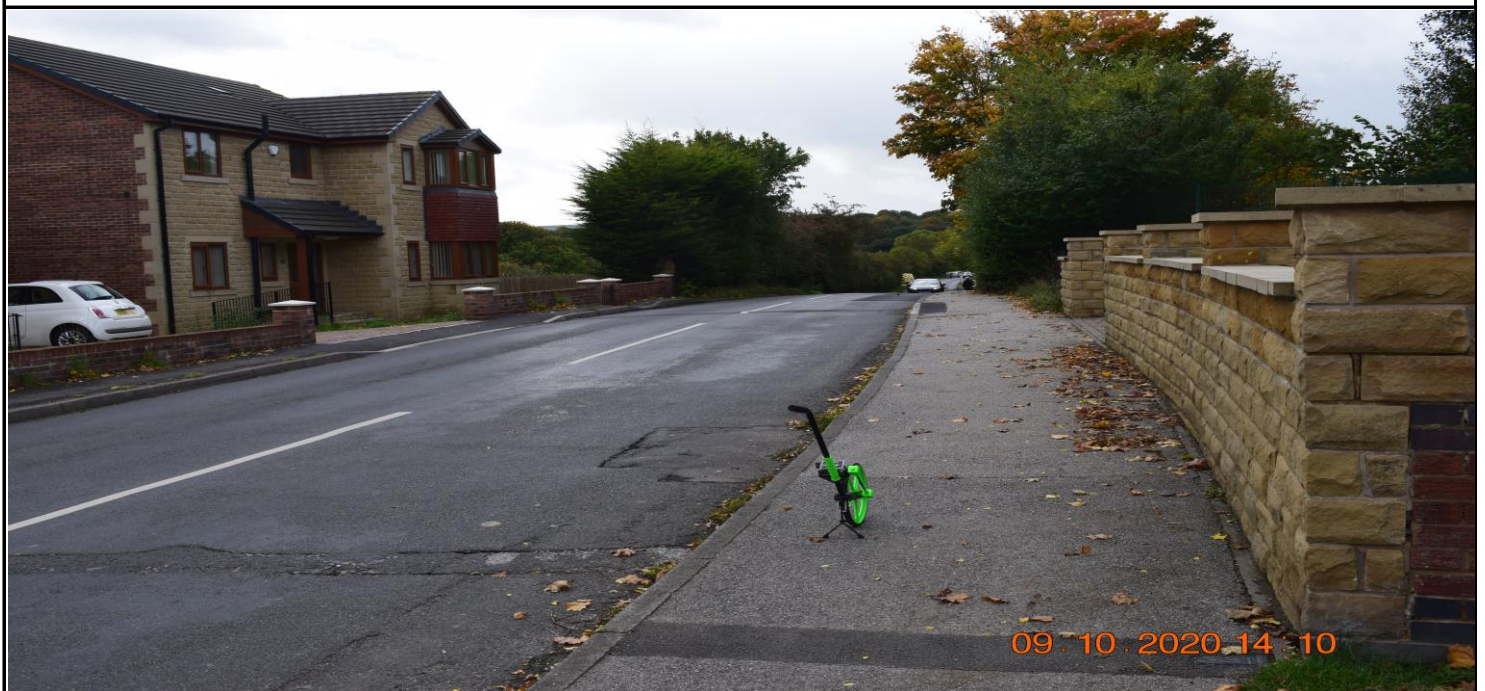
Photo Ref : 3

| Project | | | | | Direction | Job No. | | Date | |
|---|---|---|---|---|---|---|---|---|---|
| CR1 | 1 | 3 | 2 | 1.00 | 2.00 | PF | | R | 3 |

Feature / Defect : Patch Failure

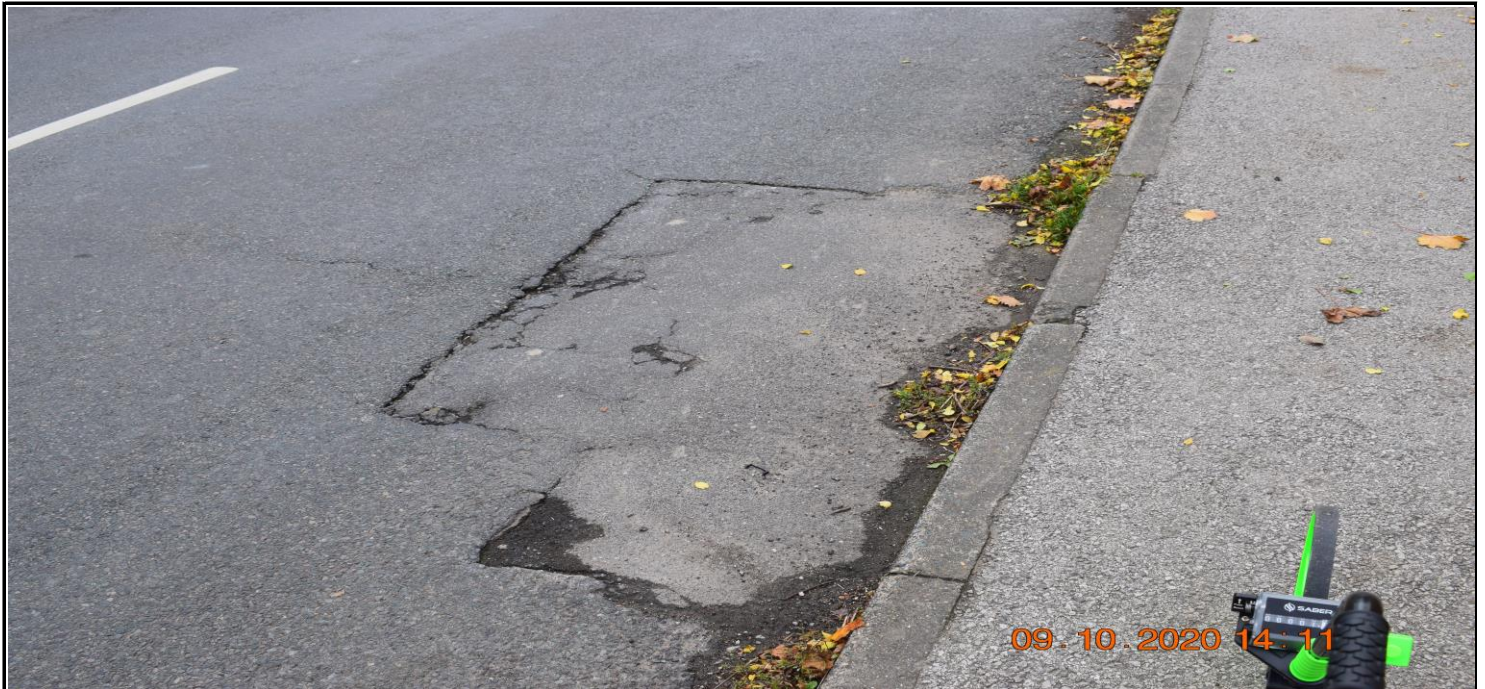
Photo Ref : 4

| Project | | | | | Direction | Job No. | | Date | |
|---|---|---|---|---|---|---|---|---|---|
| CL1 | 12 | 22 | 10 | 0.50 | 5.00 | CR(1) | 1 | L | 4 |

Feature / Defect : Major Cracking

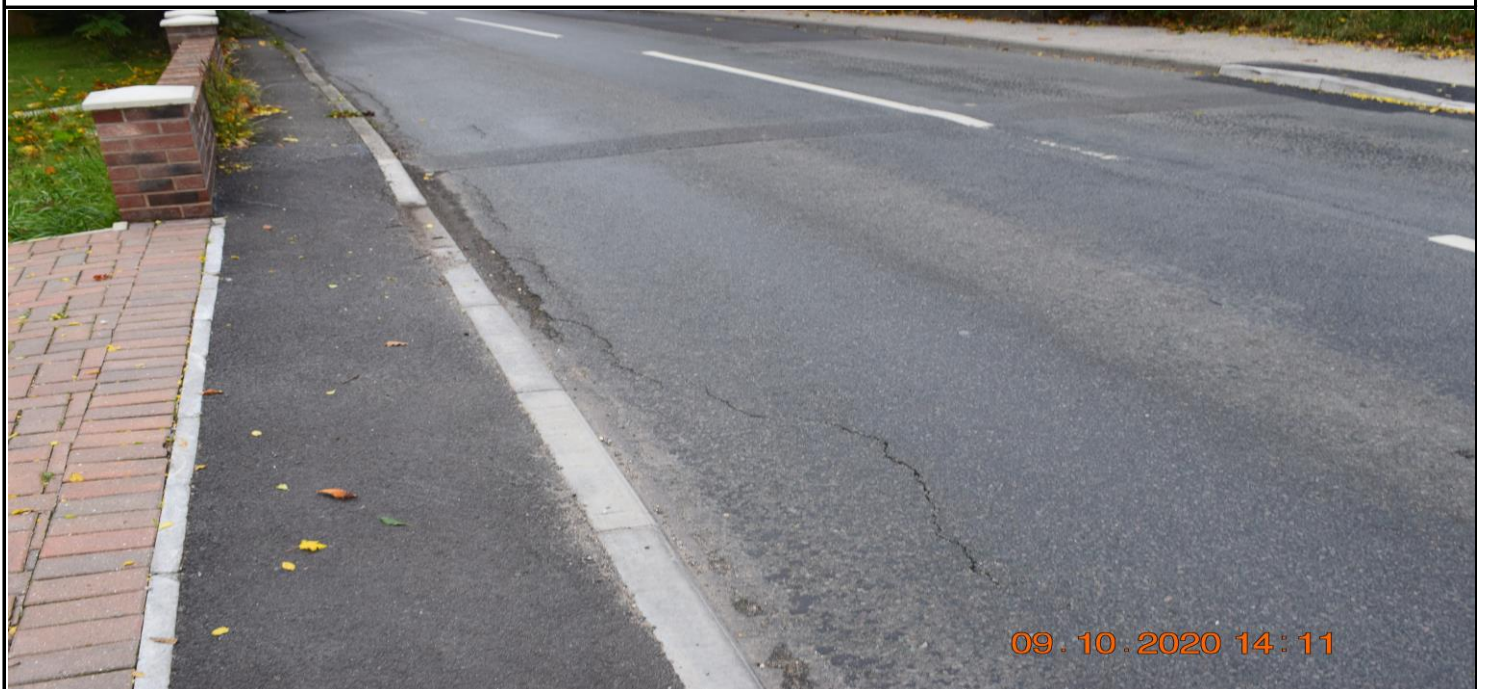
Photo Ref : 5

| Project | | | | | Direction | Job No. | | Date | |
|---|---|---|---|---|---|---|---|---|---|
| CR1 | 20 | 22 | 2 | 0.50 | 1.00 | CR(1) | 1 | R | 5 |

Feature / Defect : Major Cracking

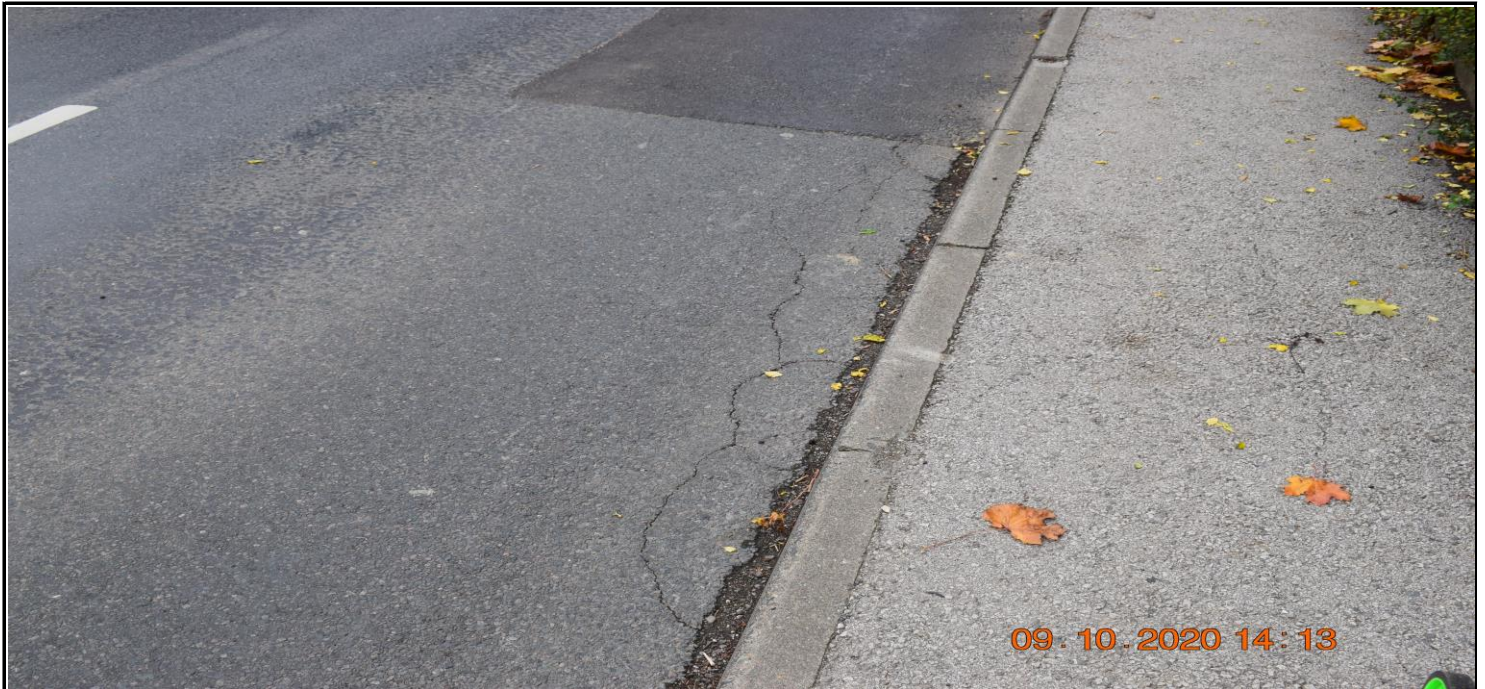
Photo Ref : 6

| Project | | | | | Direction | Job No. | | Date | |
|---|---|---|---|---|---|---|---|---|---|
| CL1 | 26 | 46 | 20 | 1.00 | 20.00 | PF | 1 | L | 6 |
| CL1 | 26 | 46 | 20 | 1.00 | 20.00 | SD(1) | 1 | L | 6 |

Feature / Defect : Patch Failure / Major Surface Defectiveness

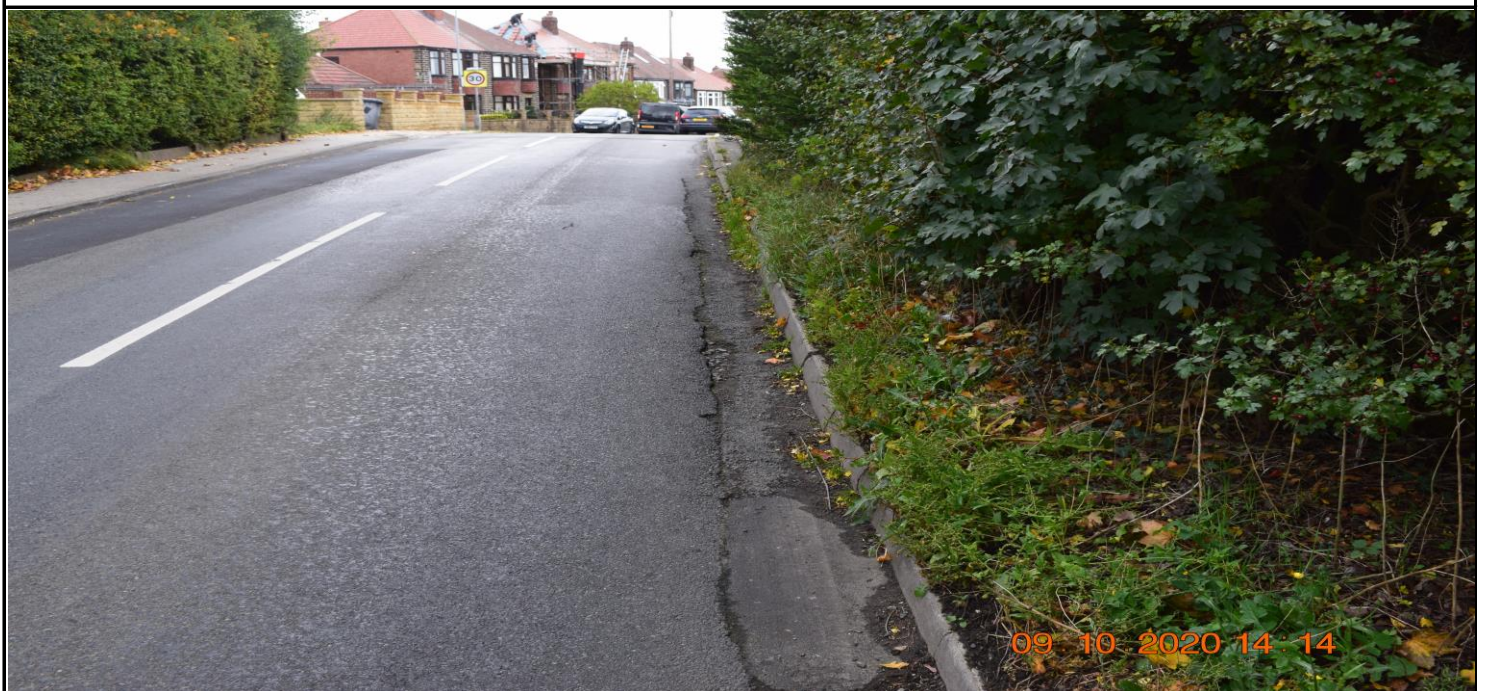
| Photo Ref : 7 | Section : Tankersley Lane |

| Project | | | | | Direction | Job No. | | Date | |
|---|---|---|---|---|---|---|---|---|---|
| CL1 | 53 | 95 | 42 | 1.00 | 42.00 | PF | 1 | L | 7 |
| CL1 | 53 | 95 | 42 | 1.00 | 42.00 | SD(1) | 1 | L | 7 |

| Chainage : 53m | Feature / Defect : Patch Failure / Major Surface Defectiveness |

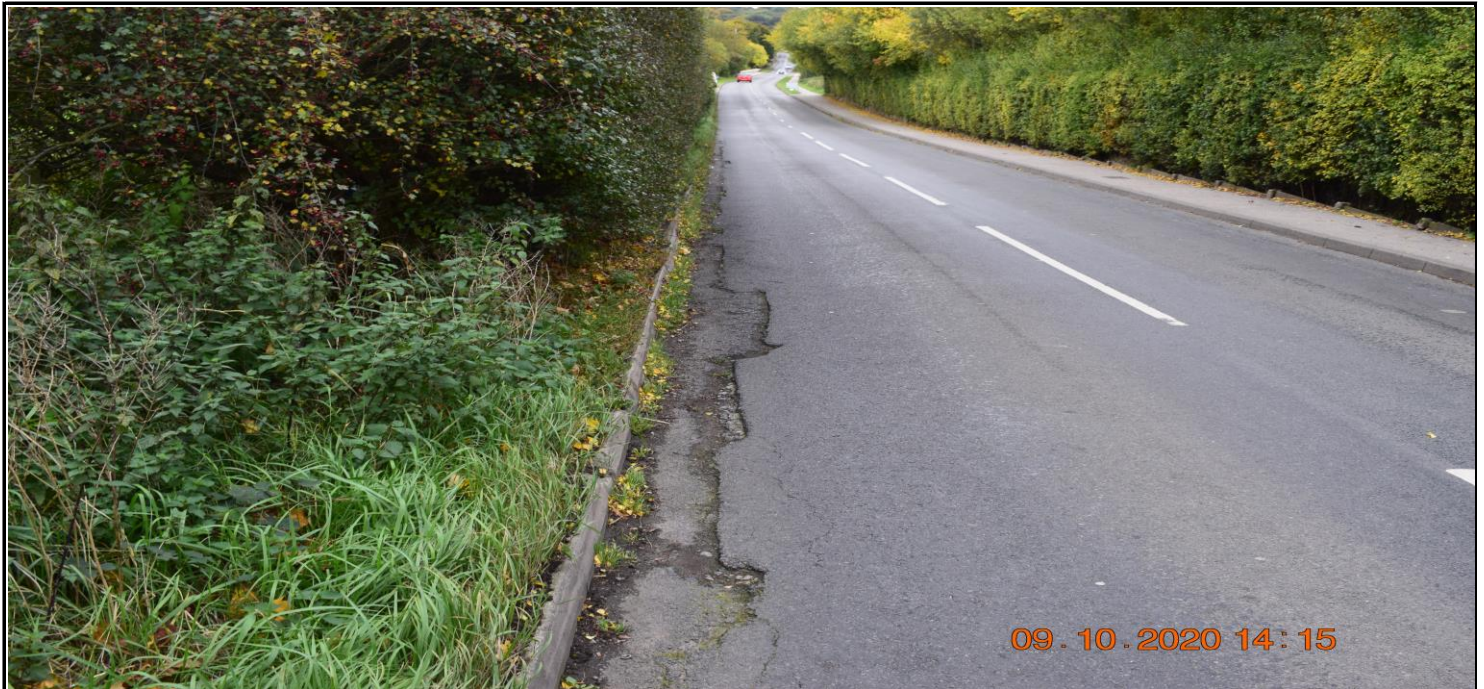
| Photo Ref : 8 | Section : Tankersley Lane |

| Project | | | | | Direction | Job No. | | Date | |
|---|---|---|---|---|---|---|---|---|---|
| CR1 | 60 | 153 | 93 | 0.50 | 46.50 | CR(1) | 1 | R | 8 & 9 |

| Chainage : 60m | Feature / Defect : Major Cracking |

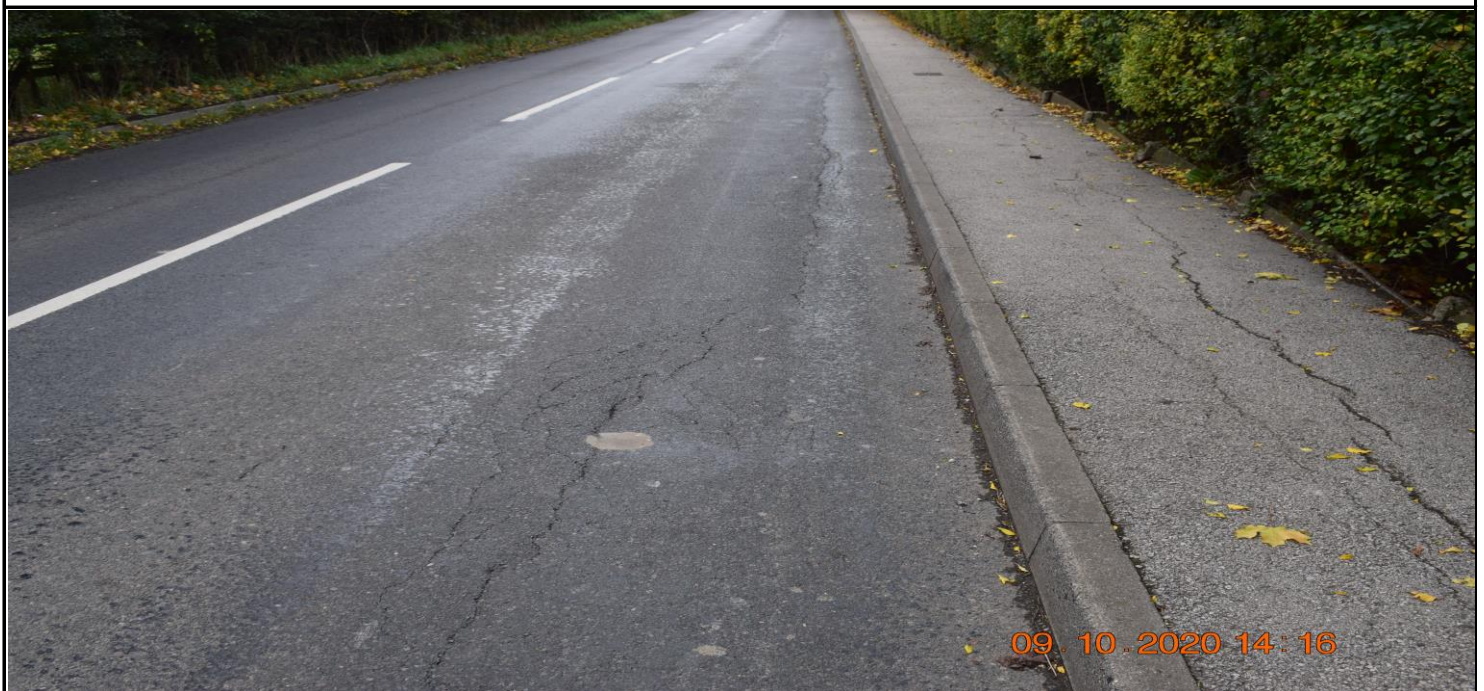
| Photo Ref : 9 | Section : Tankersley Lane |

| Chainage : 120m | Feature / Defect : Major Cracking |

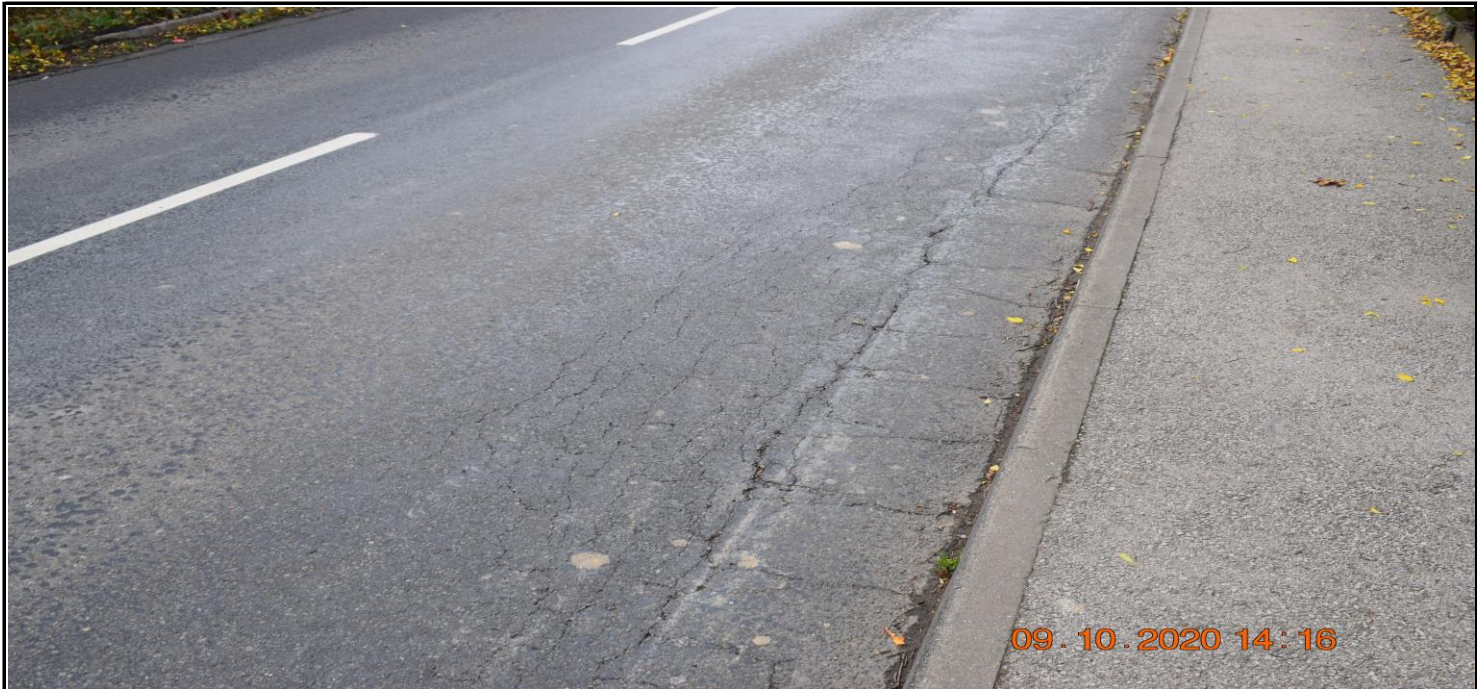
| Photo Ref : 10 | Section : Tankersley Lane |

| Project | | | | | Direction | Job No. | | Date | |
|---|---|---|---|---|---|---|---|---|---|
| CL1 | 100 | 103 | 3 | 0.50 | 1.50 | CR(1) | 1 | L | 10 |
| CL1 | 101 | 102 | 1 | 0.50 | 0.50 | CR(1) | 1 | L | 10 |

| Chainage : 101m | Feature / Defect : Major Cracking |

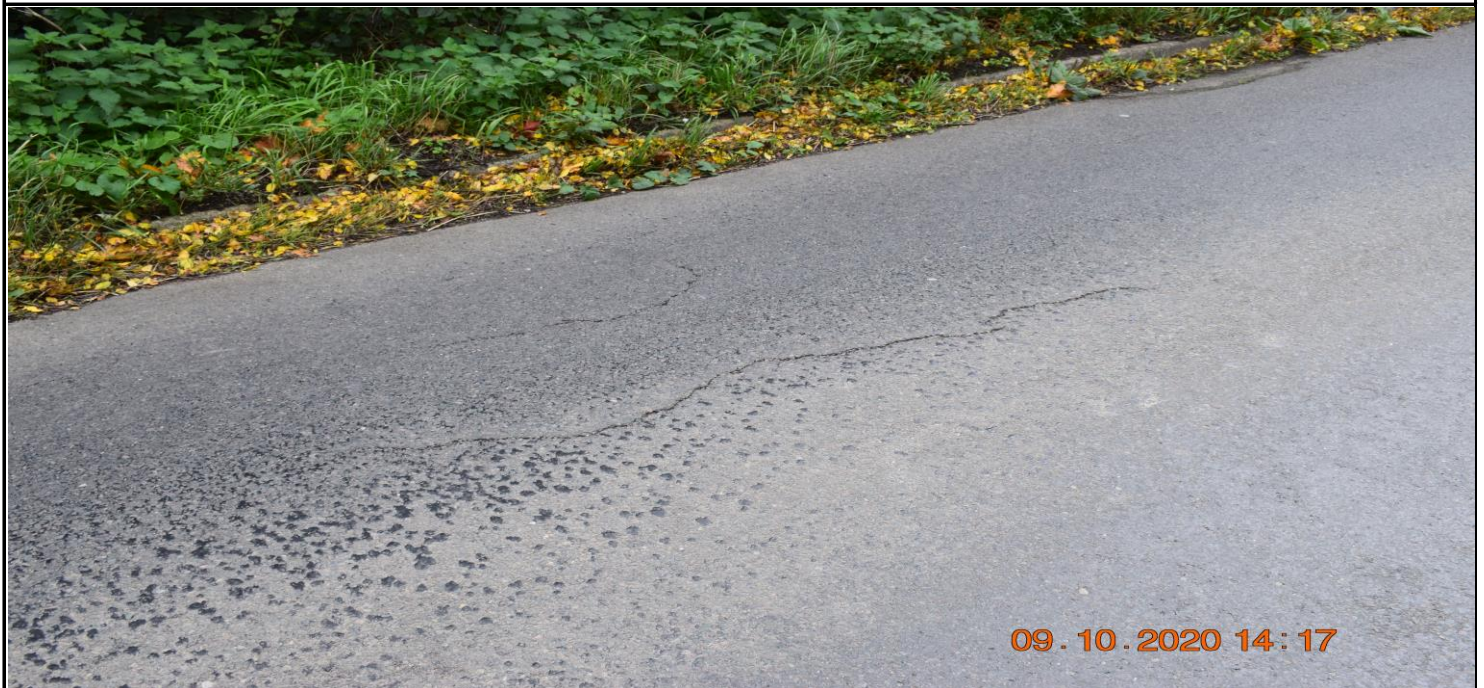
| Photo Ref : 11 | Section : Tankersley Lane |

| Project | | | | | Direction | Job No. | | Date | |
|---|---|---|---|---|---|---|---|---|---|
| CL1 | 136 | 139 | 3 | 0.50 | 1.50 | CR(1) | 1 | L | 11 |

| Chainage : 136m | Feature / Defect : Major Cracking |

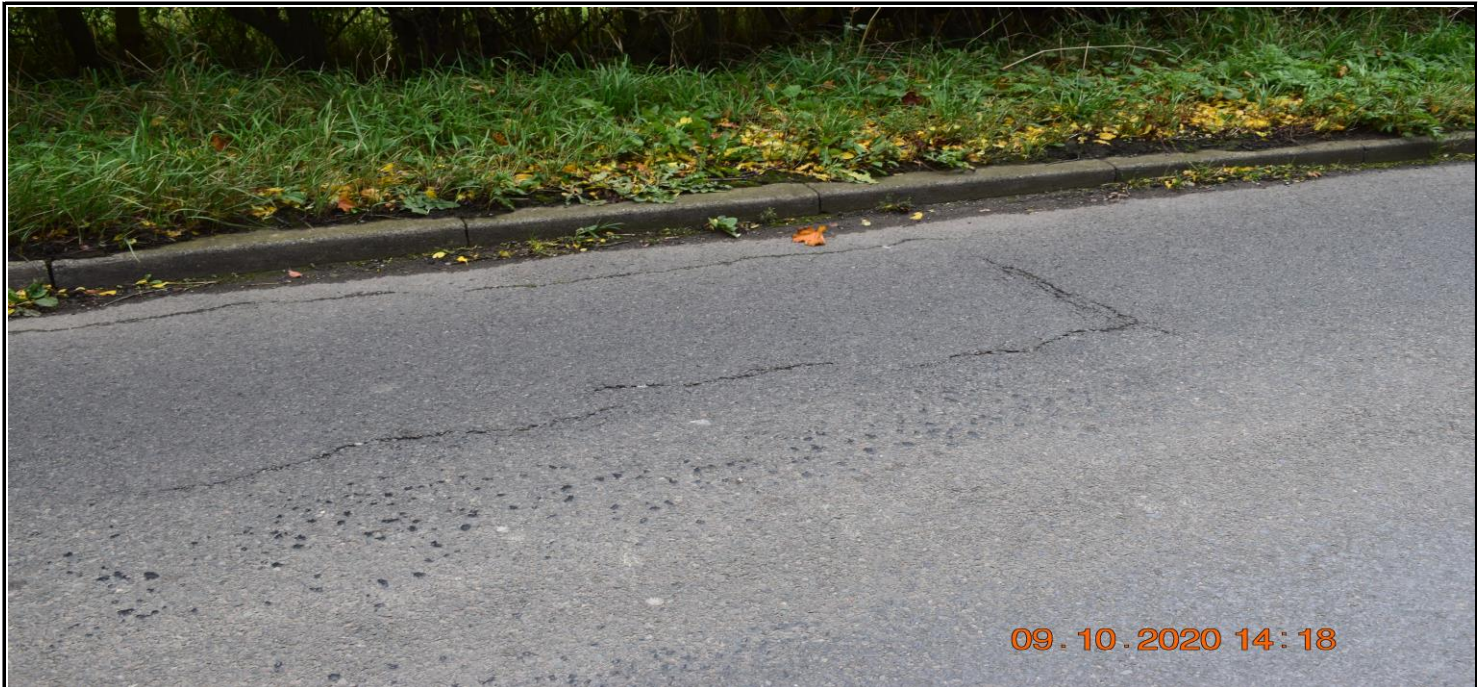
| Photo Ref : 12 | Section : Tankersley Lane |

| Project | | | | | Direction | Job No. | | Date | |
|---|---|---|---|---|---|---|---|---|---|
| CL1&CR1 | 153 | | 0.5 | 7.30 | 3.65 | TC(1) | 1 | F | 12 |

| Chainage : 153m | Feature / Defect : Major Transverse Crack |

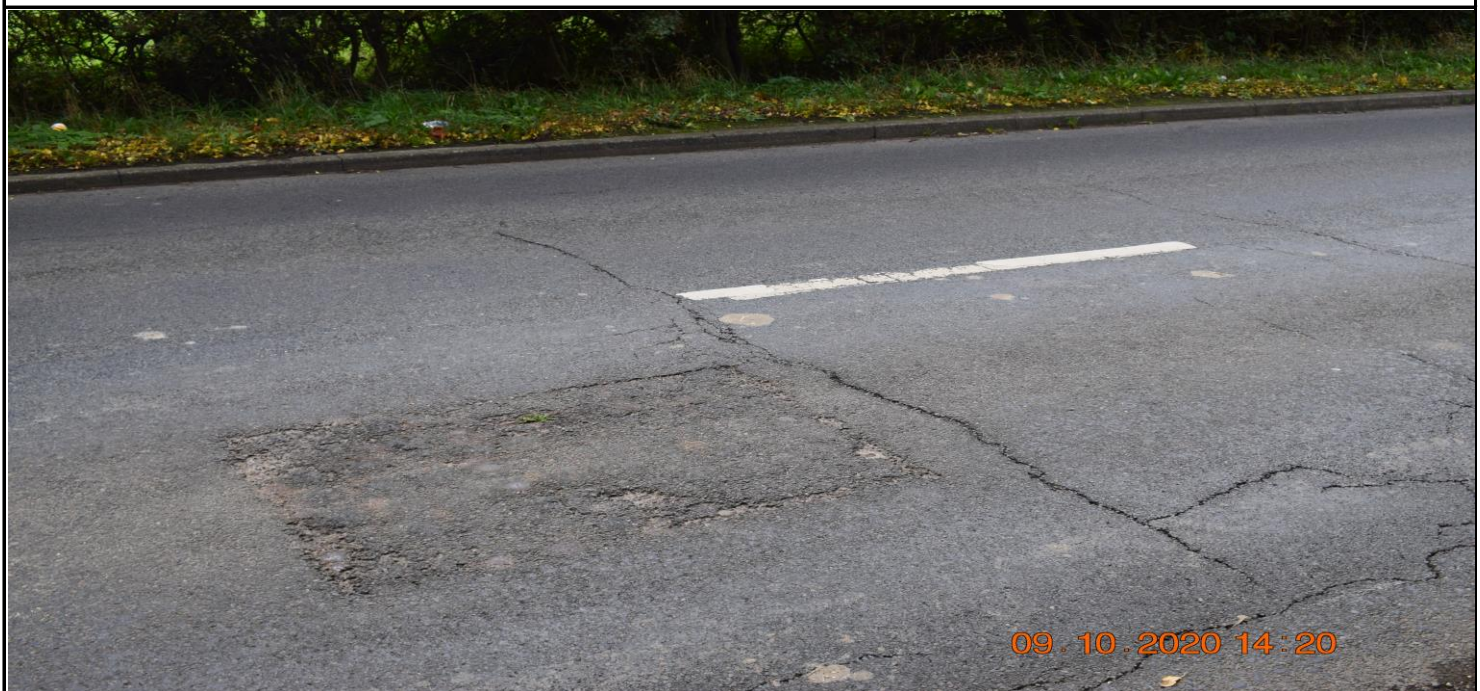
| Photo Ref : 13 | Section : Tankersley Lane |

| Project | | | | | Direction | Job No. | | Date | |
|---|---|---|---|---|---|---|---|---|---|
| CR1 | 153 | 202 | 49 | 1.00 | 49.00 | CZ(1) | 1 | R | 13 & 16 |

| Chainage : 153m | Feature / Defect : Major Cracking |

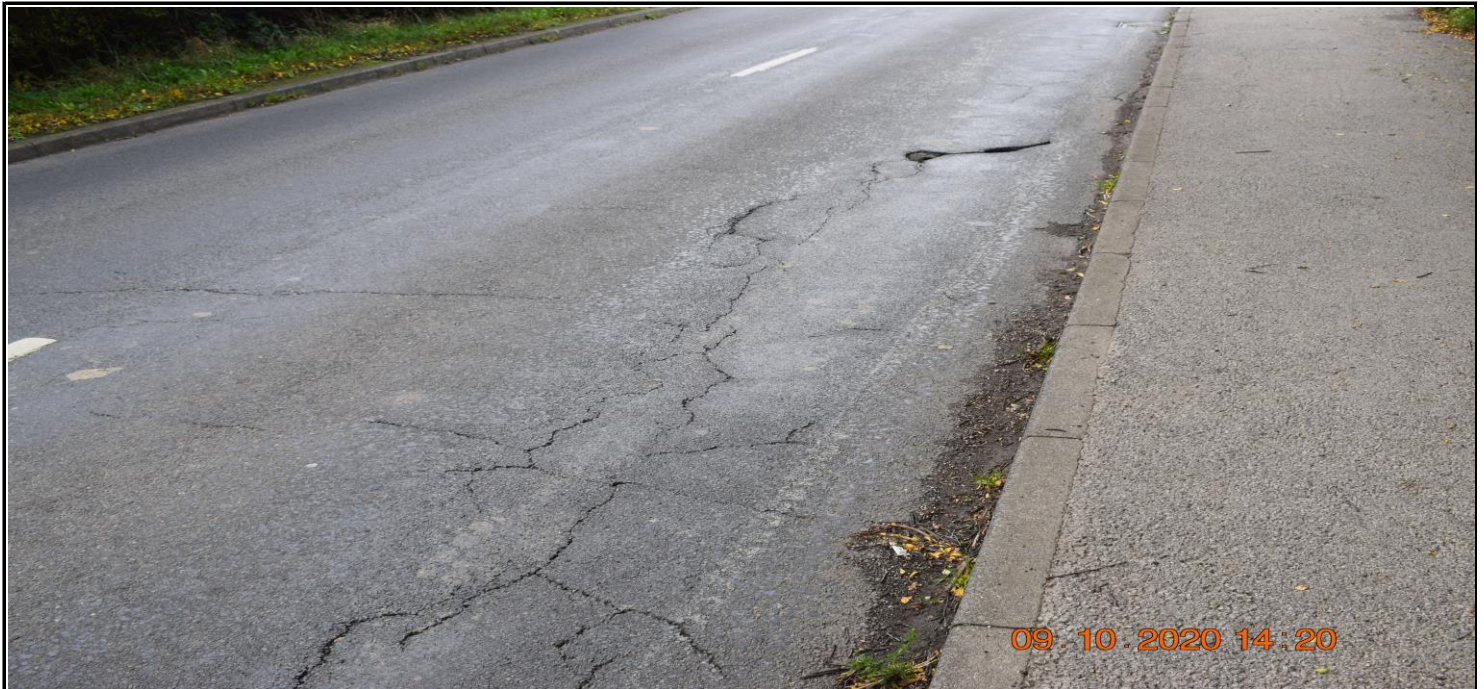
| Photo Ref : 14 | Section : Tankersley Lane |

| Project | | | | | Direction | Job No. | | Date | |
|---|---|---|---|---|---|---|---|---|---|
| CL1 | 156 | | 0.5 | 1.00 | 0.50 | TC(1) | 1 | R | 14 |
| CR1 | 156 | | 0.5 | 1.00 | 0.50 | TC(1) | 1 | L | 14 |

| Chainage : 156m | Feature / Defect : Major Transverse Crack |

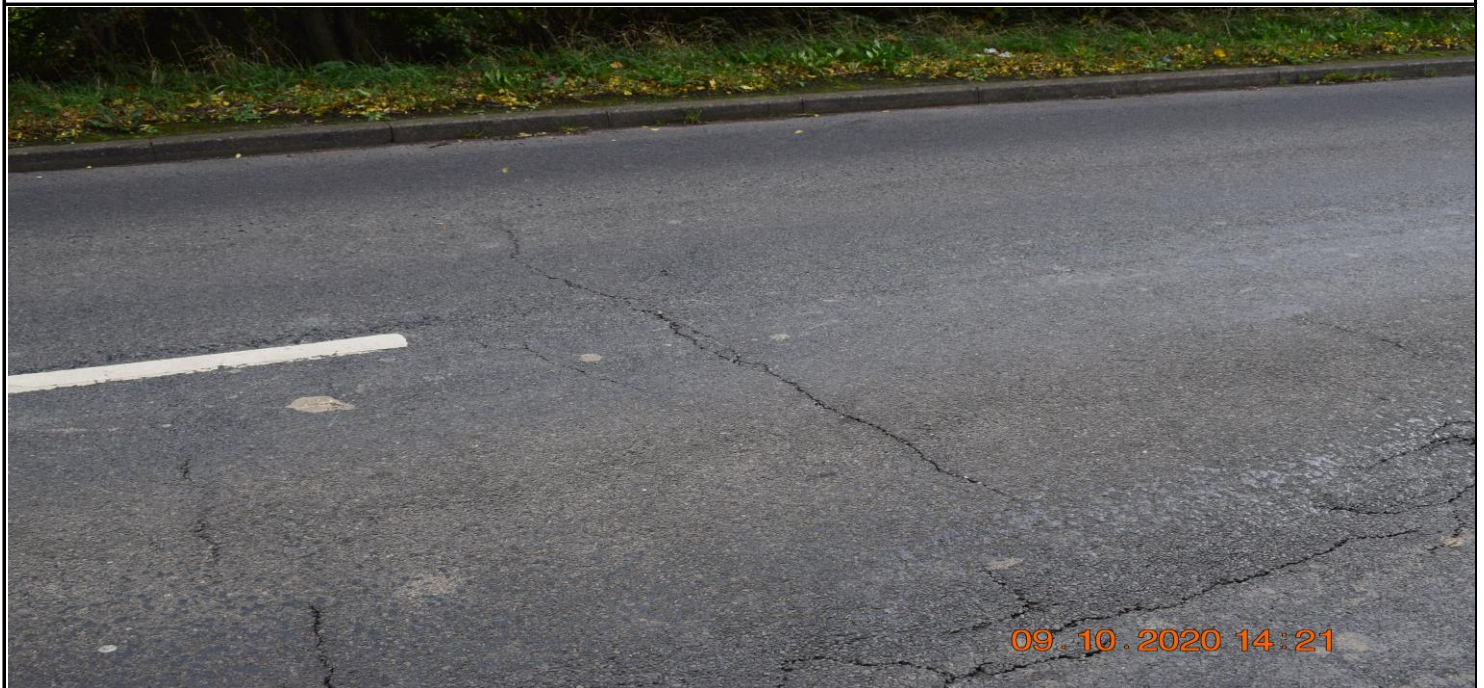
Photo Ref : 15

| Project | | | | | Direction | Job No. | | Date | |
|---|---|---|---|---|---|---|---|---|---|
| CL1&CR1 | 177 | | 0.5 | 3.65 | 1.83 | TC(1) | 1 | F | 15 |

Feature / Defect : Major Transverse Crack

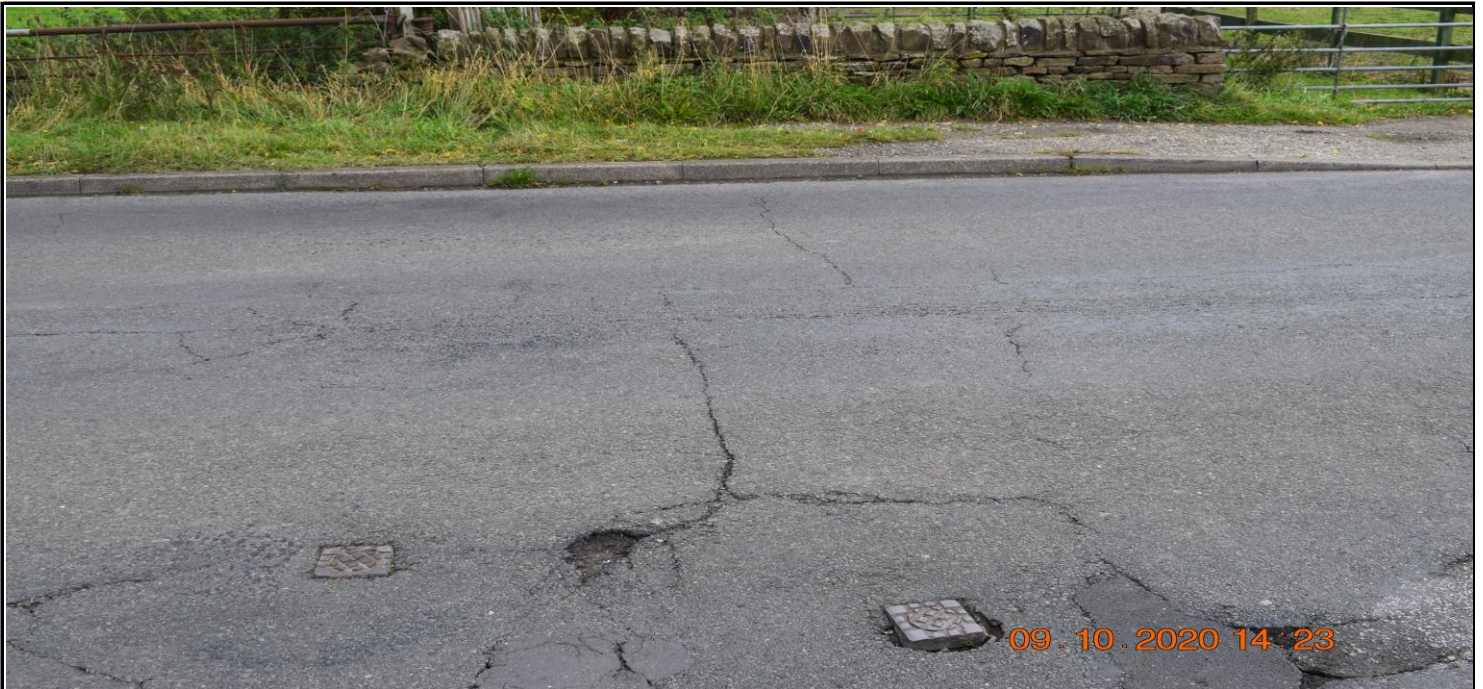
Photo Ref : 16

Feature / Defect : Major Cracking

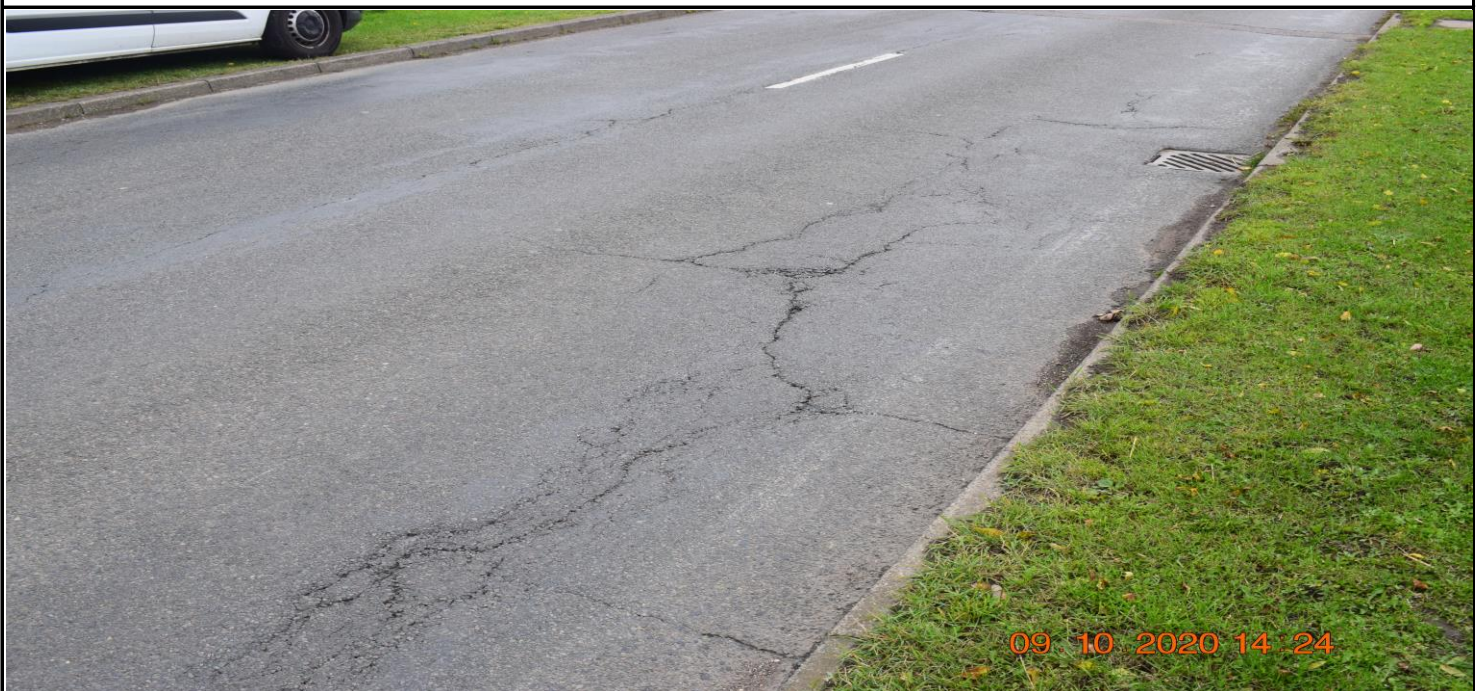
Photo Ref : 17

Feature / Defect : Major Cracking

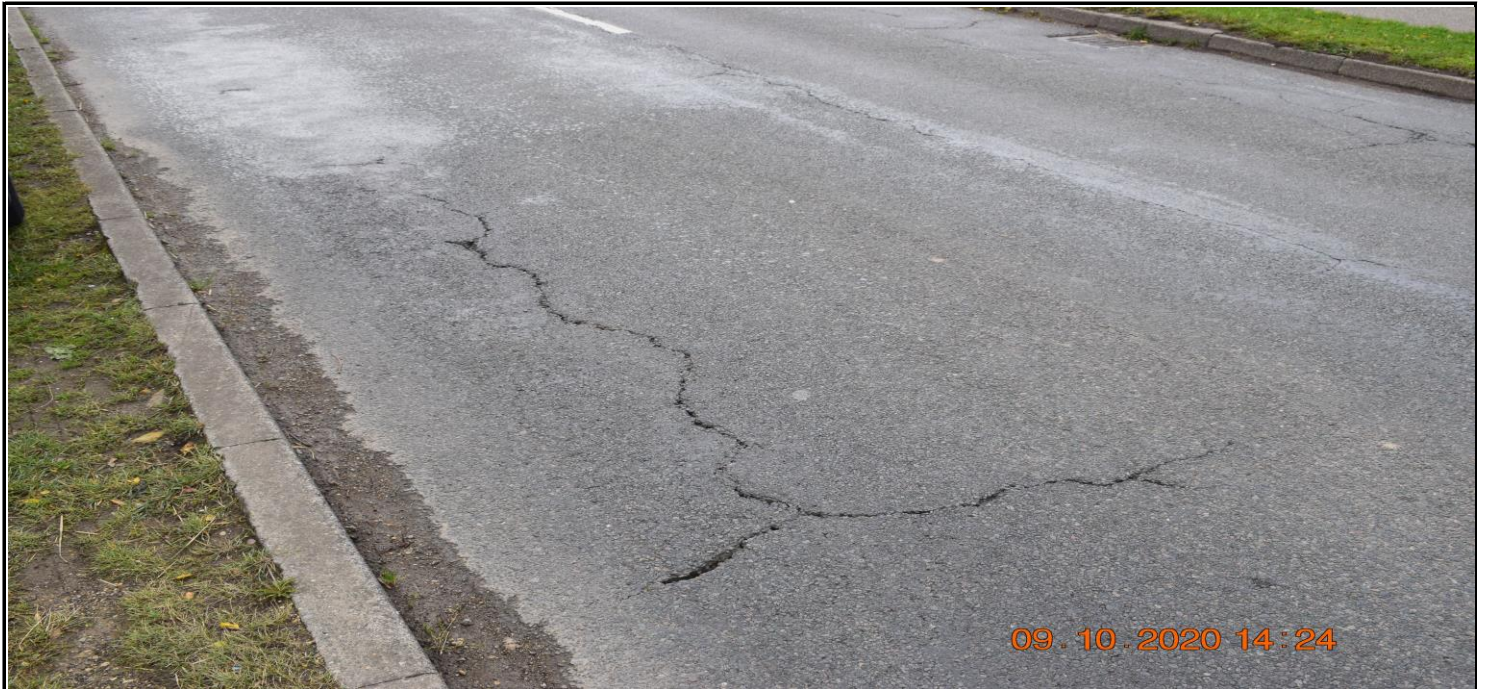
Photo Ref : 18

| Project | | | | | Direction | Job No. | | Date | |
|---|---|---|---|---|---|---|---|---|---|
| CL1/CR1 | 167 | 256 | 89 | 0.50 | 44.50 | CR(1) | 1 | | 18 |

Feature / Defect : Major Cracking

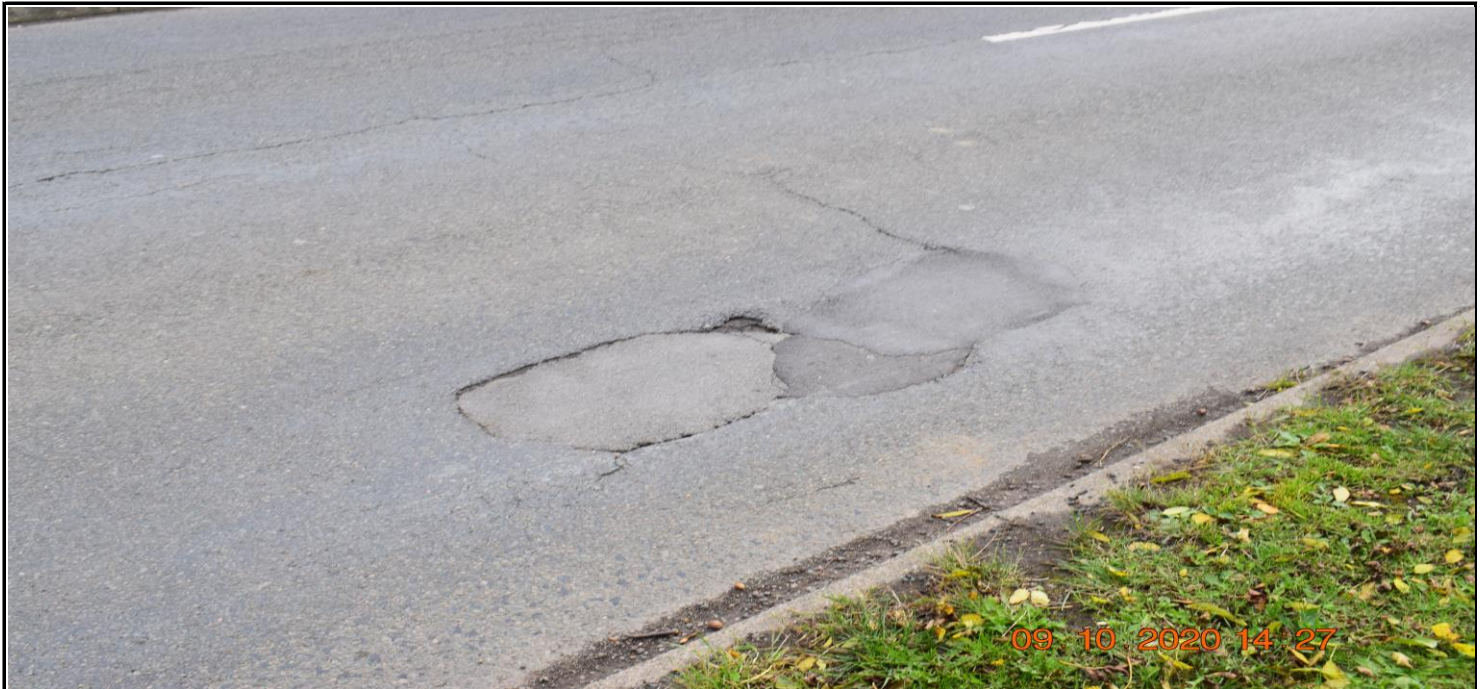
| Photo Ref : 20 | Section : Tankersley Lane |

| Chainage : 256m | Feature / Defect : Major Cracking |

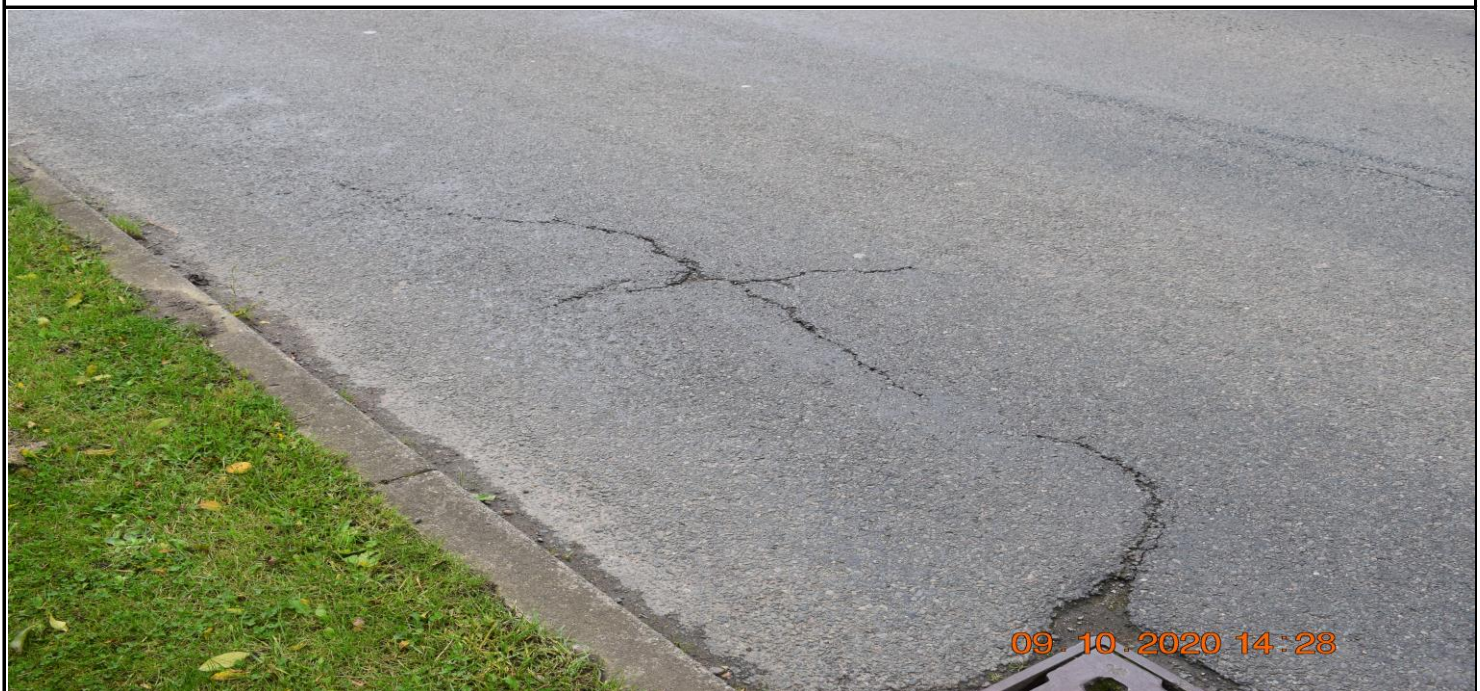
Photo Ref : 21

Feature / Defect : Major Cracking

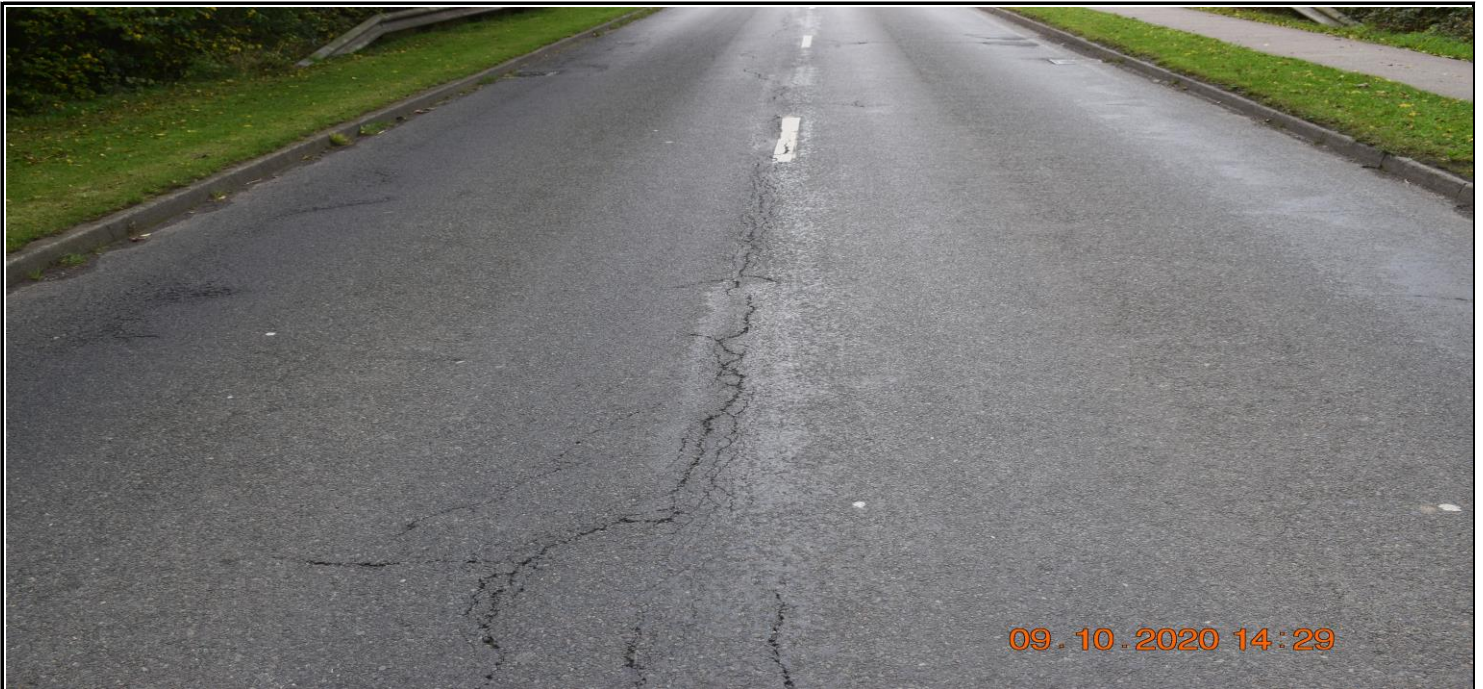
Photo Ref : 22

Feature / Defect : Patch Failure

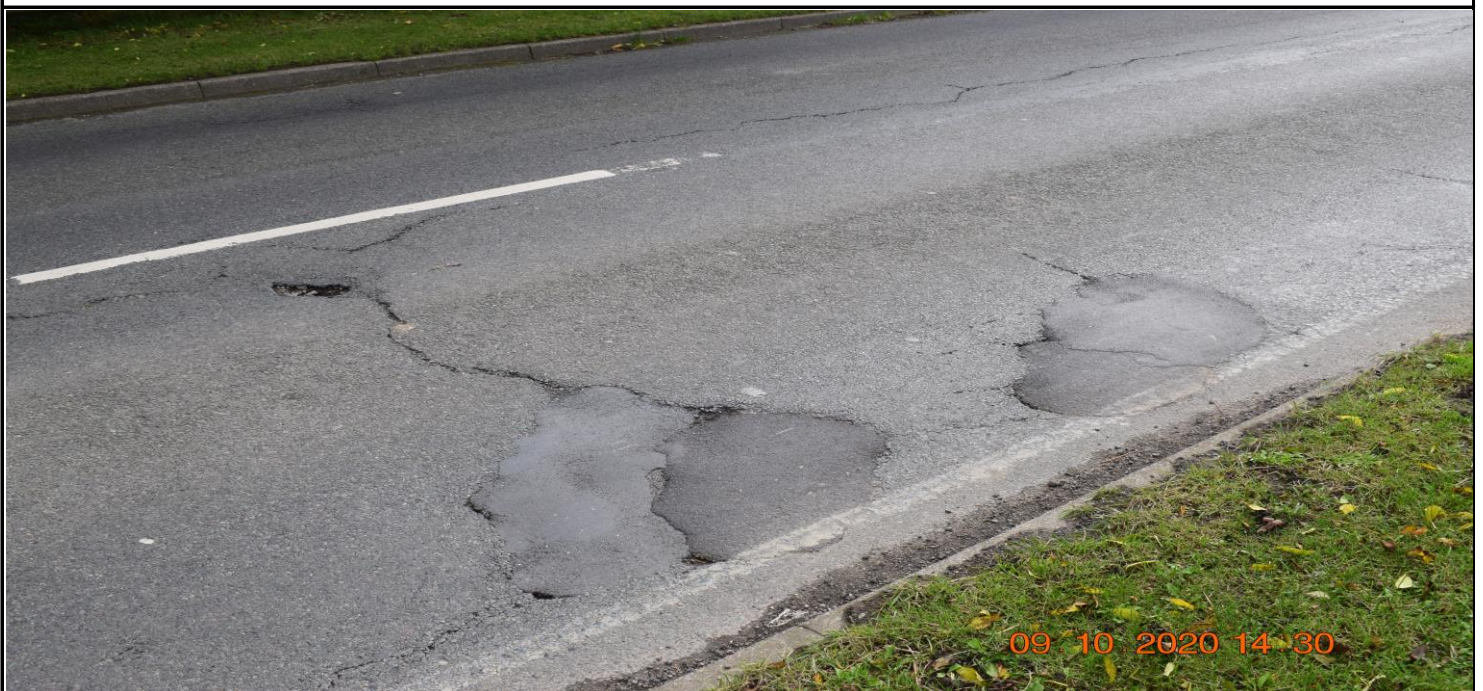
Photo Ref : 23

Feature / Defect : Major Cracking

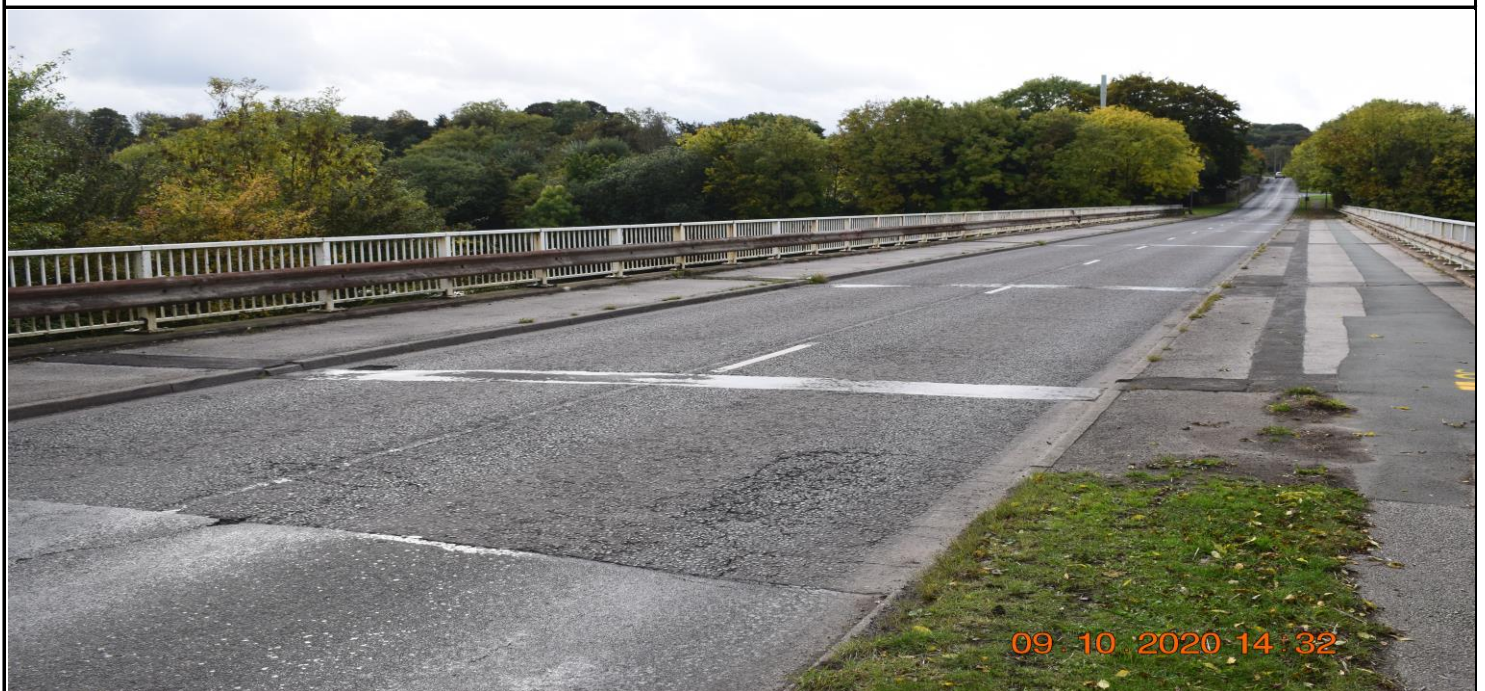
Photo Ref : 25

Feature / Defect : Major Crazing
