19th July 2019

Ref C300/03/ATS

Ref: Shallow Mining Investigation on Land Adjacent to 86A Burton Road, Barnsley South Yorkshire.

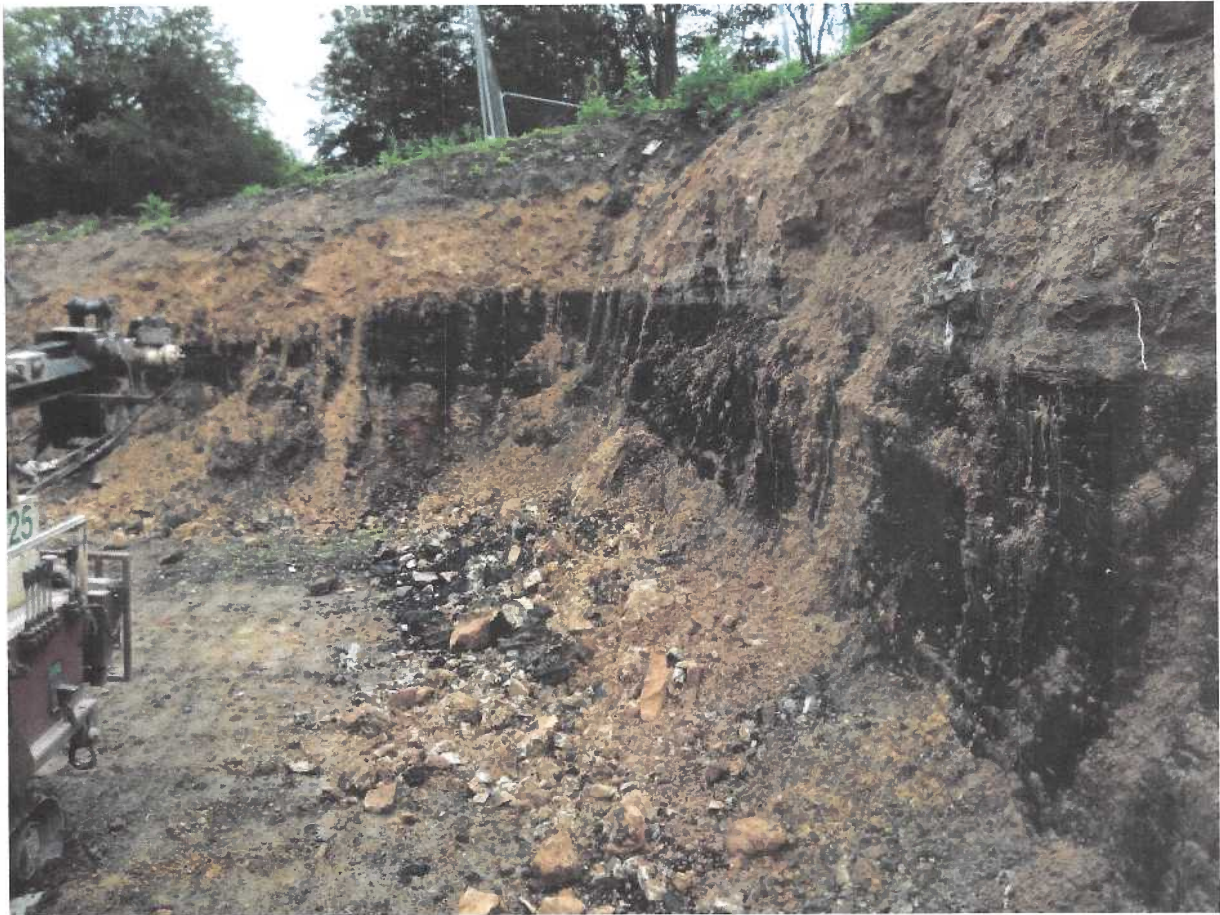
ATTACHMENT C – PHOTOGRAPH

At the time of the investigation a site strip had been carried out with an excavation into the slope to form a bench. The boreholes were drilled on this bench. A coal seam had been exposed in the rear face of the excavation, it was recorded at 1100mm thick. This is presumed to be the Meltonfield Coal. A photograph of the exposed seam within the face of the excavation is presented in Attachment C of this report.

Based on the geological records it is considered likely that the seam seen to outcrop on the site, and exposed within the excavation face of the bench, is the Meltonfield coal and the shallowest coal seam encountered in the boreholes is probably the Two Foot seam. The thickness of strata recorded between the two seams in the Geological Memoir is 10.6 m. The thickness recorded on site is 11.2 m to 12.3 m. If the shallow seam is the Two Foot then the deeper seams encountered are not recorded in the stratigraphic column and are assumed to be unnamed.

Exposure of probable Meltonfield Coal seam in excavation face

The coal exposed at the rear of the excavated bench should be blinded with concrete to prevent the possibility of spontaneous combustion.
