**BARNBURGH LANE, GOLDTHORPE PH.2
for Gleeson Homes & Regeneration**

TREE SURVEY

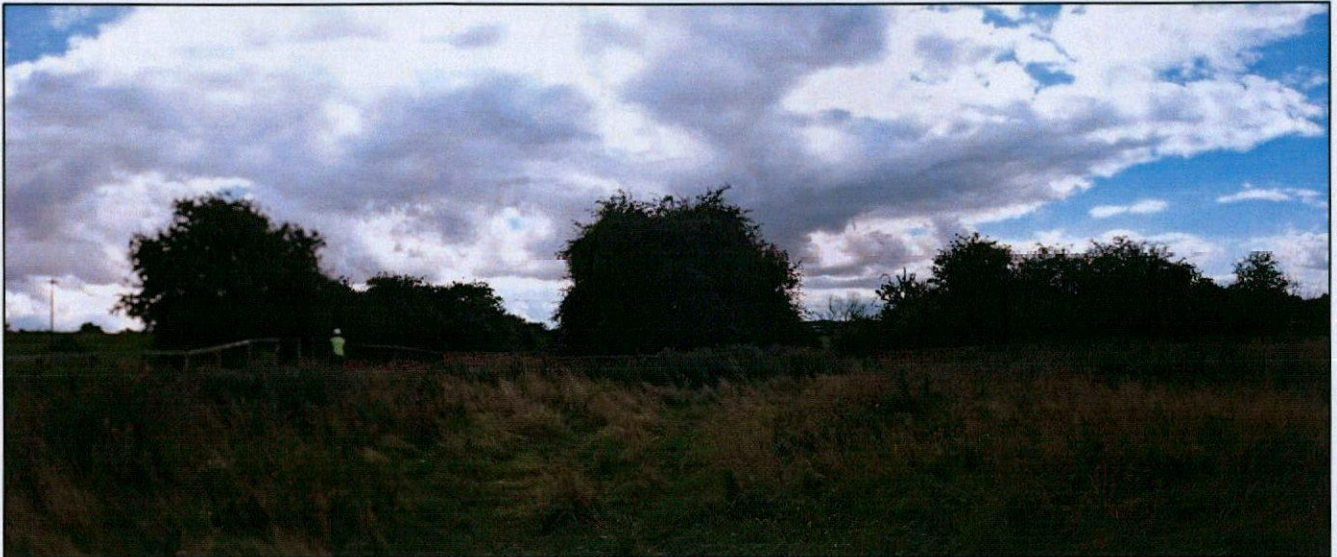
Photo 1: ▲

3.1 The most visually-prominent trees are the mature Hawthorn (T2, T3 and G4) along the southern boundary. These only reach a height of around 7m but their local prominence relates as much to their presence as a group as their height.

View south showing groups of mature Hawthorns that lie just beyond the southern boundary – T2 left, G3 centre and G4 right.

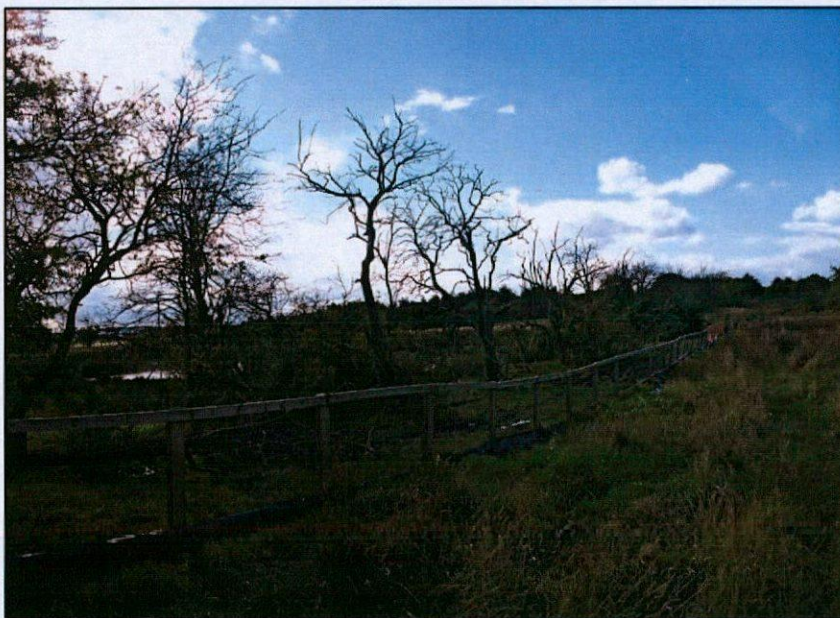
Photo 2:

4.2 There is only group of dead trees on site (G4) – probably due to poor ground conditions as a result of waterlogging from the adjacent pond. Their removal will visually marginally benefit the area as a whole.

G5	Hawthorn	7	18	As plan	D	0	Dead	<10	U	Line of dead or dying trees on edge of wetland area/pond.	Remove
H6	Hawthorn	7	13	As plan	M	0	Fair	10-20	C	Overgrown field hedgerow has been left unmaintained for some time. Dense foliage to ground level.	No action
H7	Hawthorn	<7	10	As plan	SM	0	Fair	10-20	C	Unmaintained field hedgerow contains occasional larger individual specimens.	No action

View south west showing line of dead Hawthorns (G5) with glimpse of pond beyond.

Remove all 'U' category trees including those approved for removal in relation to approved development. Erect a robust fence to protect not only the retained trees themselves, but also the rooting zones at limit of canopy spread or in accordance with BS 5837:2012.

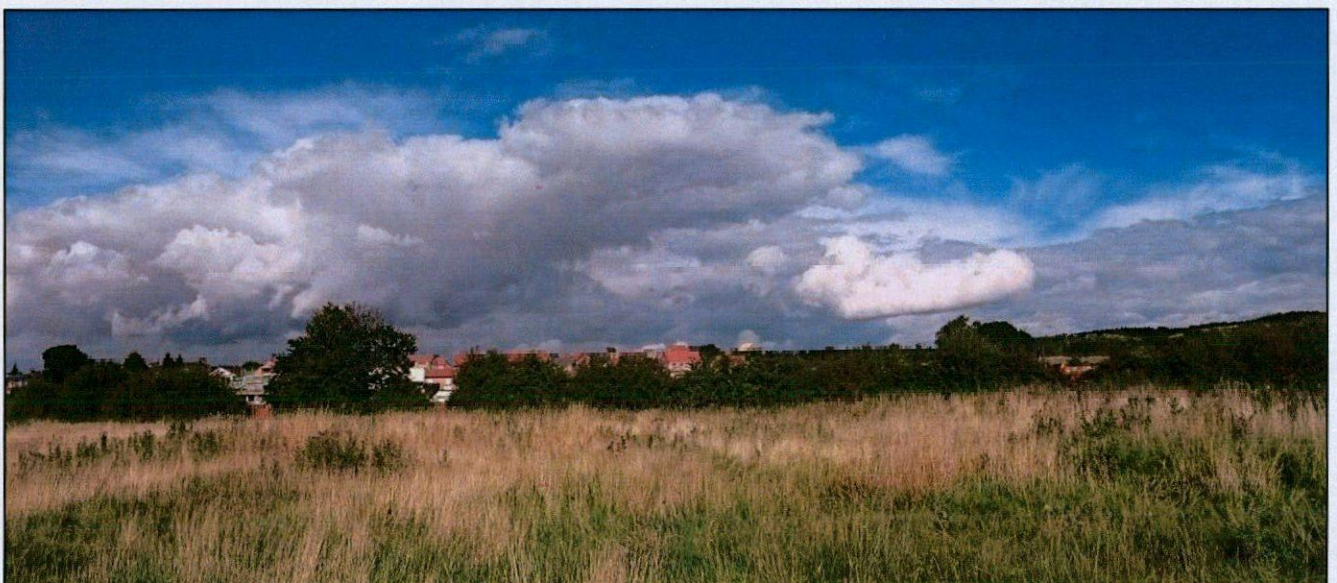
Photo 3:

3.2 Other than the above the only vegetation consists of hedging along most of the site boundaries. Although the individual specimens contained therein are only of modest quality and height (around 7 m maximum) these do provide dense screening at lower levels from offsite views.

3.3 The hedgerows are generally unmaintained features but could be brought back into management relatively easily.

View north showing hedge H7 – typical of hedging along most site boundaries. ▼
