Site: **Barnsley LIFT - Tranche 3 - Darton
Darton Council Offices
Huddersfield Road
Darton
S75 5NB**

Report: **Tree Condition Survey**

Reference No: **AA/4479/02.09**

Date: **Instructions Received: 13.01.09
Site Visits: 14.01.09 &
16.01.09
Report Completed: 03.02.09**

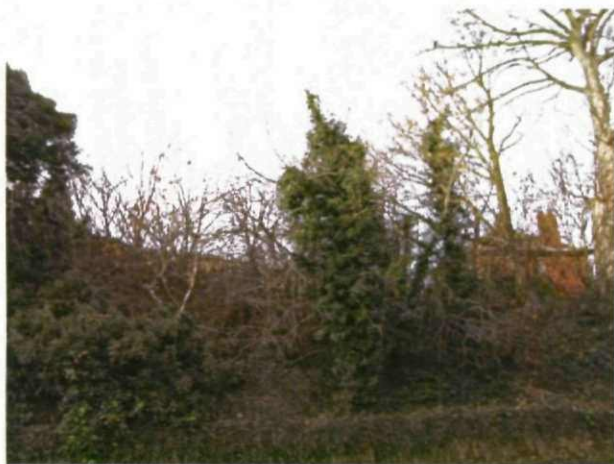
23 - G7 from Churchfield Lane.JPG

0653	Ash <i>Fraxinus excelsior</i>	8	200	-	-	-	-	-	Y	-	D	Dead.	Fell.	-	-	-	-	-	R
G7	Shrubs Various sp.	6	-	-	-	-	-	-	MA	N	G	Mostly Ivy covered Hawthorn and young Ash growing on the steep banking.	Reduce height to 2m.	-	>10	1.5	-	25	C2

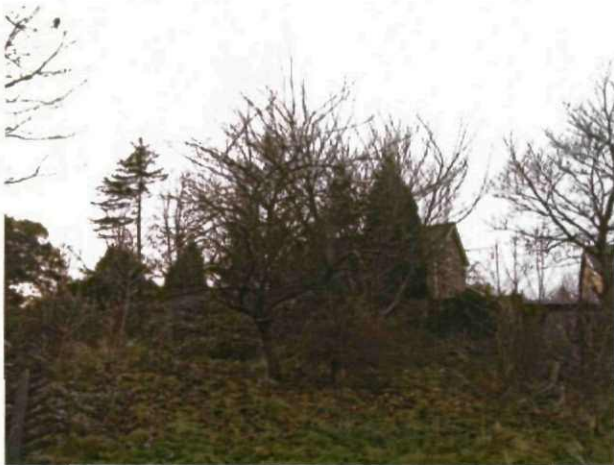
27 - 0654, OG1 from site.JPG

Tree No	Species	Height	Trunk Diameter	Crown Spread				Clearance	Age	Vitality	Condition	Comment	Work Required	% Leaf Volume	SULE	RPRadius	RPArea	Mature Height	Category
				North	East	South	West												
0654	Apple <i>Malus sp.</i>	6	250	3	4	4	4	1	M	N	G	-	Crown clean. Crown thin.	20	>20	3	28.3	10	B2
0655	Cherry <i>Prunus sp.</i>	8	490	6	6	6	6	0	M	N	F	Multi stemmed from 0.5m. Decay to trunk and one stem has failed.	Fell.	-	<10	-	-	-	R
0656	Sycamore <i>Acer pseudoplatanus</i>	11	395	5	5	5	5	2	MA	N	P	Cavity to base and probing revealed extensive decay.	Fell.	-	-	-	-	-	R
0657	Cherry <i>Prunus sp</i>	9	280	2	5	4	5	1.5	MA	N	G		Crown clean. Crown lift to 4m over offsite driveway.	-	>20	3.4	35.5	15	B2
0658	Oak <i>Quercus robur</i>	11	300	2	6	4	4	2	Y	N	G	Twin stem from 1.2m.	Crown clean. Crown lift to 4m over offsite driveway.	-	>40	3.6	40.8	25	B2
G8	Privet <i>Ligustrum ovalifolium</i>	2	-	0.5	-	0.5	-	0	M	N	G	Trimmed evergreen hedge.	-	-	>40	1	-	5	C2

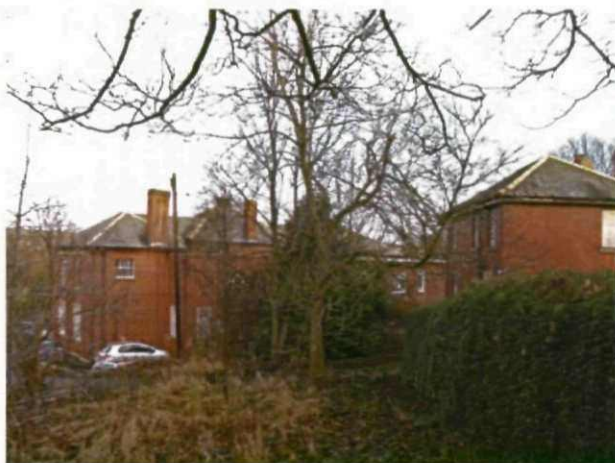
35 - G8, 0659, 0660, G9 from site boundary.JPG

0659	Ash <i>Fraxinus excelsior</i>	13	320	4	2	5	5	0	MA	N	G	-	Crown clean.	-	>20	3.9	46.4	25	B2

Tree No	Species	Height	Trunk Diameter	Crown Spread				Clearance	Age	Vitality	Condition	Comment	Work Required	% Leaf Volume	SULE	RPRadius	RPArea	Mature Height	Category
				North	East	South	West												
0660	Sycamore <i>Acer pseudoplatanus</i>	13	390	4	4	3	2	2	MA	N	F	Twin stem from tight fork at 0.5m – appears stable at present.	-	-	<20	4.7	68.9	25	C2
0661	Sycamore <i>Acer pseudoplatanus</i>	9	2 X 200	3	4	3	2	0	Y	N	G	Twin stem from ground level.	Remove basal suckers.	-	>20	2.8	24.7	25	C2
G9	Shrubs Various sp.	7	-	-	-	-	-	0	MA	N	G	Group of evergreen and deciduous shrubs.	-	-	>20	1.5		15	C2

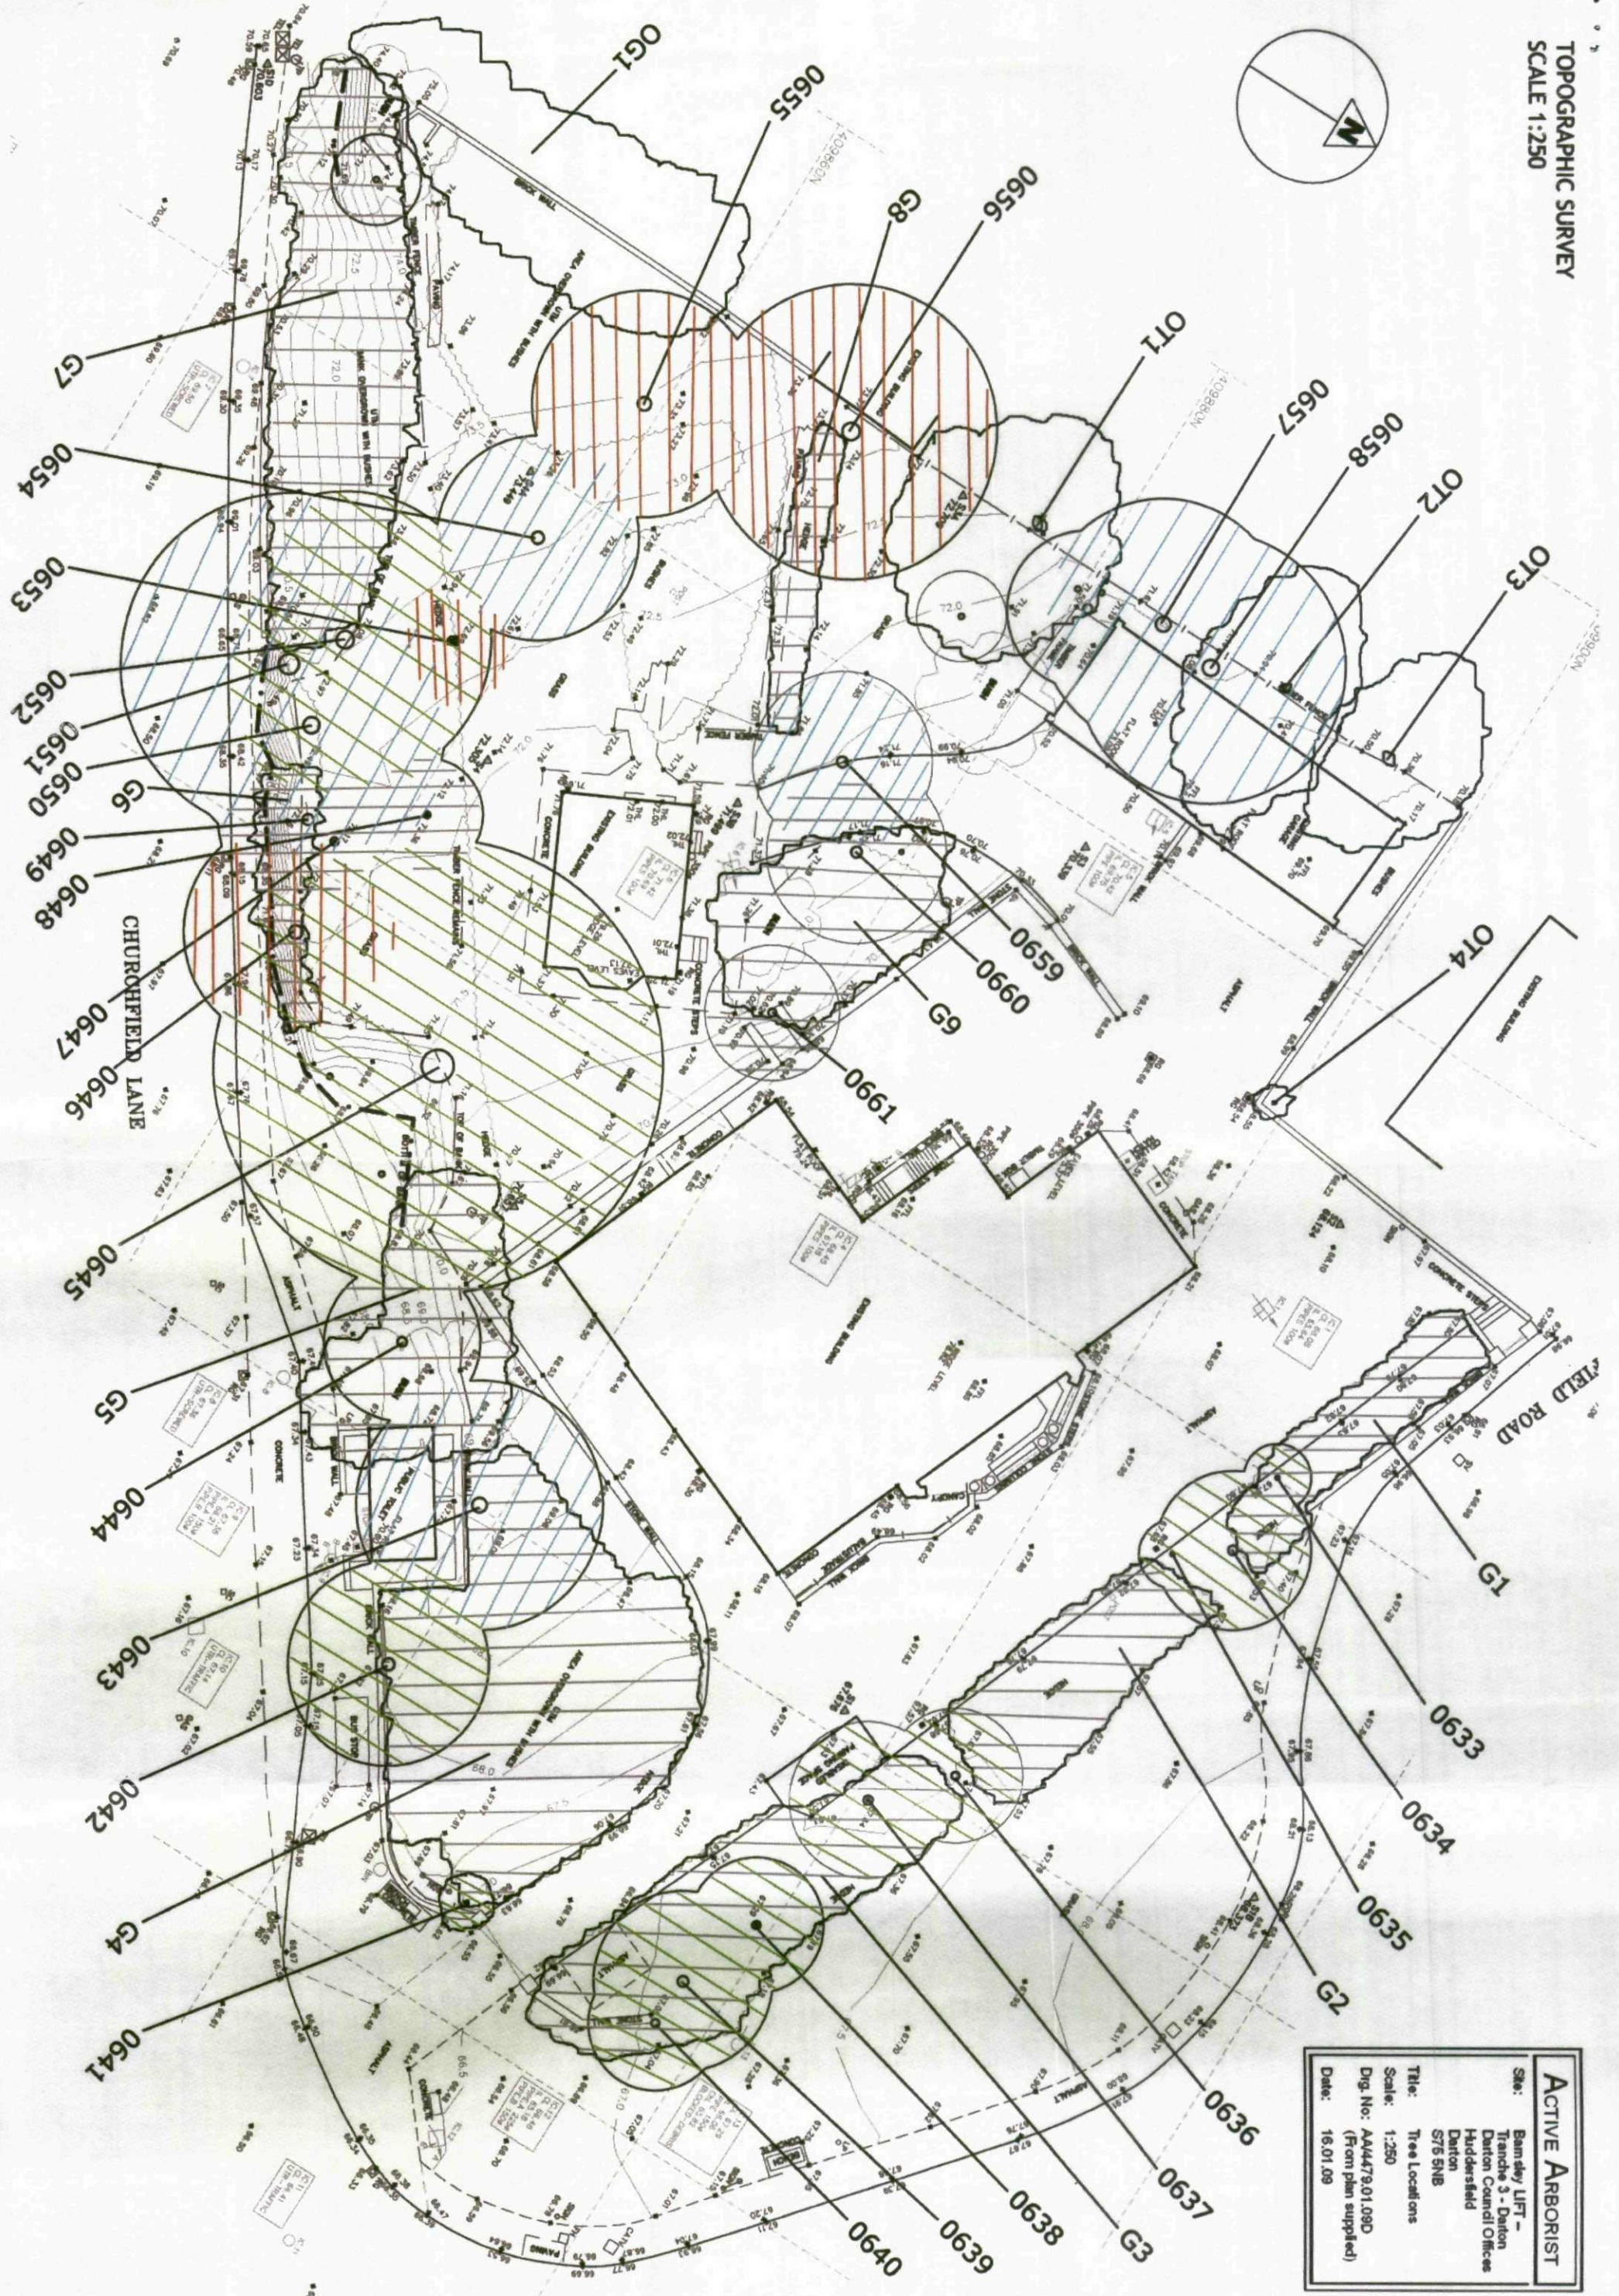
ACTIVE ARBORIST
Site: Bamsey LIFT - Tranche 3 - Darton Darton Council Offices Huddersfield Darton S75 5NB
Title: Tree Locations
Scale: 1:250
Dwg. No: AA4479.01.09D (From plan supplied)
Date: 16.01.09

Several trees were found to have defects and are therefore unsuitable for retention – these are shown in red on the Tree Location plan.
