Date: 29<sup>th</sup> October 2025  
Your ref: (S75 1DX)  
My Ref: SI 00404

**COAL MINING RISK INTERPRETATION REPORT – FOLLOWING THE SITE  
INVESTIGATION FOR PROPOSED RESIDENTIAL DEVELOPMENT AT LAND REAR OF 49 TO  
55 WOODSTOCK ROAD, BARNSELY S75 1DX**

**Borehole Site Investigation Plan 00404/B**  
**Development at:**  
**49 to 55 Woodstock Road, Barnsley S75 1DX**  
**NGR: 433830E / 407835N (NTS)**

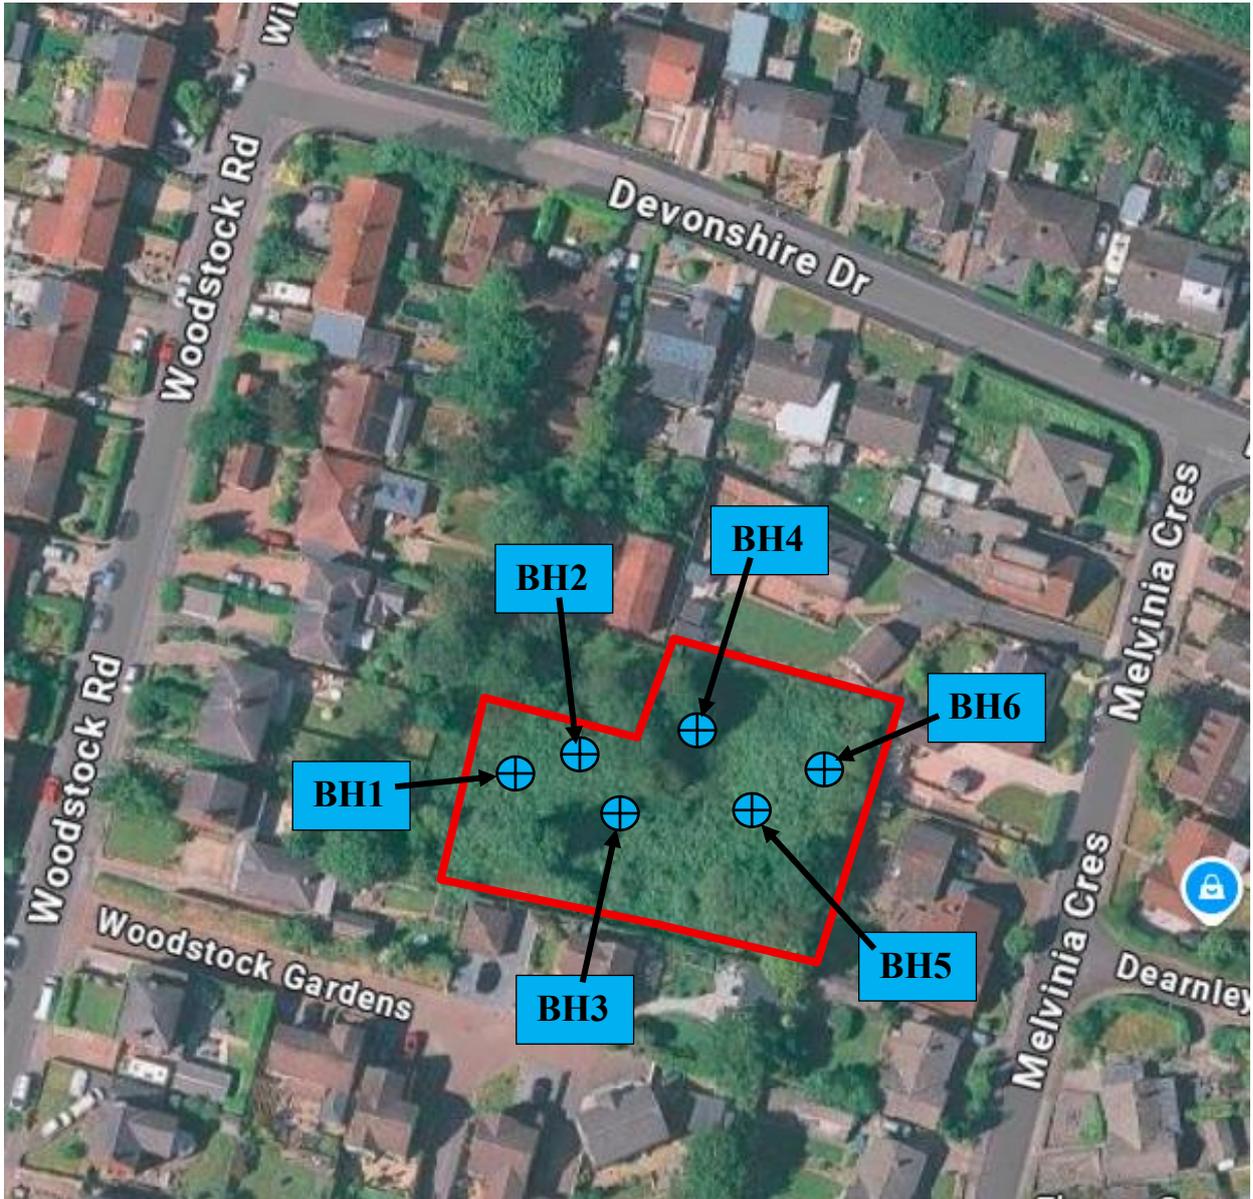
5.2 Borehole Location Plan No. 00404/B

Planning permission has been granted for a new residential dwelling at the above location, subject to the mining legacy risks been fully realised and mitigated from on site, if necessary. Cape Site Services has now undertaken this work via an intrusive site investigation of 6 boreholes, the location of which is outlined on plan no. 00404/B – as attached and illustrated in appendix 5.2. The site is centred at OS NGR: 433830E / 407835N.

Prior to the intrusive site investigation, a search for utilities was undertaken both via online data providers and physically on site using a Cable Avoidance Tool (CAT). Boreholes were marked out with tape measure from boundary lines as illustrated on plan no. 00404/B outlined in appendix 5.2.
