TITLE: SITE LAYOUT PLAN; YEW TREE PLANTATION
PROJECT/SITE: STAIRFOOT QUARRY
MAP DETAILING LOCATIONS OF TREES REQUIRING WORK

Hanson - Stairfoot : Yew Tree Plantation.
DV/KR Site Inspection 7th April 2011

Title:	PhotoRecord - Updated May 2011
Client:	Hanson:Stairfoot
Reference:	10-3014 031 D17
Date:	08.04.2011
Produced by:	Liz McGhee
Checked by:	David Venables

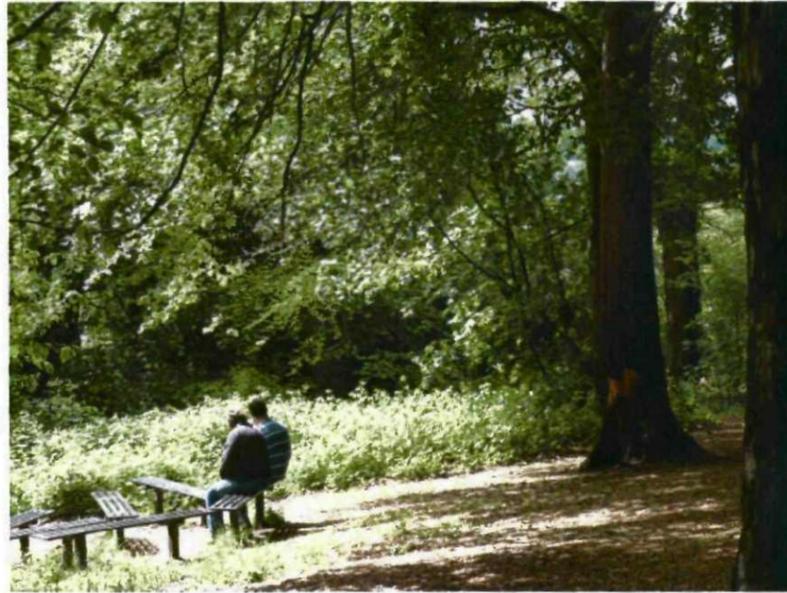
1. Tree 1 - Beech showing major fire damage at base of stem. Recommendation: Reduce crown back to 3m above major fork in main stem to create a habitat pole.

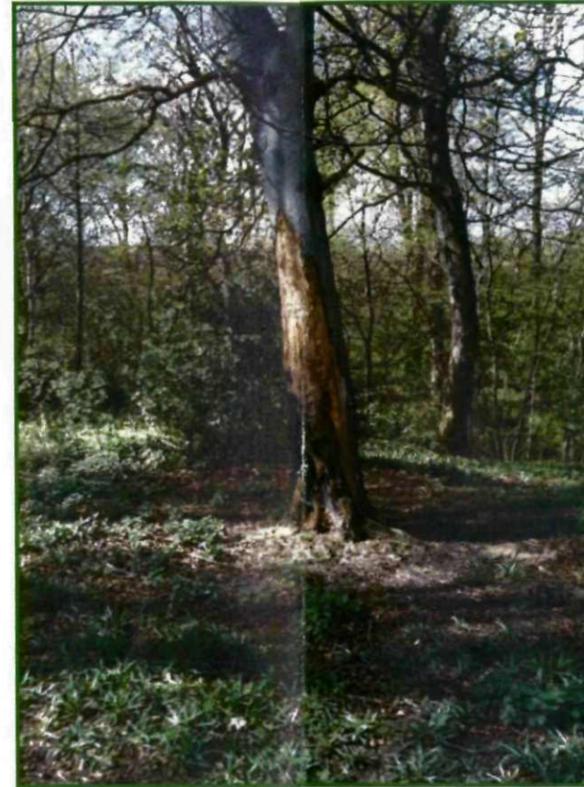
2. Tree 2 - Beech showing major fire damage to base of tree resulting in extensive area of significant decay. Recommendation: Fell tree to ground level as the tree has a limited life expectancy in its present condition.

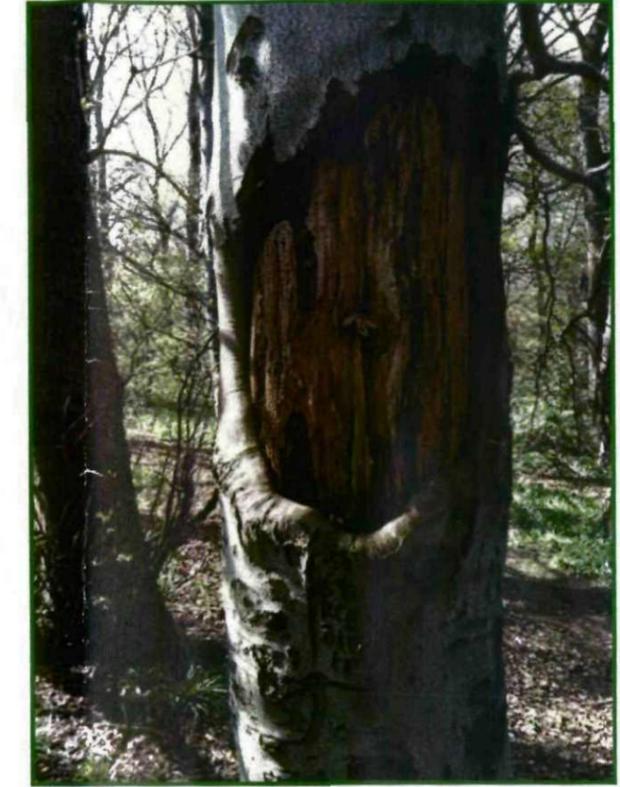
3. Tree 3 - Beech tree with a large cavity at 1.5m to 2.5m with decay. Recommendation: Monitor annually for signs of decline.

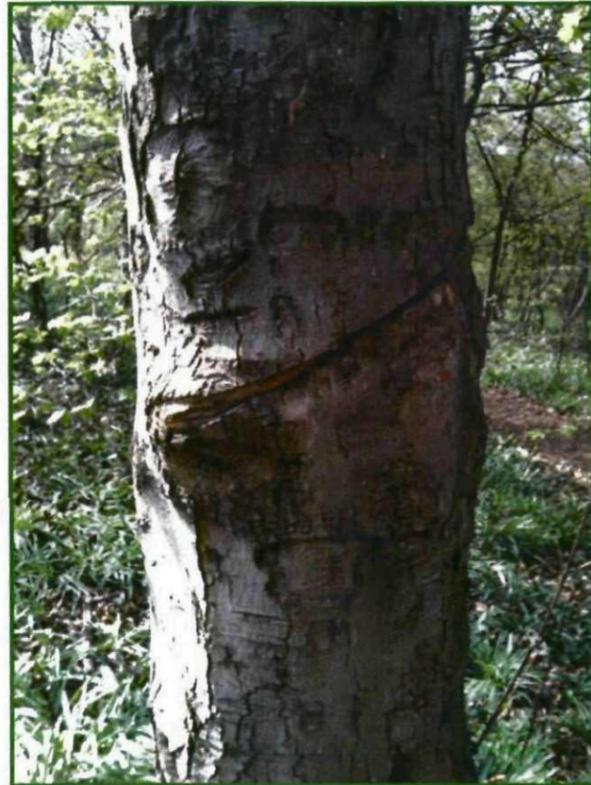
4. Tree 4 - Sycamore with a saw cut through half of the stem, showing minor bark inclusion. Recommendation: Fell tree to ground level as structural unsafe and of limited life expectancy.

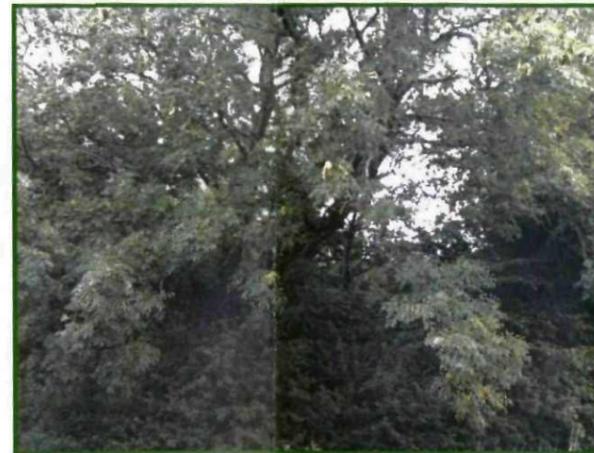
7. Tree 7 - Ash tree with significantly thinning and declining over footpaths. Recommendation: Monolith crown back to main stem.

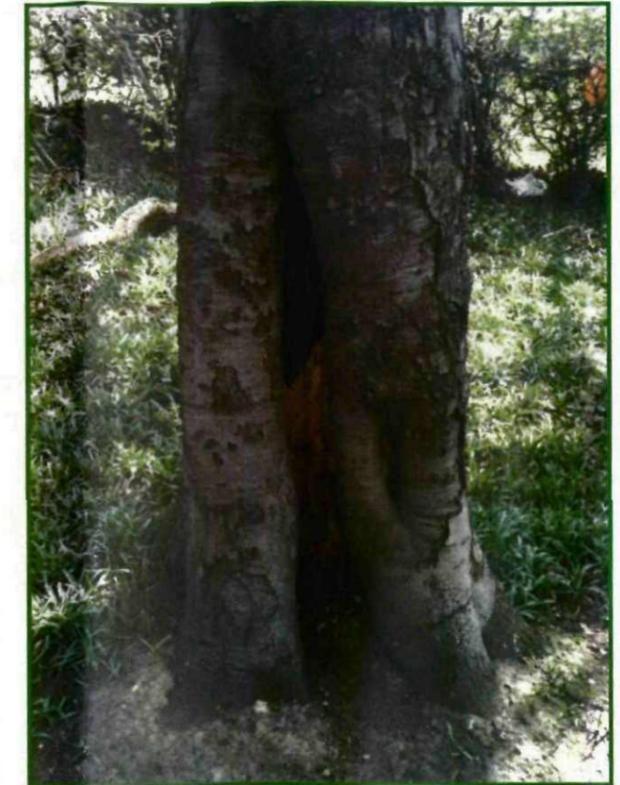
6. Tree 6 - Beech with major cavity at ground level to 1.5m, with evident signs of significant decay. Recommendation: Reduce back to a 5 - 6m habitat pole.

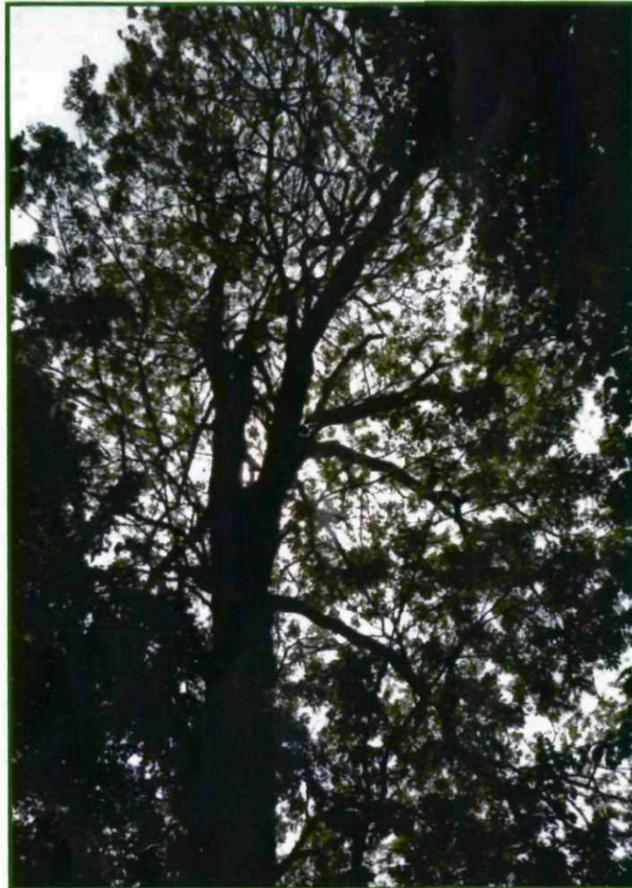
8. Tree 8 - Over mature ash tree with declining crown. Recommendation: Reduce heavy lower limb over path back to main stem.

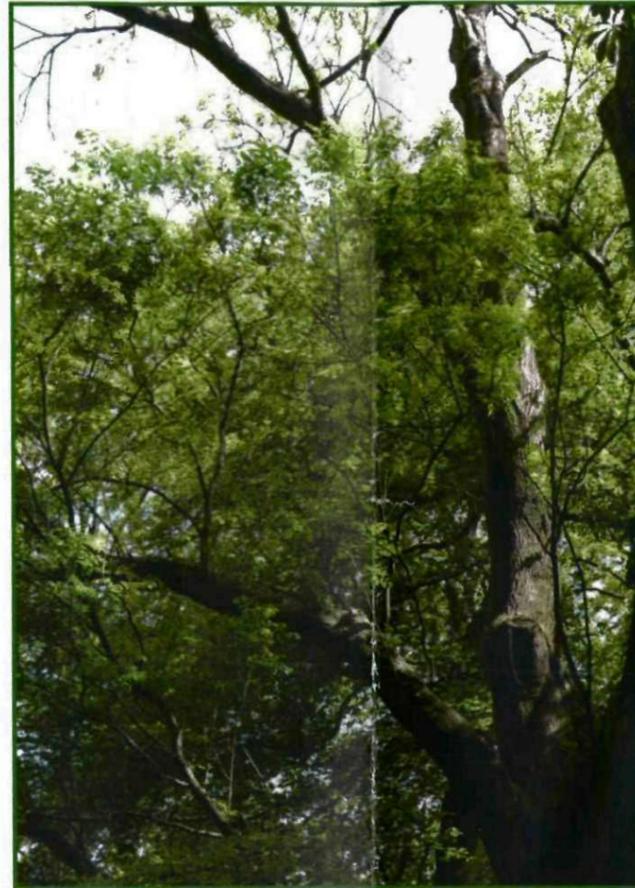
9. Tree 9 - Over mature ash with significantly decline crown. Recommendation: Reduce two heavy lower limbs over path to robust, live stem points.
