ARBORICULTURAL REPORT

To **BS5837:2012** at:

***38 Bowden Grove,
Dodworth,
Barnsley,
S75 3TB***

Date: *April 2016*
Reference: *AWA1550*

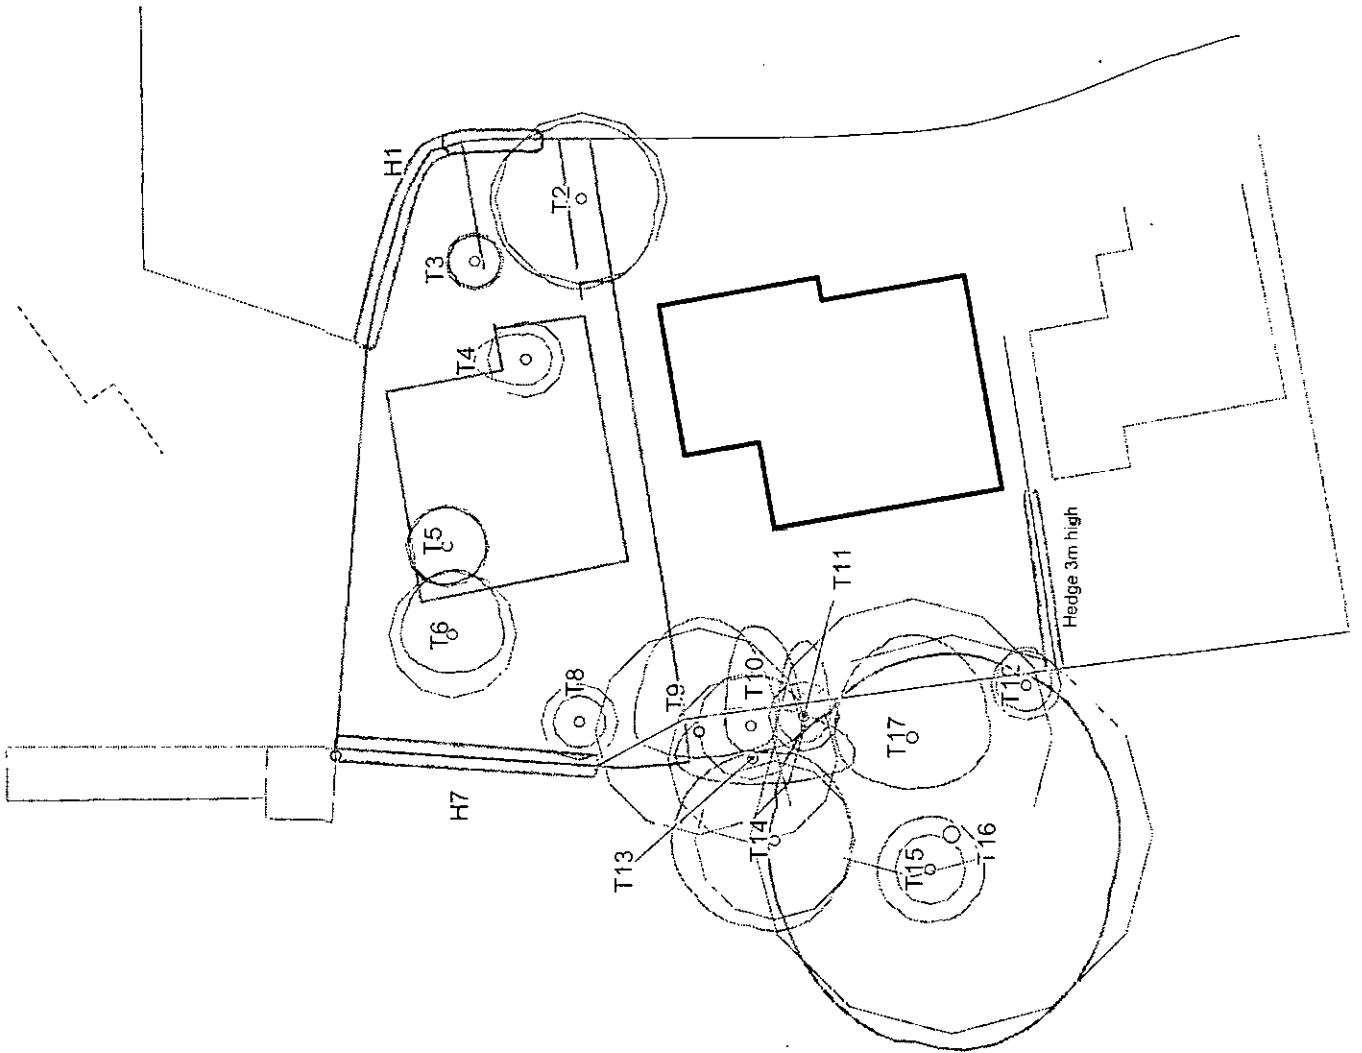
Appendix 6:
Tree Impacts Plan
28 Downside Grove, Barmaley, S76 3TB
SHEFFIELD
BRITISH BOARD 643 2012

- 3.3.2 From assessing the new development proposals, 5 trees and a section of hedge will require removal to facilitate the new development (H1, T2, T3, T4, T5 & T6), as they are situated within the-footprint of the new development or their retention and protection throughout the development is not suitable. The trees requiring removal are highlighted in red on the Tree Impacts Plan and detailed in the tree data schedule at Appendix 4.

- 3.3.4 The tree Root Protection Area (RPA) detailed on the Tree Constraints Plan at Appendix 5, has been used as a layout design tool, to inform on the area around the trees where the protection of the roots and soil structure is treated as a priority. The trees and hedges along or beyond the western boundary will not be impact by the proposed development, provided care is taken during construction.

- 3.4.1 The retained trees may require protection by fencing in accordance with BS 5837: 2012, during the development phase.
- 3.4.2 If required by the Local Planning Authority, an associated Arboricultural Method Statement, detailing protective fencing specifications and construction methods close to the retained trees can be provided.
