19th July 2019

Ref C300/03/ATS

Ref: Shallow Mining Investigation on Land Adjacent to 86A Burton Road, Barnsley South Yorkshire.

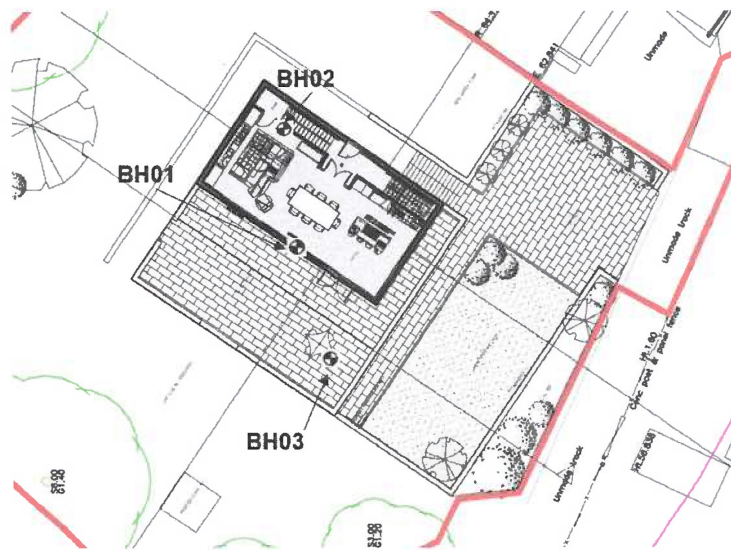
The locations of the exploratory holes are shown below.

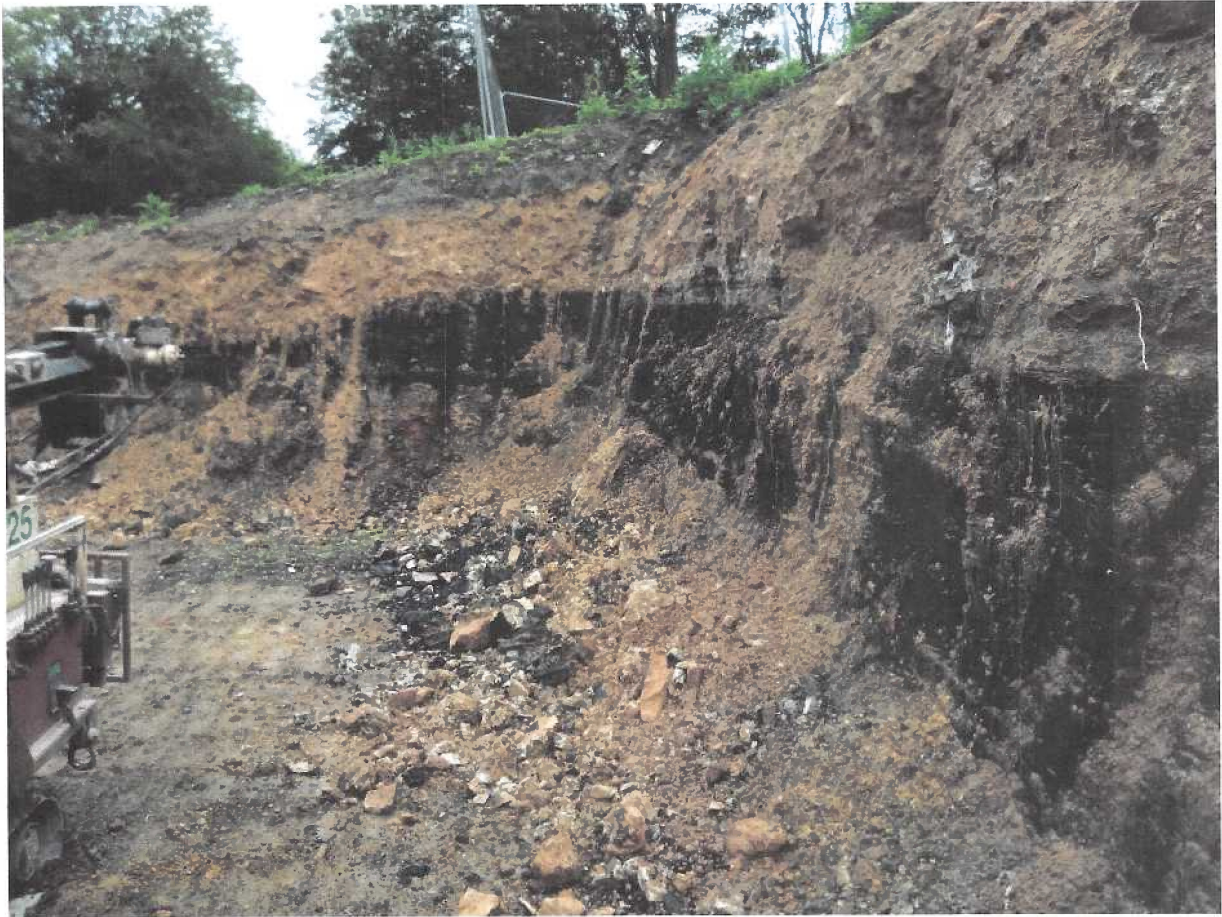
ATTACHMENT C – PHOTOGRAPH

At the time of the investigation a site strip had been carried out with an excavation into the slope to form a bench. The boreholes were drilled on this bench. A coal seam had been exposed in the rear face of the excavation, it was recorded at 1100mm thick. This is presumed to be the Meltonfield Coal. A photograph of the exposed seam within the face of the excavation is presented in Attachment C of this report.

Based on the geological records it is considered likely that the seam seen to outcrop on the site, and exposed within the excavation face of the bench, is the Meltonfield coal and the shallowest coal seam encountered in the boreholes is probably the Two Foot seam. The thickness of strata recorded between the two seams in the Geological Memoir is 10.6 m. The thickness recorded on site is 11.2 m to 12.3 m. If the shallow seam is the Two Foot then the deeper seams encountered are not recorded in the stratigraphic column and are assumed to be unnamed.

Exposure of probable Meltonfield Coal seam in excavation face

The coal exposed at the rear of the excavated bench should be blinded with concrete to prevent the possibility of spontaneous combustion.
