# Princess Theatre, Hoyland

## Bat Survey Report

11<sup>th</sup> August 2026

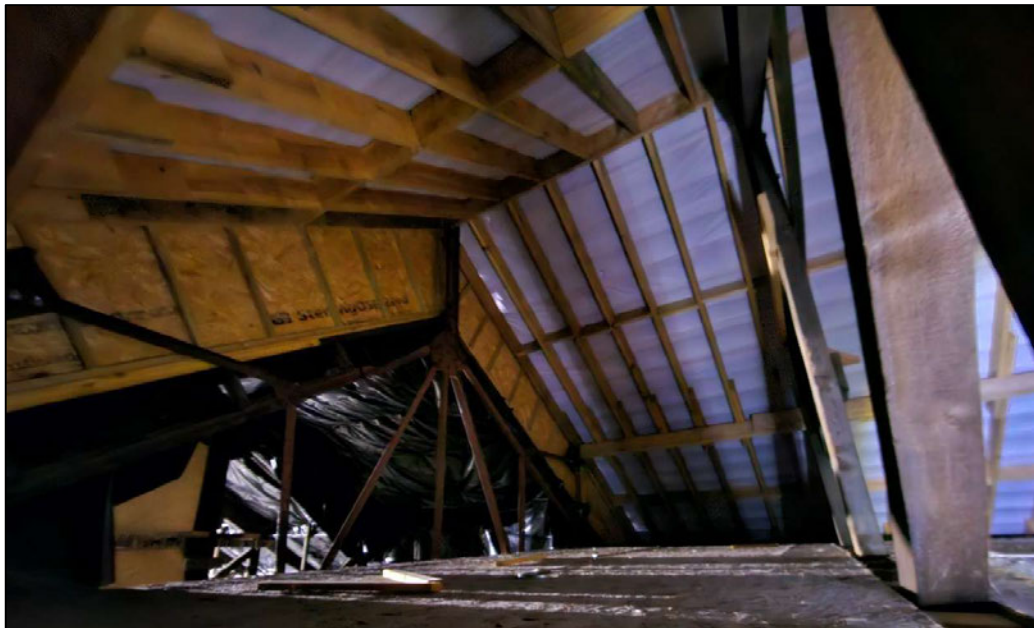
**Plate 4. The interior of the reroofed southern section of the building**

- 5.2.6 No bats or signs of bats were present within the interior of the building. The recent reroofing at the southern end of the building and the installation of the plastic sheeting below the rafters and purlins at the northern end were considered likely to have been actions which reduced the chance of historic signs of bats being visible.

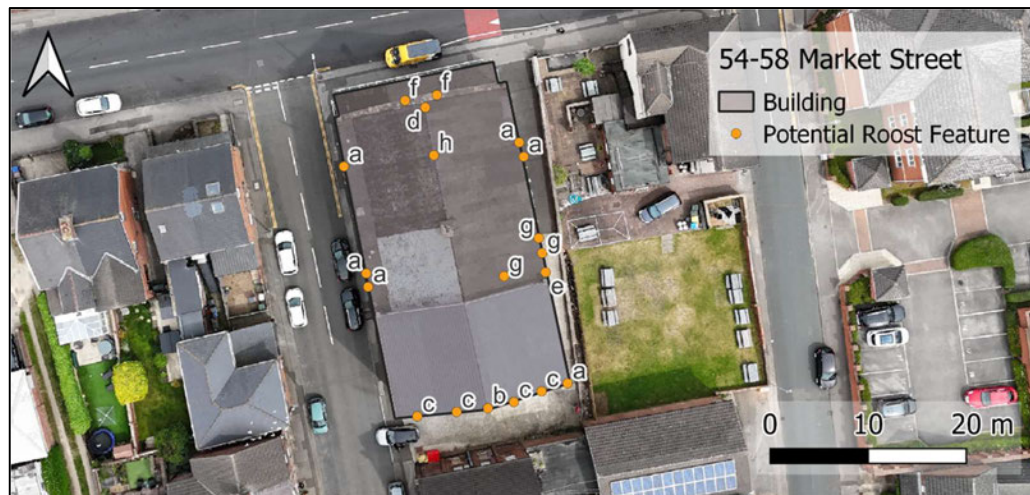
**Figure 4. Potential roost feature locations**

- 5.2.5 The potential bat roost features present comprised gaps below slipped slates, behind fascias and barge boards, gaps in the masonry, and between coping stones and the ridge. The potential roost features are shown in Table 3, and their approximate locations shown on Figure 4.

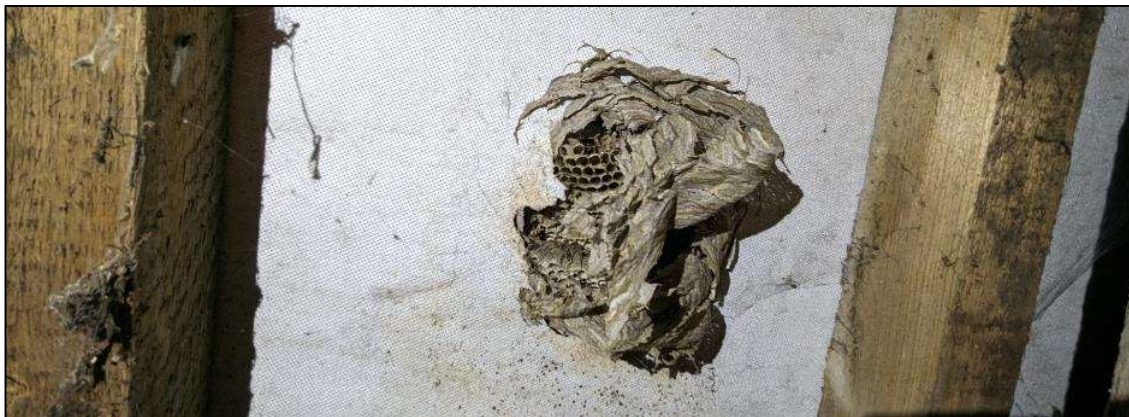
**Plate A2.2. Damage to a breathable roofing membrane adjacent to a wasp nest**

In recent years a fairly substantial proportion of the lofts we have surveyed which had existing breathable felt, were found to have been damaged by wasps (Plate A2.2). The wasps appear to have chewed holes in the felt and formed nests. This doesn't appear to be a problem associated with traditional bitumen coated roofing felt. Any holes within roofing felt are likely to significantly reduce its functionality as a secondary weather barrier. Where bats or birds come into contact with breathable roofing membranes, they can also damage it causing it to leak, they can also significantly reduce the breathability of the felt in that location.
