Our Ref: 99-158

**Bence Farm Barn, Barnsley Road, Darton, BARNSELY S75 5NU**  
**Report on the structural condition of an existing agricultural building proposed for conversion to a domestic dwelling**

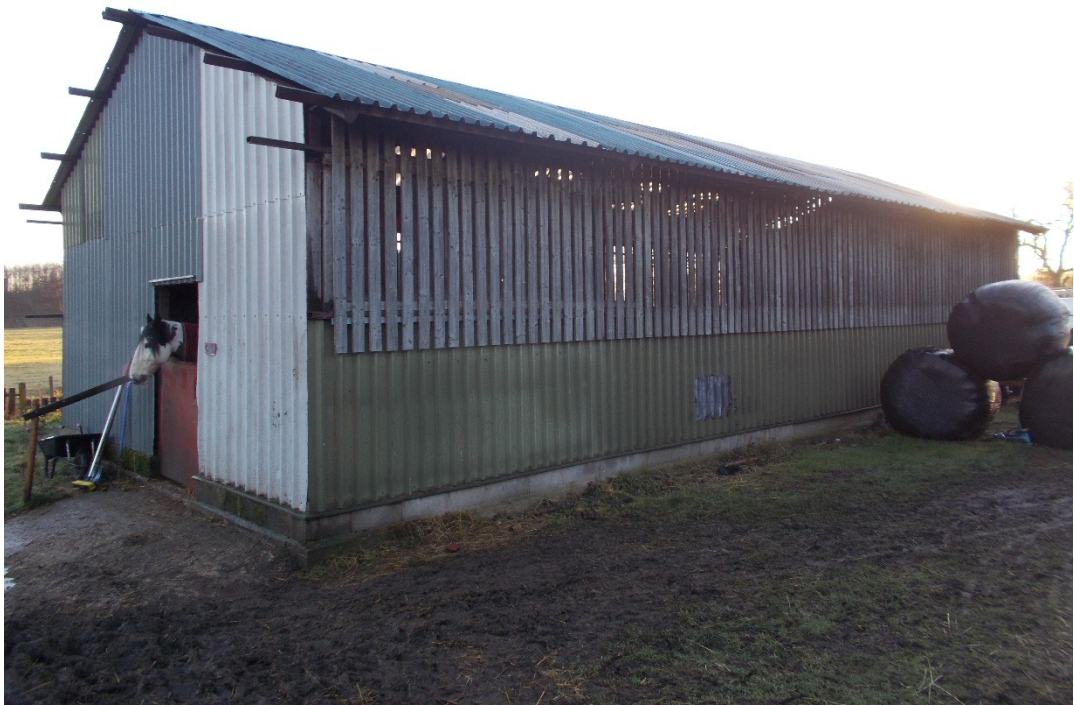
The existing agricultural building is formed as a steel frame with coverings of profiled steel sheet or vertical timber boards (see photographs 1 – 2 for general views on the external elevations). These existing coverings will, it is anticipated, be replaced with lightweight insulated panels better suited to the development proposed.

**Photograph 1: External view from north west**

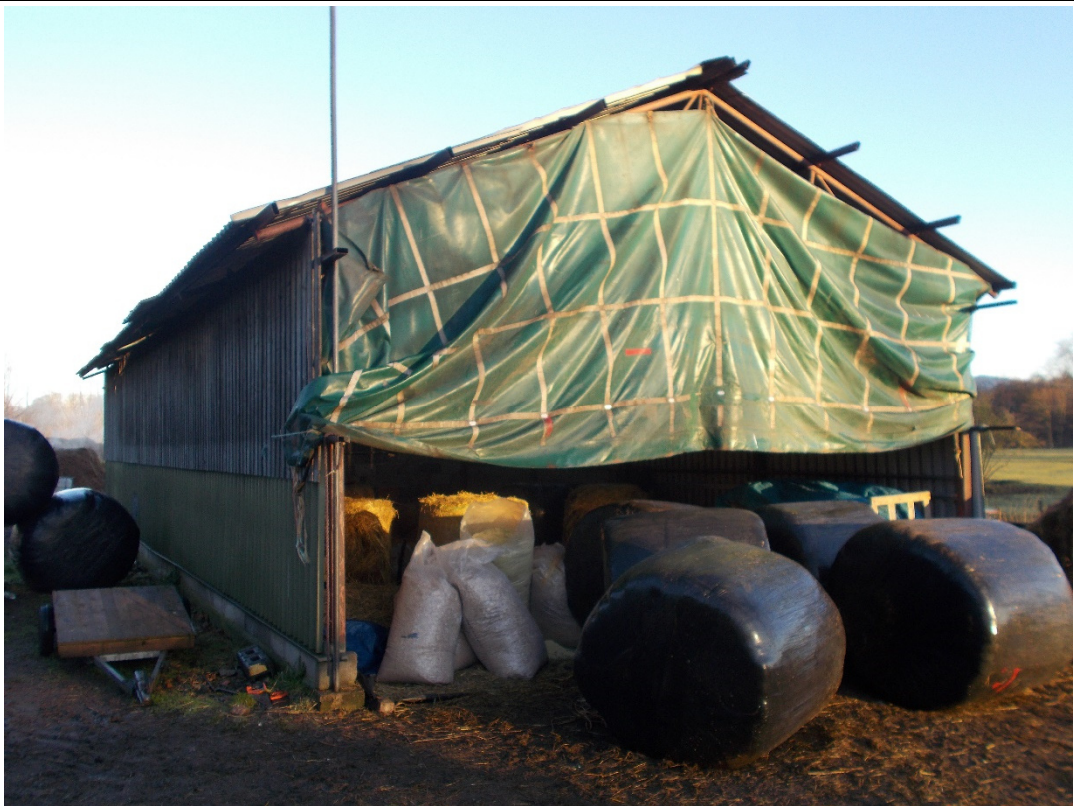
**Photograph 2: External view from south west**

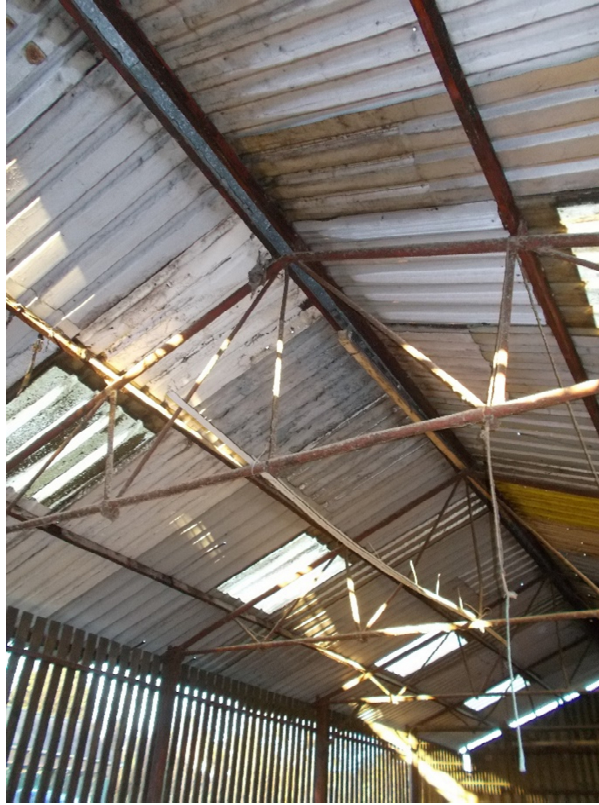
Longitudinal stability is achieved through embedment of steel posts into a low-level concrete plinth. Transverse stability is again achieved through embedment of posts into the plinth and through provision of braced connections between top of posts and underside of steel roof trusses (see photographs 3 – 5 for internal views on the steel frame).

The steel frame was seen to be well constructed remaining 'true' in respect of line, level and plumb. No significant corrosion was observed throughout any of its members.

**Photograph 3: Internal view on steel roof structure**

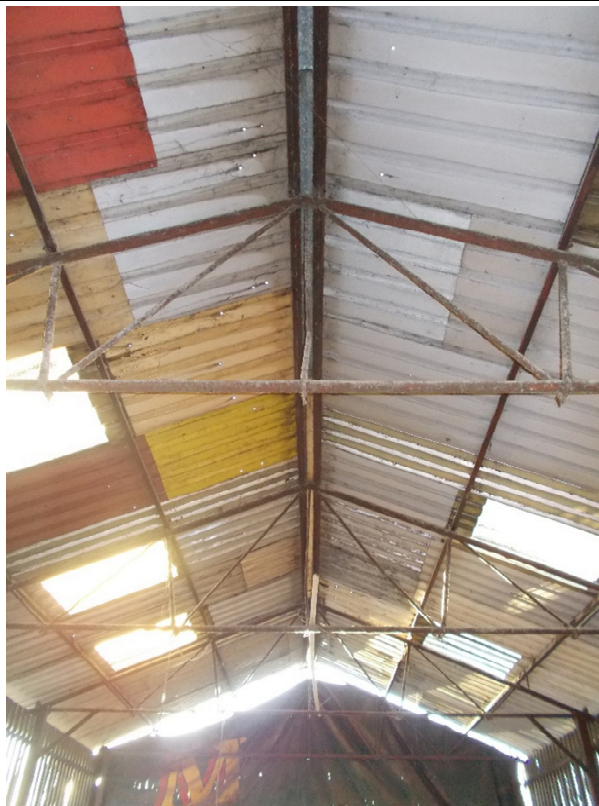
**Photograph 4: Longitudinal view on steel roof structure**

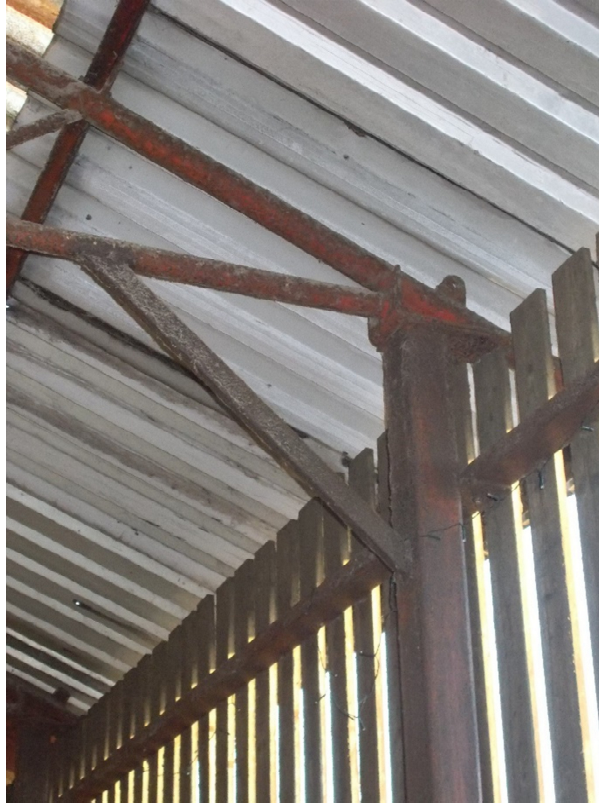
**Photograph 5: Steel eaves detail**
