THE BARN, CLIFFE HOUSE FARM, CUBLEY,  
PENISTONE, SOUTH YORKSHIRE S36 9FR

for GEMMA GARNHAM & KEVIN COOPER

MAY 2017 (Rev A OCT 2017)

## 1.0 CONDITION REPORT

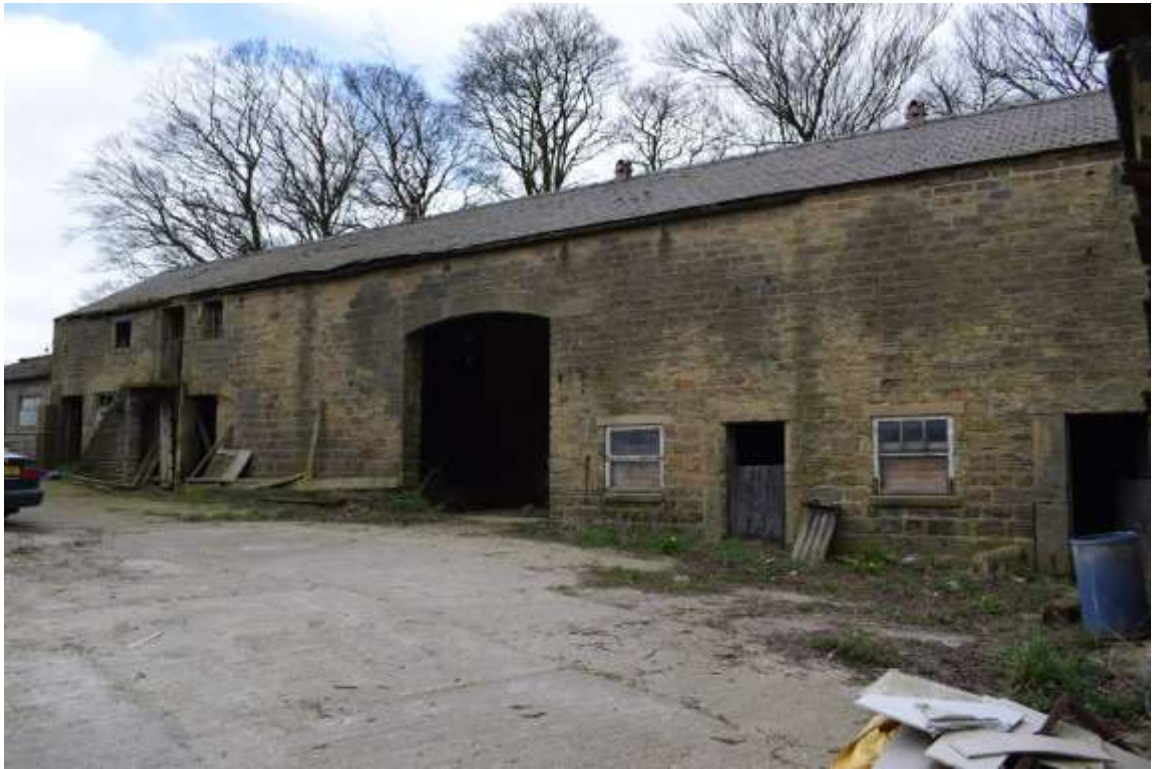
**Fig 01.** Front elevation of The Barn, Cliffe House Farm

The blue Welsh slate roof generally is in reasonable condition with very little evidence of rainwater ingress internally. The front pitch (**Fig's 01, 06, 08 & 10**) has some undulation to the slating above the spine wall between the threshing floor and the southern hay loft and above the southern hay loft truss which is allowing rainwater to blow up the slates and into the building.

Very little of the moulded timber gutter remains, a number of eaves slates have lifted and as a result in a number of places there is moss and lichen growth on the stonework below eaves indicating long term saturation. Apart from the undulations and raised eaves slates very few of the remaining slates to the front (eastern) pitch have cracked or slipped. The blue glazed ridge tiles also appear in reasonable condition though some of the mortar bedding has cracked and come away. The glazed terracotta ridge vents are also in good condition. There is some moss growth generally in the vertical joints between the tiles.

The roof is to be stripped, the moss and lichen cleaned off the slates, a breather membrane introduced and the roof re-laid on treated softwood battens with copper or stainless steel fixings ensuring as many of the existing slates as possible are retained and those missing or crack are replaced with like for like (ensuring a good match to avoid the finished roof looking patchy). The ridge tiles are to be bedded on lime mortar finished to a neat fillet. The rotten moulded timber gutter and any missing cast iron gutter brackets are to be replaced with like for like.

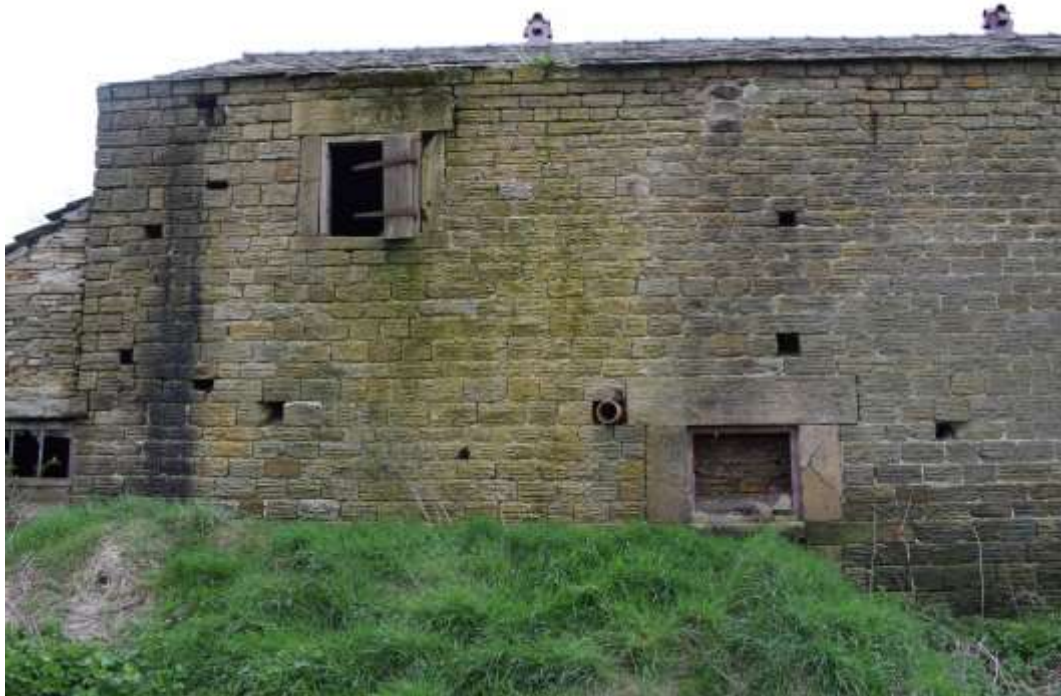
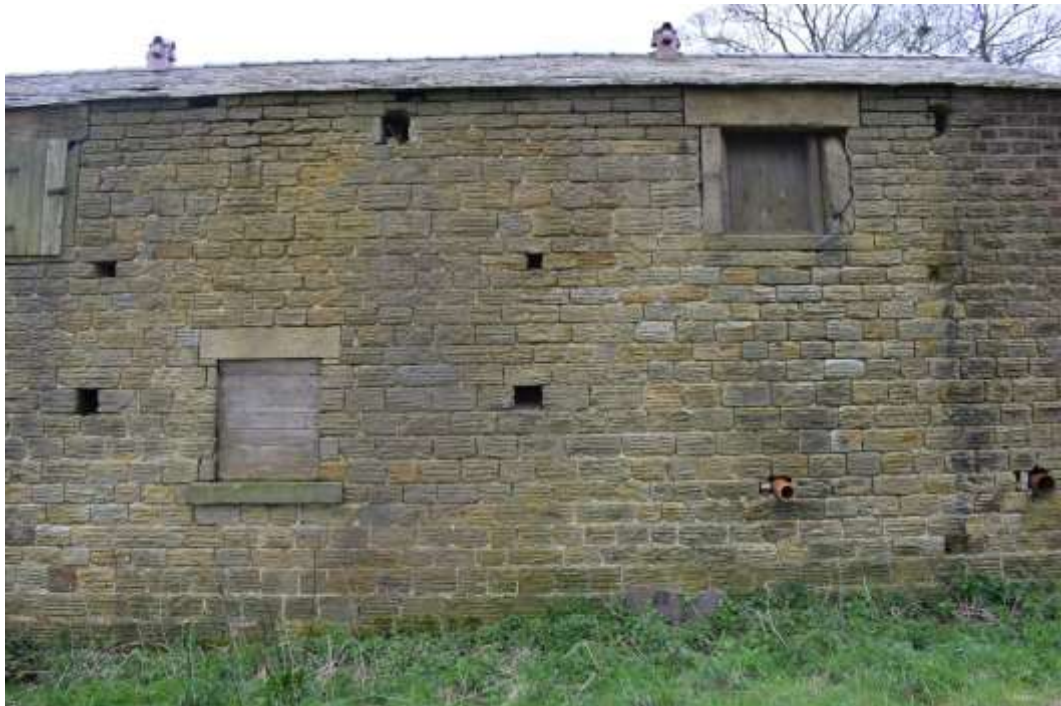
The rear (western) pitch (**Fig's 12, 13, 15 & 24**) is in slightly poorer condition with a number of strap repairs which have been introduced to prevent the slates slipping where the fixings have corroded. There are also some slipped and broken slates which are allowing rainwater ingress. This western pitch does not appear to have the same moss growth as the eastern pitch but there is a lichen bloom throughout this pitch due to the close proximity of the mature trees within the paddock further west.

A number of stone jambs have split (the door and window at the top of the external staircase, both cowhouse doors facing the yard, the cowhouse door to the rear elevation and all three pitching eyes to the rear elevation) and require some repair. Some will simply require pinning with stainless steel ties but others, where parts of the stone have come away, will require some careful piecing-in. Repairs should be minimal to ensure as much historic fabric as possible is retained.

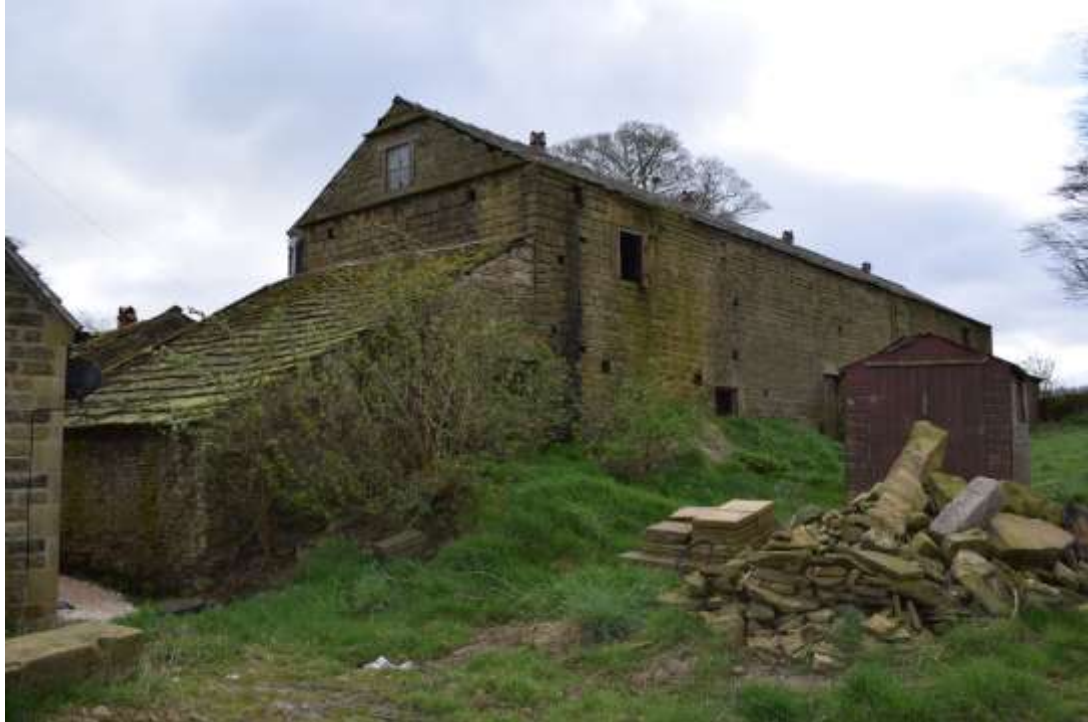
**Fig 15.** *The lean-to link building at the junction between the combination barn and the cart shed range*

The roof of the lean-to link building between the barn range and the cart shed range (**Fig. 15**) is stone slated, mono-pitched and undulates like a wave (the ridge where it abuts the northern gable of the barn is not level so this may be a characteristic of its original construction rather than structural movement). The eaves height of this building is low and

this compromises the useable internal floor space (the internal floor level being higher than the external ground level along the northern elevation which faces the converted shelter shed). Subject to the necessary approvals this building is to be increased in height and its stone roof slates set aside for re-use.

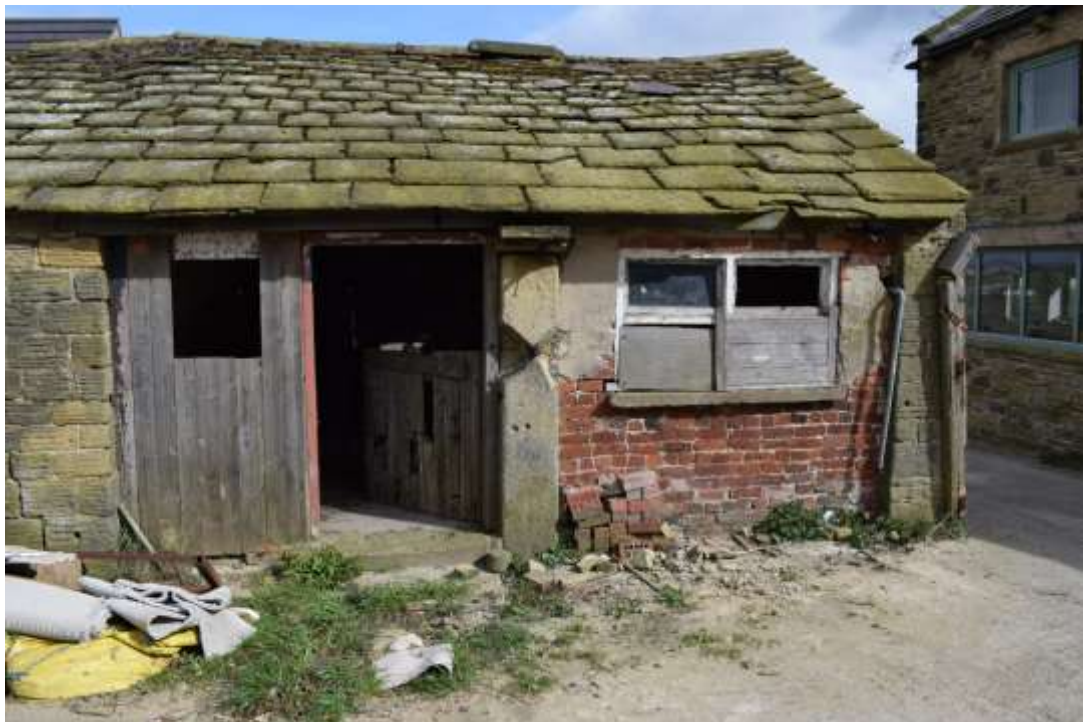
**Fig 16.** *The pair of cart stores at the eastern end of the cart shed range*

The southern pitch, facing the yard, (**Fig's 16 & 17**) is in a similarly poor condition with a high proportion of slipped slates. The roof is of truss, purlin and rafter form but the tie beams are set low (around 2m which is level with the door lintels) which restricts the headroom and potential use of this range.

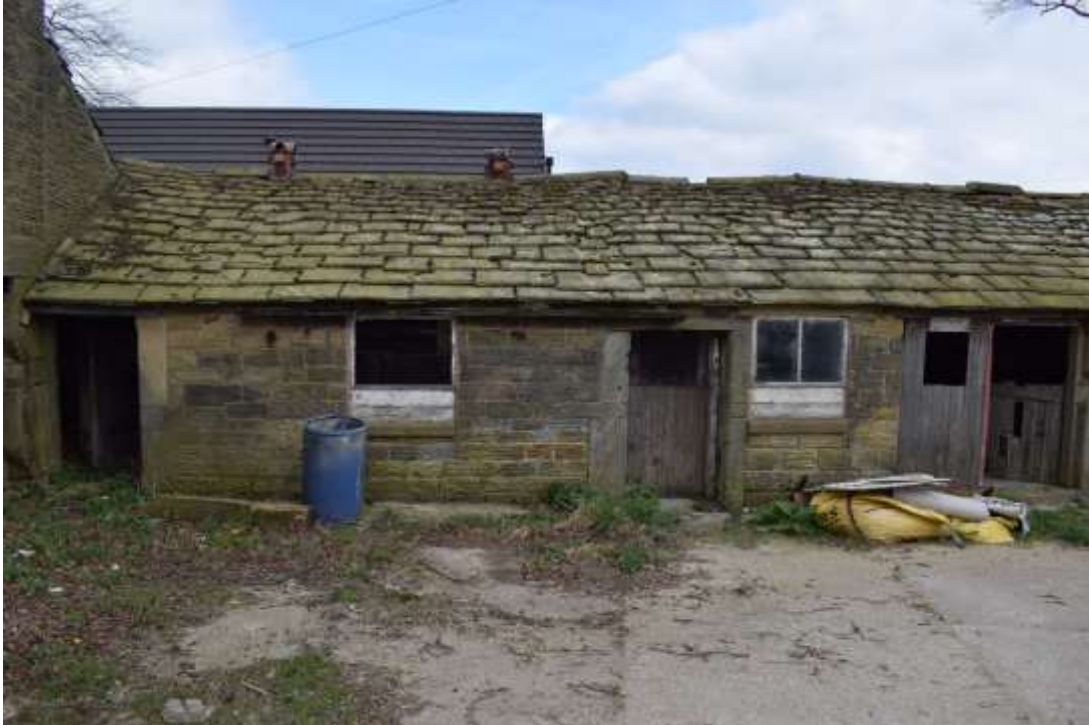
**Fig 17.** The western end of the cart shed range at the abutment with the barn

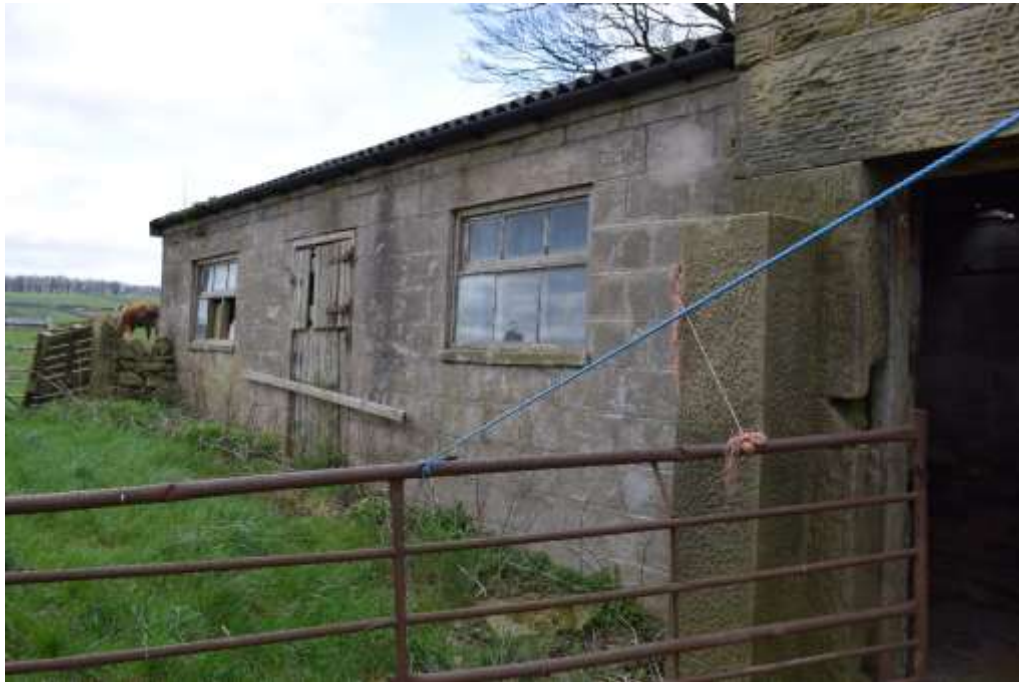
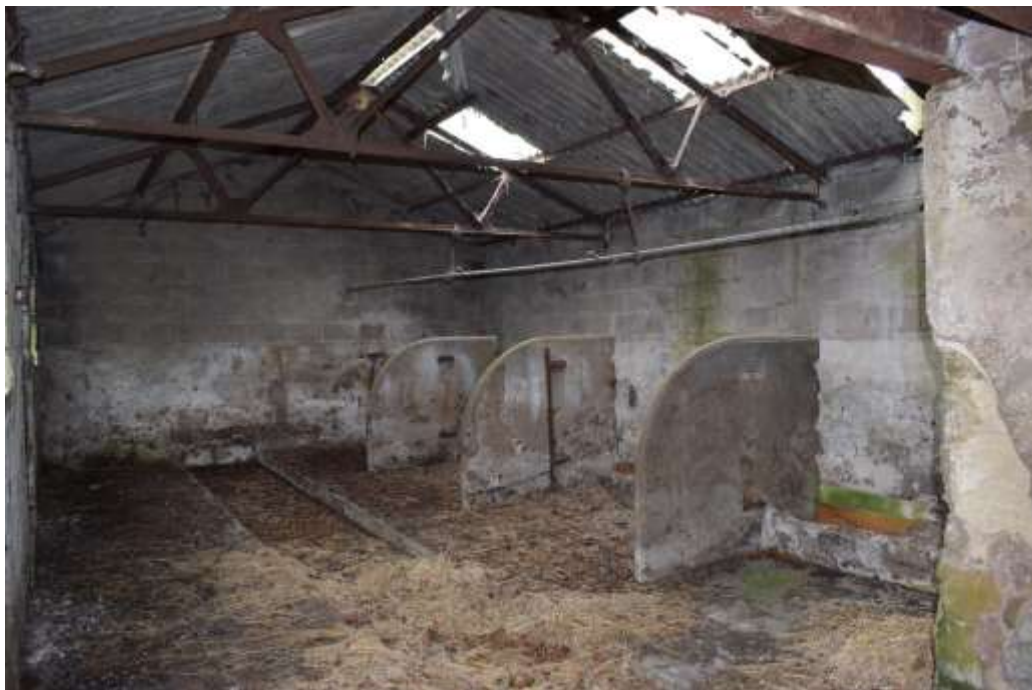
At the southern end of the barn is a mid-20<sup>th</sup> century blockwork extension which served as a milking parlour (**Fig's 19 & 20**). The profiled asbestos roof sheeting is supported by slender and shallow steel trusses. This structure has no aesthetic or constructional contribution to make to its historic setting and is to be demolished and re-built to current building standards on its original footprint but reduced slightly in length to allow access around the southern end of the building into the rear garden and paddock.

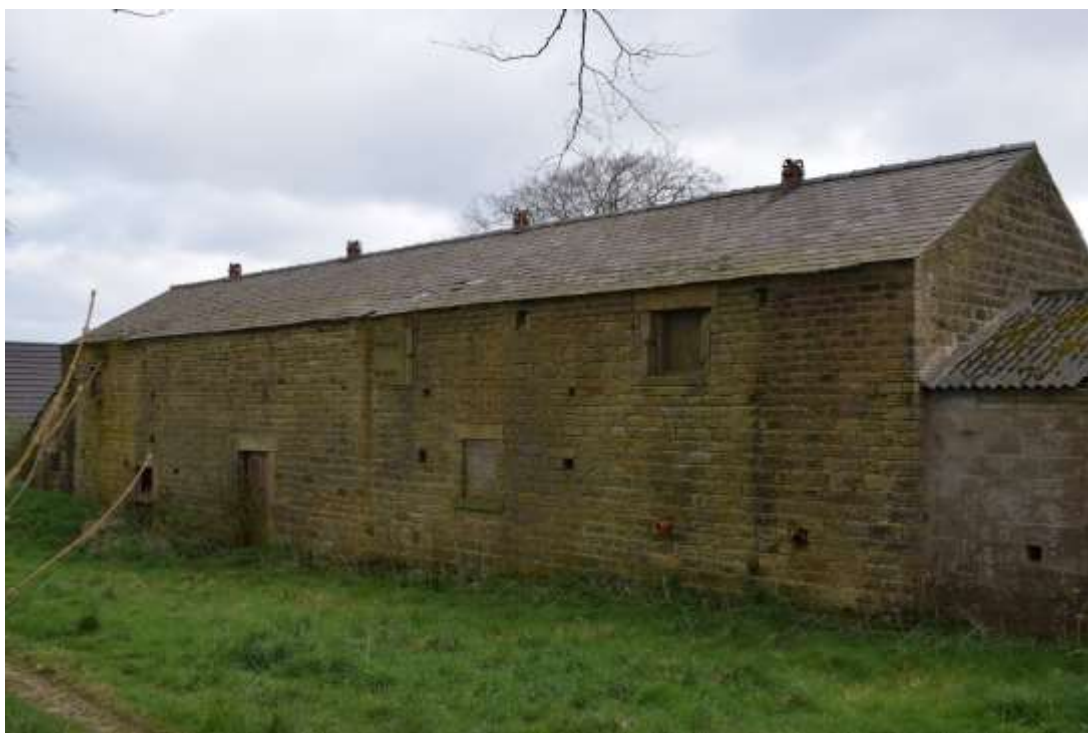
**Fig 24.** *The rear (western) roof pitch showing the strap repairs and the lichen bloom*

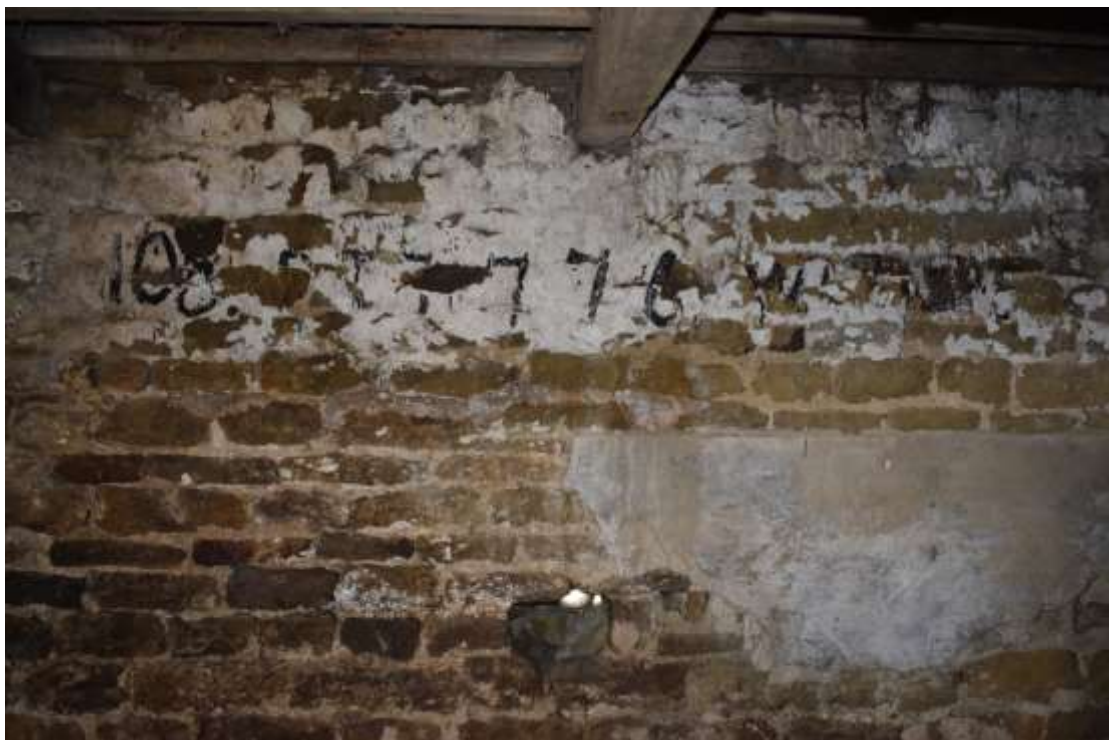
**Fig 25.** The internal face of the rear wall in the southern milking parlour (former oxen stable).

Within the milking parlours the walls have been finished up to a height of between a metre and a metre and a half with cement render (**Fig. 25**). This is to be very carefully removed with hand tools taking care not to damage the stonework beneath in the process and re-pointed with lime mortar. Any existing limewash is to be brushed down to remove any flaking areas but otherwise retained.

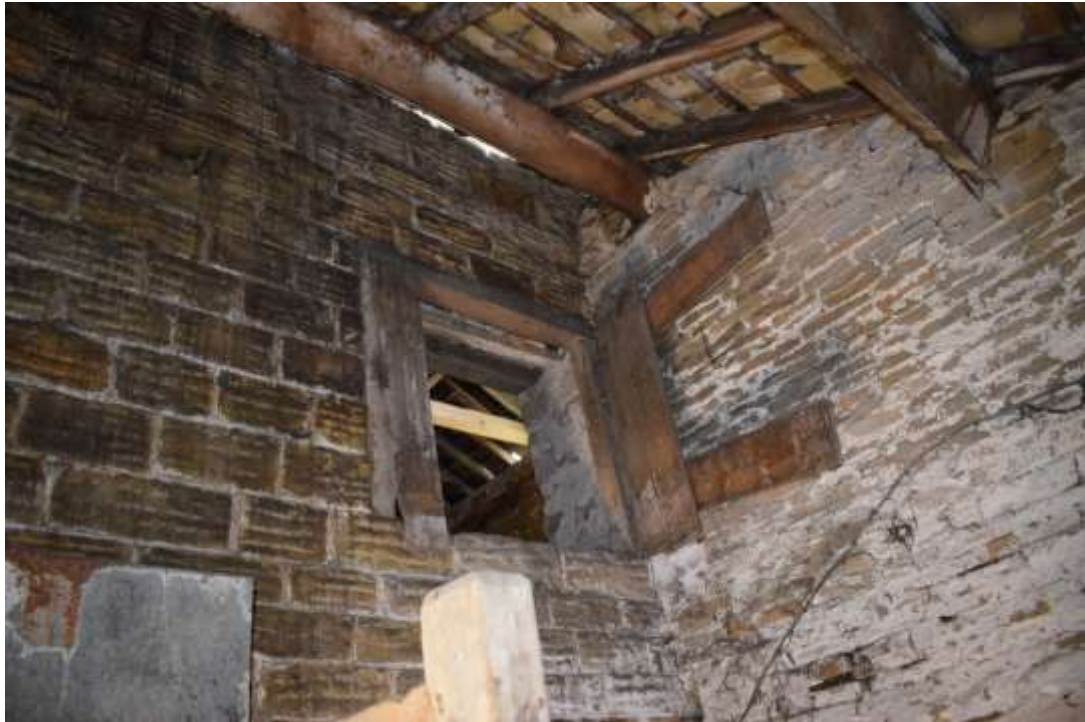
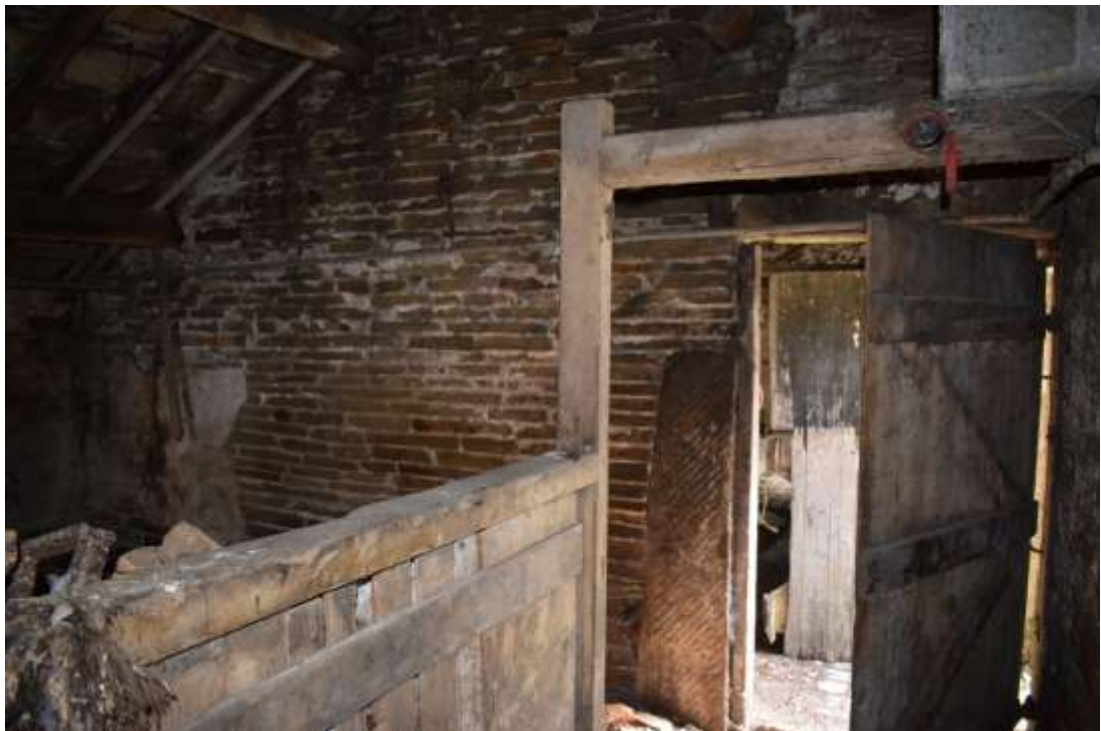
The masonry walls internally have been bedded on lime mortar (much of this is still present) and finished with limewash (**Fig's 26 & 27**) which is to be brushed down and retained. The relatively recent stall enclosures are to be removed and disposed of off-site, recycling wherever possible.

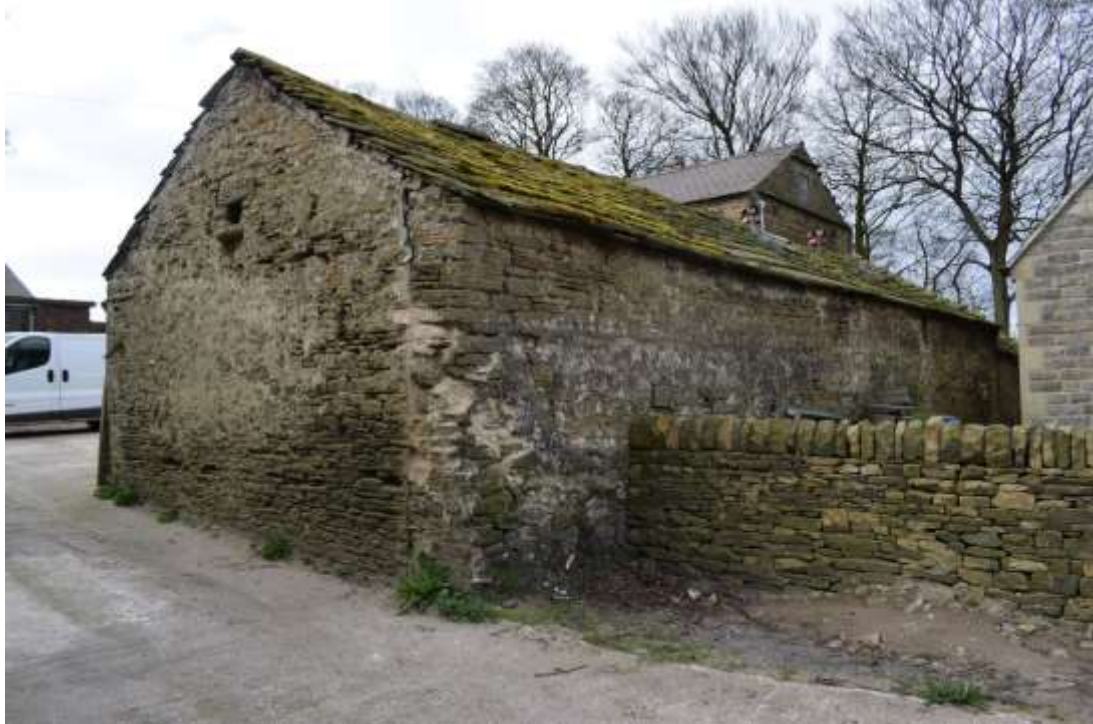
The roof of the cart shed range is also stone slated and dual pitched (**Fig's 01, 16 & 17**). The northern pitch (**Fig. 28**) is covered in moss (a mature tree which grew tight up against the northern elevation has recently been felled and is the likely cause of this) and has a number of broken, slipped and delaminating slates.

**Fig 28.** The north-eastern corner of the cart shed range from the north which frames the only vehicular access into the farm yard.
