Pudding Hill, Park View, Brierley, Barnsley

Yorkshire Housing Ltd c/o  
Acanthus Architects  
Woodhall  
Woodhall Lane  
Leeds  
West Yorkshire  
LS28 5NY

25<sup>th</sup> November 2012

BA3857

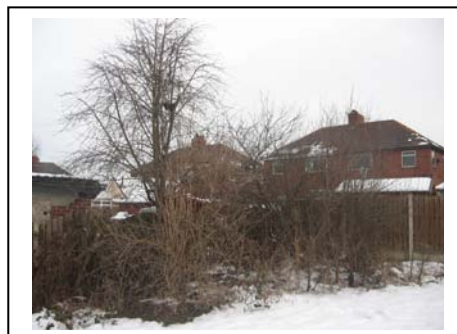
2.13.1 The group of trees T1 & T2 in the northern corner as shown opposite; are beginning to compete for space and would benefit from thinning out.

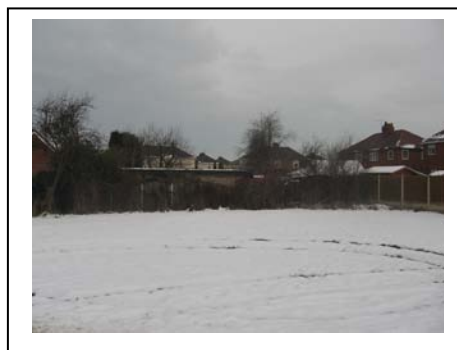
2.13.2 The line of trees on the western boundary T5 to T12 have become established close to the neighbouring fence as shown opposite. Several of the trees are located close to the boundary fencing and damage is visible. These trees are not expected to be sustainable in the short to medium term without site management changes. Ideally the boundary should be confirmed before management of the group is finalised as the position of trees may straddle the boundary and need joint agreement.

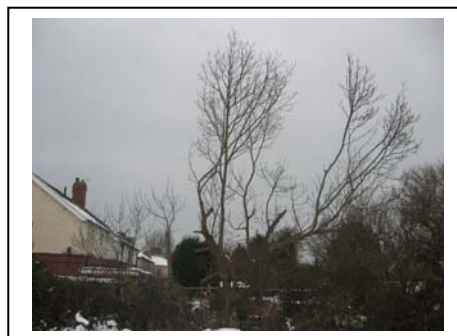
2.13.3 The most dominant tree T11 Ash which is located in the neighbouring garden. The main stem does suggest possible internal issues and ideally, this should be assessed more closely. As shown in the photograph opposite this tree as been lopped/topped (In addition to T12 also located off site). The resultant regrowth and localised stem decay does pose a risk to the site in the near future. Ideally the owner should be encouraged to either remove the tree entirely or to maintain the tree at a lower height so the risk to both sites can be controlled to a degree.
