ARBORICULTURAL REPORT

& Impact Assessment

***Darton Park,
Darton,
Barnsley,
South Yorkshire
S75 5LZ***

Reference: AWA2564

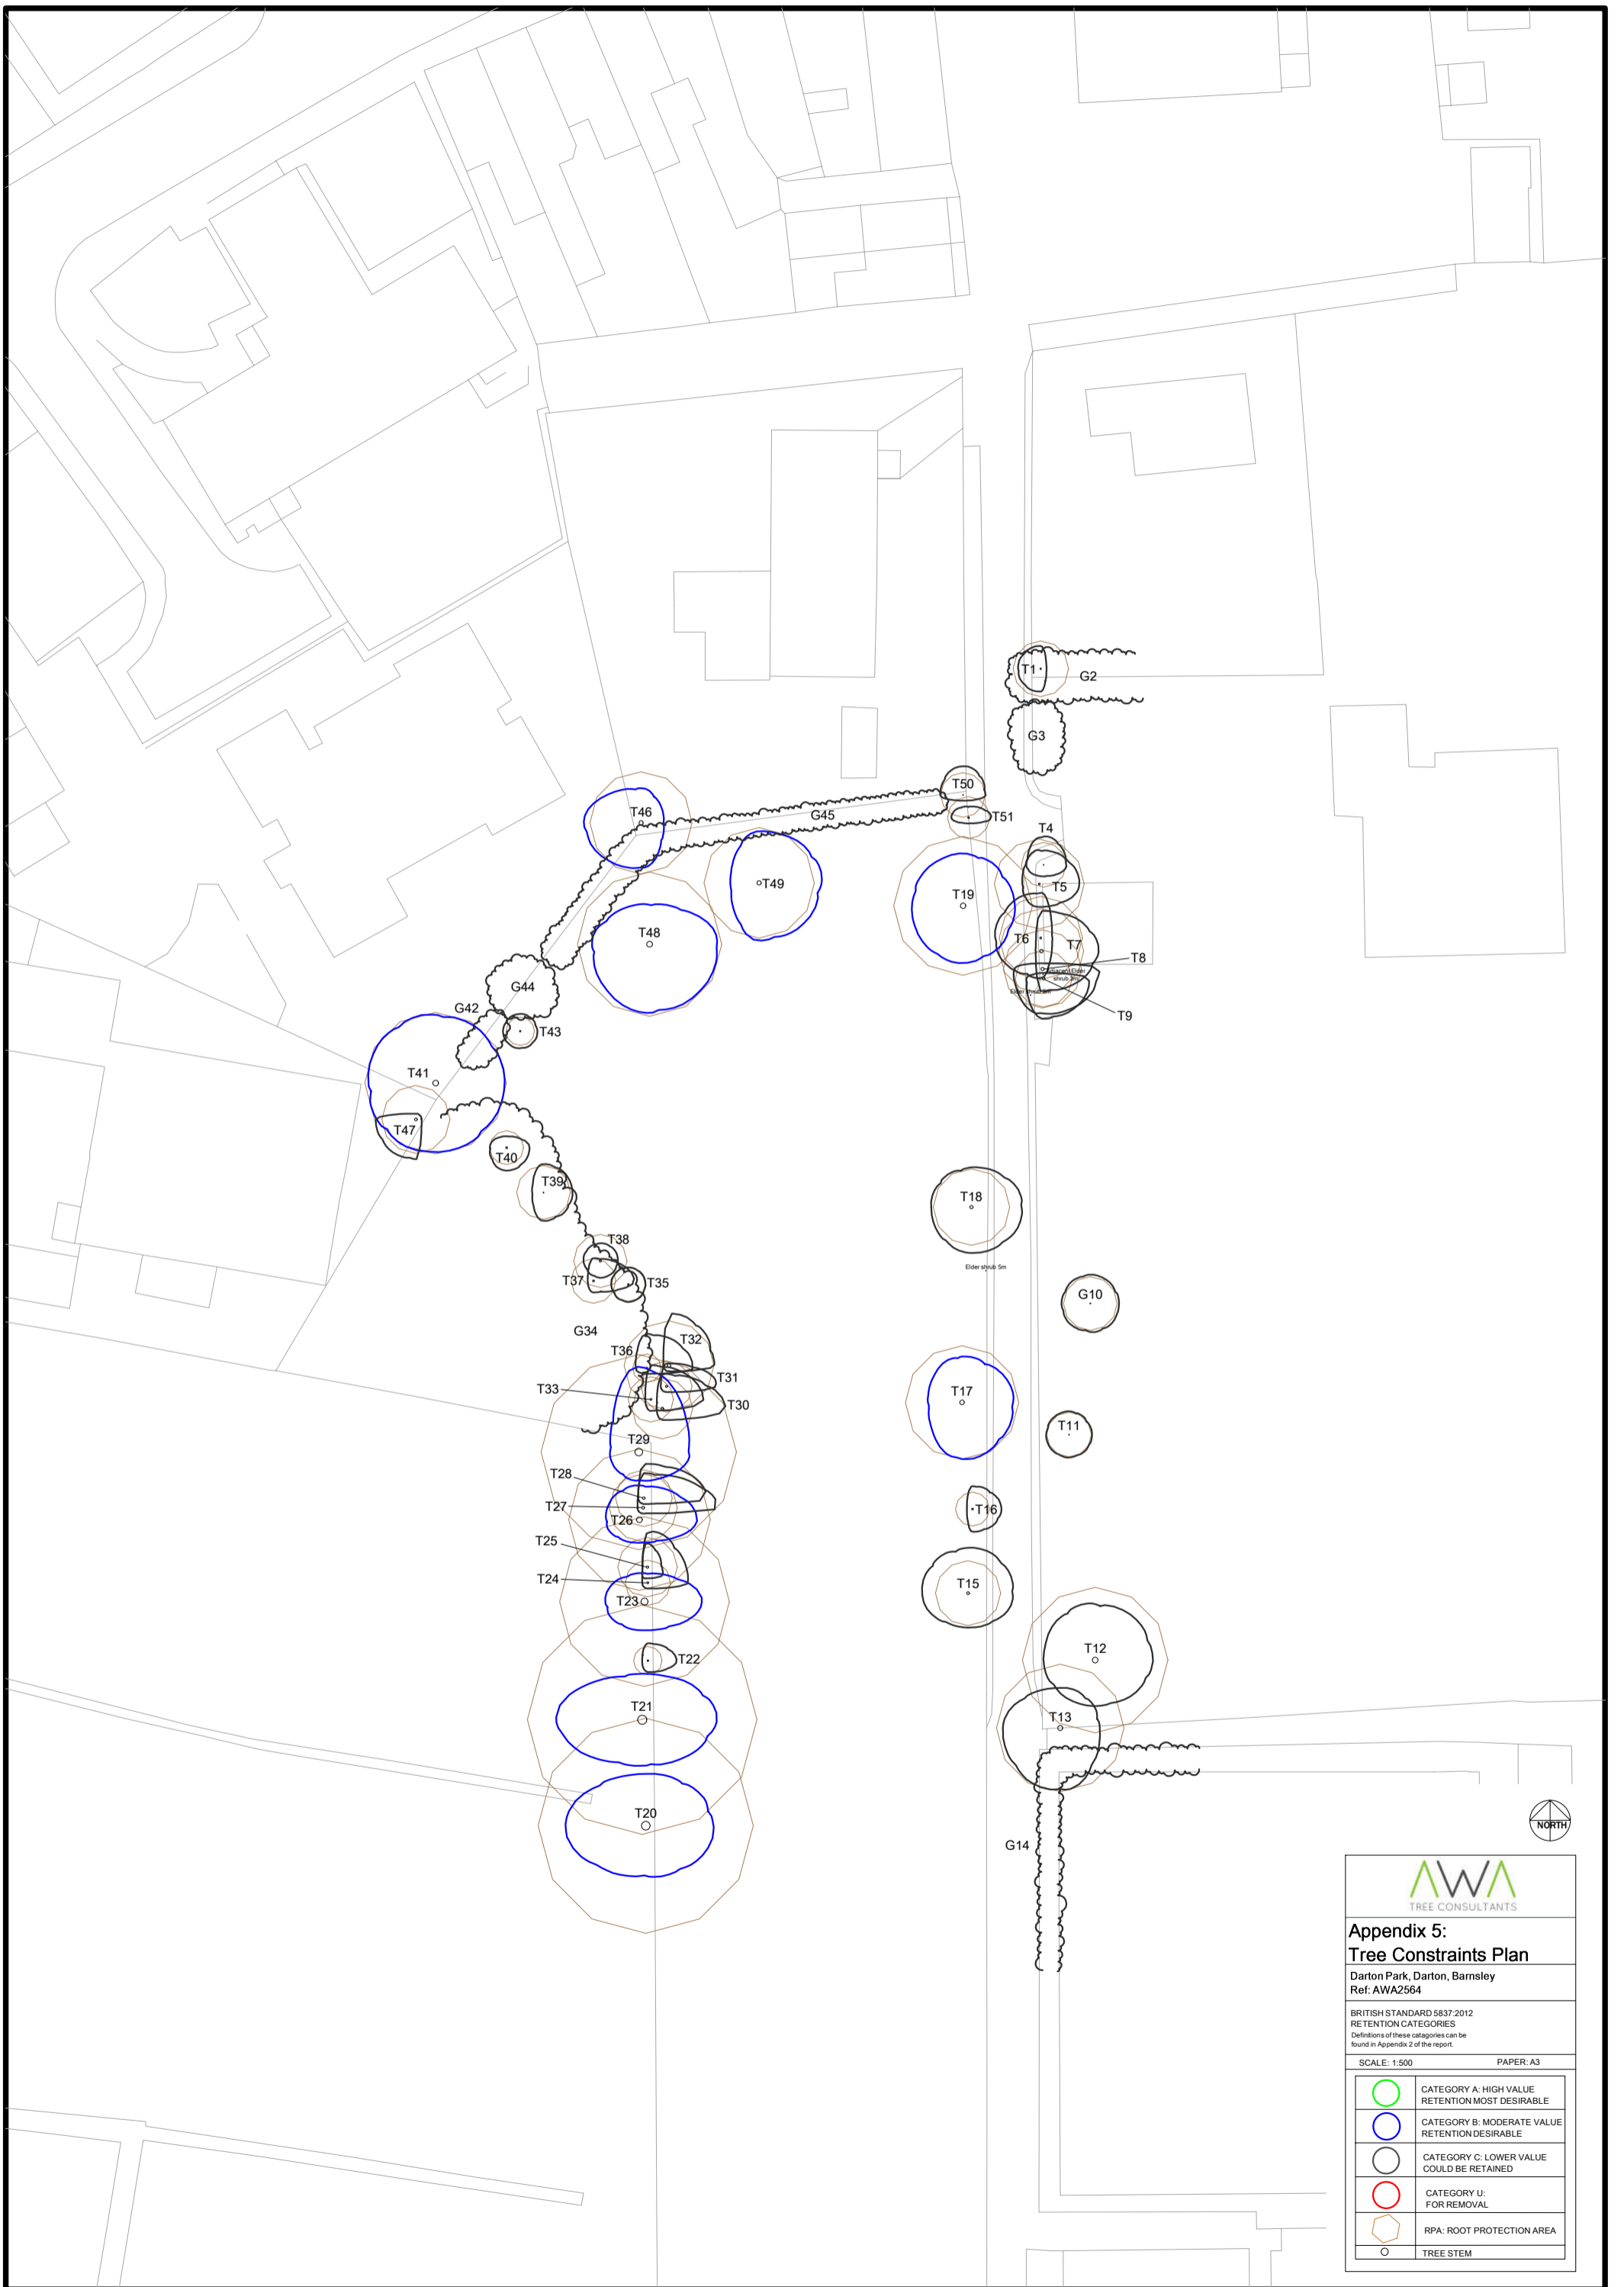
Appendix 5:
Tree Constraints Plan
 Darton Park, Darton, Barnsley
 Ref: AWA2564

- 3.2.9 The tree Root Protection Area (RPA) detailed on the Tree Constraints Plan at Appendix 5, has been used as a layout design tool, to inform on the area around a tree where the protection of the roots and soil structure is treated as a priority.

- 3.2.11 The RPA for each tree has been plotted as a polygon centred on the base of the stem. Due to the presence of roads, structures, topography (and past tree management) the RPA is likely to be a simplified representation of the tree roots actual morphology and disposition. However, detailed modifications to the shape of the RPA would largely be based on conjecture and so have been avoided.

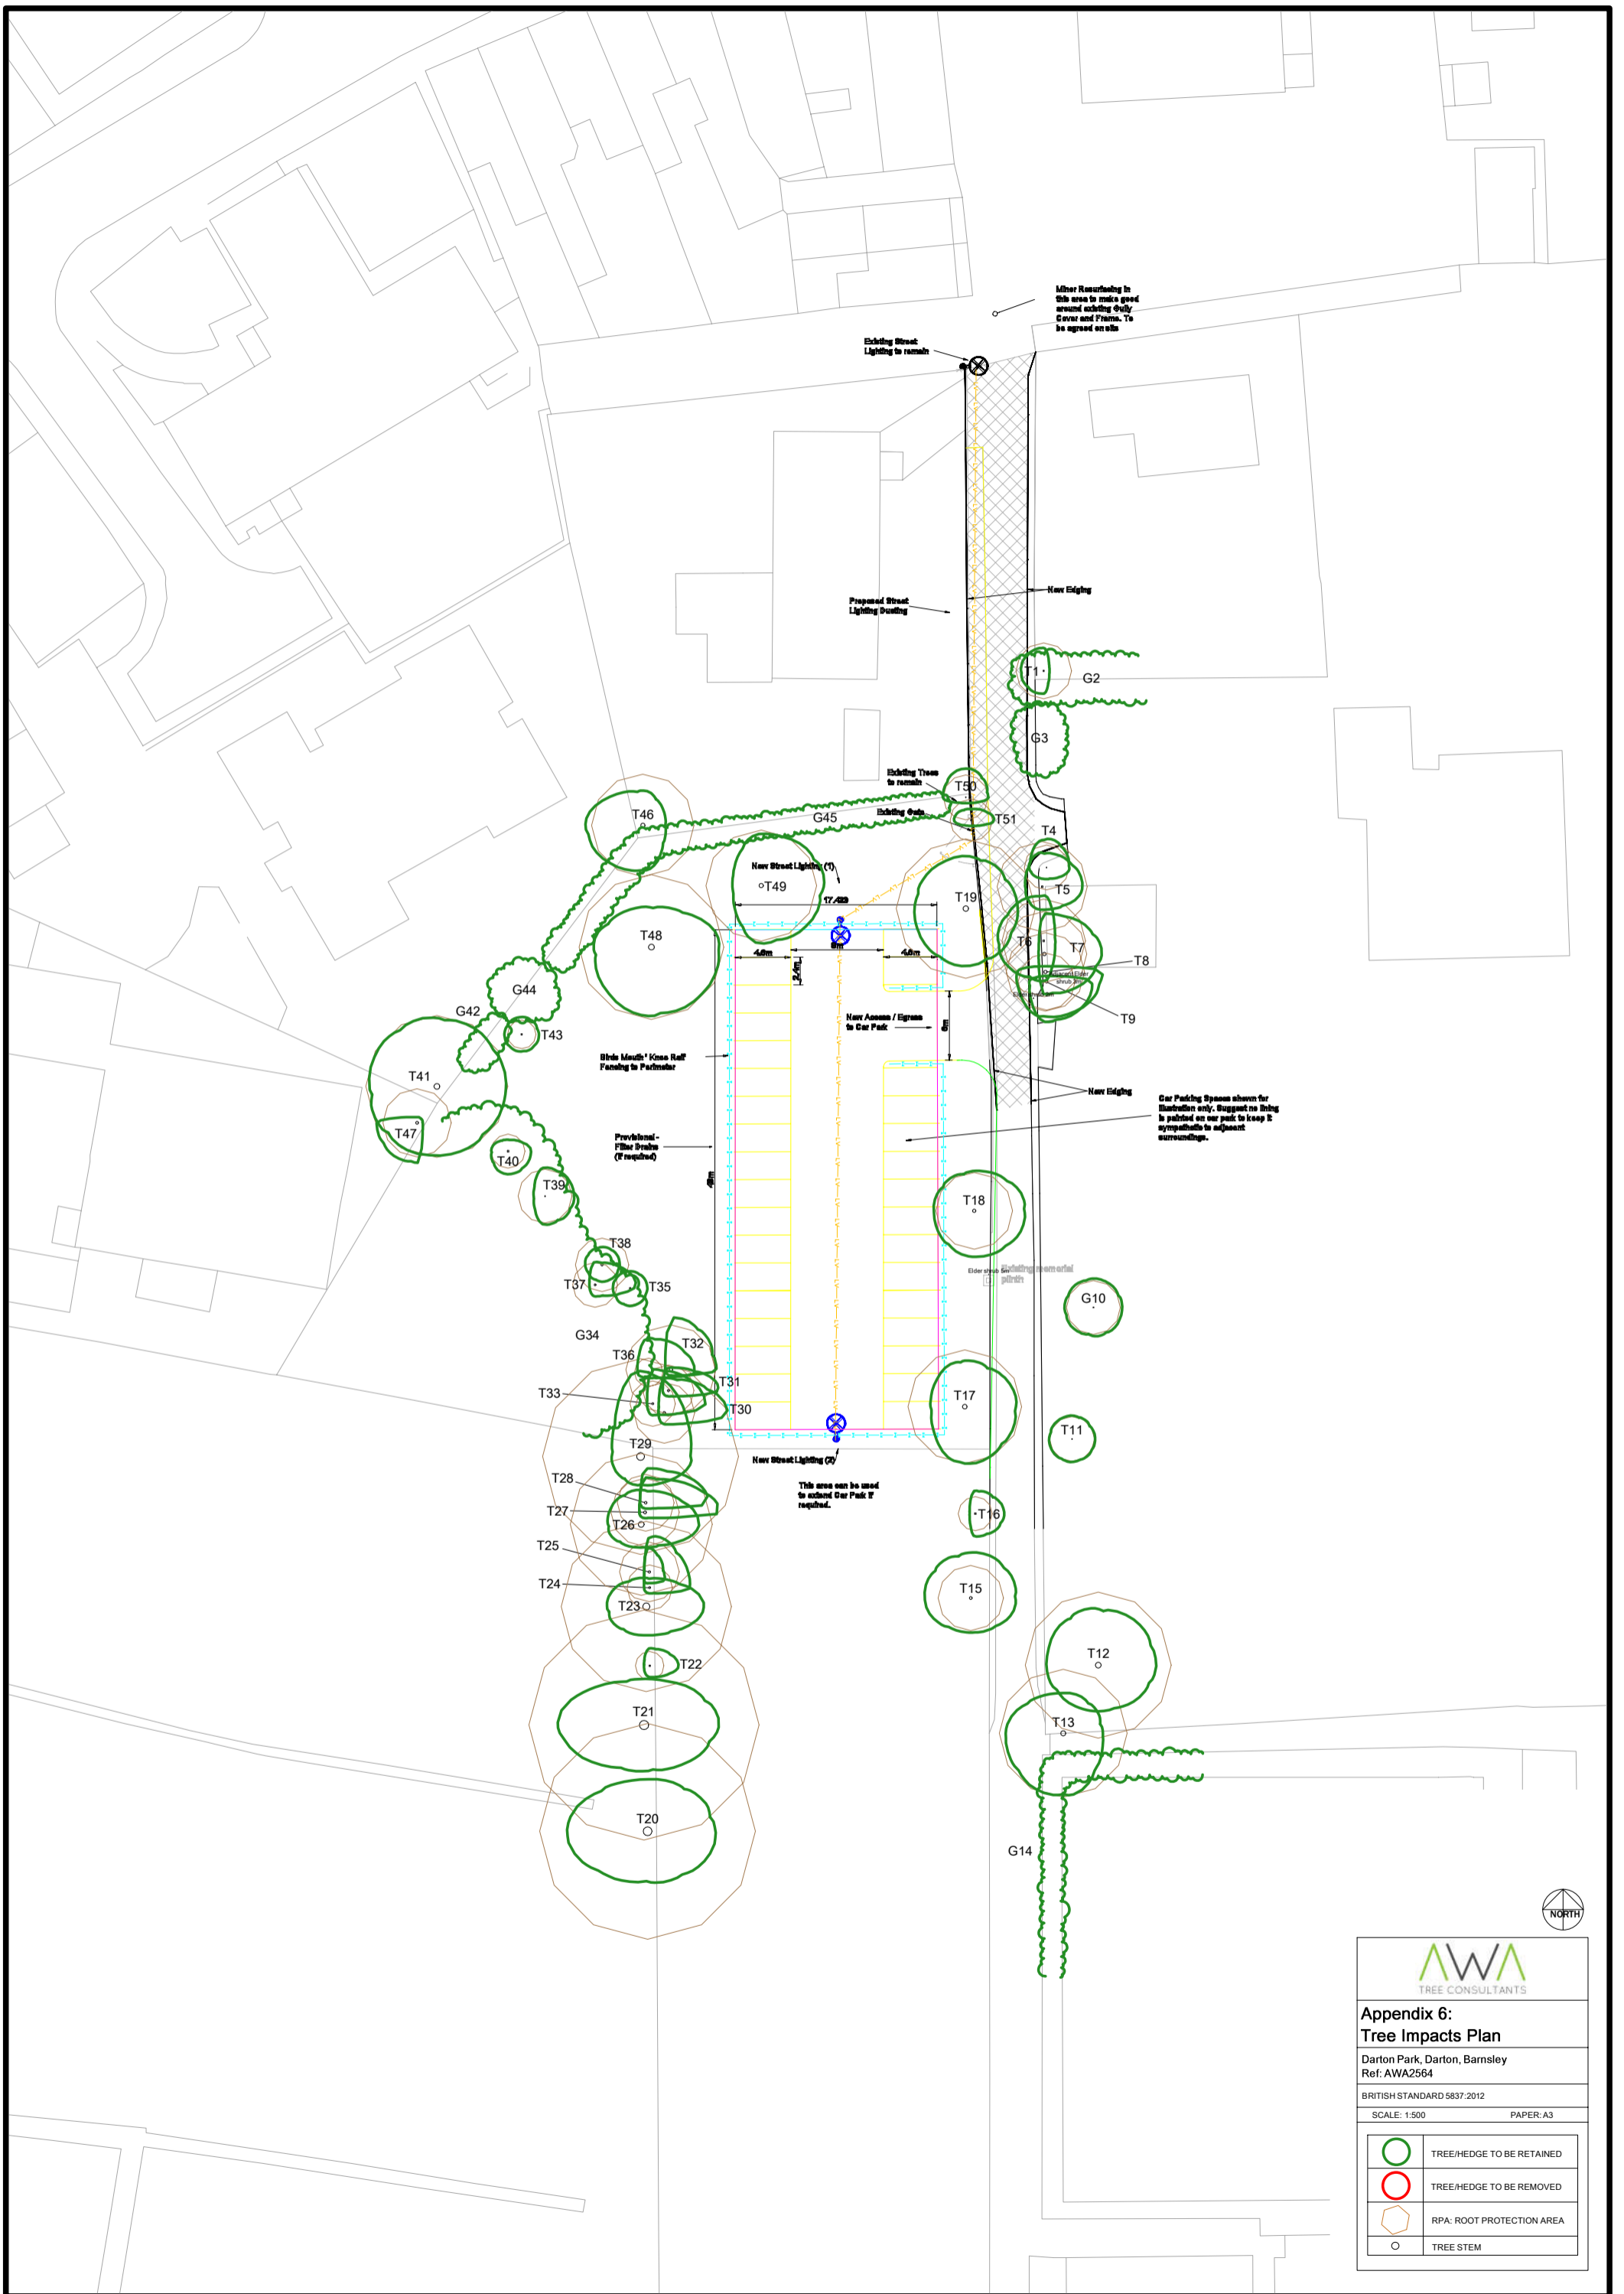
Appendix 6:
Tree Impacts Plan
 Darton Park, Darton, Barnsley
 Ref: AWA2564
 BRITISH STANDARD 5837:2012
 SCALE: 1:500 PAPER: A3

4.3.2 Potentially damaging activities are proposed in the vicinity of retained trees. The proposed new car park encroaches into the edge of the retained Whitebeams T17, T19 and T49 and Lime T18. However, the encroachment is minor, as such, the retained trees should remain largely unaffected by the works, provided care is taken during construction so that tree roots are damaged as little as possible.

4.3.3 The proposed resurfacing of the existing access road and footway will take place within the RPA of retained adjacent trees T1 to T9. However, as there is an existing access road in place and the proposal is to resurface the existing road, the retained adjacent trees should remain largely unaffected by the works, provided care is taken during construction so that tree roots are damaged as little as possible.

4.3.4 The proposed new 'birds mouth knee rail fencing' to the perimeter of the car park is within the RPA of retained trees T17, T18, T19, T29 and T49. The encroachment into the trees' RPA should not significantly adversely impact on the health or future condition of the trees, provided post type footings

- 4.5.1 The retained trees will require protection by fencing in accordance with BS 5837: 2012, during the development phase.
- 4.5.2 If required by the Local Planning Authority, an associated Arboricultural Method Statement, detailing protective fencing specifications and construction methods close to the retained trees can be provided.
