STRUCTURAL REPORT - EXISTING BARN BUILDING RESIDENTIAL ANNEXE CONVERSION FOR WOODLAND VIEW

Proposed Two Bedroom Annexe ancillary to an existing property known as
Woodland View, Anchor Farm, Elmhirst Lane, Dodworth, S75 4LD

Report Ref: TH/Woodland View/Struct/02/Sept2020/v.01

2nd September 2020

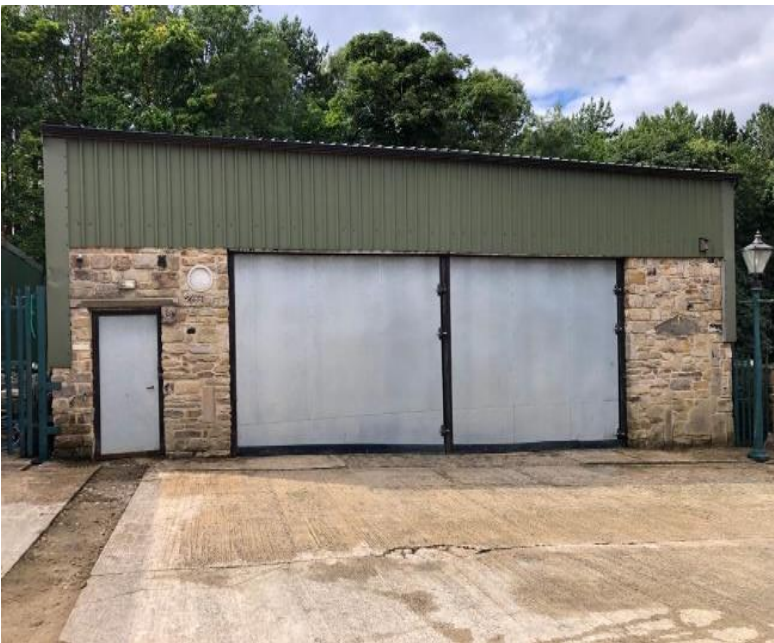
2.1 EAST ELEVATION (FRONT)

On the east elevation at the (main) front of the building facing the courtyard area the general structure of the building is plumb and exhibits no signs of substantial (or any) movement and/or significant damage.

The structural fabric requires only very nominal repairs and minor alterations and it is capable of full retention with no major (or any) areas of deflection and no requirement to remove and/or replace large sections (although there may be a requirement to consider appropriate fire protection etc.).

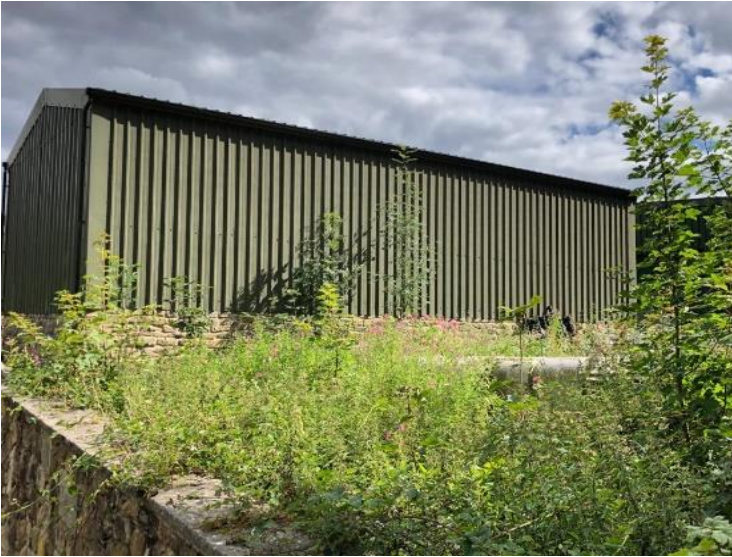
2.2 WEST ELEVATION (REAR)

The west elevation (rear) is plumb and exhibits no signs of substantial (or any) movement and/or significant damage.

The roof structure is also fully intact and stable, and whilst there may be some fabric repairs and infilling etc., the roof fabric and skeleton is considered capable of retention with no requirement to remove and/or replace large structural sections (although there may be a requirement to consider appropriate fire protection & aesthetic effects etc.).

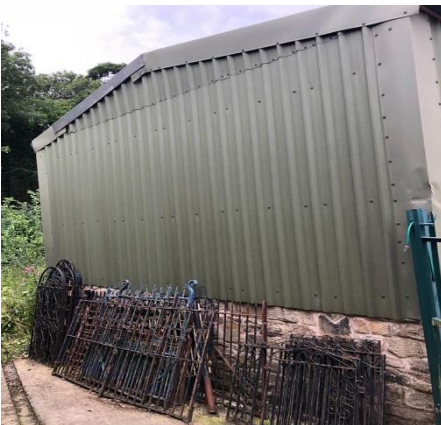
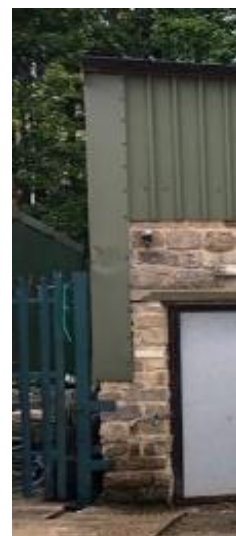
2.3 NORTH ELEVATION (SIDE)

On the north elevation at the LHS of the building as viewed from the front the general structure of the frame is plumb and exhibits no major signs of structural movement and/or damage.

The fabric cladding requires some nominal repairs but in the main the structure is capable of full retention.

The roof shows no signs of deflection and there is no immediate requirement to remove and/or replace large sections.

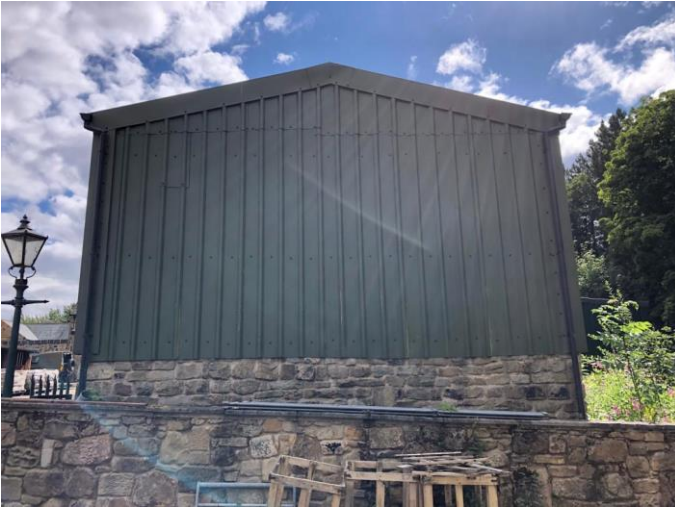
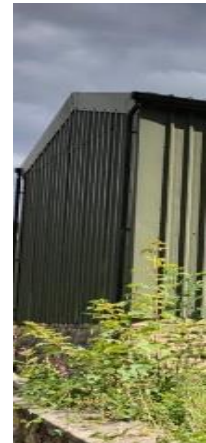
2.4 SOUTH ELEVATION (SIDE)

The south gable to the RHS is plumb and in good general order. It exhibits no signs of structural deflection and/or damage. The gable elevation is fully capable of retention with no areas of bulging / deflection and no requirement for extensive replacement / repairs.

The south elevation RHS as viewed from the front is plumb and exhibits no signs of structural deflection and/or significant damage.

No alterations will be required and in general the fabric is fully capable of retention with no areas of bulging/deflection and no requirement to repair by any means of disruptive dismantling or rebuilding.
