**BARNBURGH LANE, GOLDTHORPE  
for Gleeson Homes & Regeneration**

**TREE SURVEY**

**Popplewell**

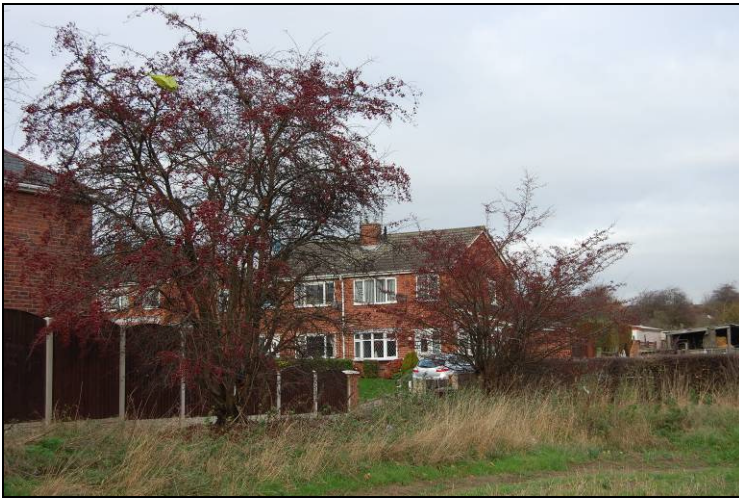
**Photo 1:**

| Tree number on dwg | Species | Height (m) | Stem diameter (mm) | Branch spread (m) | Age class | Crown clearance (m) | Physiological condition | Estimated remaining contribution (years) | Category grading | Notes / Structural condition | Preliminary management recommendations |
|---|---|---|---|---|---|---|---|---|---|---|---|
| T1 | Hawthorn | 5 | 500b | N 2.5<br>S 2.5<br>E 2.5<br>W 2.5 | M | 0 | Fair | 20-40 | C1 | Multi-stemmed from base. Topped at 1m in past leaving detached stubs and new shoots. Dense. Crossing branches. Limited individual value. Relatively easy to replace if lost to development. | No action. |
| G2 | 3Nr Hawthorn<br>1Nr Elder | 6 | <350b | As plan | M | 0 | Fair | 20-40 | C2 | Multi-stemmed crowns. Elder with significant deadwood. Crossing branches. Some decaying stubs. Reasonable shape and form. Limited individual value. | No action. |

View of the Hawthorns G2 (left) and T1 (right) which are located in the north west corner of the site.

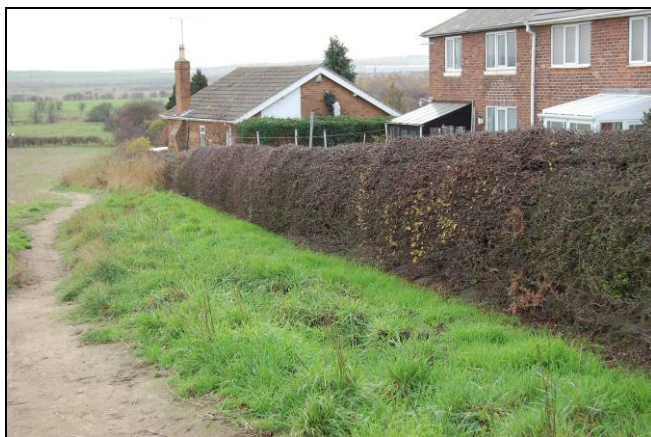
**Photo 3:** ▲

| Tree number on dwg | Species | Height (m) | Stem diameter (mm) | Branch spread (m) | Age class | Crown clearance (m) | Physiological condition | Estimated remaining contribution (years) | Category grading | Notes / Structural condition | Preliminary management recommendations |
|---|---|---|---|---|---|---|---|---|---|---|---|
| H6 | Hawthorn | 1.5 | | 1m wide | MA | 0 | Good | 20-40 | C2 | Regularly pruned. Foliage to base. Dense. No major visual defects. | Continue to maintain. |

View south of H6 (Hawthorn hedge) which travels along the western boundary of the site.

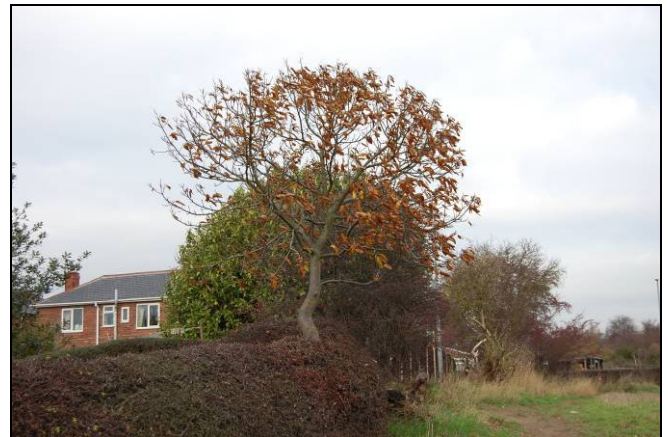
**Photo 4:**

View south from Barnburgh Lane looking at H18 to the left of the view which runs along the eastern boundary of the site. G16 and G17 can also be seen beyond this hedge. H13 can be seen to the centre of the view, located along the southern boundary with G9 and T10 also visible to the right.

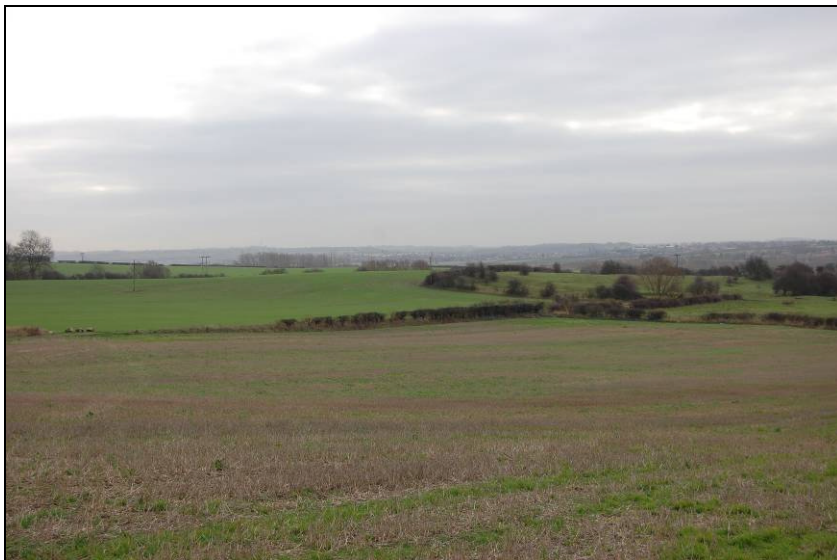
**Photo 5:**

View south east to the bottom corner of the site. H15 can be seen to the left of the view with H13 to the right travelling along the southern boundary of the site.

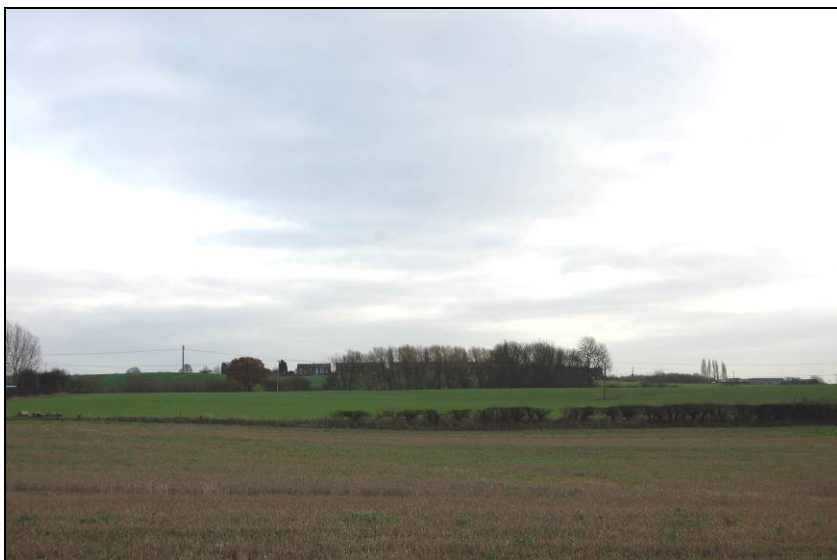
**Photo 6:**

View east from the centre of the site. H15 can be seen in the foreground travelling along the eastern boundary of the site.

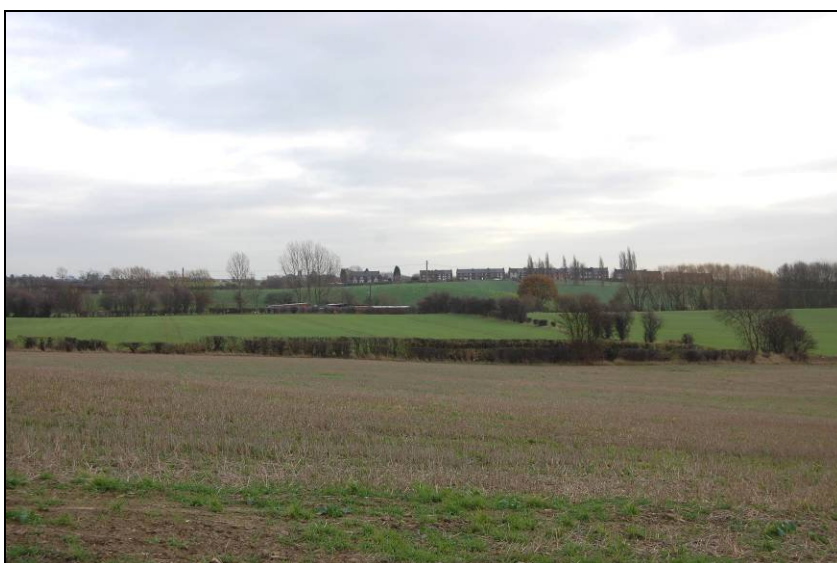
**Photo 7:**

Again looking east, H18 can be seen in the foreground of the view with G16 and G18 seen behind to the right.

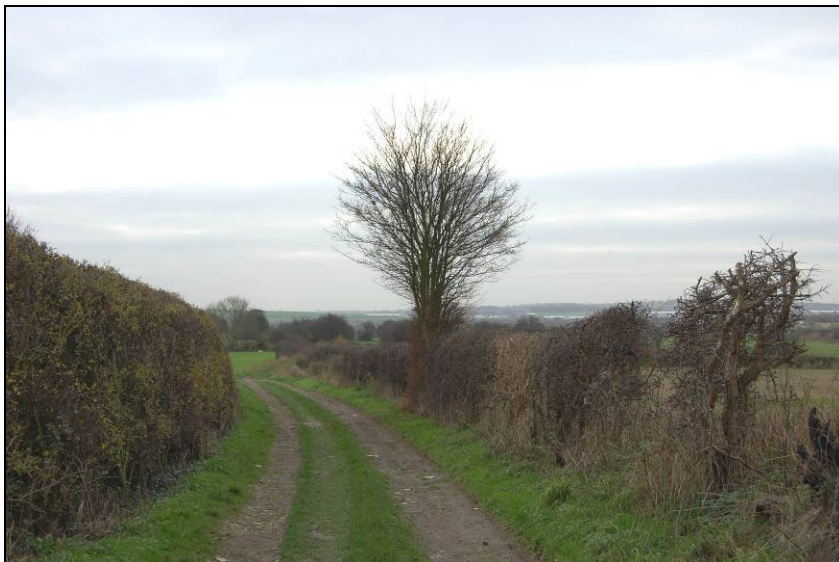
**Photo 8:**

| Tree number on dwg | Species | Height (m) | Stem diameter (mm) | Branch spread (m) | Age class | Crown clearance (m) | Physiological condition | Estimated remaining contribution (years) | Category grading | Notes / Structural condition | Preliminary management recommendations |
|---|---|---|---|---|---|---|---|---|---|---|---|
| G20 | Field Maple | 8 | <200 | N 1.5<br>S 1.5<br>E 1.5<br>W 1.5 | MA | 0 | Fair | 20-40 | C2 | Multi-stemmed from base. Topped at 1m. Crossing branches. Bark wounds on stem. | No action at present. |

View south along engine lane to the east of the site. H18 and G20 can be seen to the right of the view with the Blackthorn hedge of H19 seen to the left.

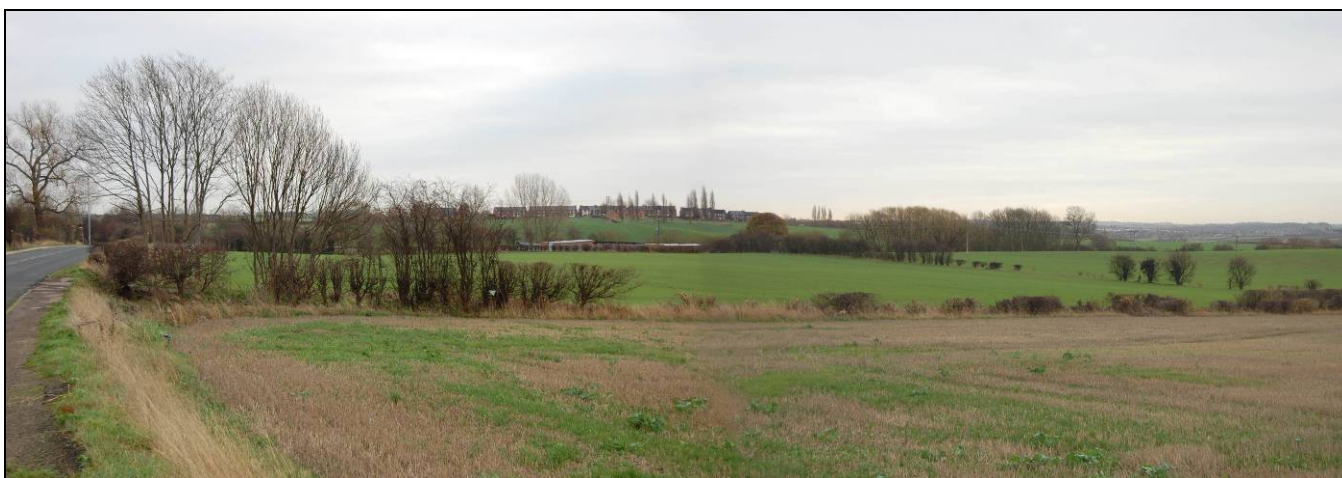
**Photo 9:**

| Tree number on dwg | Species | Height (m) | Stem diameter (mm) | Branch spread (m) | Age class | Crown clearance (m) | Physiological condition | Estimated remaining contribution (years) | Category grading | Notes / Structural condition | Preliminary management recommendations |
|---|---|---|---|---|---|---|---|---|---|---|---|
| G24 | Ash | <12 | <260 | N 4<br>S 4<br>E 4<br>W 4 | MA | 0 | Poor | 10-20 | C2 | A collection of poor stems many with significant bark wounds and deadwood. Limited value. Relatively easy to replace if lost to development. | Remedial prune. |

View east looking at the north east corner of the site. H23 can be seen in the foreground with G24 seen beyond on the far side of Engine Lane. The gappy Hawthorn hedge (H18) can also be seen to the right of the view as it extends down the eastern side of the site. ▲
