The Crescent Cudworth
Demolition & Creation of Urban Park

Photos Of Existing - Internals
Sheet 1

| The Crescent | DR-A-012 | P1 |

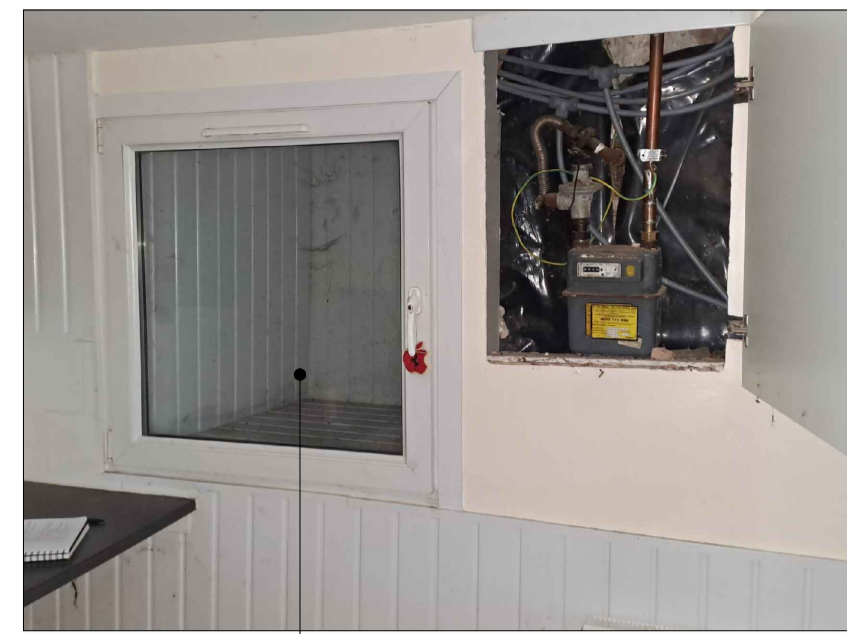
PHOTO 1

Escape window from basement kitchen of Flat 309a

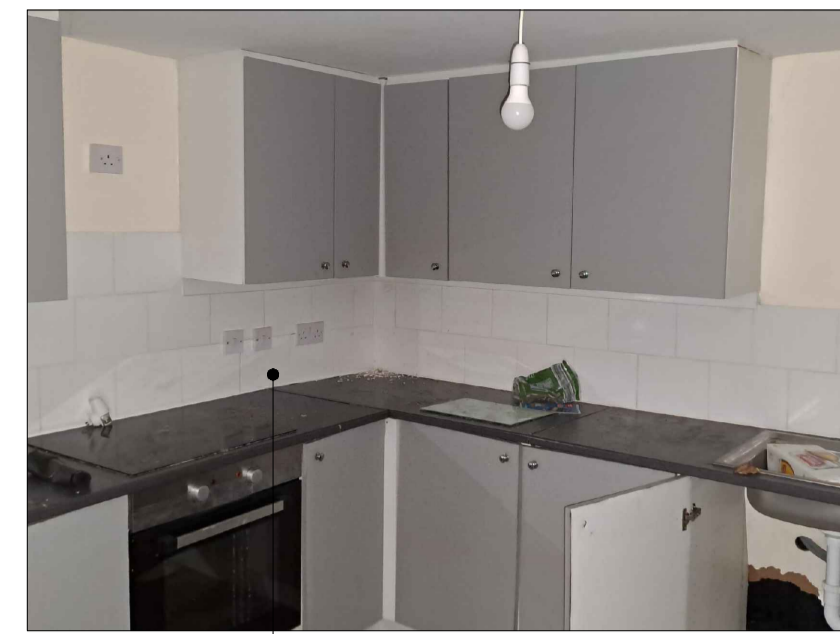
PHOTO 2

Kitchen fittings insitu in basement kitchen of Flat 309a

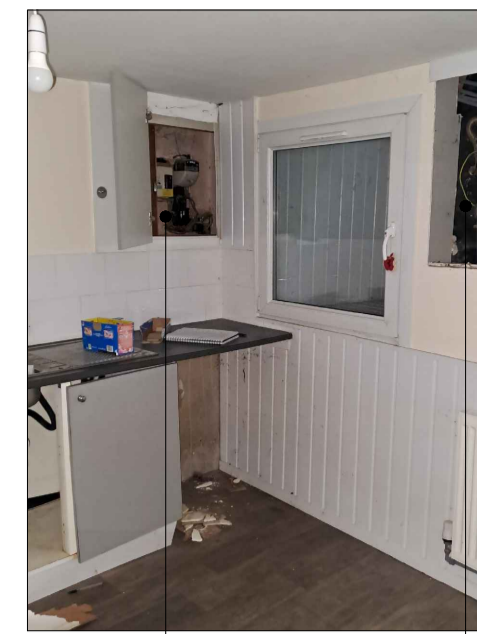
PHOTO 3

Meters recessed behind plasterboard dry lining in basement kitchen of Flat 309a

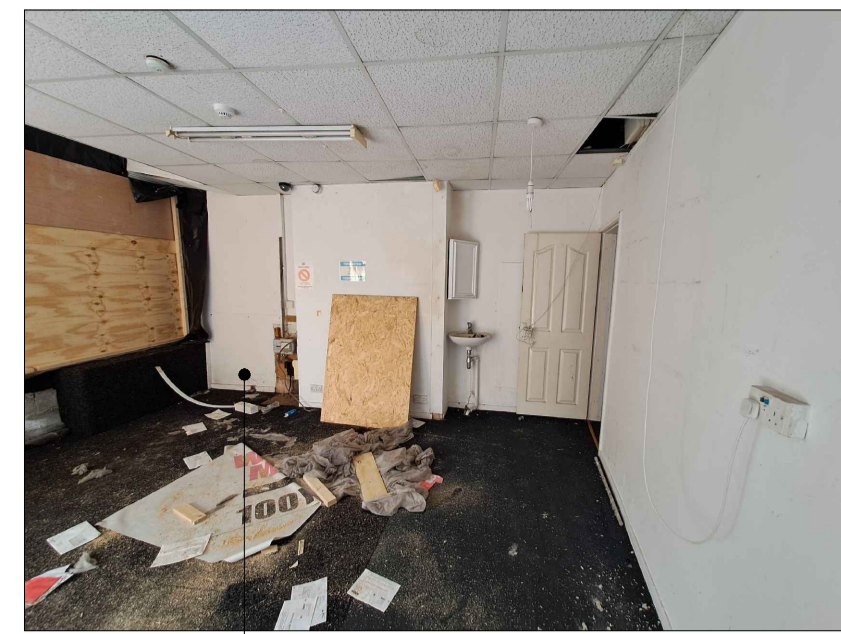
PHOTO 4

Indication of finishes in No.307 (vacant retail) ground floor accommodation

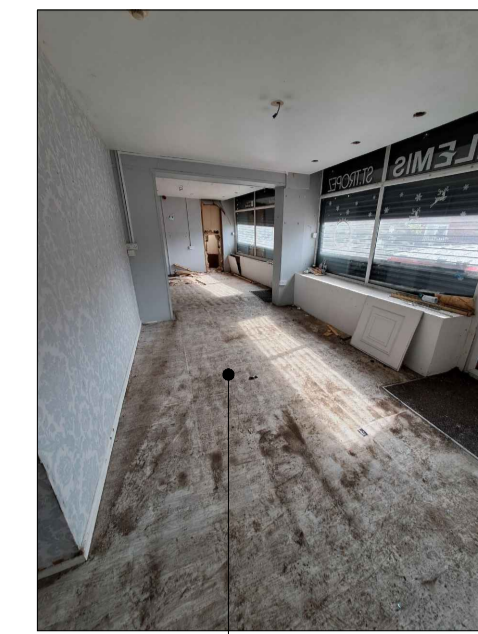
PHOTO 5

Indication of finishes in No.303 to 305 (vacant retail) ground floor accommodation

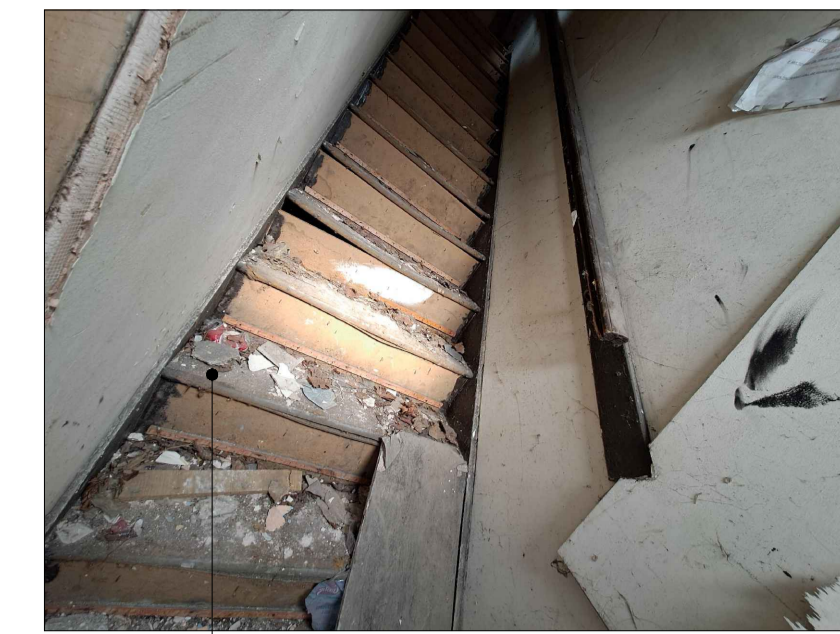
PHOTO 6

Indication of timber staircase from ground floor to first floor accommodation (typical)

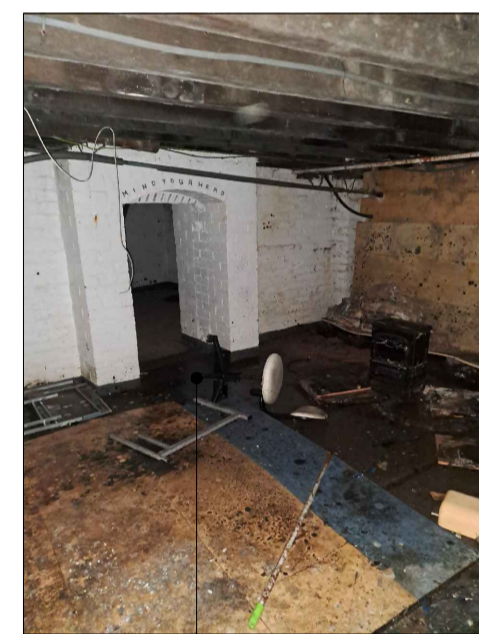
PHOTO 7

Indication of basement construction (typical) - No.305

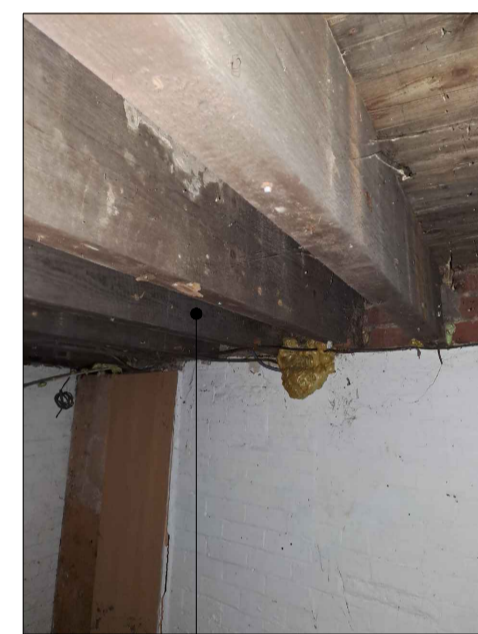
PHOTO 8

Indication of timber joists forming suspended ground floor construction (typical)

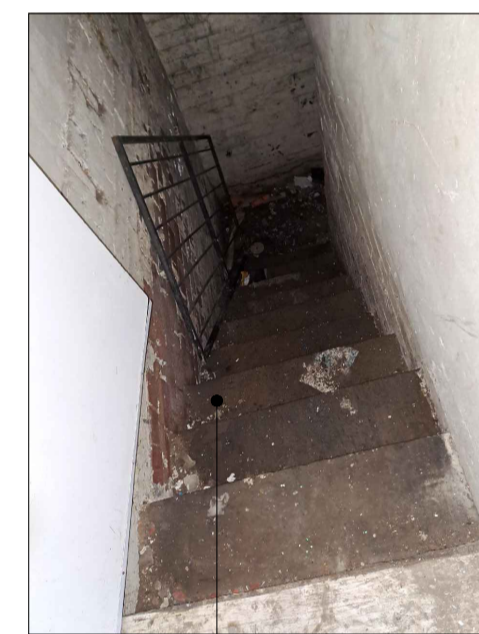
PHOTO 9

Indication of stone steps forming staircase from ground floor to basement (typical)

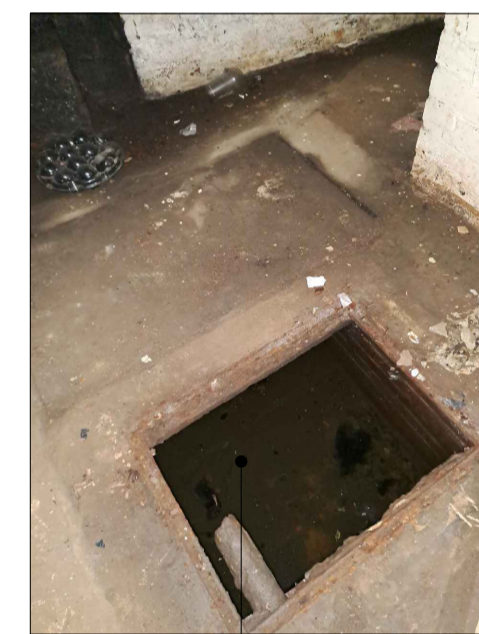
PHOTO 10

Assumed sump inspection chamber in basement of No.303 - Requires investigation - Refer to Photos 30 to 32 for further details

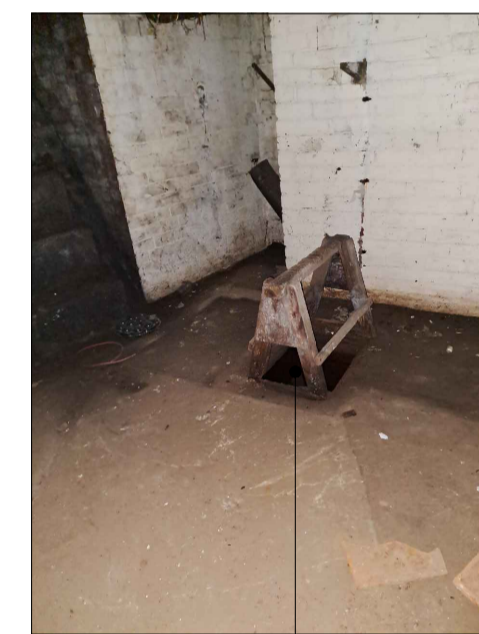
PHOTO 11

Assumed sump inspection chamber in basement of No.303

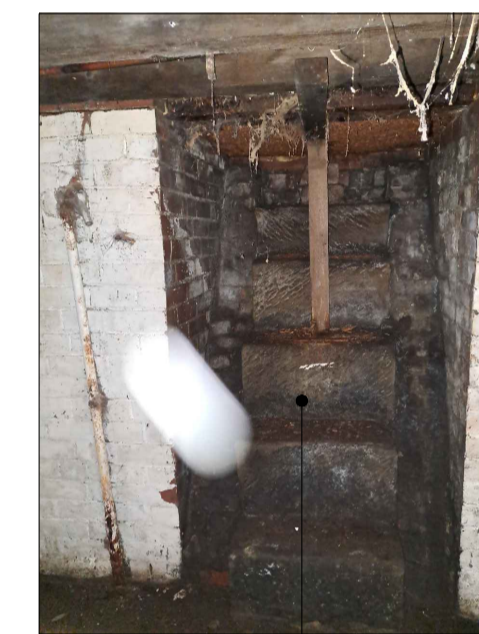
PHOTO 12

Stone steps forming staircase - assumed to be from basement to covered access (blocked up)

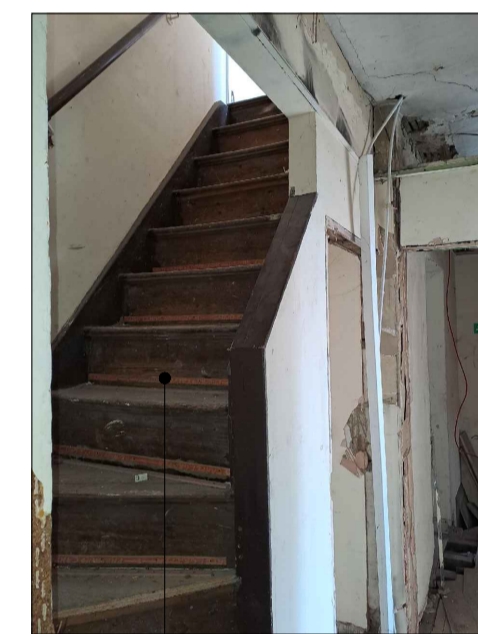
PHOTO 13

Indication of timber staircase from first floor to attic accommodation (typical)

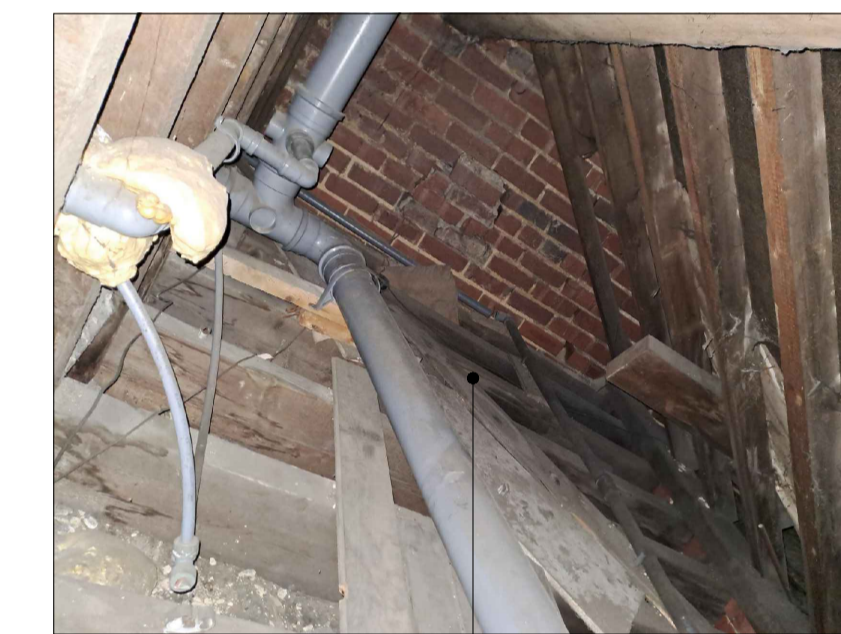
PHOTO 14

Indication of eaves roof construction to rear of attic accommodation (typical)

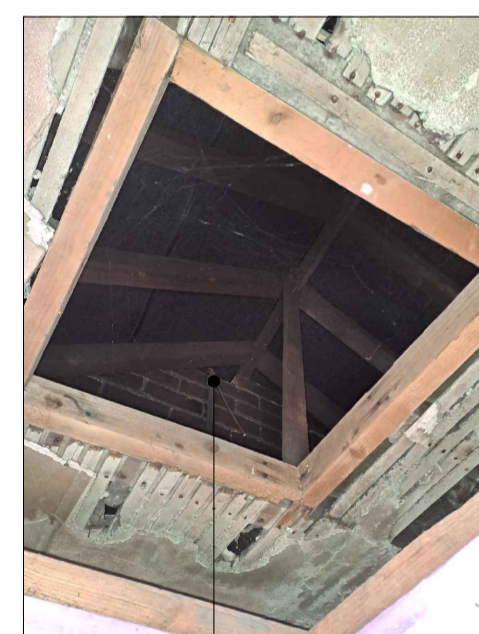
PHOTO 15

Indication of ridge roof construction above attic accommodation (typical)

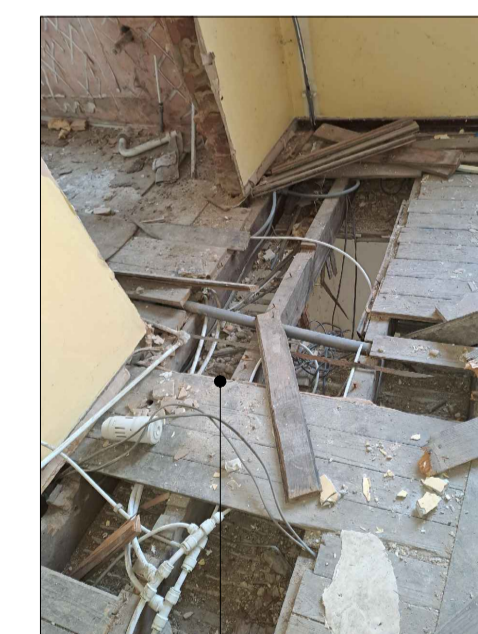
PHOTO 16

Indication of suspended first construction in disrepair above ground floor accommodation (certain areas)

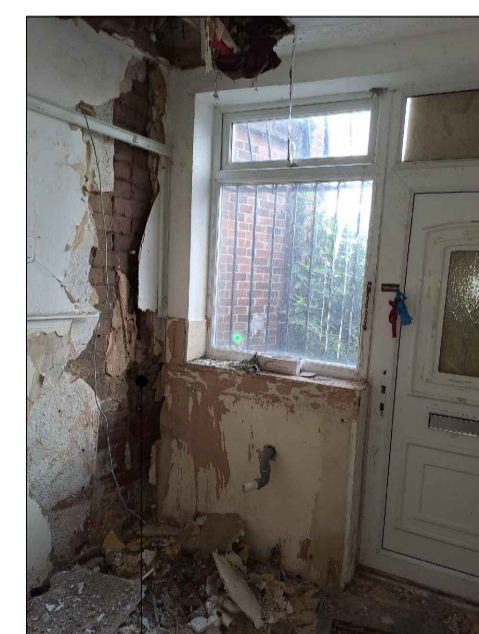
PHOTO 17

Indication of existing construction in disrepair to ground floor flat accommodation to rear of building (straddles No.305 & No.307)

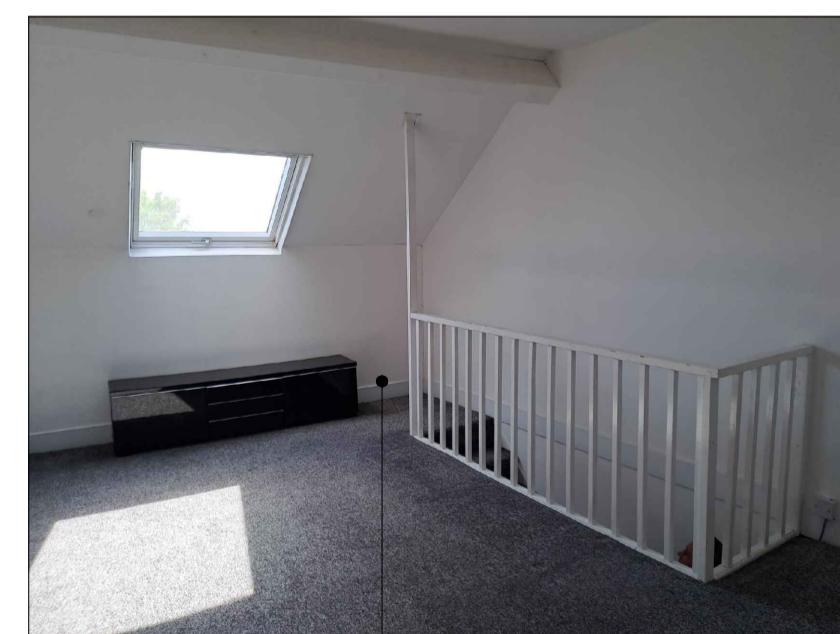
PHOTO 18

Indication of finishes insitu in attic bedroom of Flat 309b

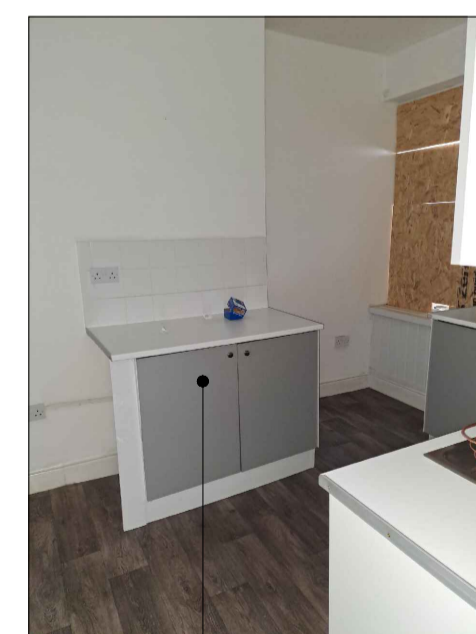
PHOTO 19

Indication of kitchen fittings & finishes insitu in first floor kitchen Flat 309b

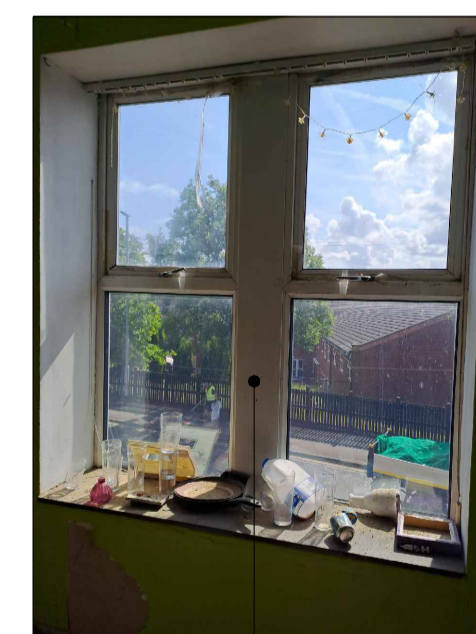
PHOTO 20

Indication of typical first floor flat window facing Barnsley Road

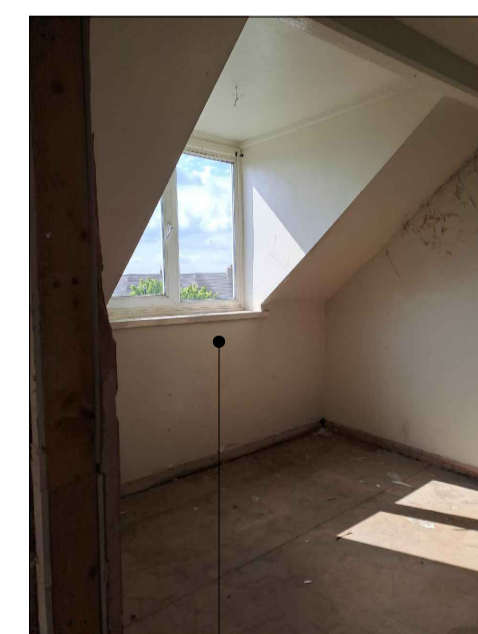
PHOTO 21

Indication of typical second floor dormer attic flat window facing Barnsley Road

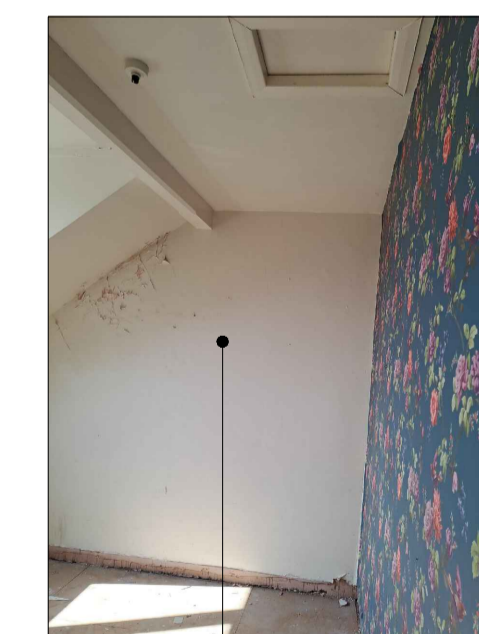
PHOTO 22

Indication of typical second floor attic flat configuration facing Barnsley Road
