Arboricultural Report

35 Woodwalk, Wombwell

Site Address:	35 Wood Walk Wombwell Barnsley S73 0IZ	Client:	Paula & Shaune Harrison
Report Ref:	WWB01-21	Report Date:	16th November 2021
Author:	Laurence Smith BSc (Hons) Arb, M Arbor A	Signed:	<i>Laurence Smith</i>

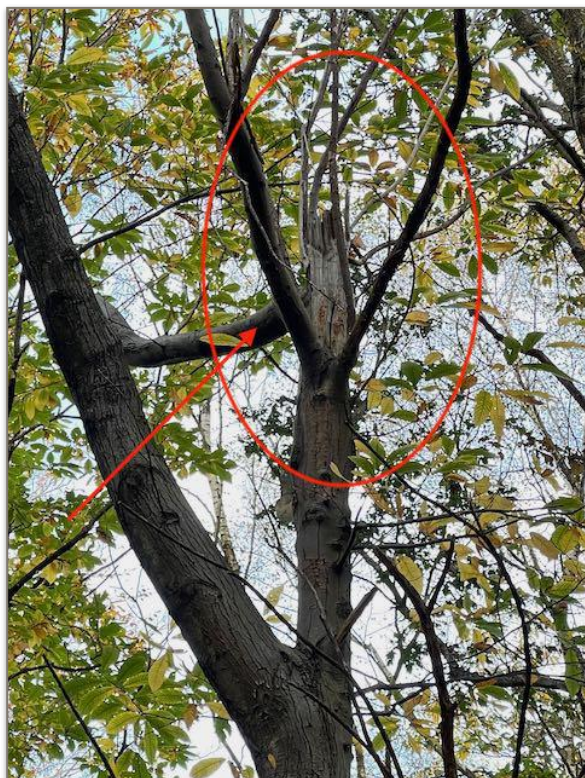
T1 appears to have historically suffered a stem failure at approximately 9m. It is unclear what has caused this, however given the size and health of the remaining limb, it is likely that this stem was in a decline and failed as a result of this. A single branch now extends over the garden from just below the failure point which also appears to be in poor health. This branch should ideally be removed to prevent additional failures.

Figure 1. Damaged stem at the crown of T1.

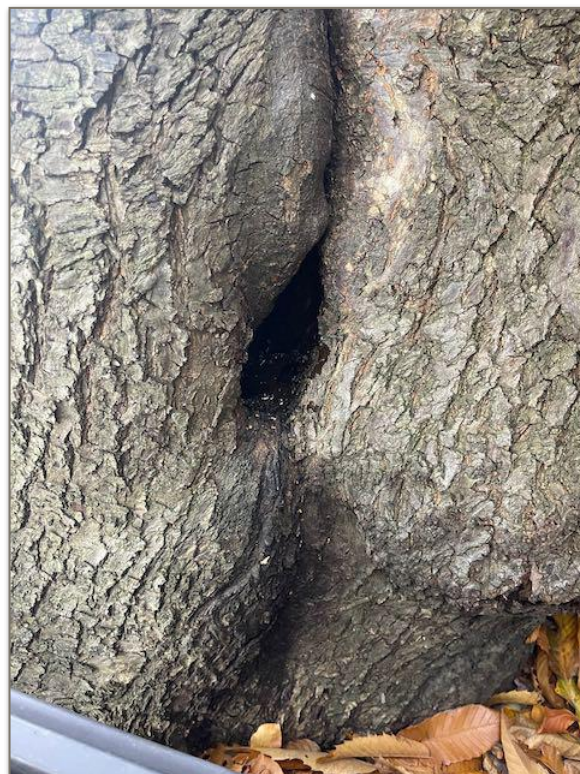
Figure 2. Minor cavity at the base of T1 not considered to be significant.

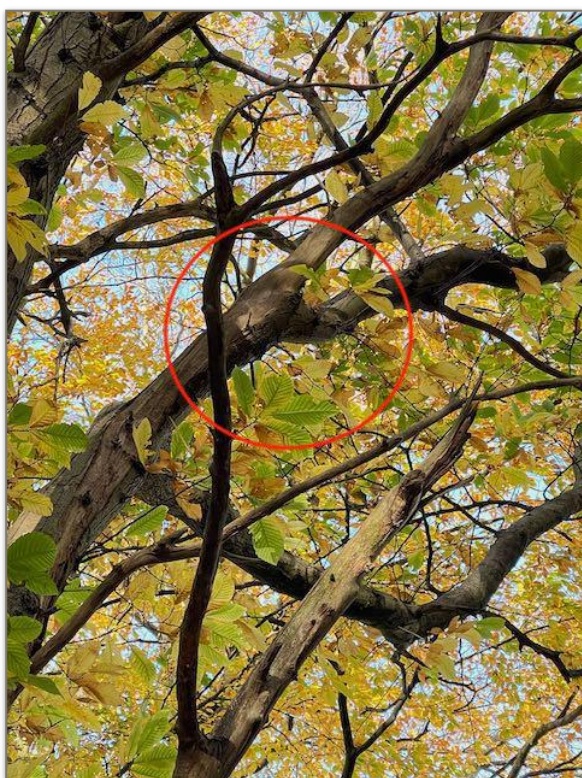
Figure 3. Declining limb on T2 over neighbouring property at 7m north.

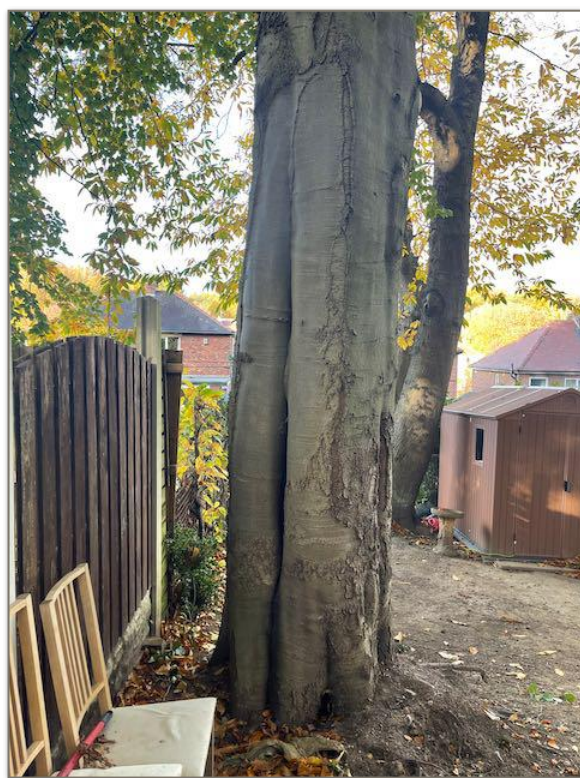
T3 has a marginally exposed root plate. It is unclear why or how this has happened. Although surface roots have clearly been damaged, the main buttressing roots still extend below the level of disturbance and as such, structural stability is not believed to be compromised. On the southerly side of this stem there is a significant historic region of damage extending from the ground level to a height of approximately 3m. Large columns of growth on either side of this damaged region suggests that the tree is reacting well to the forming decay cavity which, at present, is minimal. Probing of this cavity was only achieved to a depth of 20mm.

Figure 4. Historic vertical column of damage on T3.

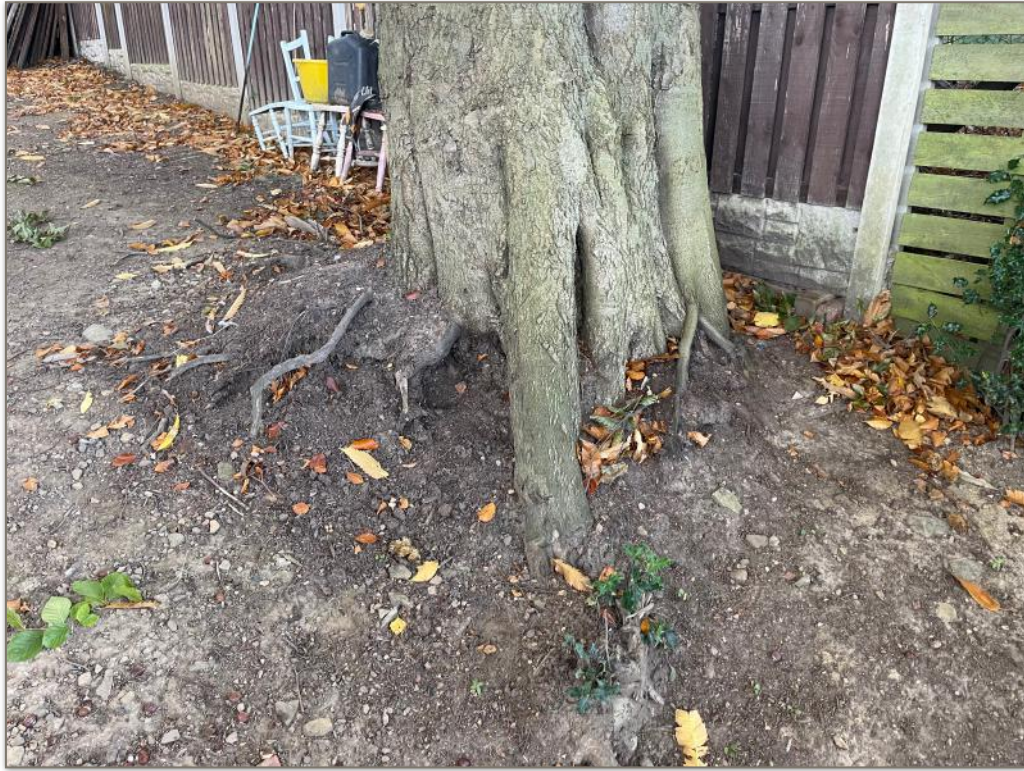
Figure 5. Excavations around the stem of T3.

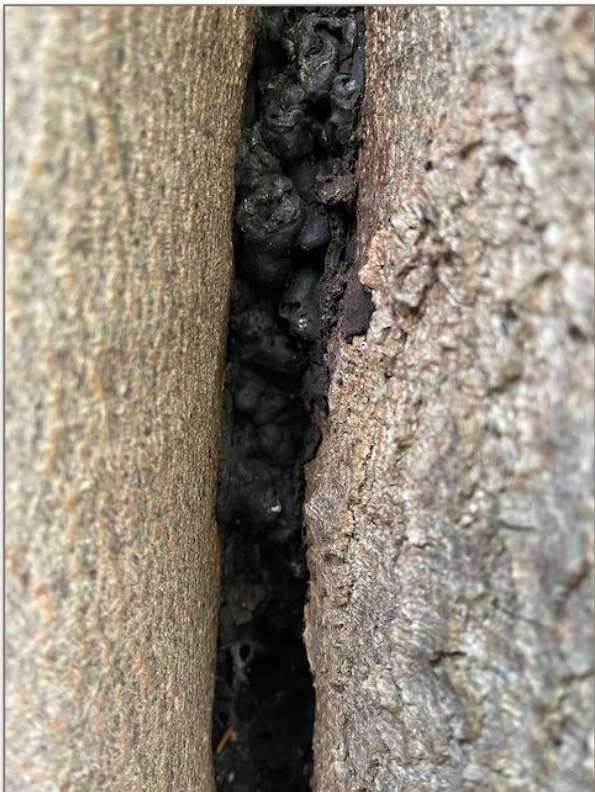
The more significant finding, however, was that almost the entire length of this cavity was covered with the old fruiting bodies of *Kretzschmaria deusta*. This is a particularly aggressive fungi which breaks down both cellulose and lignin in both stem and root structures. This decay method causes what is termed as 'soft rot' and can lead to failures in visually healthy trees. Given the current condition of the wood inside the cavity and the species' ability to cope with cavitation, it is reasonable to suggest that the infection is in the early stages and that the tree is currently sound. Despite this, the decay will continue to breakdown structures within the tree and will eventually lead to the death or failure of the specimen.

Figure 6. Black bubbly historic fruiting bodies of *Kretzschmaria deusta* located within the cavity of T3.

While this tree is currently believed to be sound and **with ongoing monitoring** potentially retainable for the next 10 years, considerations should be given to how easily this tree could be removed at a later date if a workshop was built in the rear of the garden. While any tree can be dismantled avoiding static objects, it would likely take significantly longer without a clear drop zone which would be reflected in the arborist's price.

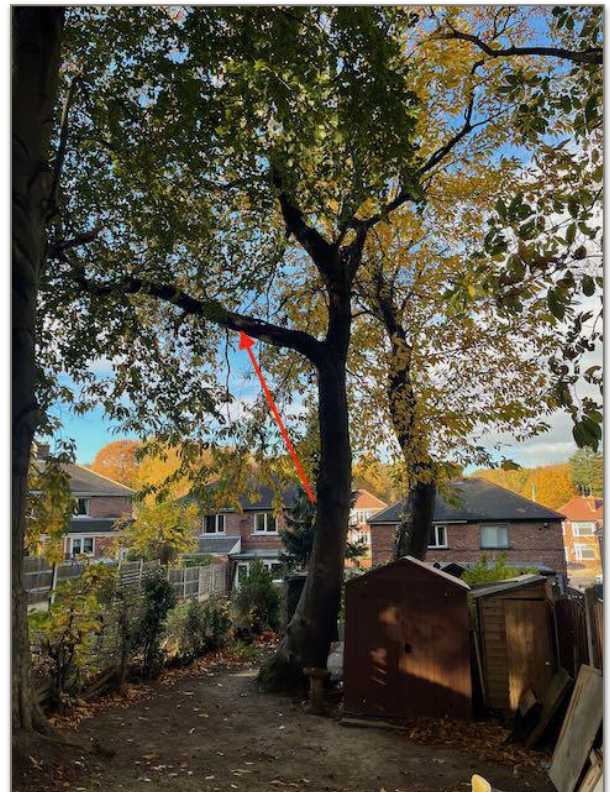
The remaining two trees T4 and T5, both appear to be in good condition with only minor deadwood in the lower canopy. It was noted that T4 has a significant limb heading south west at 7m which is growing into a large unoccupied region of light. The unions were visually inspected along this limb and considered sound with no observed significant defects. While it would be possible to undertake some reduction work on this limb, any meaningful reduction would lead to large wounds exposing the damaged region to decay any potentially further problems.

Figure 7. Heavy lateral limb on T4 with a well formed Union.

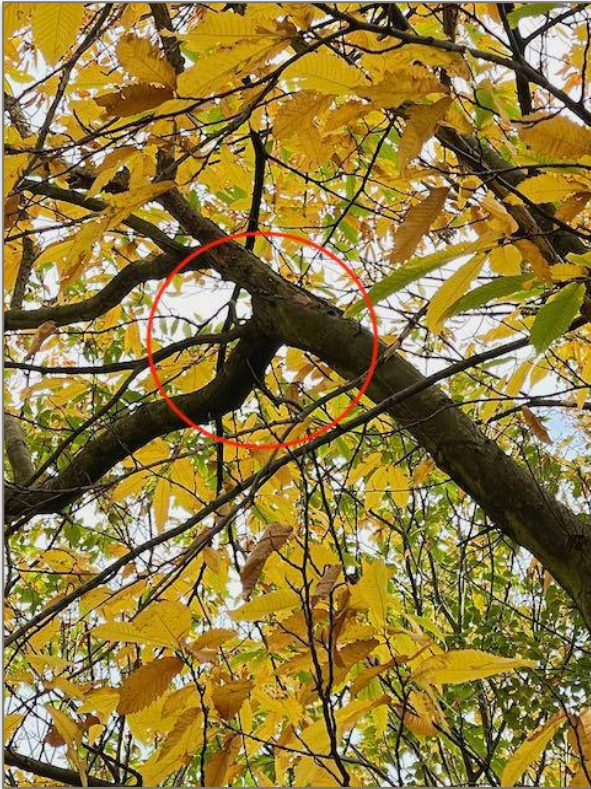
Figure 8. Dieback of a limb at 12m east.

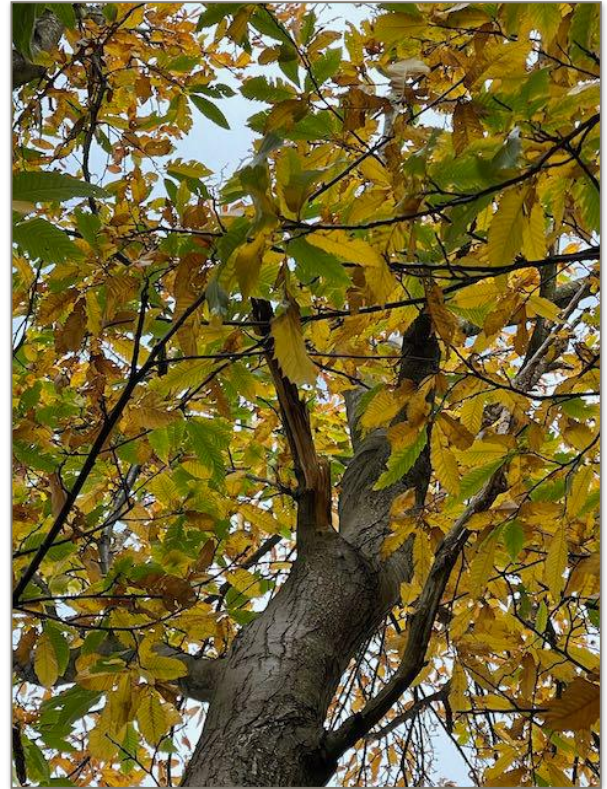
T5 is the specimen that has most recently shed a limb causing some concern. Upon closer inspection, 3 additional failure sites were observed on the south westerly side of this specimen. With the exception of the one union failure, all further failures were as a result of stem fracture. From what could be observed from the ground, the union did not appear to have been a weak union type. Given these findings of multiple failures on one side, it is likely that these failures are as a result of high wind conditions from a direction opposing the prevailing winds. Unfortunately these type of failures are not possible to predict as there are no visual defects. While some pruning could be achieved to limit the extent of branches in this aspect, there is no guarantee that this will prevent failures in the future and it may possibly affect the wind exposure on other parts of the tree. In relation to this, no recommendations have been given for this specimen other than the tidying up of damaged branches and removal of deadwood.

Figure 8. Failure wound on T5

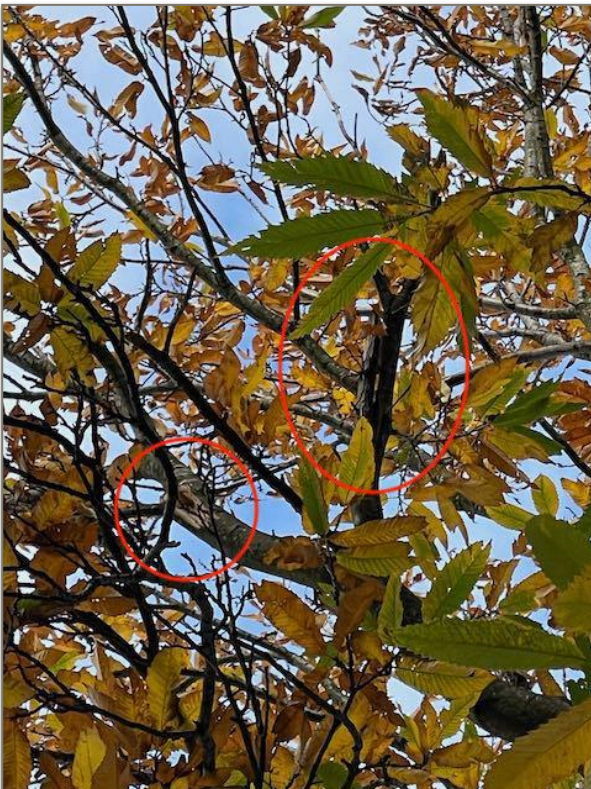
Figure 9. Two further historic failure locations on T5.
