## TREE REPORT

**Address:** 2 OLD MILL COTTAGE  
OXSPRING S16 8YE.

**Client:** MR ARTHUR WOOD.

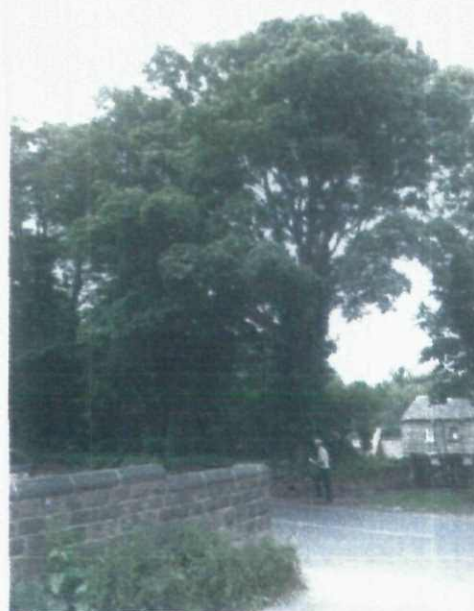
**T3 - Sycamore**

Overall shape and appearance LARGE SPREAD EVENLY BALANCED

Hazardous branches (Y/N) OVER HANGING BRANCH

SIGNS OF NESTING.

IVY AROUND TRUCK AND GROUND

2

REMOVE IVY FROM TRUCK.

30% CROWN REDUCTION

REMOVE BRANCHES OR WEIGHTY FRUIT BRANCHES

OVERHANGING ROAD

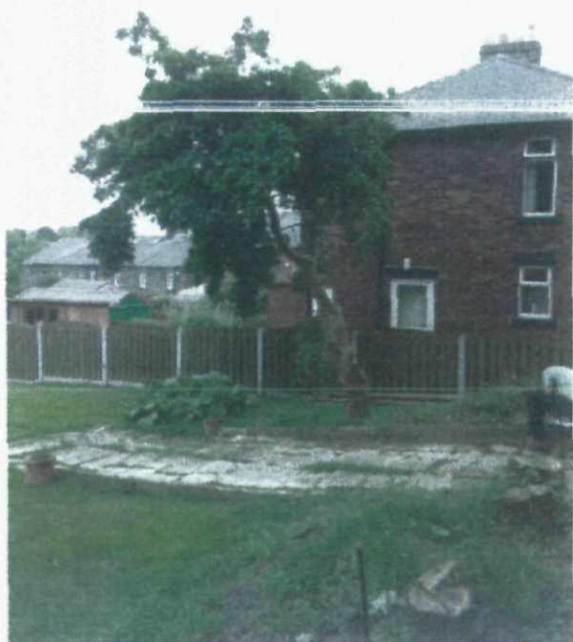
**T1 - Laburnum**

Any other signs of damage PREVIOUS PRUNING CUTS NOT FULLY HEALED, IMPROPER CUTS MADE.

Overall shape and appearance SLOW GROWTH ON ONE SIDE

Deadwood (Y)/(N) SOME BRANCHES % 5

Epicormic growth present (Y)/(N) DUE TO PREVIOUS PRUNING

2

REMOVE DEAD WOOD

CARRY OUT GROWN REDUCTION ESPECIALLY  
ON OVERHANGING TO NEIGHBOURS

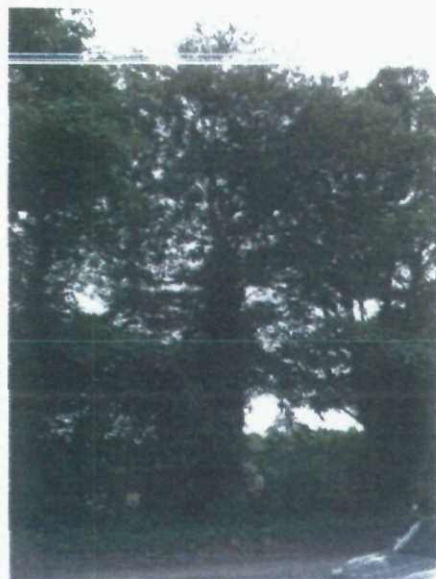
**T4 - Lime**

Overall shape and appearance HEALTHY LOOKING, BALANCED

EVIDENCE OF BIRDS NESTING  
IVY ON TRUNK

REMOVE IVY GROWTH UP TRUNK  
REDUCE HEIGHT OF TREE 20%

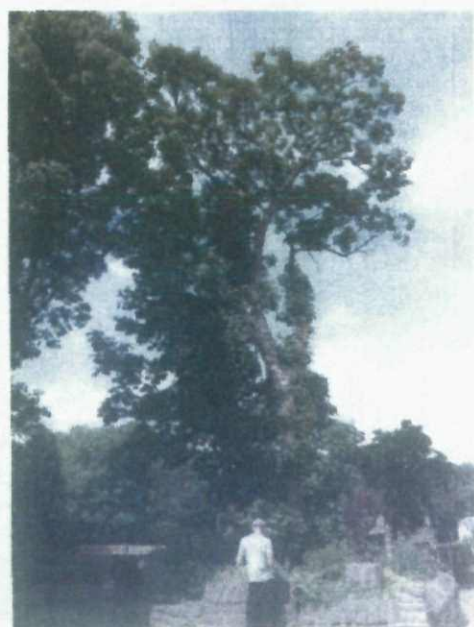
**T2 - Sycamore South Corner**

Any other constraints/objects LOTS OF SHRUBS MAKING ACCESS TO TRUNK DIFFICULT

Overall shape and appearance LOLLY POP - WEIGHTED RIGHT SIDE

Deadwood (Y)N MINIMAL % 1

Hazardous branches (Y)N OVERHANG TO NEIGHBOURS

TELEPHONE LINE THROUGH TREE.

REMOVE 4 SAPPLINGS AT BASE OF TREE.

REMOVE DEAD WOOD AND DANGEROUS BRANCHES

BALANCE CANOPY.

REMOVE BRANCHES AROUND TELEPHONE LINE

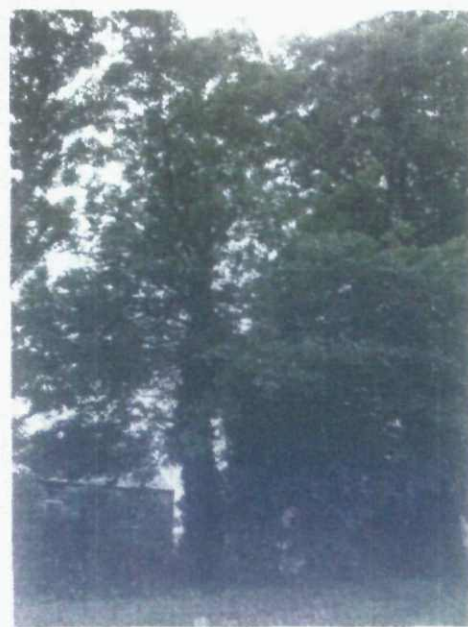
**T5 Sycamore**

Overall shape and appearance LIGHT DEPRIVED, WEIGHTED ONE SIDE.

Deadwood (Y/N) MINIMAL % 2

\* NOT DANGEROUS BUT RECOMMEND FELLING  
TO GIVE TREES EITHER SIDE SPACE TO GROW  
REMOVE 4 LIME SAPPLINGS AND REMOVE  
HAWTHORN BY ROAD

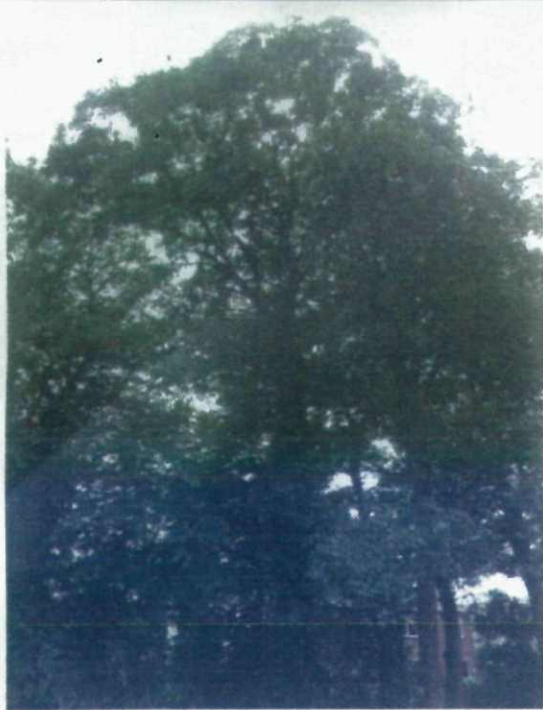
**T6 - Sycamore**

Overall shape and appearance BIG SPREAD HEALTHY

Deadwood (Y)/N MINIMAL % 1-3

EVIDENCE OF NESTING

2

REDUCE IN HEIGHT, CROWN REDUCTION, 18 FT

LIME SAPPING AT BASE OF TREE REMOVE.

REMOVE DEAD WOOD

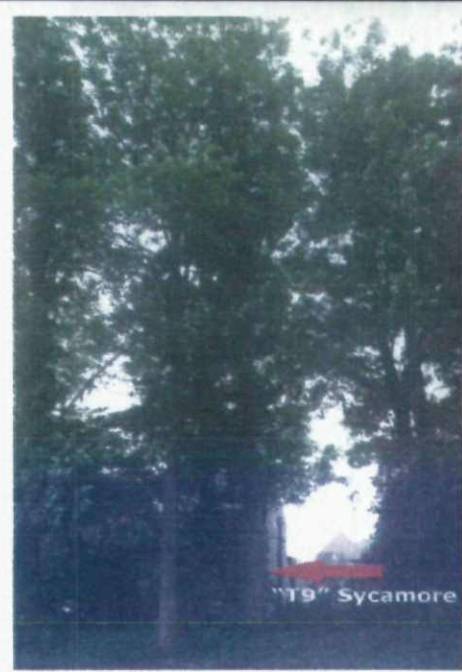
**T9 - Sycamore**

Overall shape and appearance HEALTHY, WELL BALANCED

Deadwood MINIMAL % 2-4

Hazardous branches Y/N OVERHANGING ROAD

CROWN REDUCE. REMOVE BRANCHES OVERHANGING  
ROAD

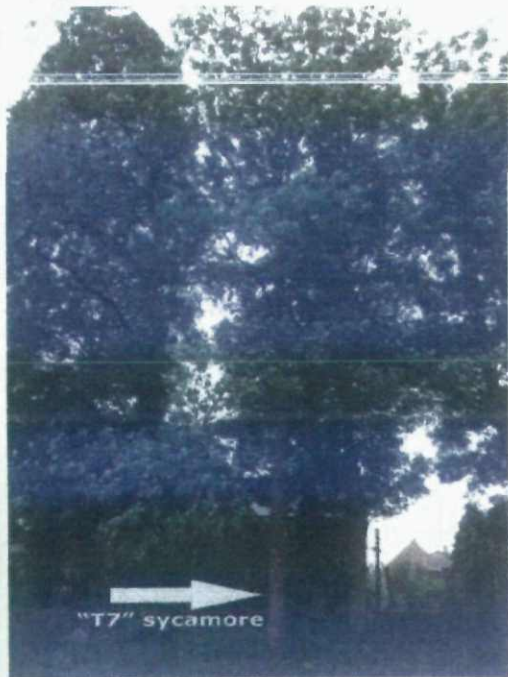
**T7 - Sycamore**

Any other signs of damage ROPE AND NAILS EMBEDDED

Overall shape and appearance TALL AND THIN SPREAD

Deadwood (Y/N) MINIMAL % 2

REDUCE HEIGHT AND REMOVE DEAD WOOD

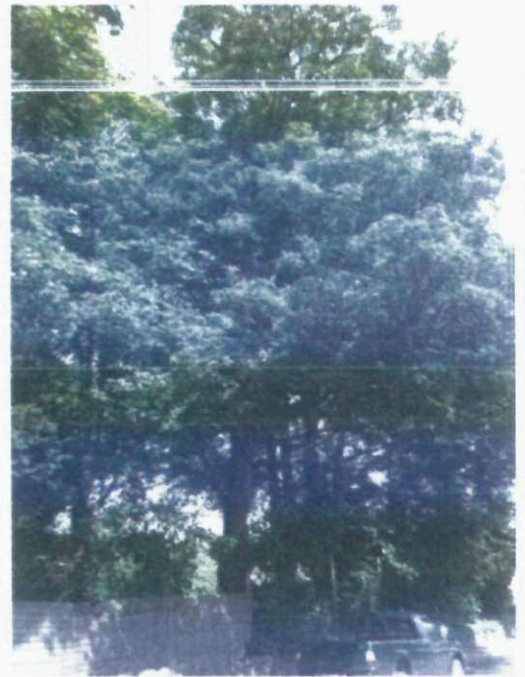
**T10 - Sycamore**

Overall shape and appearance EVENLY BALANCED

Deadwood Y/N MINIMAL % 2

Hazardous branches Y/N LARGE OVERHANGING BRANCH

REDUCE HEIGHT AND OVERHANGING  
BRANCHES.

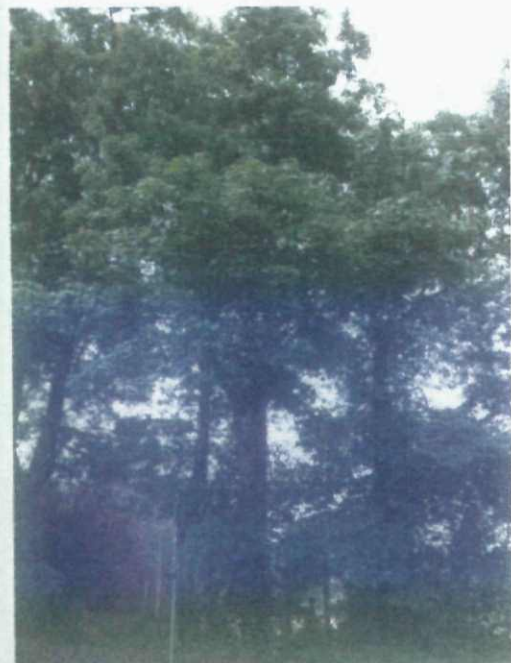
**T8 - Sycamore**

Overall shape and appearance EVENLY BALANCED

Deadwood (Y)/(N) MINIMAL % 2

Hazardous branches (Y)/(N) OVERHANGING BRANCH

SLIGHT LEAN

2

REDUCE IN HEIGHT AND CROWN REDUCTION.

REMOVE BRANCHES OVERHANGING ROAD.

OR POSSIBLE FELL TREE DUE TO LEAN/HEIGHT RATIO
