ARBORICULTURAL REPORT
(BS 5837:2012)

ROUGHBIRCHWORTH LANE
OXSPRING
SHEFFIELD
S36 8YZ

September 2022

Job Number 5098
Rev A 27/01/2023

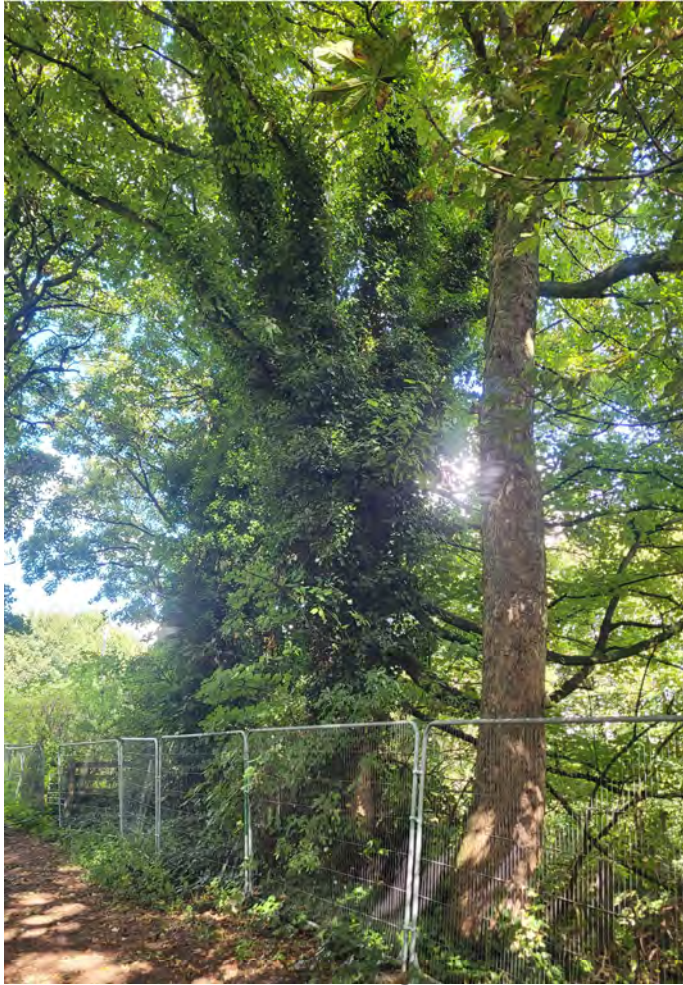
Tree No.	Species	Dbh (mm)	Height (m)	Age	Crown Spread				Crown C	Cond R	Observations and Comments	Preliminary Recommendations	ERC (Yrs)	TQC R	RPA (m ²)	RPA Circle Radius (m)
					N	E	S	W								
T8	Sycamore	600	18	M	0	8	6	4	8	B	Located within linear group on edge of steep bank that drops down toward footpath. Major crown asymmetry. Ivy clad stem creeping into crown. Profuse basal shoots.	Sever Ivy at base to 1m and remove basal shoots.	20+	B2	162.8 6	7.20
T9	Sycamore	480	16	M	7	7	0	4	8	B	Located within linear group on edge of steep bank that drops down toward footpath. Major crown asymmetry. Slender specimen within group. Ivy clad stem creeping into crown.	Sever Ivy at base to 1m and remove basal shoots.	20+	B2	104.2 3	5.76
T10	Sycamore	480	16	M	5	7	0	2	8	B	Located within linear group on edge of steep bank that drops down toward footpath. Major crown asymmetry. Suppressed specimen within group. Ivy clad stem creeping into crown.	Sever Ivy at base to 1m and remove basal shoots.	20+	B2	104.2 3	5.76

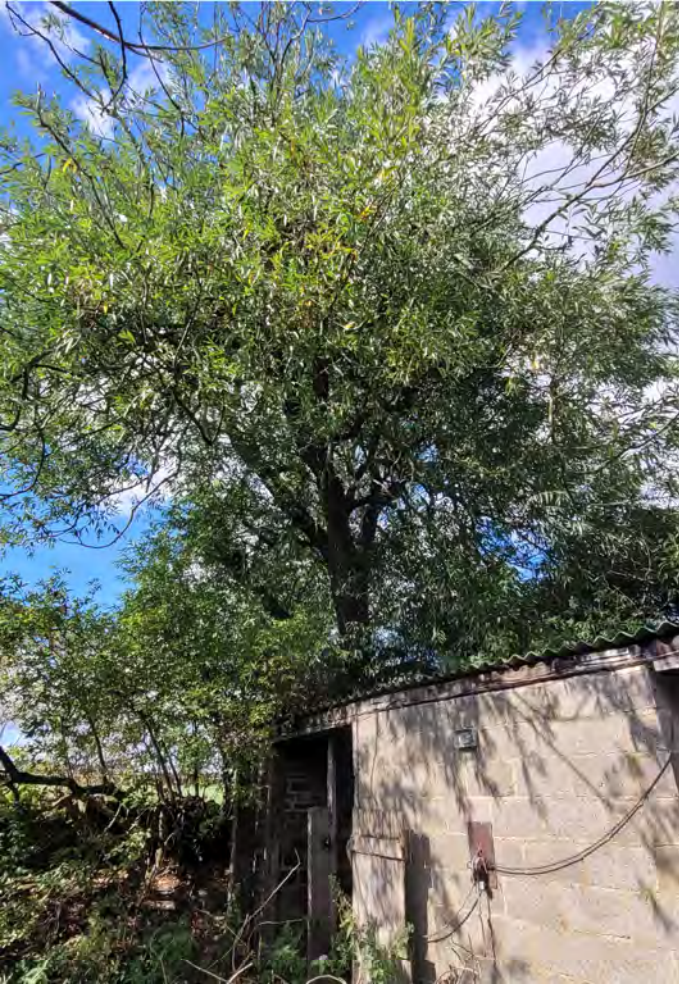
Tree No.	Species	Dbh (mm)	Height (m)	Age	Crown Spread				Crown C	Cond R	Observations and Comments	Preliminary Recommendations	ERC (Yrs)	TQC R	RPA (m ²)	RPA Circle Radius (m)
					N	E	S	W								
T13	Crack Willow	500	12	EM	6	6	6	6	1	C	Located on bank area adjacent building. Smashed up crown with several broken and creaking branches. Poor specimen.	n/a	5-10	U	113.10	6.00
T14	Elderberry	300	5	FM	5	3	2	3	0	B/C	An old shrub growing from base of building. Reaching point of collapse.	n/a	5-10	U	40.72	3.60
T15	Elm	0	7	EM	-	-	-	-	-	D	A dead tree adjacent old building.	n/a	n/a	U	0.00	0.00
T16	Sycamore	760	18	M	8	7	7	8	3	B	A large co-dominant specimen on the edge of the group adjacent to an old broken-down wall. Stem swamped in Ivy. Reasonable form and vigour. Recent works at base, soil moving and building waste piled up. Possible root damage.	Sever Ivy at base to 1m.	20+	B2	261.30	9.12
T17	Sycamore	580	16	M	7	5	4	4	3	B	A suppressed specimen on the edge of the group. Stem swamped in Ivy. Poor form, stem and basal shoots present. Recent works at base, soil moving and building waste piled up. Possible root damage.	Sever Ivy at base to 1m and remove basal shoots.	20+	B2	152.18	6.96

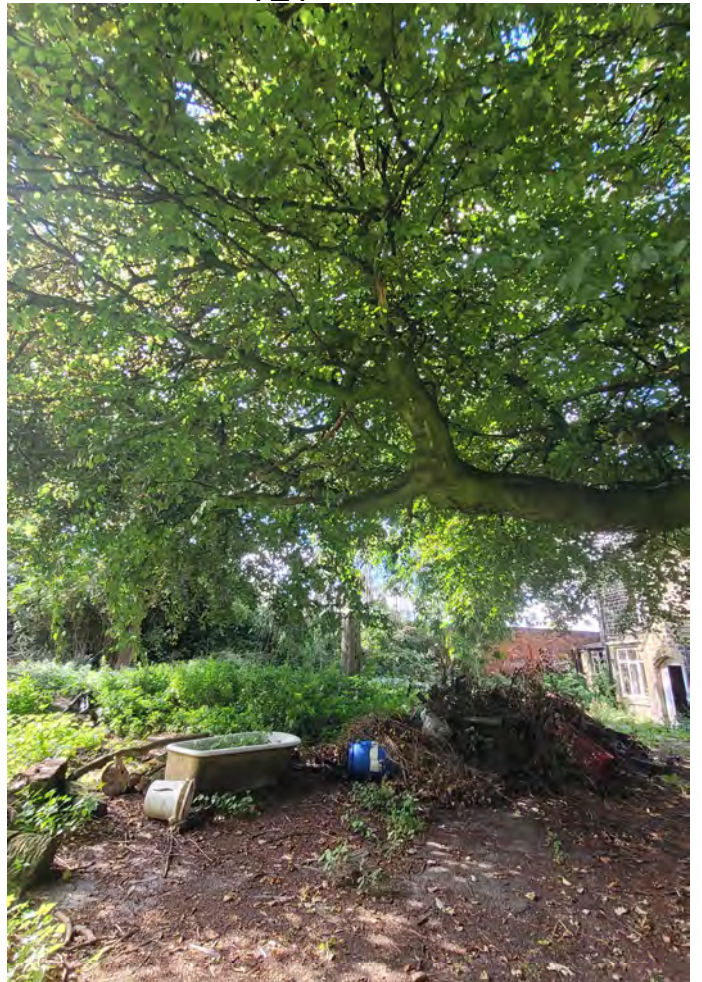
Tree No.	Species	Dbh (mm)	Height (m)	Age	Crown Spread				Crown C	Cond R	Observations and Comments	Preliminary Recommendations	ERC (Yrs)	TQC R	RPA (m ²)	RPA Circle Radius (m)
					N	E	S	W								
T21	Copper Beech	700	15	M	4	9	11	9	2	B	A large co-dominant specimen on the edge of the group with major crown asymmetry. Stem swamped in Ivy. Major southern limb with some damage on the underside from previous passing vehicles. Hazard beam formed further out, heavily weighted limb. Recent works at base, soil moving and building waste piled up. Possible root damage.	Sever Ivy at base to 1m.	20+	B2	221.67	8.40
T22	Weeping Ash	560	8	M	6	6	7	6	2.5	C	Typical form with several wounds and cavities. Affected by Ash Dieback. Canker on lower stem.	n/a	5-10	U	141.87	6.72
T23	Cherry	600	11	M	6	6	6	6	3	B	Located within the adjacent property. Twin-stemmed, no access to base or stems. Good vigour, crown touching building.	n/a	20+	B2	162.86	7.20

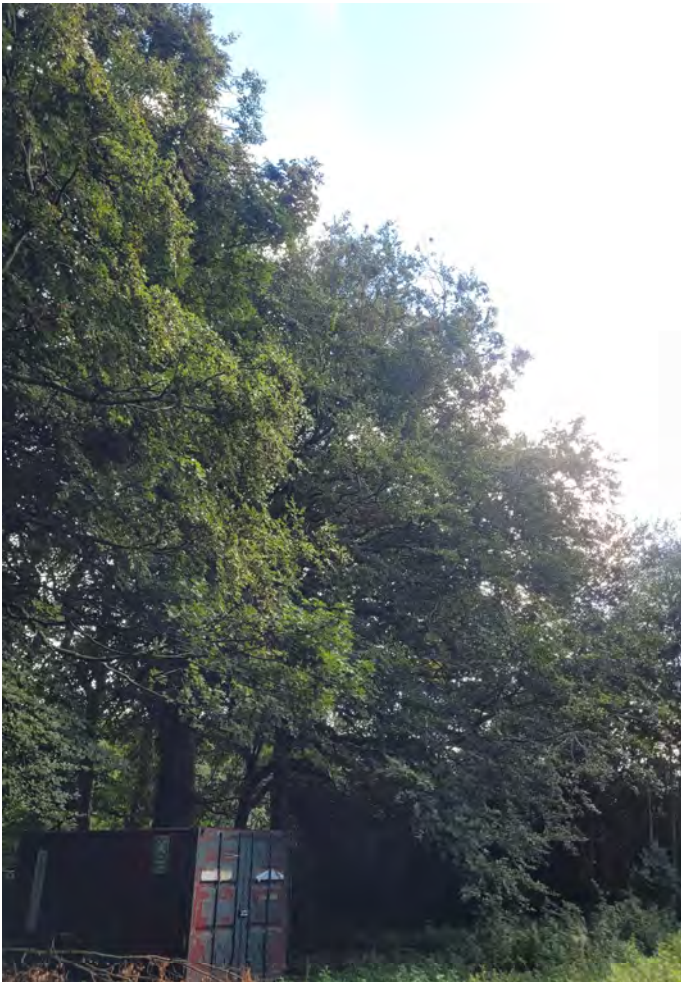
T26 minor dieback

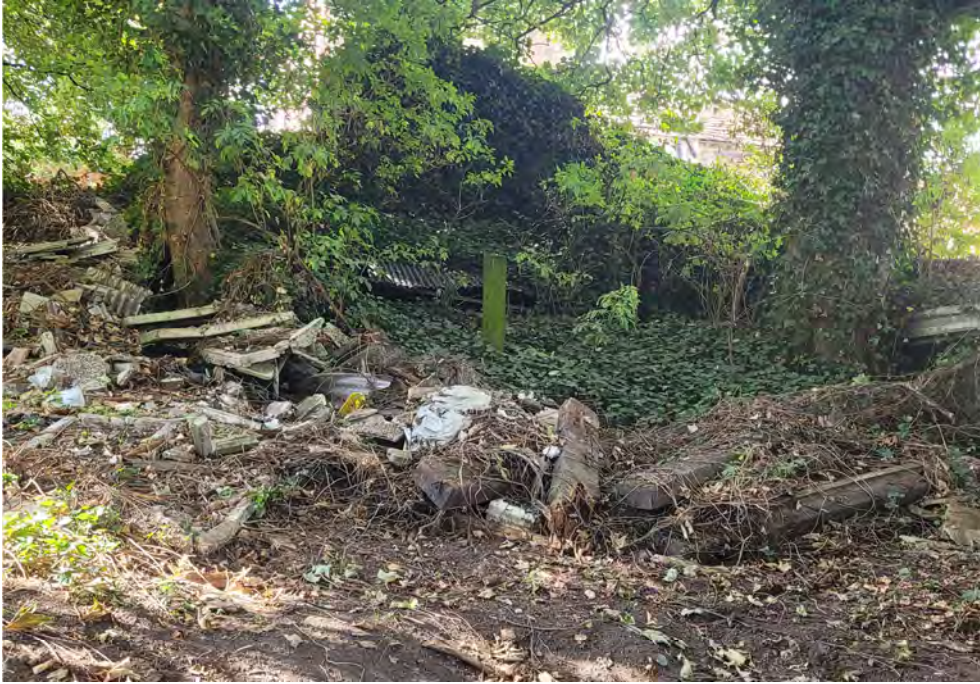
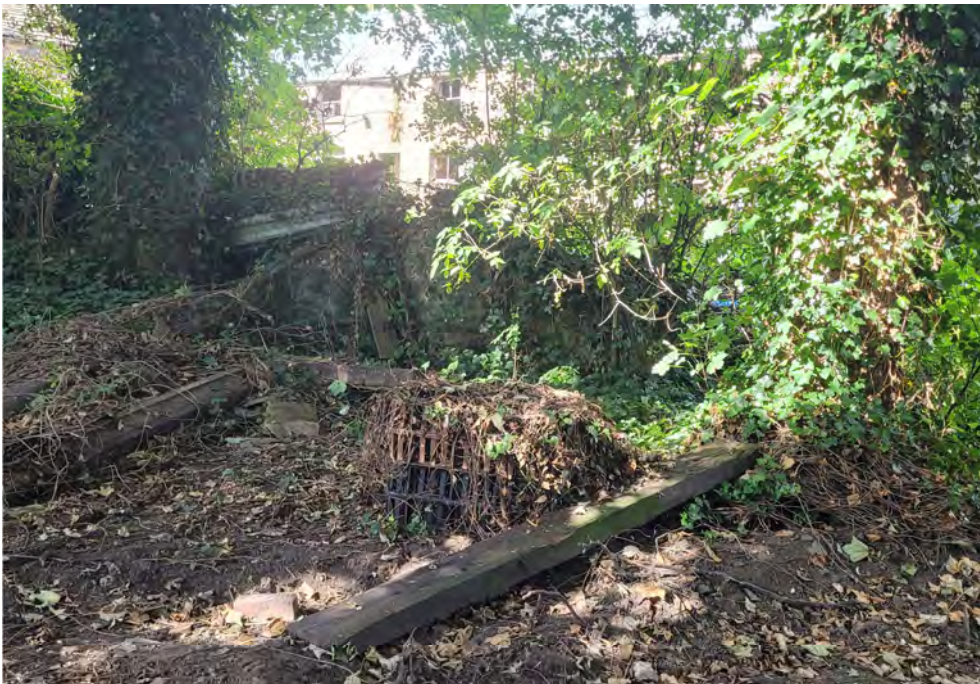
T18	Sycamore	500	16	M	5	2	4	5	3	B/C	A suppressed specimen within the group. Small crown. Ivy clad stem. Recent works at base, soil moving and building waste piled up. Evidence of root damage.	Sever Ivy at base to 1m.	10+	C2	113.10	6.00
T19	Sycamore	420	10	EM	2	2	3	5	6	B/C	A suppressed specimen on the edge of the group. Stem swamped in Ivy. Poor form, Recent works at base, soil moving and building waste piled up. Possible root damage.	Sever Ivy at base to 1m.	10+	C2	79.80	5.04
T20	Sycamore	850	17	M	4	5	8	7	5	B	A large co-dominant specimen on the edge of the group with minor crown asymmetry. Stem swamped in Ivy. Recent works at base, soil moving and building waste piled up. Possible root damage.	Sever Ivy at base to 1m.	20+	B2	326.85	10.20

Ground disturbance and waste near T17 and surrounding trees
