# **ARBORICULTURAL REPORT**

## **& Impact Assessment**

***Smart Innovation Centre,  
Church Street,  
Darfield,  
Barnsley,  
South Yorkshire  
S73 9LG***

Reference: AWA2312

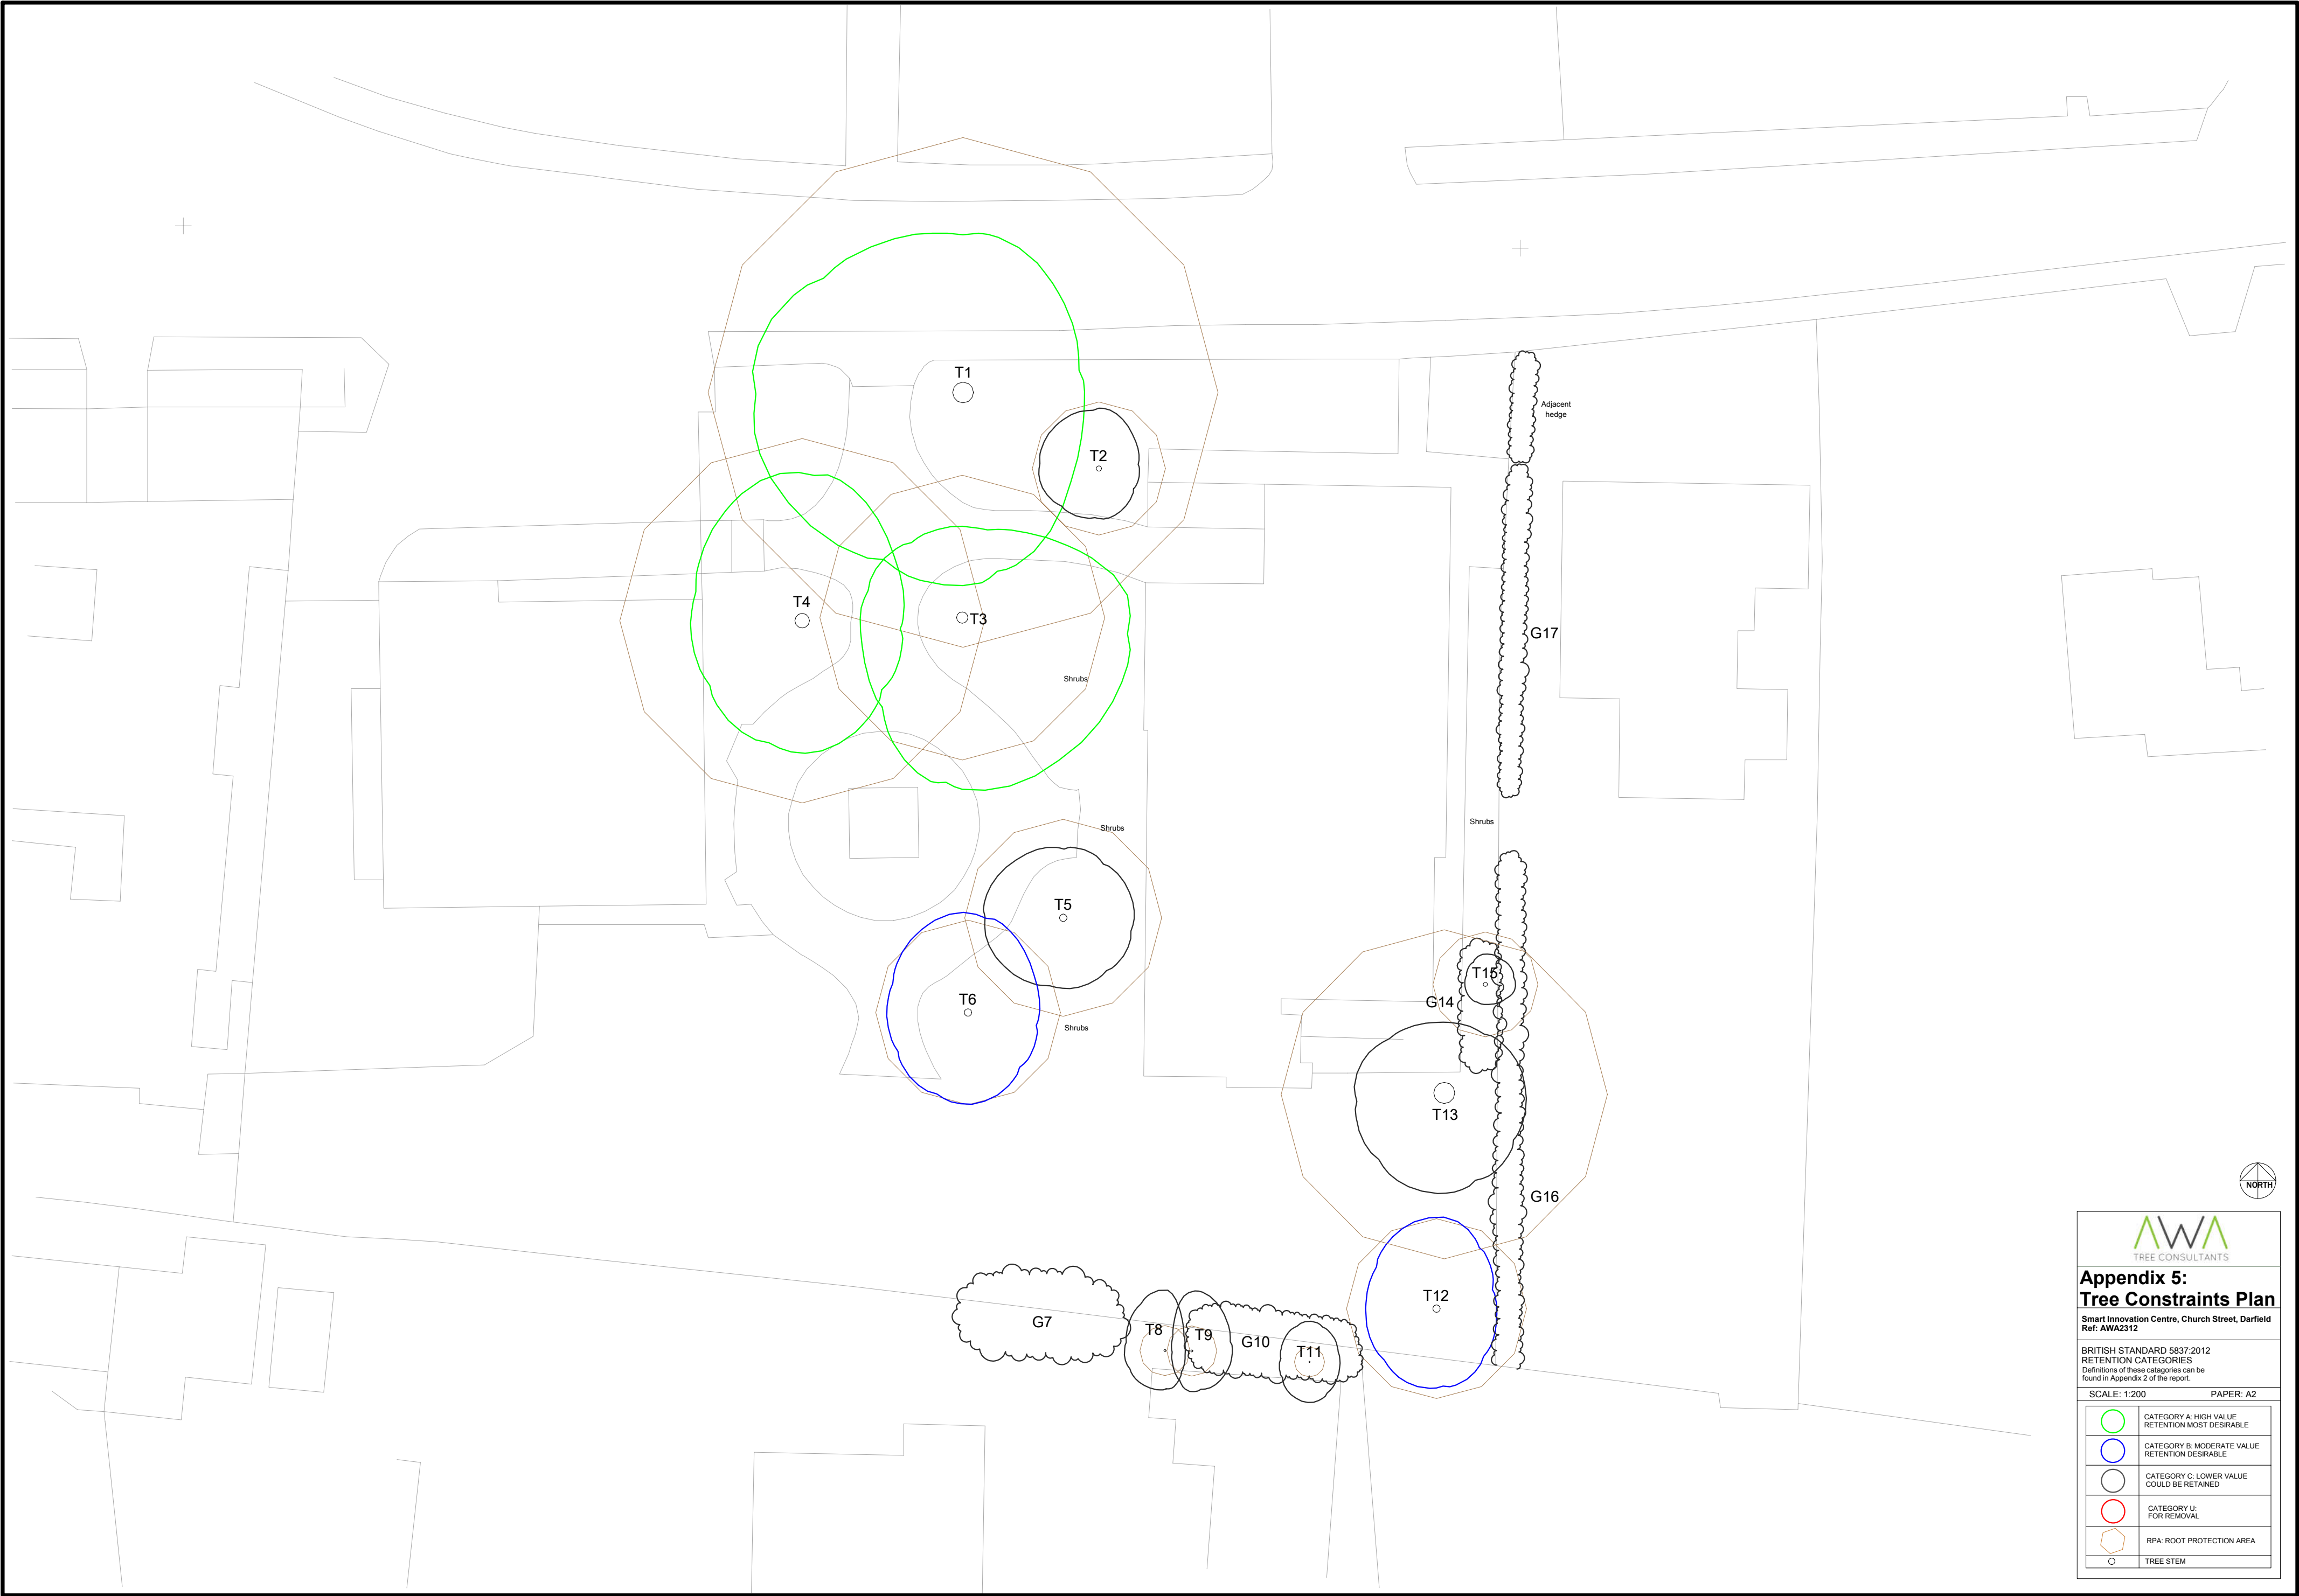
**Appendix 5:  
Tree Constraints Plan**

- 3.2.4 The site's most significant tree is the large mature Plane T1 situated within the adjacent war memorial garden to the west of the site. The tree is situated in a prominent roadside position and is in good overall condition, providing high amenity value to the site and surrounding area. The tree is situated on raised ground with retaining walls to the north and west of the tree's main stem and downward sloping ground to the east.

- 3.2.5 Two large Beech trees are also situated within the adjacent war memorial garden (T3 and T4). Both are large trees in good overall condition and provide moderate to high amenity value to the site and the surrounding area. Both trees have soil compaction at their bases from foot traffic, with

extensive compaction at the base of T4.

- 3.2.7 The Holly T12 at the site's south eastern corner is in good overall condition and provides moderate amenity value to the site.
- 3.2.8 The Plane T13 has been previously 'topped' at around 4m from ground level, with regrowth forming the tree's crown. The calculated RPA for the tree was therefore likely an exaggerated representation of the tree roots' actual morphology and disposition; the detailed RPA has therefore been slightly adjusted to provide a more accurate representation. There is a moderate cavity with minor decay to the eastern side of the tree's main stem at 1.5m.

- 3.2.11 The tree Root Protection Area (RPA) is detailed on the Tree Constraints Plan at Appendix 5. The RPA for each tree has been plotted as a polygon centred on the base of the stem. Due to the presence of roads, structures, topography (and past tree management) the RPA is likely to be a simplified representation of the tree roots actual morphology and disposition.

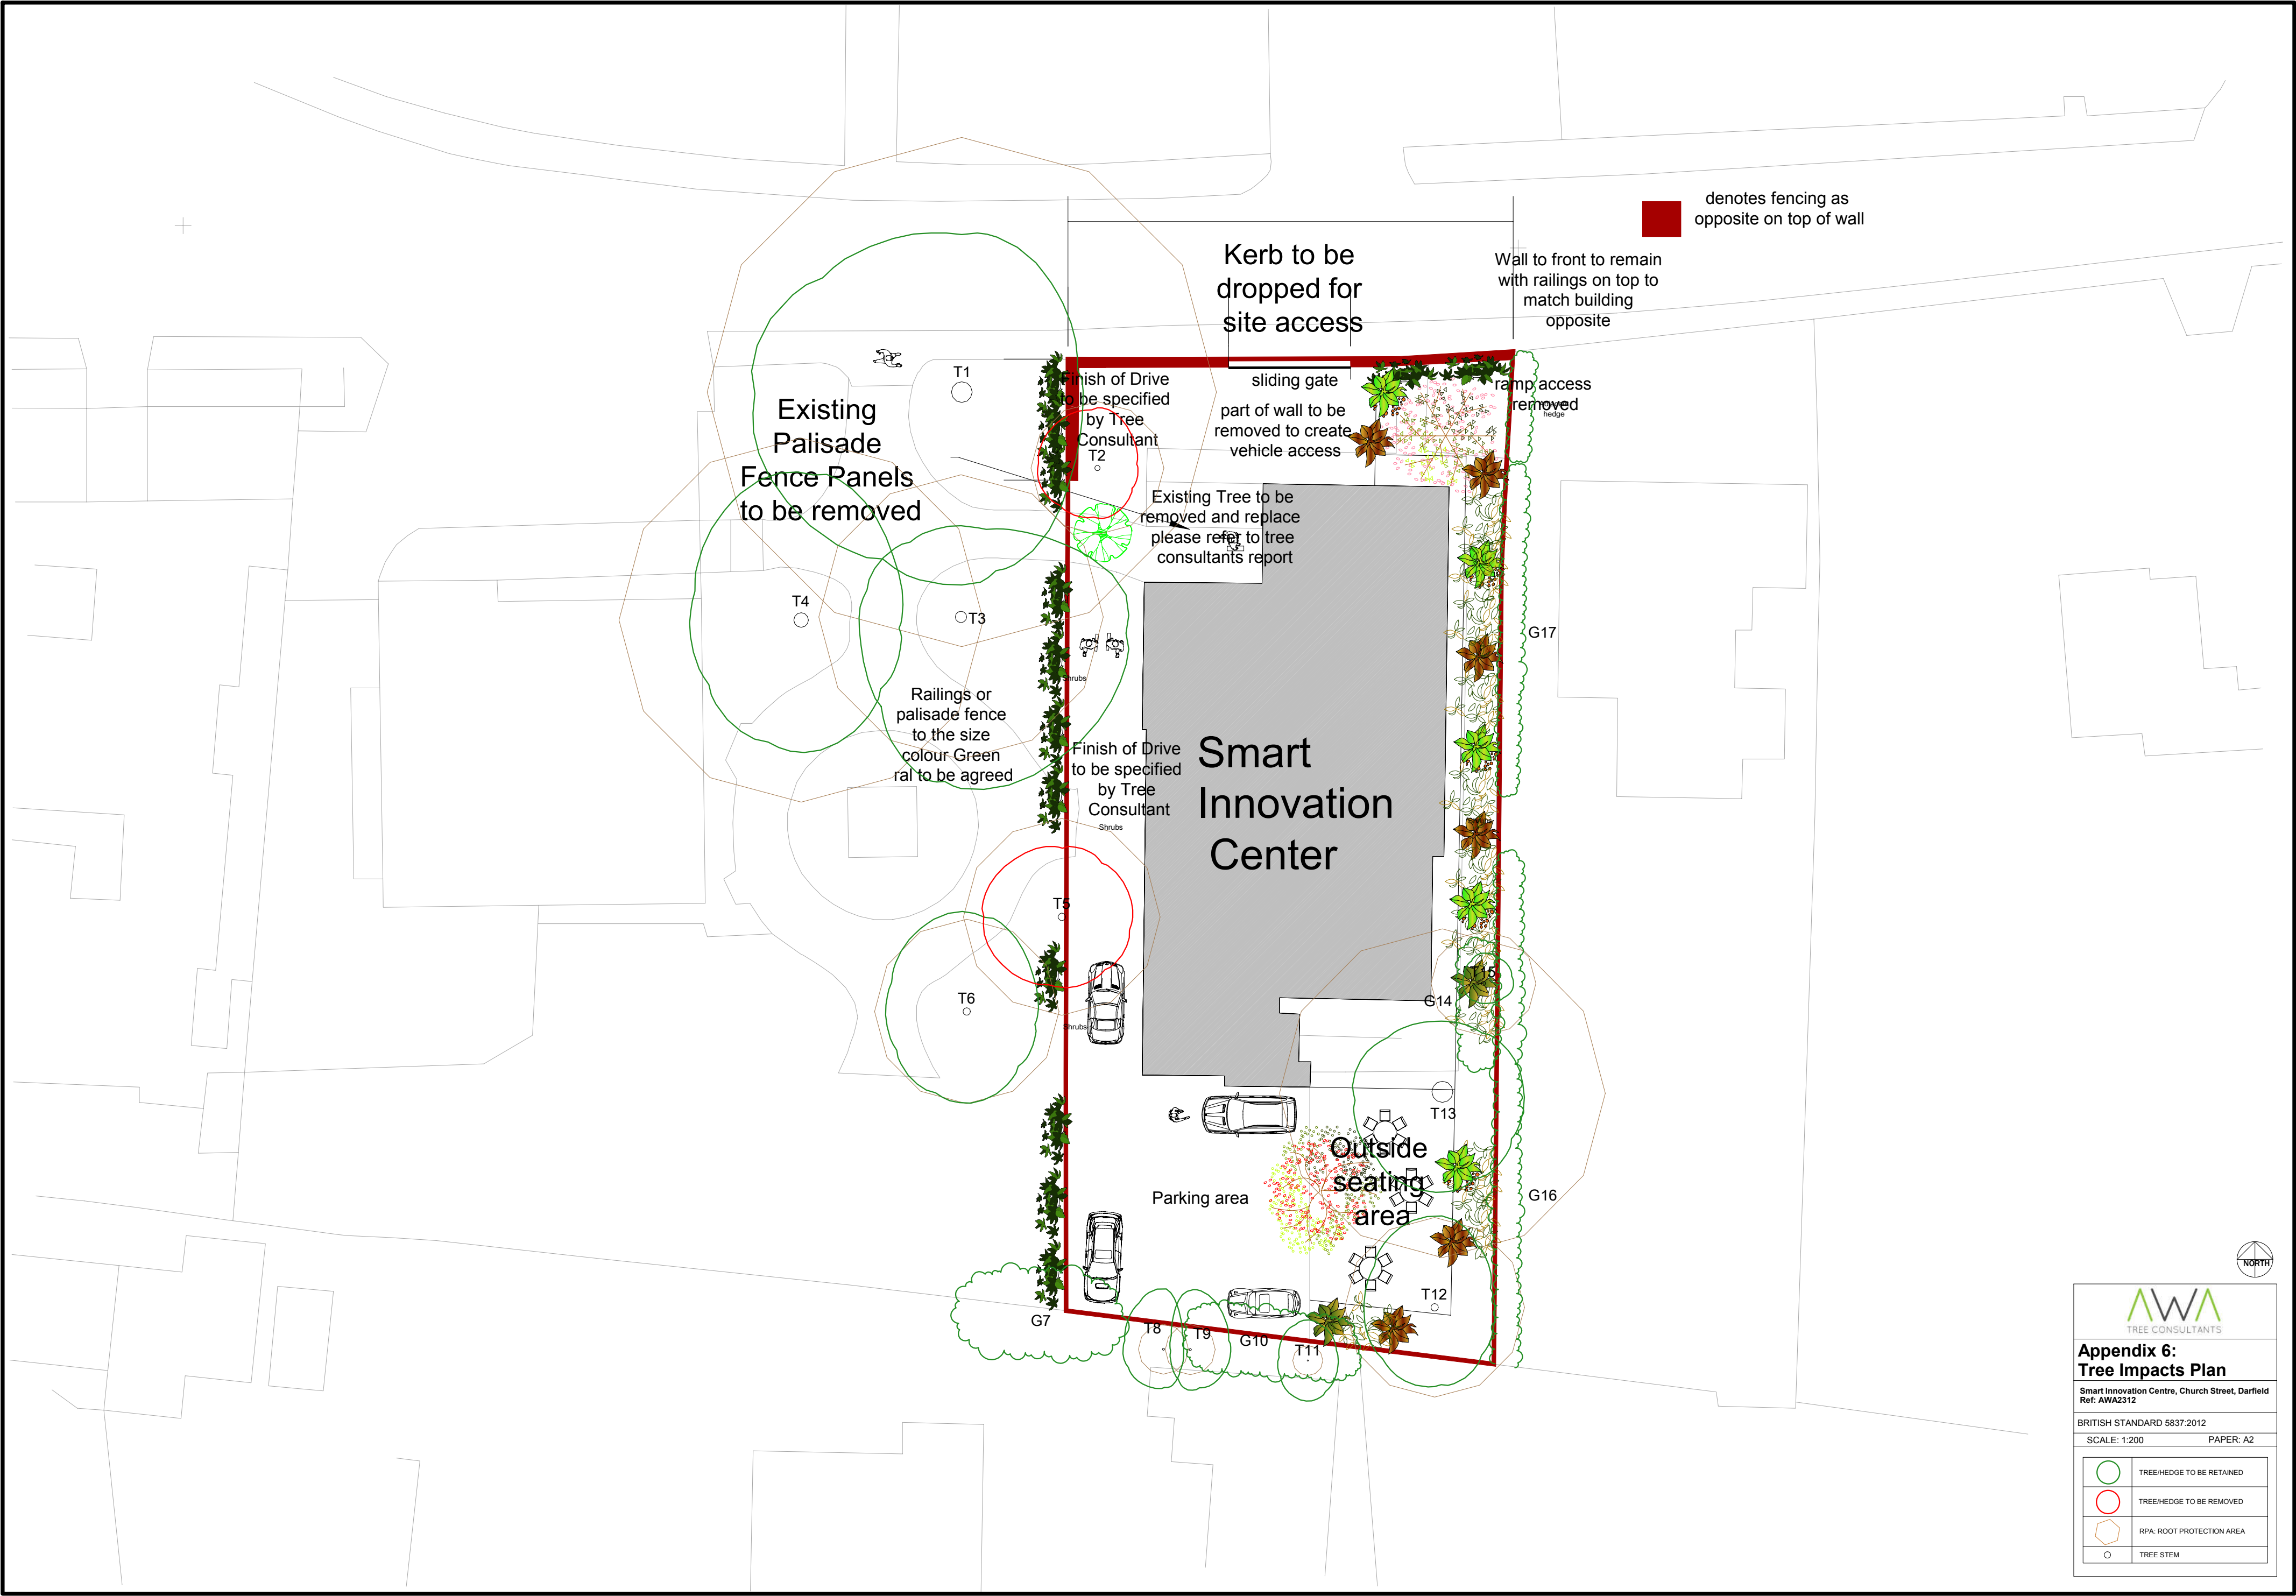
**Appendix 6:  
Tree Impacts Plan**

- 4.2.1 From assessing the new development proposals, 2 trees will require removal as they are situated in the footprint of the structure or their retention and protection throughout the development is not suitable.

- 4.2.2 The trees that require removal are the adjacent Holly trees T2 and T5. They are both of low value and their removal will have little negative impact at the site. Their removals can be easily mitigated against with new landscape plantings at the site if required.

- 4.3.1 The tree Root Protection Area (RPA) detailed on the Tree Constraints Plan at Appendix 5, has been used as a layout design tool, to inform on the area around a tree where the protection of the roots and soil structure is treated as a priority.
- 4.3.2 Potentially damaging activities are proposed in the vicinity of retained trees. The new access drive passes through the RPA of the high value Plane T1 and Beech T3. The construction of hard surfaces within the RPA can have negative impacts on tree roots. However, to overcome the potential negative impacts, the ground levels around both T1 and T3 are to remain

the same, with the proposed access road sloping up slightly west from the proposed new access point, and the new drive is to be constructed using 'no-dig' type construction methods with a porous final surface.

- 4.2.3 The adjacent Plane T1 will require its eastern crown lifting to around 3m from ground level to allow vehicle access along the proposed new drive. It is likely the tree will readily tolerate these pruning works and the amenity value it provides will not be significantly diminished.

- 4.2.4 The adjacent shrubby groups G7 and G10 will require pruning back to the boundary fenceline to facilitate the proposed new car parking area. The species within the groups are all able to tolerate significant pruning works with little negative impacts.

- 4.5.1 The retained trees will require protection by fencing in accordance with BS 5837: 2012, during the development phase.
- 4.5.2 If required by the Local Planning Authority, an associated Arboricultural Method Statement, detailing protective fencing specifications and construction methods close to the retained trees can be provided.
