# ARBORICULTURAL REPORT & Impact Assessment to BS 5837:2012 at:

***Stairfoot Roundabout - Area B,  
Stairfoot,  
Barnsley,  
S71 5DS***

Prepared for: ***Barnsley Metropolitan Borough Council***

Reference: AWA7182

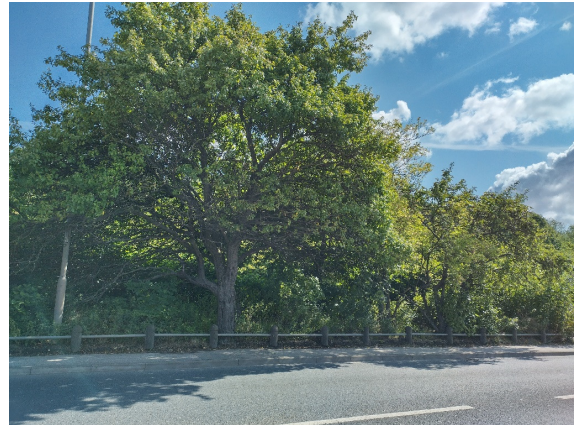
Photo 2: T21 from west.

| Tree Species | | | | Measurements | | | | Crown (m) | | | | Tree Condition | | | | | | | Value | | Management | |
|---|---|---|---|---|---|---|---|---|---|---|---|---|---|---|---|---|---|---|---|---|---|---|
| T21 | Apple | Malus domestica | Mature | 7 | 1 | 480 | No | 1.5 | 4.5 | 4.5 | 4 | 4 | No visual defects | Single stemmed. Epicormic growths. Old pruning wounds. Stubs. Tight union. Partially included bark. Minor cavities. Minor decay | Minor dieback. Moderate deadwood | Road and pavement to southwest. Crown raised over road. Lower crown over pavement mostly dead. | Fair | Fair | 20 to 40 yrs | Moderate | C | No works required |

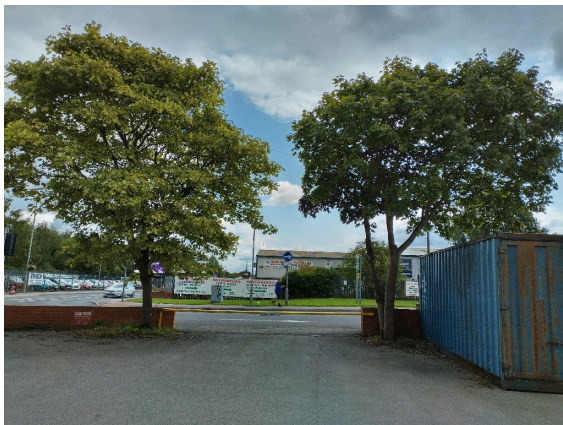
Photo 3: T41 and T42 from northwest.

| Tree Species | | | | Measurements | | | Crown (m) | | | | Tree Condition | | | | | | | | Value | | Management | |
|---|---|---|---|---|---|---|---|---|---|---|---|---|---|---|---|---|---|---|---|---|---|---|
| T41 | Norway Maple | Acer platanoides | Semi-mature | 7 | 1 | 280 | No | 1.5 | 4 | 3.5 | 3.5 | 4 | No visual defects | Single stemmed. Vertical. Old pruning wounds. Stubs | Old pruning wounds. Minor deadwood | Wall 0.5m to southeast. | Good | Good | 20 to 40 yrs | Moderate | B | No works required |

| Tree Species | | | | Measurements | | | | Crown (m) | | | | Tree Condition | | | | | | | Value | | Management | |
|---|---|---|---|---|---|---|---|---|---|---|---|---|---|---|---|---|---|---|---|---|---|---|
| T42 | Norway Maple | <i>Acer platanoides</i> | Semi-mature | 7 | 2 | 280<br>260 | No | 3 | 4 | 3.5 | 3 | 4 | No visual defects | Twin stemmed at base. Old pruning wounds. Stubs. Tight union. Partially included bark | Minor dieback. Minor deadwood | Wall 0.5m to southeast. 1 stem leans over car park to northwest. Container situated below on RPA to west. | Good | Fair | 20 to 40 yrs | Moderate | B | No works required |

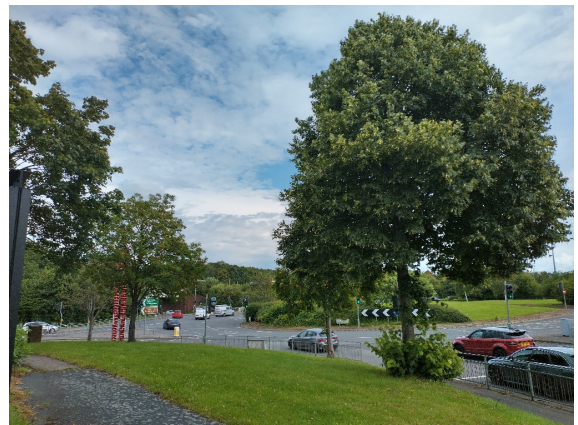
Photo 4: T45, T46 and T47 from southwest.

| Tree Species | | | | Measurements | | | | Crown (m) | | | | Tree Condition | | | | | | | Value | | Management | |
|---|---|---|---|---|---|---|---|---|---|---|---|---|---|---|---|---|---|---|---|---|---|---|
| T46 | Rowan | <i>Sorbus aucuparia</i> | Early-mature | 5 | 1 | 240 | No | 2 | 3 | 3.5 | 3 | 2 | No visual defects | Single stemmed. Slight lean. Old pruning wounds. Epicormic growths. Bark damage. Mower damage. Minor decay | Minor deadwood. Minor dieback. Old pruning wounds | Bark damage around base of stem. Slight lean to east. Overhanging pavement to south. | Fair | Fair | 10 to 20 yrs | Moderate | B | No works required |

| Tree Species | | | | Measurements | | | Crown (m) | | | | Tree Condition | | | | | | | Value | | | Management | |
|---|---|---|---|---|---|---|---|---|---|---|---|---|---|---|---|---|---|---|---|---|---|---|
| T47 | Rowan | Sorbus aucuparia | Early-mature | 6 | 1 | 220 | No | 2 | 2.5 | 2.5 | 3 | 3 | No visual defects | Single stemmed. Vertical. Bark damage. Mower damage | Minor deadwood | 2 co-dominant stems at 2m with tight union but possible supporting branch above. | Good | Fair | 20 to 40 yrs | Moderate | B | No works required |

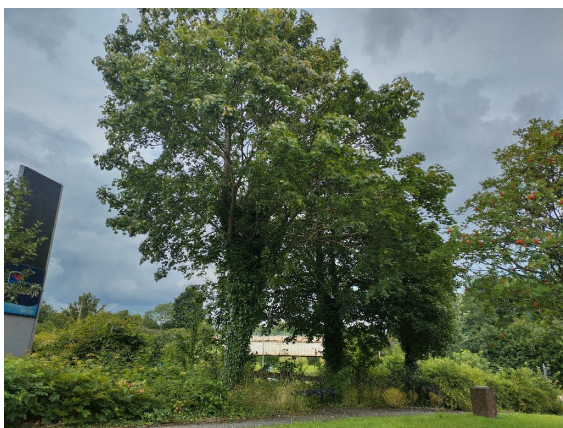
Photo 5: T49 and T50 from south.

| Tree Species | | | | Measurements | | | Crown (m) | | | | Tree Condition | | | | | | | Value | | | Management | |
|---|---|---|---|---|---|---|---|---|---|---|---|---|---|---|---|---|---|---|---|---|---|---|
| T50 | Norway Maple | Acer platanoides | Semi-mature | 9 | 1 | 470 | No | 2 | 5 | 4.5 | 4.5 | 4 | No visual defects | Single stemmed. Vertical. Ivy covered | Ivy covered. Minor deadwood | Overhanging pavement to south. Carpark 0.5m to north. | Good | Good | >40 yrs | Moderate | B | Removal required to facilitate the development |

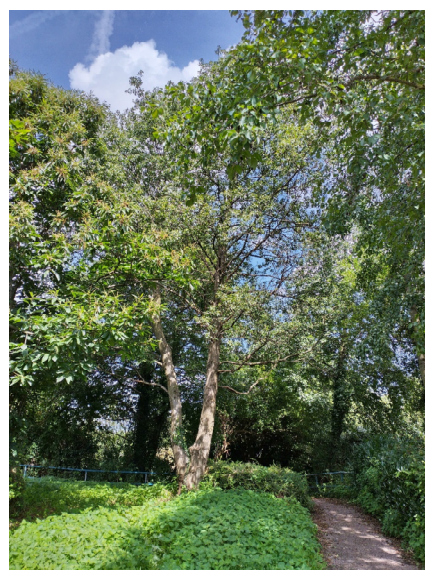
Photo 6: T71 from south.

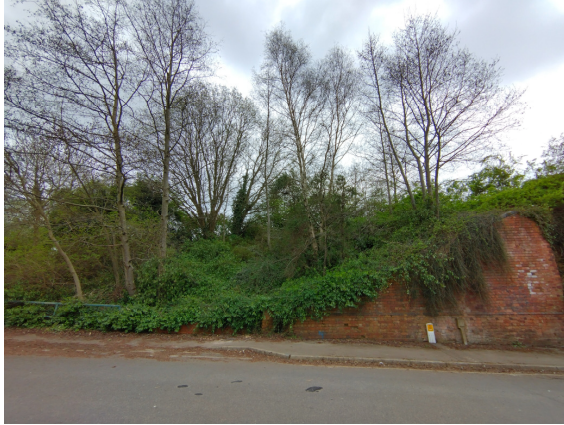
Photo 1: Northern edge of G78 from north.

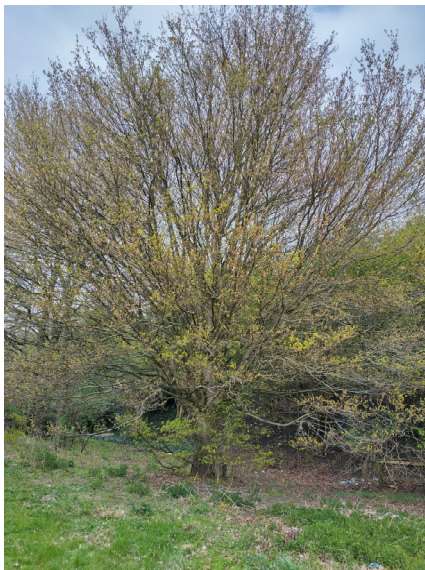
Photo 3: T226 from south

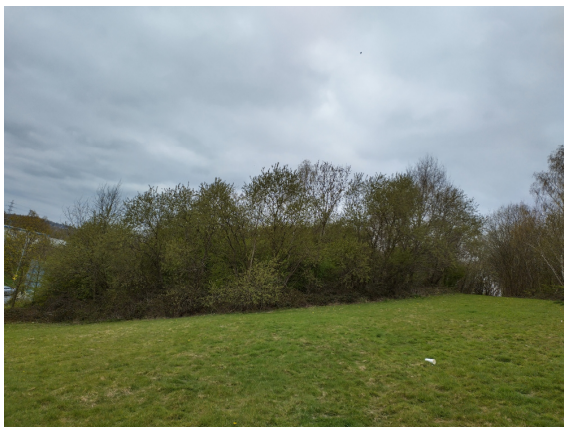
Photo 5: G247 from south.

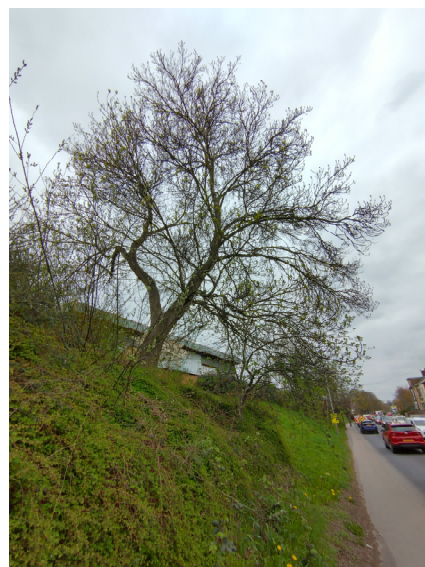
Photo 6: T242 from south.
