**HALL FARM, HIGH HOYLAND.**

**BAT SURVEY.**

**Ref No:- 100431.**

**Date: 8<sup>th</sup> June 2010.**

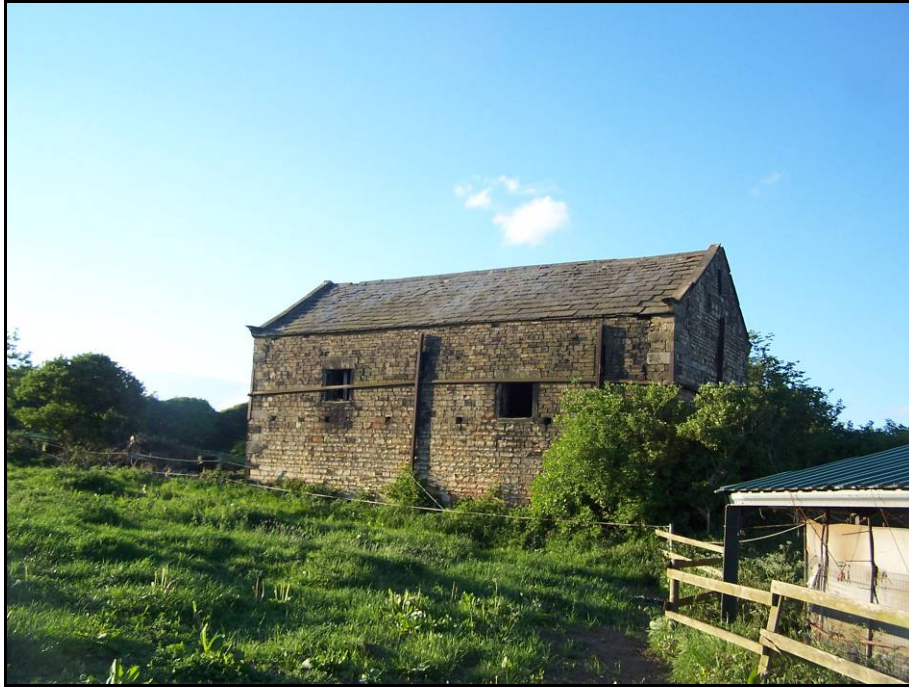
### **3.2.2. Building 1.**

3.2.2.1.1. Building 1 is a two storey stone building with a stone tiled pitched roof. The building is currently disused and in a deteriorating state.

3.2.2.1.2. The walls of the building are coursed stone with a rubble fill and brickwork to the interior. There are no windows or doors fitted to the building and there are also various holes in the walls due to the deteriorating stonework.

3.2.2.2.1. The walls of the building are in a deteriorating state with abundant voids to the inside and through to the rubble fill of the walls. No bat field signs were identified around the exterior of the building although the walls provide a high potential for roosting bats.

3.2.2.2.2. The roof of the building is in a generally good condition with all roof and ridge tiles in place although the non uniform nature of the tiles leaves abundant voids. No bat field signs were identified around the roof of the building.

3.2.2.2.3. No bat field signs were identified around the interior of the building during this survey although the brick and stonework displays abundant voids and the timber roof frame displays gaps around the joints providing potential bat roosting sites.

3.2.2.2.4. A number of barn owl pellets were identified within the building during this survey although no barn owl nest was identified.

3.2.2.2.5. A crow's nest was identified in the southeast gable end of the building with a crow identified going to the nest during the survey implying that the nest is currently in use.

3.2.2.2.6. A number of other old nests were identified within the walls and along the ridge of the building during this survey although none of the nests appeared to be in use at the time of this survey.

5.4. Due to the presence of barn owl pellets within Building 1 it is recommended that either a barn owl nest box is designed into one of the new buildings on the site or that a barn owl nest box on a pole is erected somewhere around the northwest corner of the site.

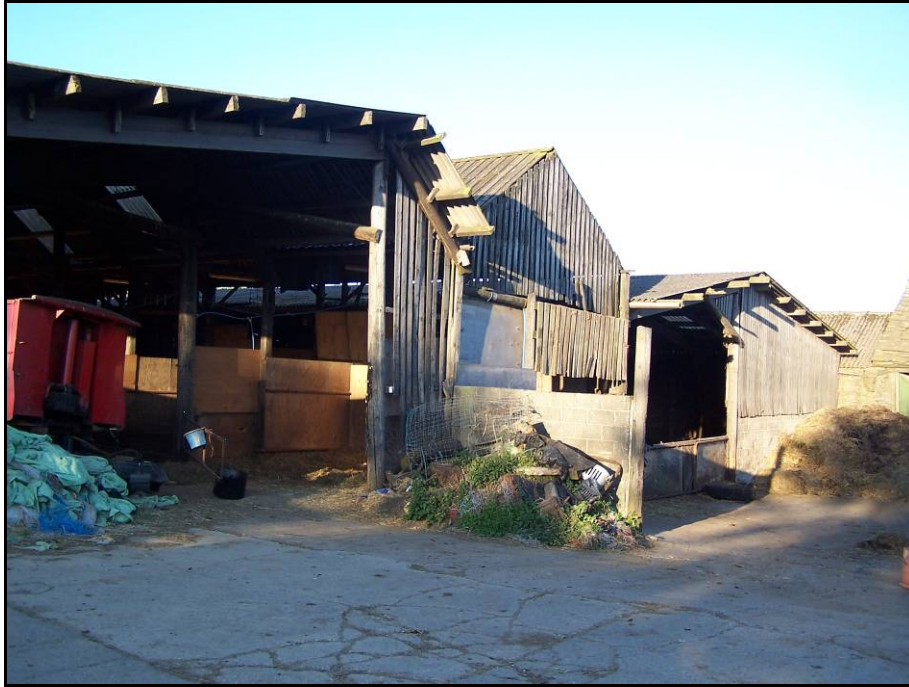
### **3.2.3. Building 2.**

3.2.3.1.1. Building 2 is a series of three connected timber framed barns with pitched roofs. The barns are currently used as stables and general storage areas.

The buildings provide little or no bat roosting potential due to the wood framed construction and single skin corrugated roof covering. No bat field signs were identified around the barns during this survey.

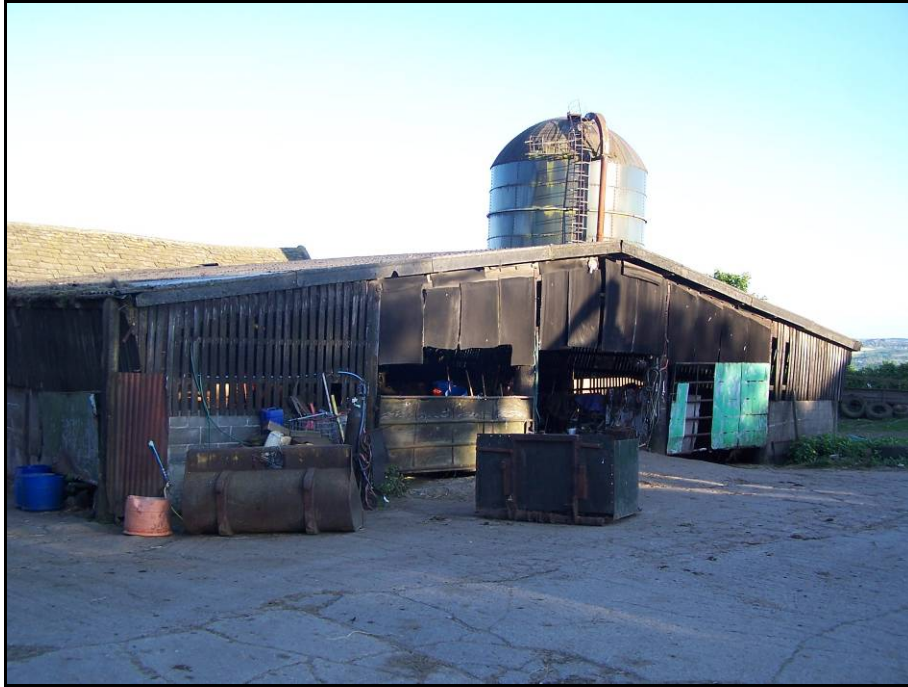
### **3.2.4. Building 3.**

3.2.4.1.1. Building 2 is a single storey wood framed barn with a low pitched roof. The barn is currently used as a stables and general storage area.

3.2.4.2.1. Due to its construction the building provides a very low bat roosting potential and no bat field signs were identified around the building during this survey.

3.2.4.2.2. A number of old bird's nests were identified within the building but no bird activity was identified around the nests during this survey.

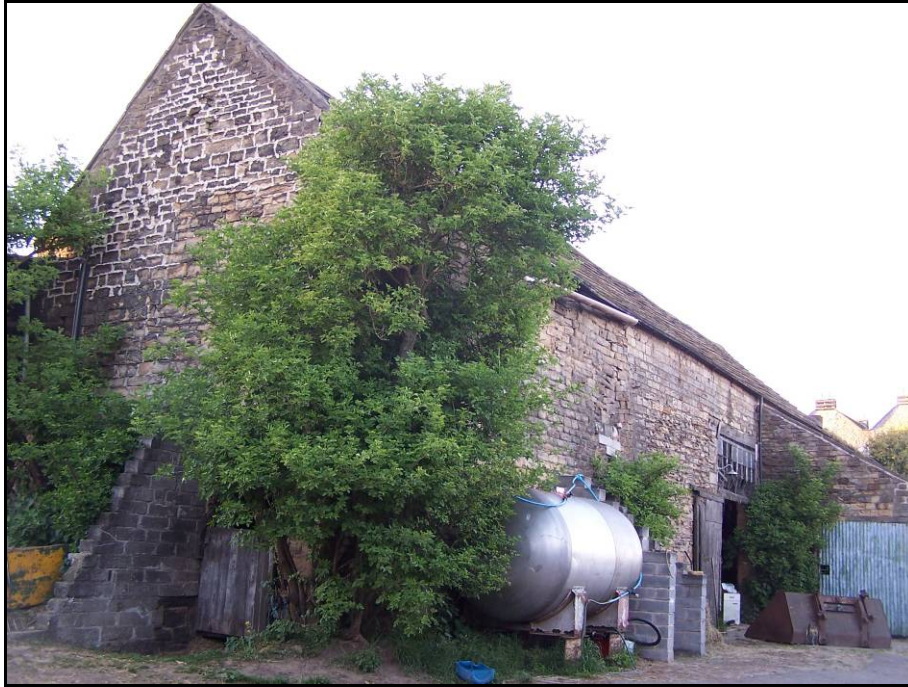
### **3.2.5. Building 4.**

3.2.5.1.1. Building 4 is a two storey stone constructed barn with a pitched roof. The building is joined to the rear of buildings 2 and 3. The building is currently used as stables and storage area on the ground floor with the first floor being disused.

3.2.5.1.2. The walls of the building are constructed from coursed stone with a rubble fill. The windows and doors around the building are all intact although not sealed and with missing panes of glass providing potential bat access points.

3.2.5.2.1. The building displays abundant voids around the exterior stonework although no bat field signs were identified around any of the voids.

3.2.5.2.2. A very small number of bat droppings were identified within the first floor room of the building. The droppings were scattered with no concentration in any one area of the room.

3.2.5.2.3. The droppings appeared to be old and therefore the species of bat could not be identified based on the droppings.

4.8. Anabat 1, located within Building 4, picked up Pipistrelle 45 bat activity as early as 21:27 with no surveyors or Anabats picking these bats up coming onto the site therefore it is assumed that the bats emerged from somewhere within Building 4.

4.9. Anabat 1 also picked up a brief unidentified Myotis bat at 22:22 which was then picked up around the perimeter of the site from 22:30 to 22:33 implying that the bat emerged from within Building 4.

5.1. Due to the early recordings of Pipistrelle 45 bats within Building 4 and the recordings of an unidentified Myotis bat within this building it is recommended that a further dusk emergence and a dawn swarming bat survey of this building and the immediately surrounding area is carried out prior to work on site commencing.

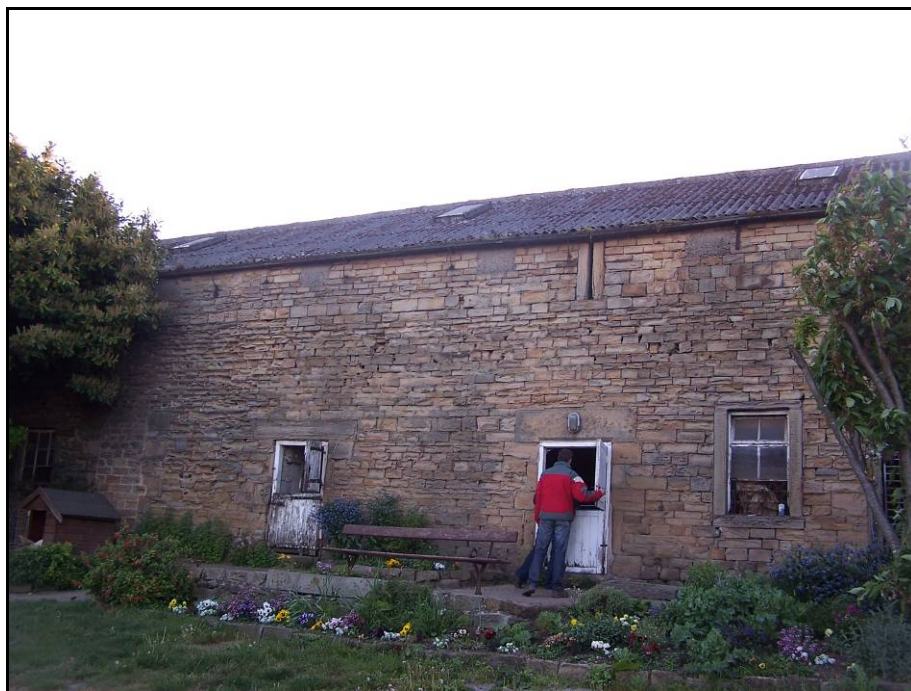
### **3.2.6. Building 5.**

3.2.6.1.1. Building 5 is a two storey stone built barn with a corrugated sheeting roof. The building is attached to the northern end of Building 4 and joins to another building not included in this survey. The building is currently used as a general storage area.

3.2.6.1.2. The walls of the building are constructed from coursed stone with a rubble fill. The windows and doors of the building are all intact although not fully sealed leaving potential bat access points.

3.2.6.2.1. The exterior stonework of the building displays abundant voids although no bat field signs were identified around the voids during this survey.

3.2.6.2.2. No bat field signs were identified throughout the interior of the building during this survey.

3.2.6.2.3. A number of old nests were identified within the building during this survey although no bird activity was identified around the nests.

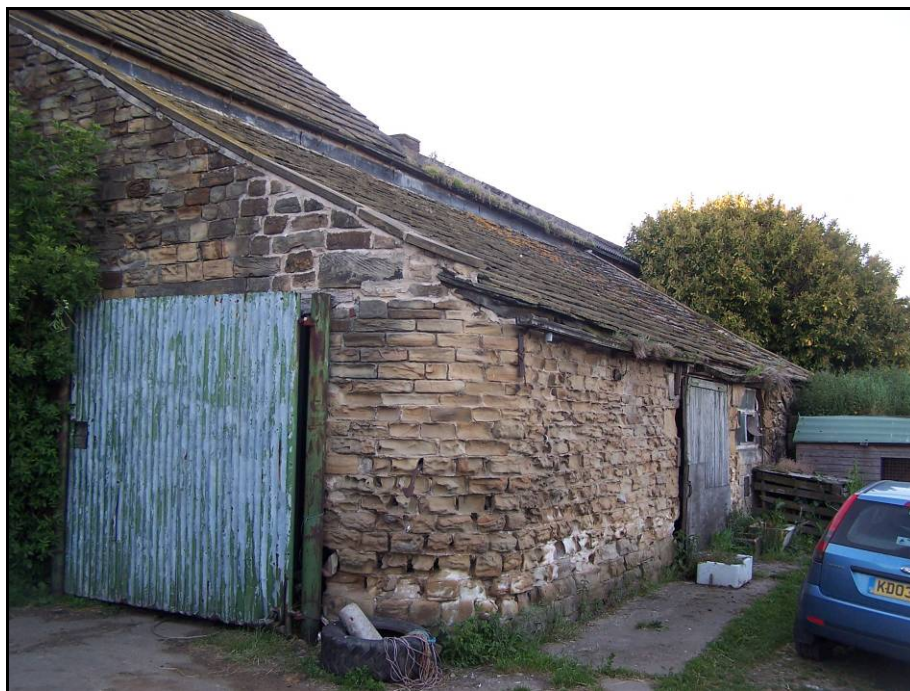
#### **3.2.7. Building 6.**

3.2.7.1.1. Building 6 is a single storey stone constructed barn with a stone tiled sloping roof. The building is joined to the front of buildings 4 and 5 and is currently used for general storage.

3.2.7.1.2. The walls of the building are constructed from coursed stone with a rubble fill. The windows and doors of the building are all in place but there are various gaps around the doors providing potential bat access.

3.2.7.2.1. The exterior walls of the building display abundant voids that would provide suitable bat roosting sites although no bat field signs were identified around the building during this survey.

3.2.7.2.2. The roof of the building displays abundant voids due to the irregular shape of the tiles. The voids will provide access to the void between the tiles and the lining felt although no bat field signs were identified during this survey.

3.2.7.2.3. No bat field signs were identified around the interior of the building during this survey.

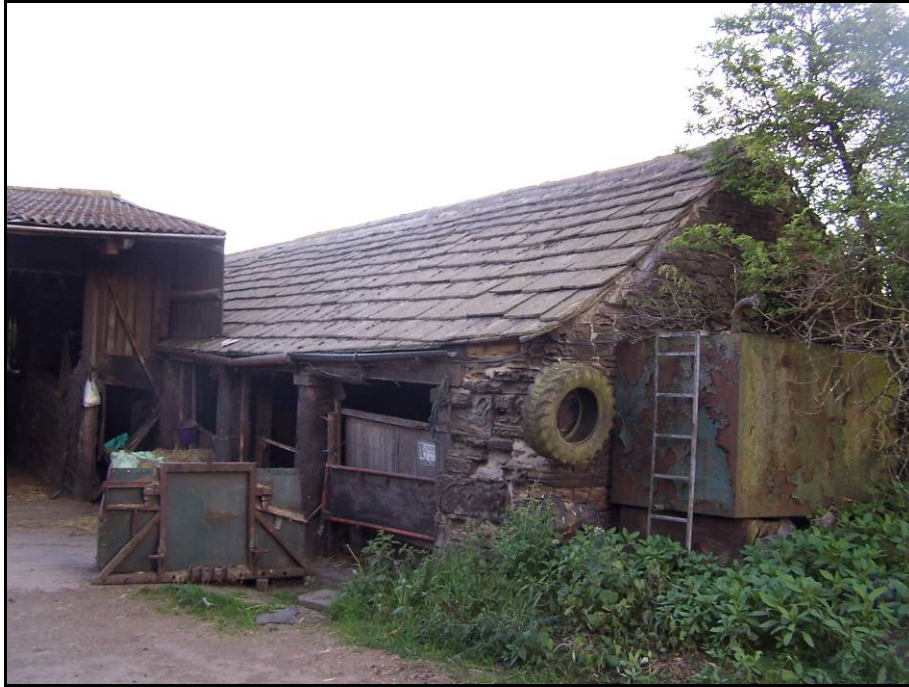
### **3.2.8. Building 7.**

3.2.8.1.1. Building 7 is a single storey stone barn with a tiled pitched roof. The building is currently used as stables.

3.2.8.1.2. The walls of the building are constructed from coursed stone with a rubble fill. The northern side of the building is predominantly open with no doors in place.

3.2.8.2.1. The exterior stonework of the building displays abundant voids although no bat field signs were identified during this survey.

3.2.8.2.2. The roof of the building displays very few voids due to the uniform shape of the stone roof tiles. No bat field signs were identified around the roof of the building.

3.2.8.2.3. No bat field signs were identified around the interior of the building during this survey.

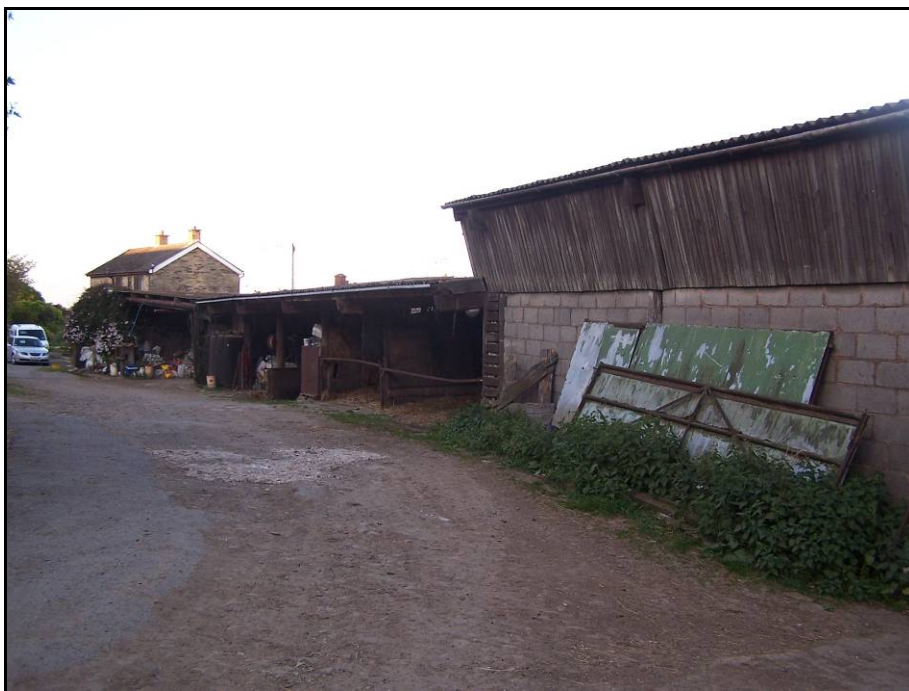
### **3.2.9. Building 8.**

3.2.9.1.1. Building 8 comprises a series of single storey wood framed barns. The barns are used as a garage, stables and general storage area.

3.2.9.2.1. The building provides a very low potential for roosting bats due to its wood framed construction.

3.2.9.2.2. Occasional bat droppings were identified in the southern end of the building during this survey. The low number of droppings and the lack of a concentration of droppings in any one area imply that the building is used for occasional foraging.

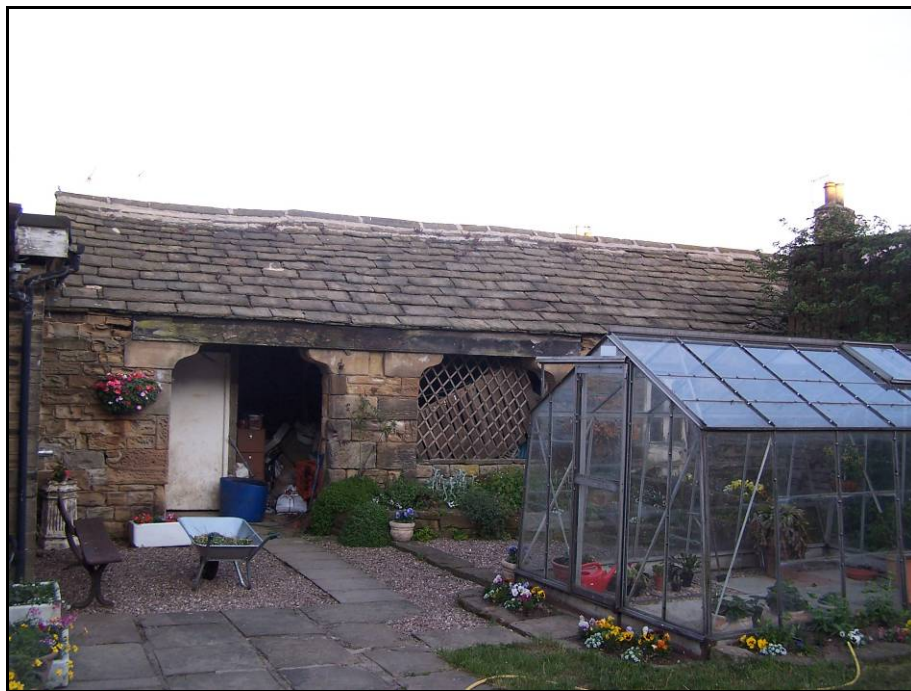
### **3.2.10. Building 9.**

3.2.10.1.1. Building 9 is a single storey stone constructed barn with a pitched roof. The building is currently used as a general storage area.

3.2.10.1.2. The walls of the building are constructed from coursed stone with a rubble fill. The western side of the building is predominantly open with no doors fitted.

3.2.10.2.1. The walls of the building display abundant voids although no bat field signs were identified around the stonework during this survey.

3.2.10.2.2. The roof tiles are quite uniform providing very few voids and all the ridge tiles are in place and well pointed. No bat field signs were identified around the roof of the building.

3.2.10.2.3. No bat field signs were identified around the interior of the building during this survey.
