# **ARBORICULTURAL REPORT & Impact Assessment to BS 5837:2012 at:**

***1 Tivy Dale Drive,  
Cawthorne,  
Barnsley,  
S75 4EN***

Prepared for:  
***NYP Architectural Services Limited***

Reference: *AWA5414*

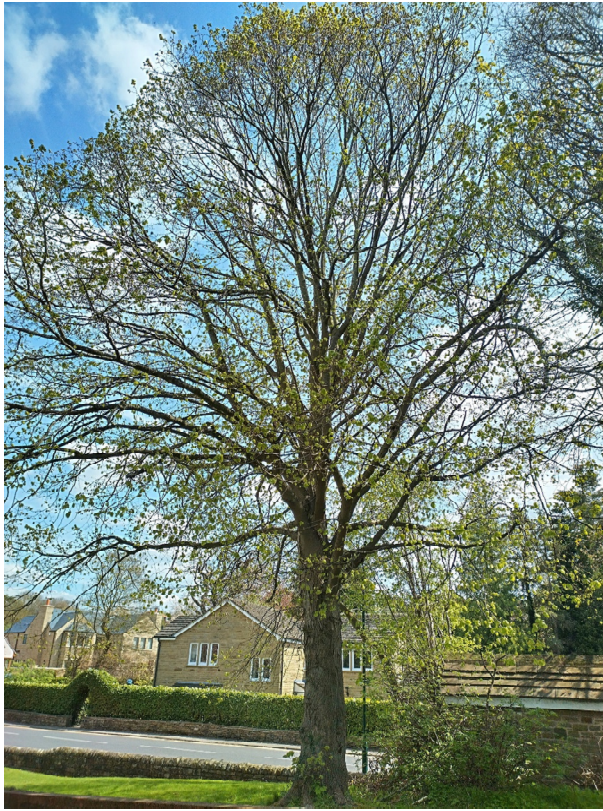
- 3.2.5 The sites most valuable trees are Lime T14 and Oak T28. Both are large,

mature trees providing moderate to high levels of amenity to the site and the surrounding properties. Lime T14 is in particularly good condition and as such is a retention category 'A' tree. Oak T28 would normally be retention category 'A' also, but it has defects which limit its value. The major defect limiting T28 was a large *Ganoderma australe* fungal bracket to the base of the stem which is likely to limit this tree's long term prospects. A formal tree risk survey is recommended to T28 regardless of development at the site.

Photo 1: T14 from west.

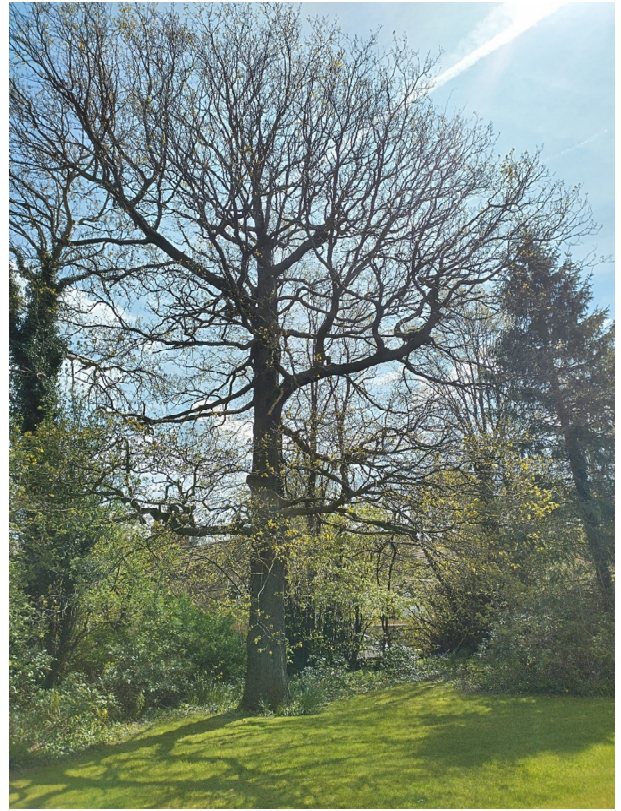
Photo 2: T28 from north west.

| | Tree Species | | | Measurements | | | Crown (m) | | | | | Tree Condition | | | | | | | | Value | | Management |
|---|---|---|---|---|---|---|---|---|---|---|---|---|---|---|---|---|---|---|---|---|---|---|
| T28 | Common Oak | Quercus robur | Mature | 21 | 1 | 850 | No | 1.5 | 7.5 | 6 | 7.5 | 7.5 | No visual defects | Single stemmed. Vertical. Old pruning wounds. Fungus. Bark damage | Minor deadwood. Moderate deadwood. Old pruning wounds. Minor snapouts | Metalwork embedded in stem. Large Ganodemra australe fungal bracket to north eastern side at base of stem. Likely historic pruning works undertaken such as crown reduction. | Good | Fair | 20 to 40 yrs | Moderate | B | Formal tree risk assessment recommended regardless of development |

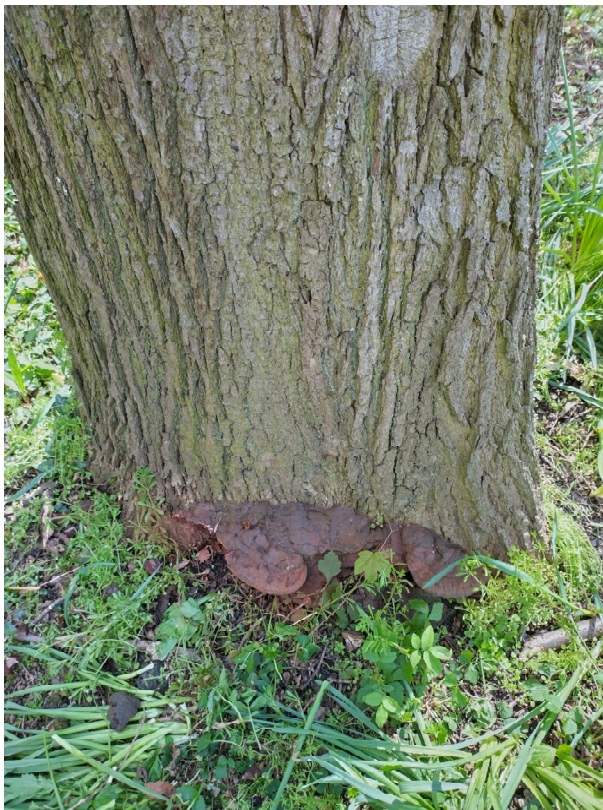
Photo 3: *Ganoderma australe* fungus to base of T28.
