# ARBORICULTURAL REPORT & Impact Assessment to BS 5837:2012 at:

***379 Carlton Road,  
Carlton,  
Barnsley,  
S71 3JB***

Report Date: *October 2025*

Reference: *AWA6984*

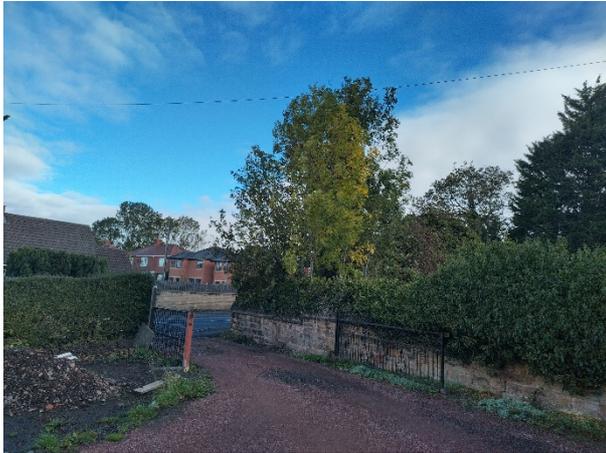
Photo 1: T1 and T2 from south

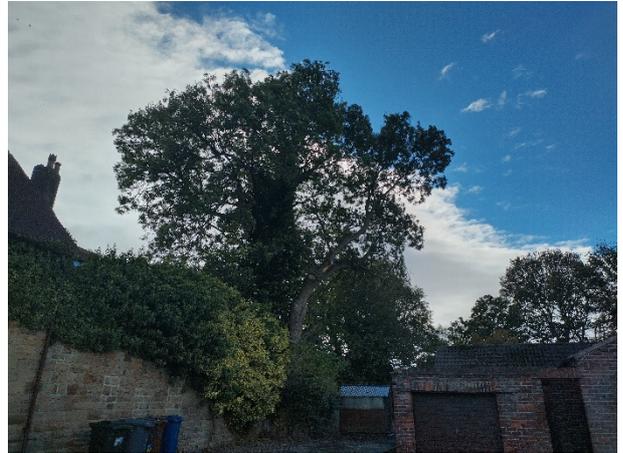
- 3.2.5 Most of the trees are semi-mature with only occasional early mature to mature trees.
- 3.2.6 The site's most significant tree is T3, a mature Ash. Situated to the east of the site and within the Carlton conservation area. T3 has some notable pruning wounds from historic works that slightly limits its value but T3 is prominent throughout the entire site and surrounding area and provides a moderate level of amenity value. No clear symptoms of Ash dieback were observed at the time of inspection, although ongoing monitoring is recommended due to the prevalence of the disease.

Photo 2: T3 from north

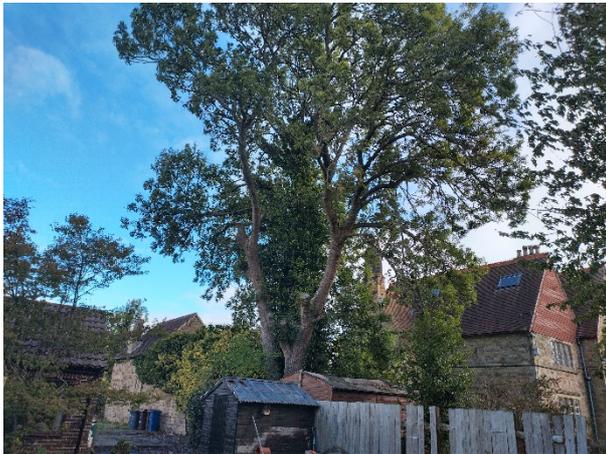
Photo 3: Stem of T3 from south

T3	Common Ash	<i>Fraxinus excelsior</i>	Mature	17	1	800	Yes	6	10	8	9	9	Limited access around base	Multiple stemmed, Old pruning wounds, Stubs, Ivy covered, Minor cavities, Minor decay	Minor deadwood, Moderate deadwood, Snapped /hanging branches, Old pruning wounds, Minor cavities	Adjacent tree. Limited access and Ivy prevented detailed inspection and stem measurements. One stem heavily Ivy clad. Significant pruning wounds to all three stems and in crown, with tear out wounds. Hung up branch in southern crown. Overhangs adjacent shed and overhangs site.	Good	Fair	20 to 40 yrs	Moderate	B	No works required to facilitate development
T4	Wild Cherry	<i>Prunus avium</i>	Semi-mature	12	2	250, 200	Yes	3	4	4.5	2	4	Limited access around base	Multiple stemmed, Ivy covered, Old pruning wounds, Stubs	Minor deadwood	Adjacent tree, limited access and Ivy prevented detailed inspection. Fence to immediate west.	Good	Fair	20 to 40 yrs	Low	C	No works required to facilitate development

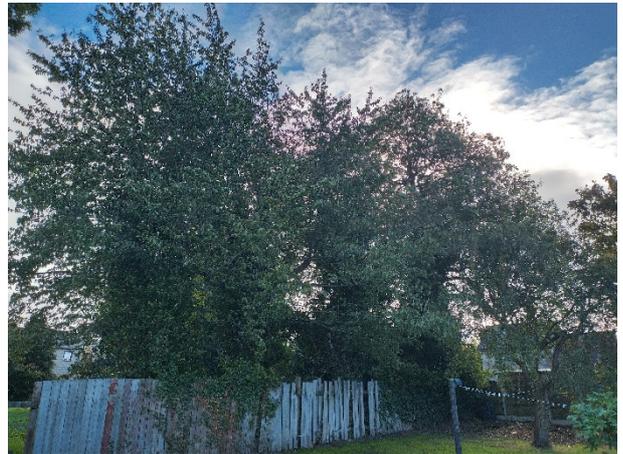
- 3.2.7 T4-T7 are adjacent semi mature Cherry, Sycamore and Ash trees along the eastern boundary of site. They provide some screening but are of lower

Photo 4: T4-T7 and T9 from north

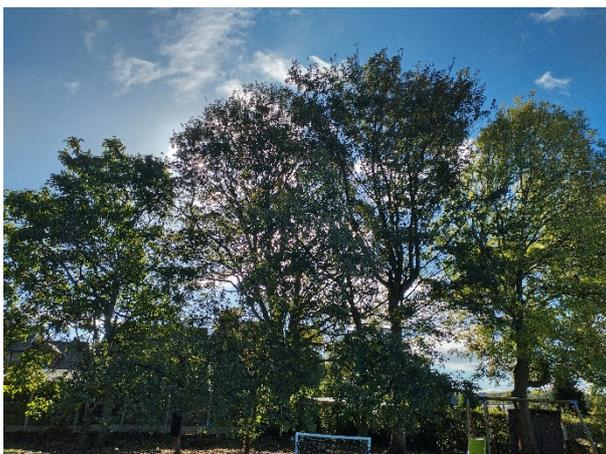
- 3.2.8 T9-T13 and T15-T17 form an area of semi and early mature garden trees at the site's southern end. These trees have some minor defects such as exposed and damaged roots but are in fair overall condition and provide some collective amenity and screening value.

- 3.2.9 T14 is an adjacent early mature Sycamore tree to the south of site. It is prominent within the site and wider area and provides a moderate level of arboricultural value.

Photo 5: T10-T17 from north

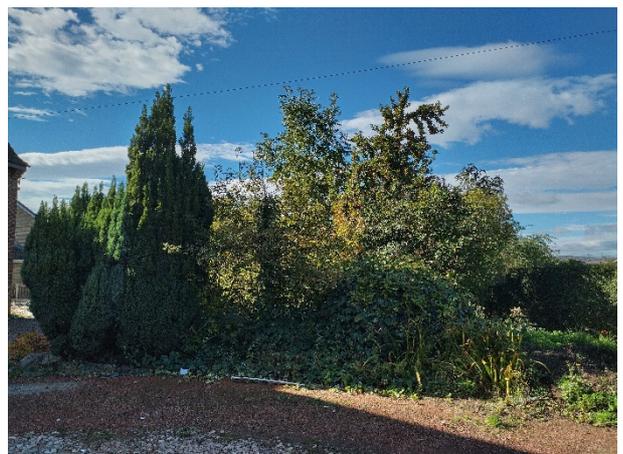
- 3.2.10 T19-T26 form part of an unmanaged ornamental shrubbery group in the northwest corner of site. These trees are of lower overall value but provide some screening value from the road.

Photo 6: T19-T26 form east

4.2.1 From assessing the new development proposals, 3 trees and 1 tree group will require removal to facilitate the development as they are situated in the footprint of the development or their retention and protection throughout the development is not suitable.

4.2.2 The trees that require removal to facilitate the development are T8, T19 and T20.

4.2.3 The tree group that requires removal to facilitate the development is G24.
